Review and document all components of the torque sensor assembly. Analyze the debris of the submitted samples, oil filter, and magnetic chip detector.

| PART NAME: | Torque Sensor Assembly |
| MODEL/PROGRAM: | TPE331 |
| MODEL/PROGRAM S/N: | P92122C |

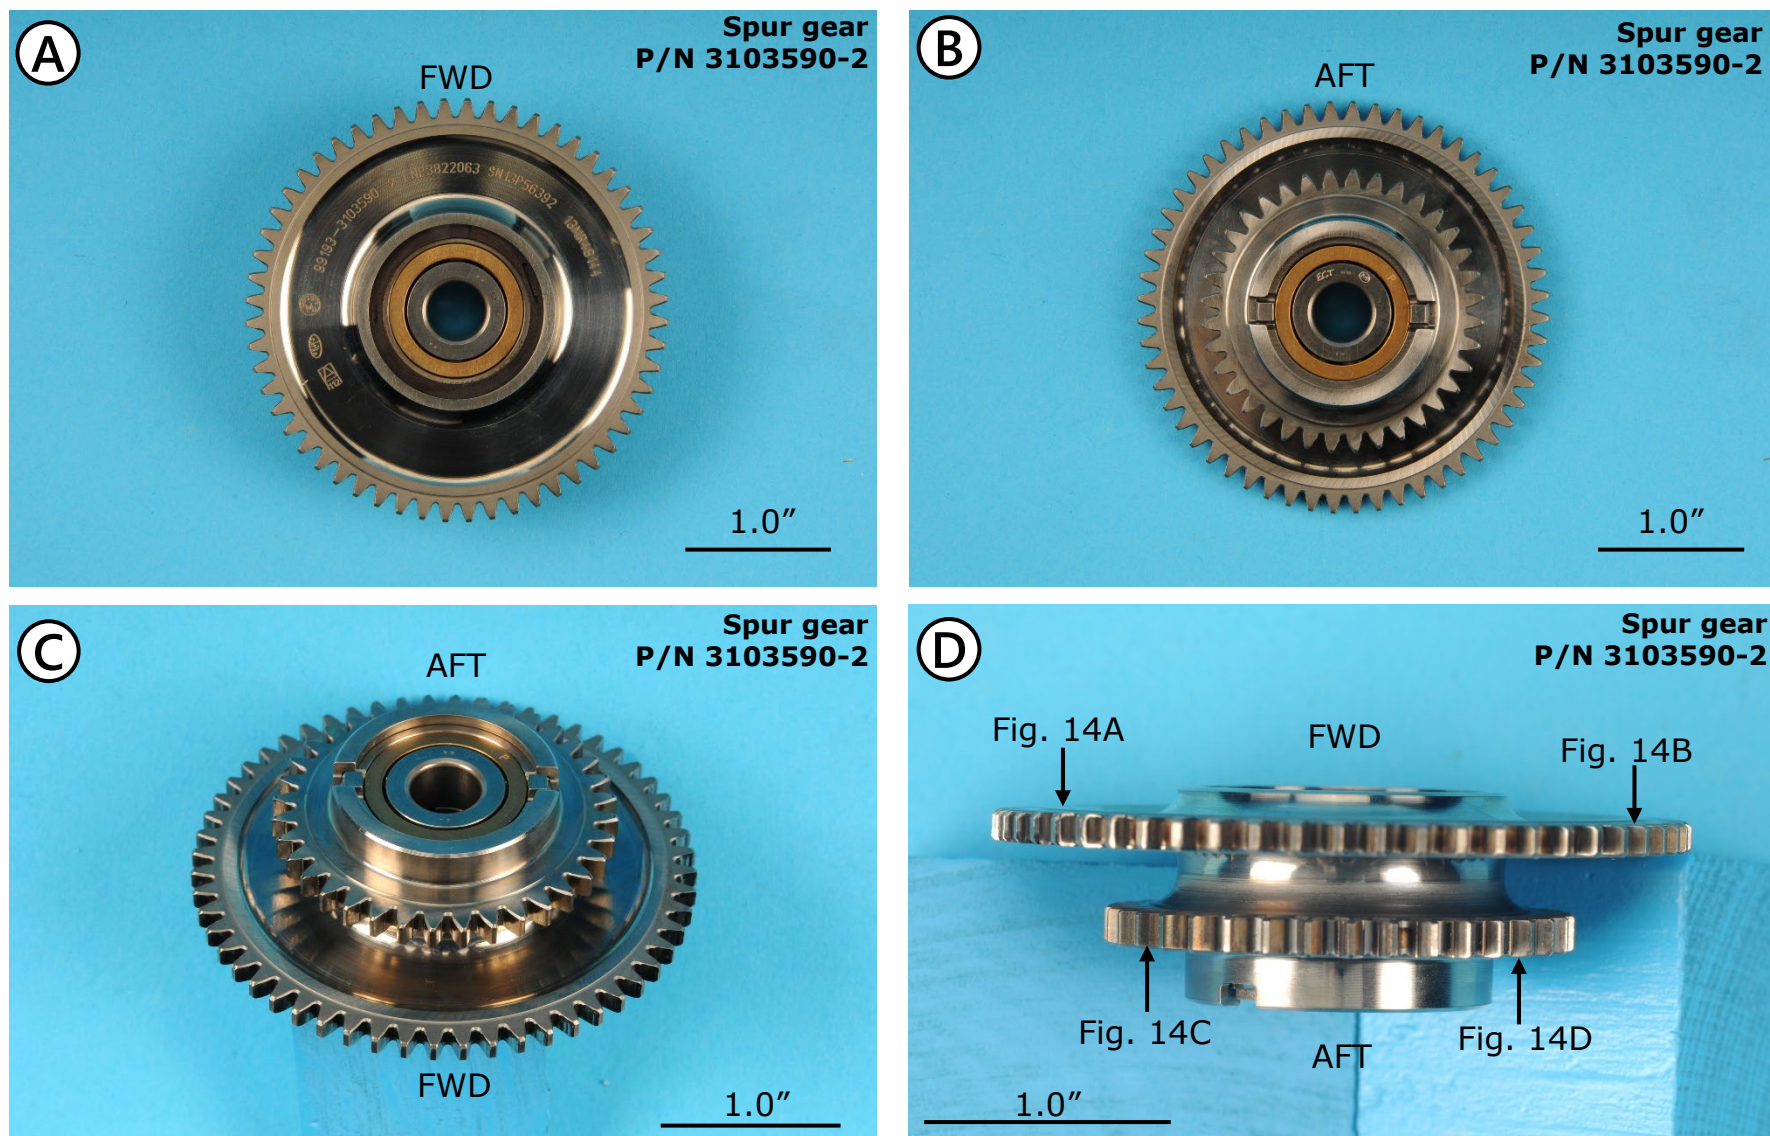
**Figure 13.**

The as-received condition of the 3<sup>rd</sup> idler spur gear from TPE331 engine S/N P92122C is shown in Figure 13-14. Wear was observed on the forward and aft gear teeth from contact with the mating components. The wear depths on the forward and aft gear teeth were measured to be approximately 0.003" and 0.004", respectively (Figure 15).

(A-D) Images showing the as-received condition of the 3<sup>rd</sup> idler spur gear (P/N 3103590-2) from TPE331 engine S/N P92122C in the assembled state. Close-up images of the gear teeth in the areas of identified in (D) are shown in Figure 14.

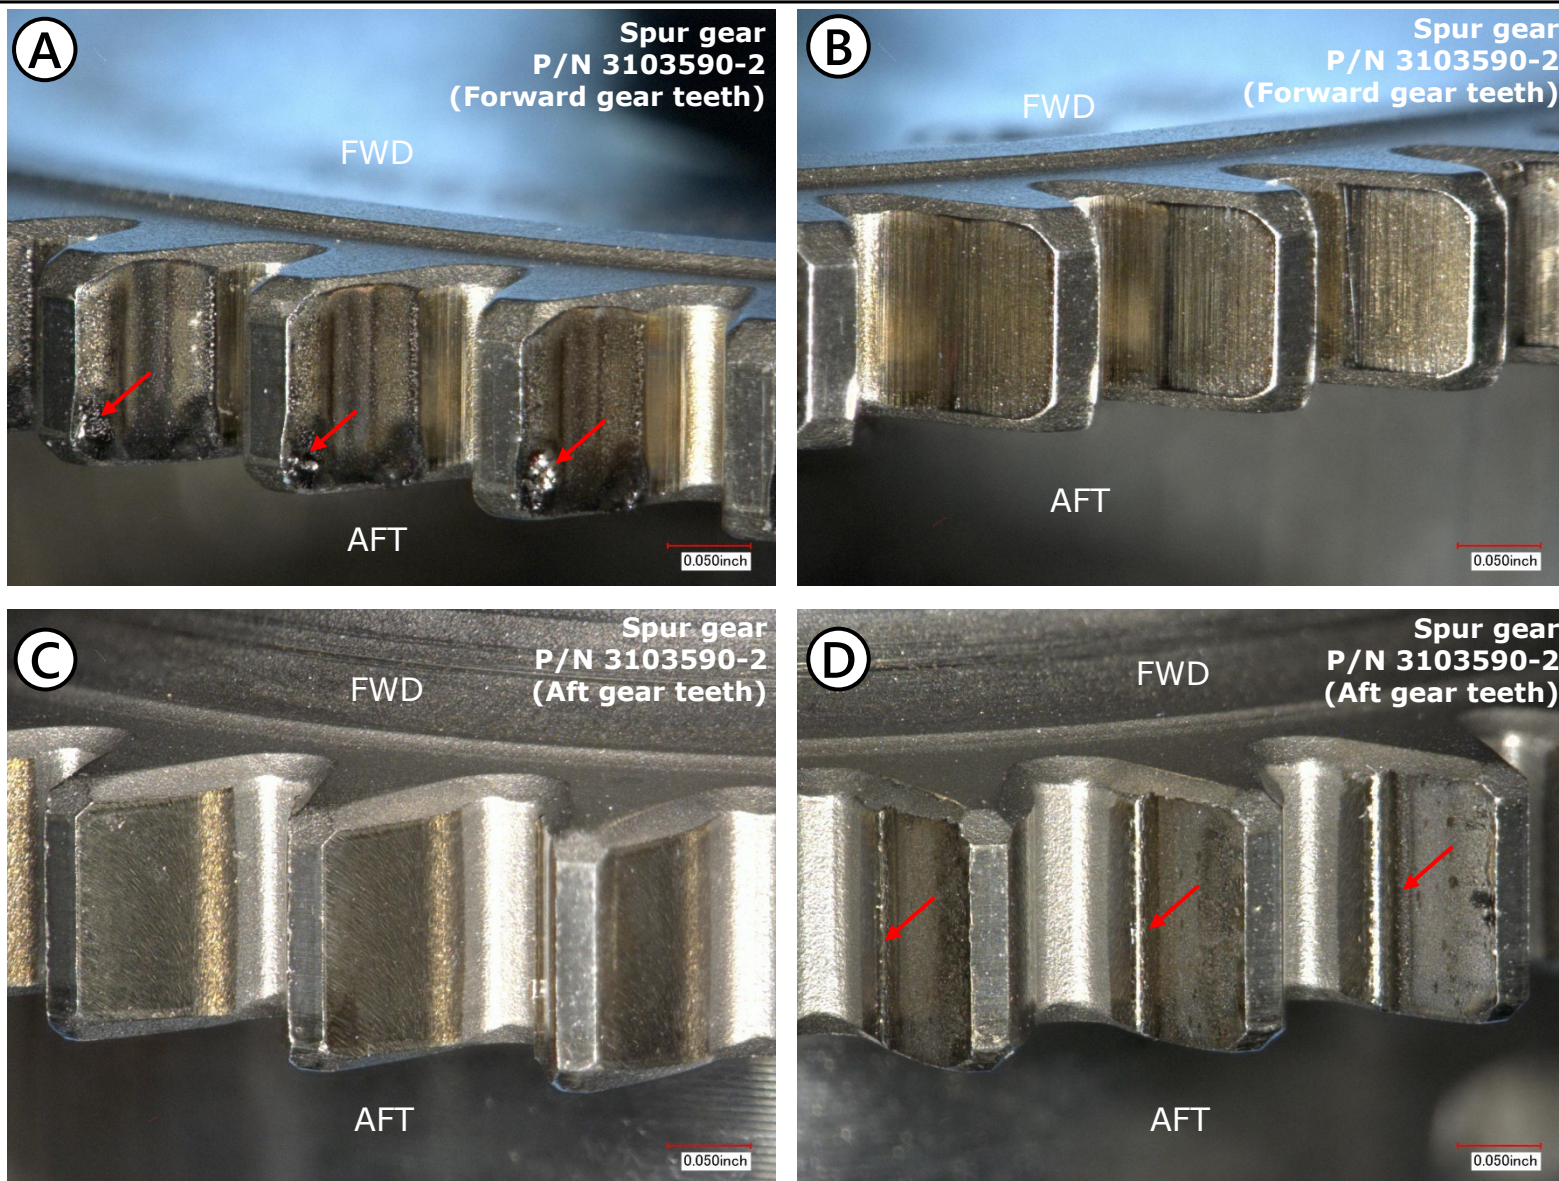
**Figure 14.**

(A-D) Digital microscope images showing the condition of the gear teeth of the 3<sup>rd</sup> idler spur gear (reference Figure 13D). Wear (red arrows) were observed predominantly on the loaded side of the gear teeth.

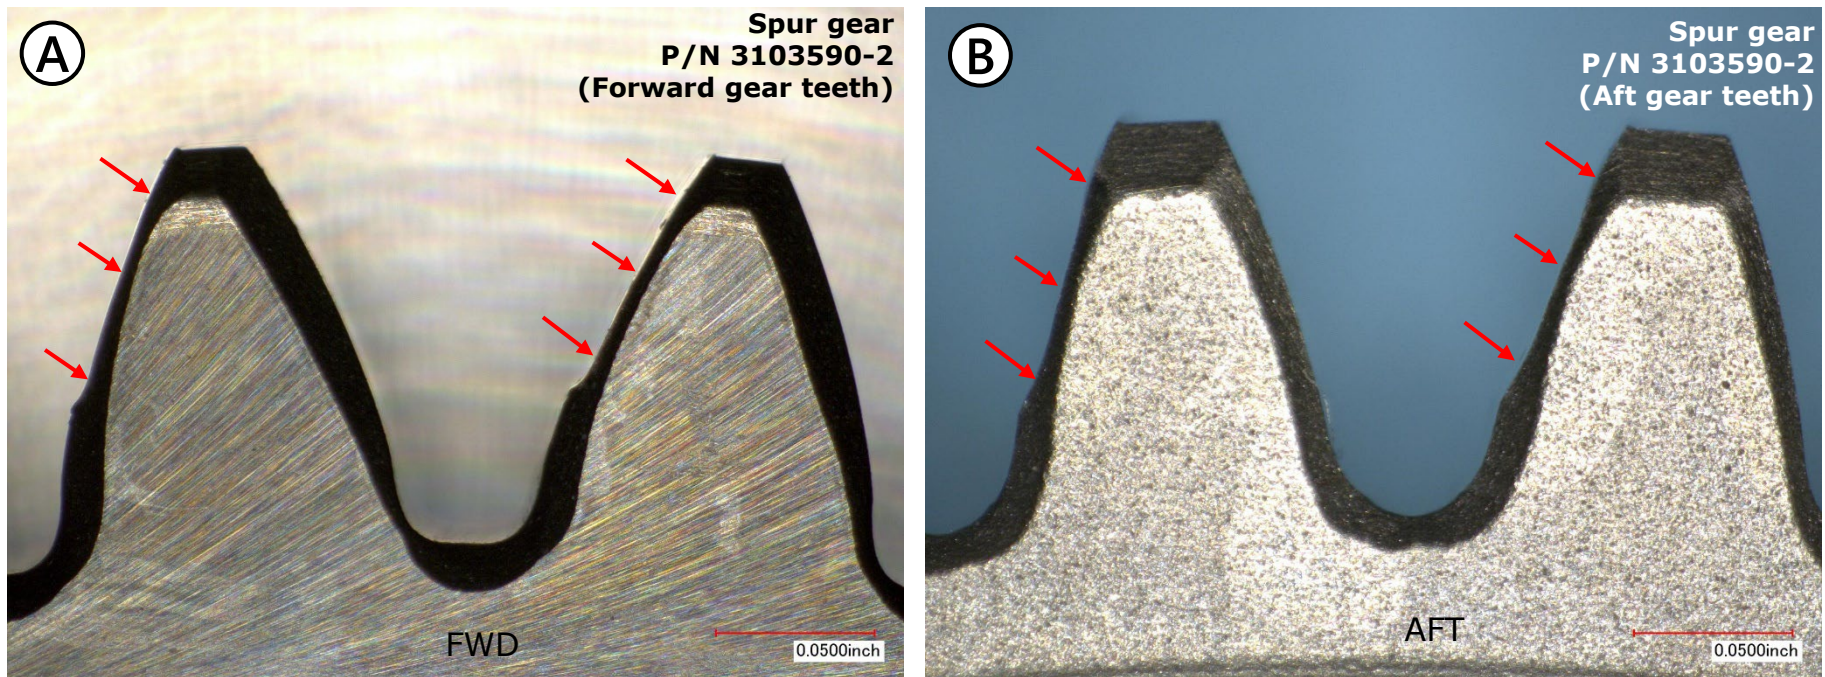
**Figure 15.**

Digital microscope images showing the condition of the (A) forward and (B) aft gear teeth of the 3<sup>rd</sup> idler spur gear (reference Figures 14-15). Wear (red arrows) was observed predominantly on one side of the gear teeth. The wear depths on the forward and aft gear teeth were measured to be approximately 0.003" and 0.004", respectively.

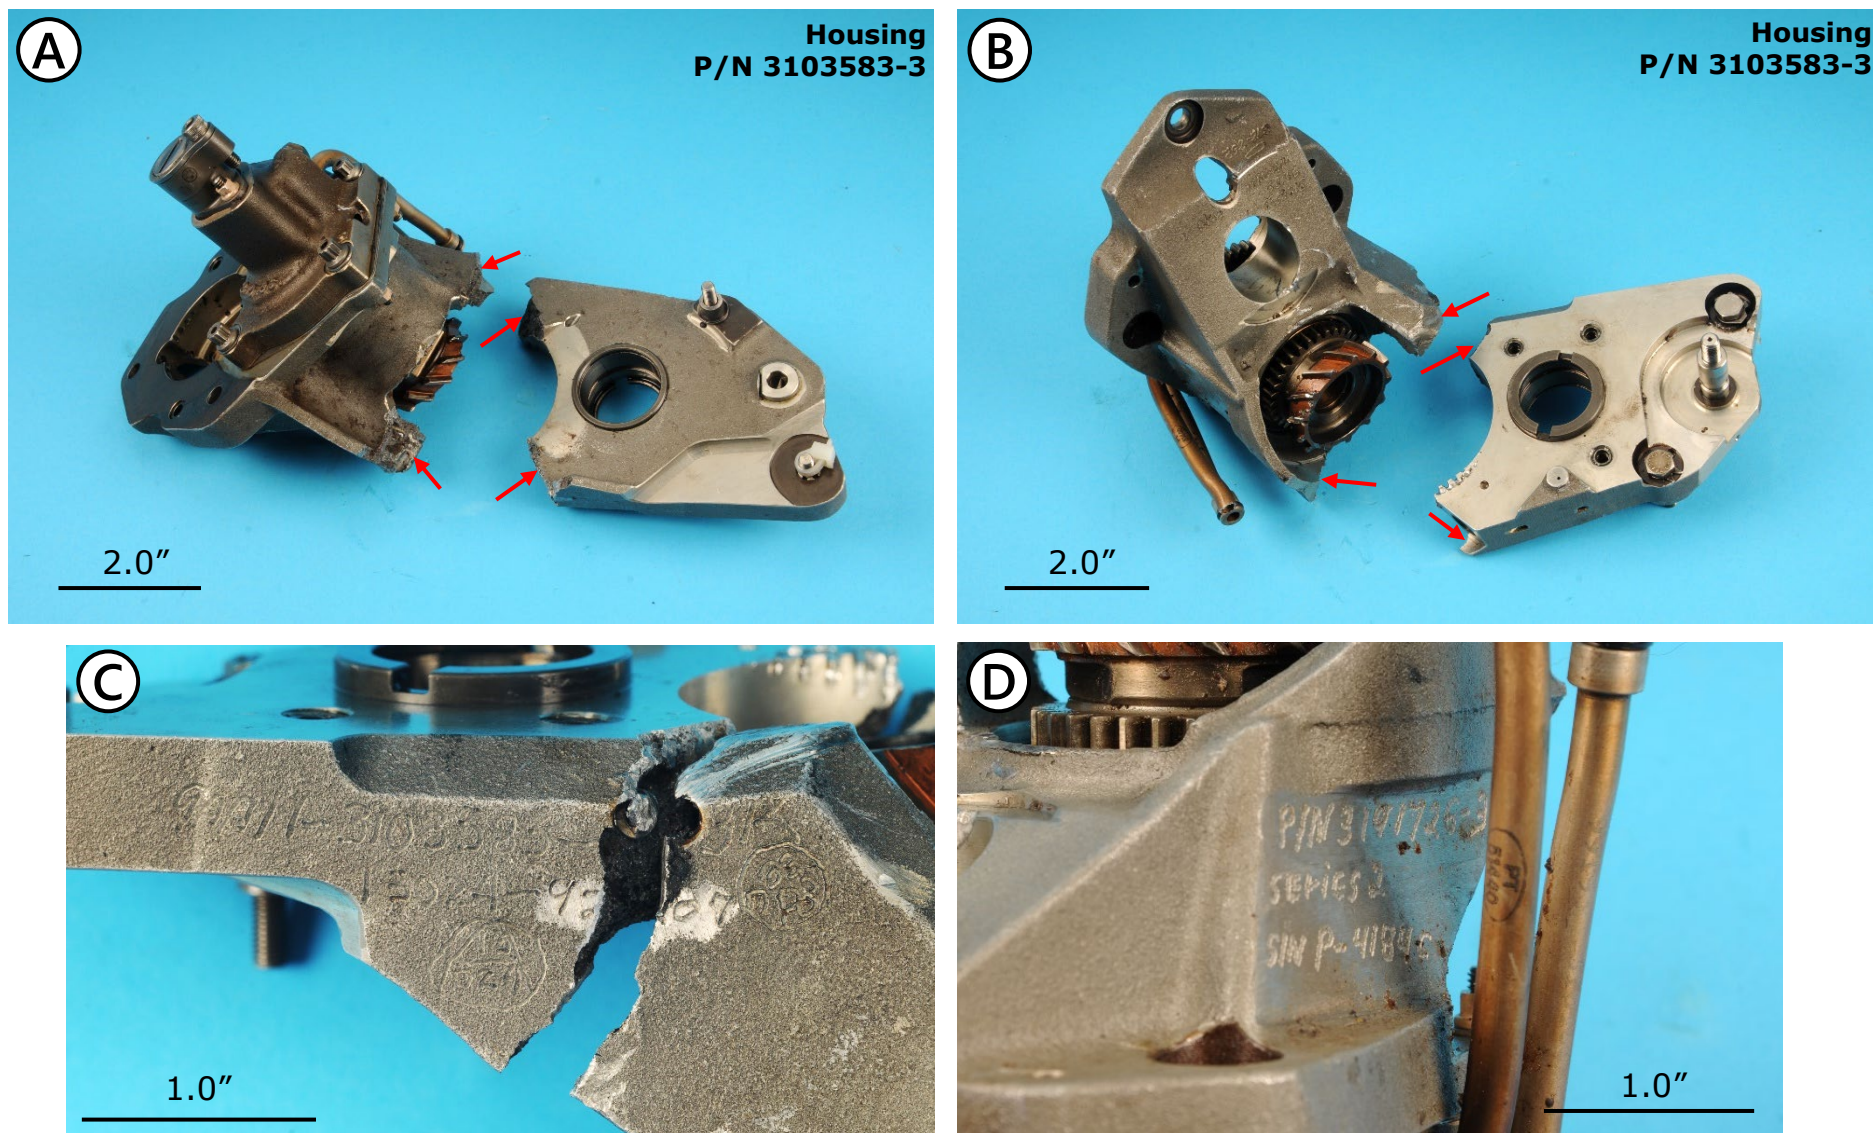
**Figure 16.**

The as-received condition of the torque sensor housing from TPE331 engine S/N P92122C is shown in Figure 16. The housing had separated into two pieces. Some of the markings observed on the housing were "P/N 3101726-3 Series 2 S/N P-4184C" and "9AA11-3103583-3."

(A-B) Overall images showing the as-received condition of the torque sensor housing assembly (P/N 3103583-3) from TPE331 engine S/N P92122C. The housing had separated (red arrows). (C-D) Close-up images showing the markings on the housing. Some of the markings observed on the housing were "P/N 3101726-3 Series 2 S/N P-4184C" and "9AA11-3103583-3."

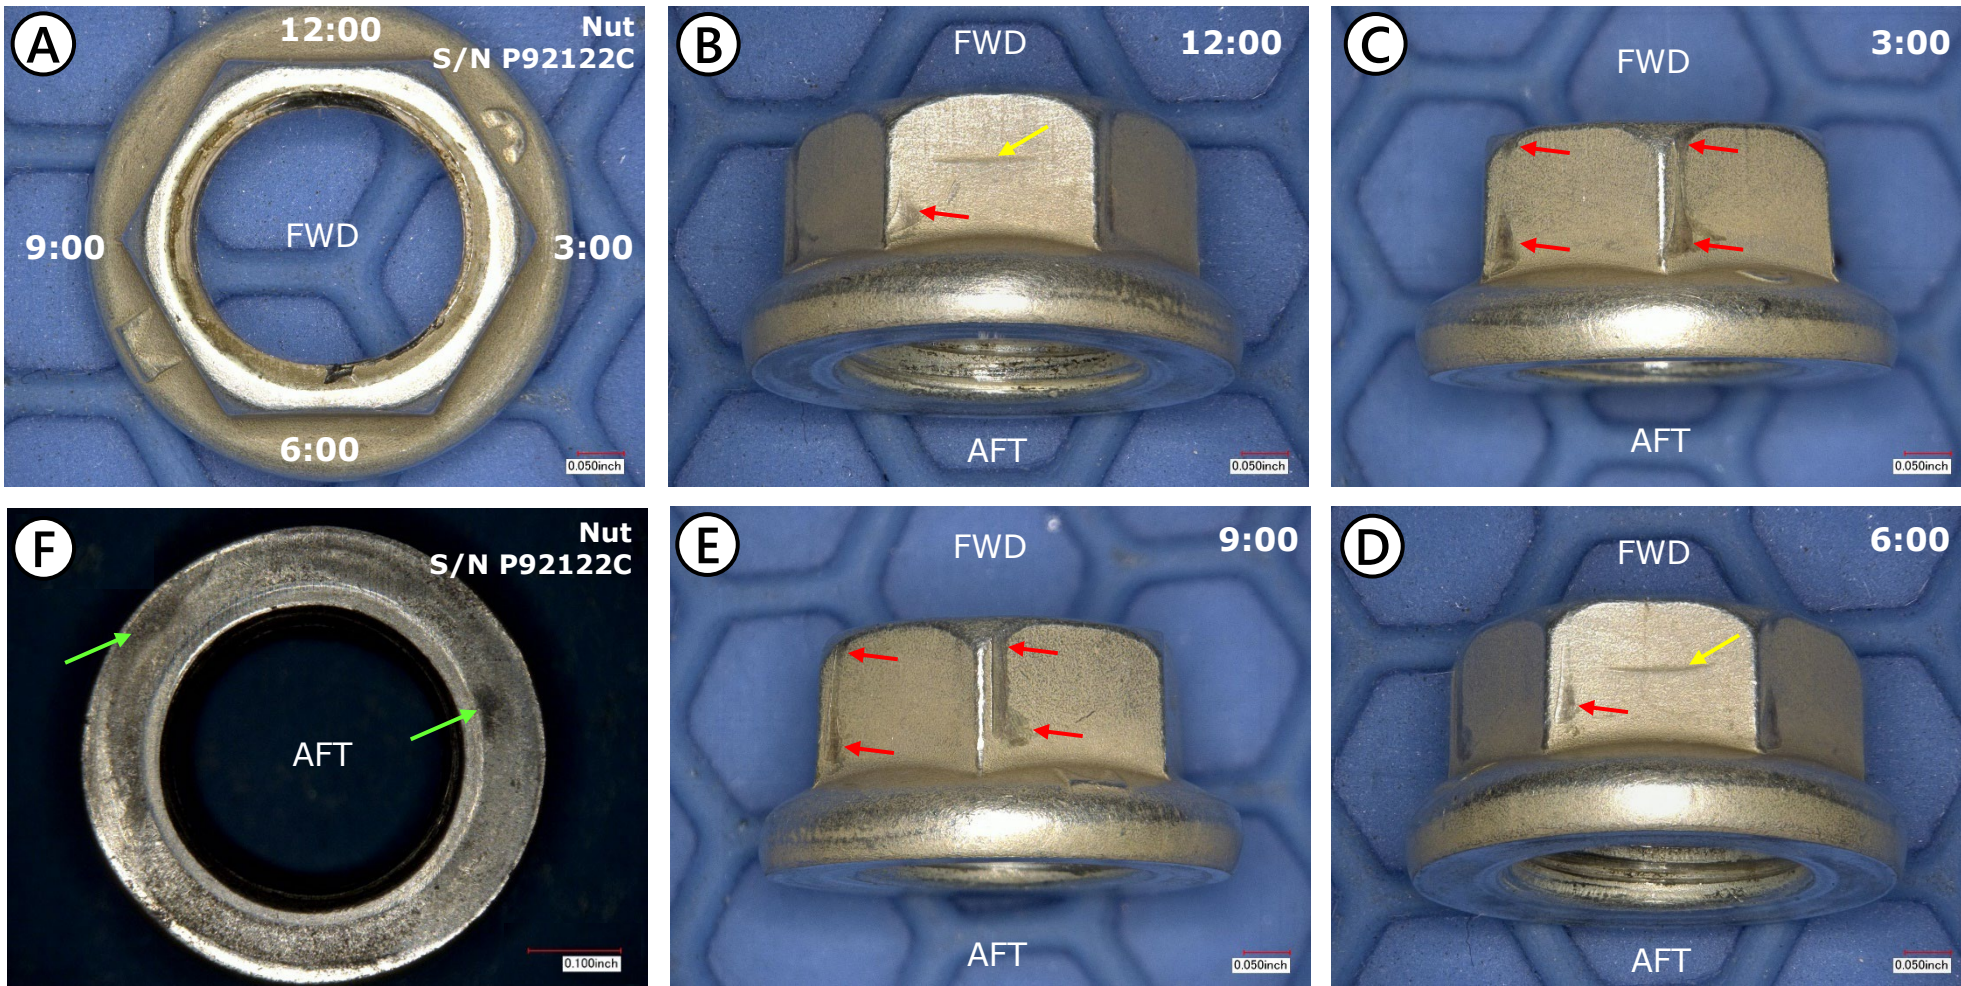
**Figure 17.**

The as-received condition of the 2<sup>nd</sup> idler gear assembly nut from TPE331 engine S/N P92122C is shown in Figure 17. Wear marks were observed on one side of each of the nut faces. Evidence of the locking tool marks were observed on two of the nut faces, as specified. Wear marks were observed on

(A-F) Digital microscope images showing the condition of the nut (P/N MS21043-5) from TPE331 engine S/N P92122C. The yellow arrows in (B) and (D) identify the locking tool marks. Wear marks were observed on one side of each of the nut faces (red arrows in (B-E)). Wear was observed on the aft side of the nut aft face (green arrows in (F)).

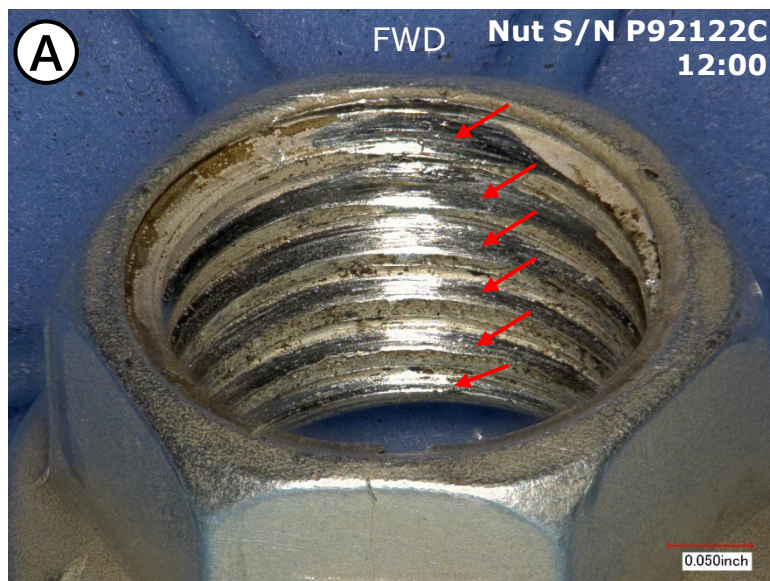
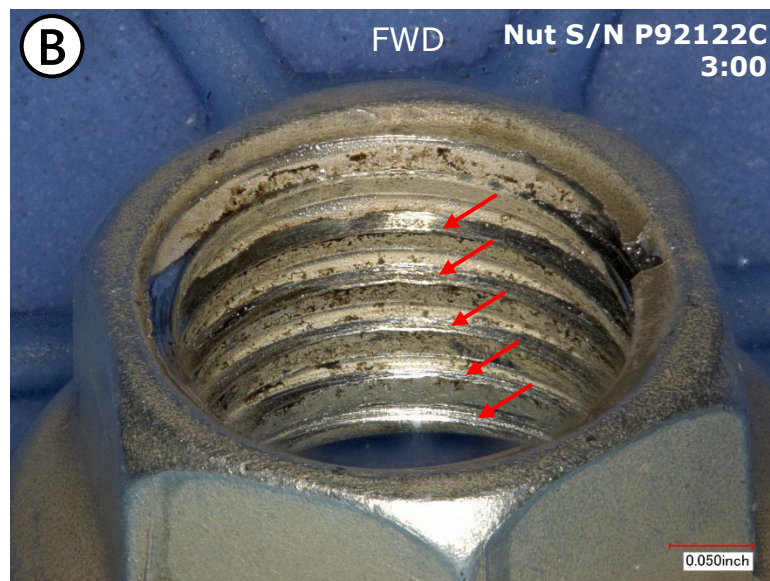
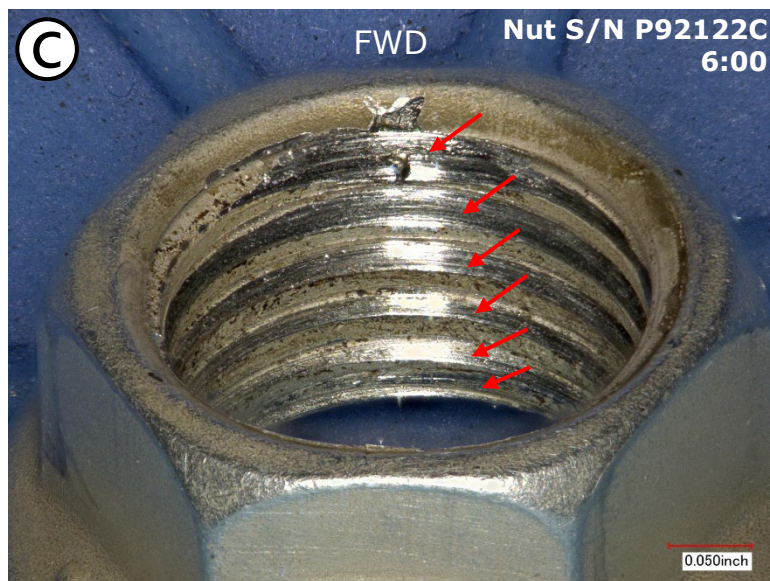
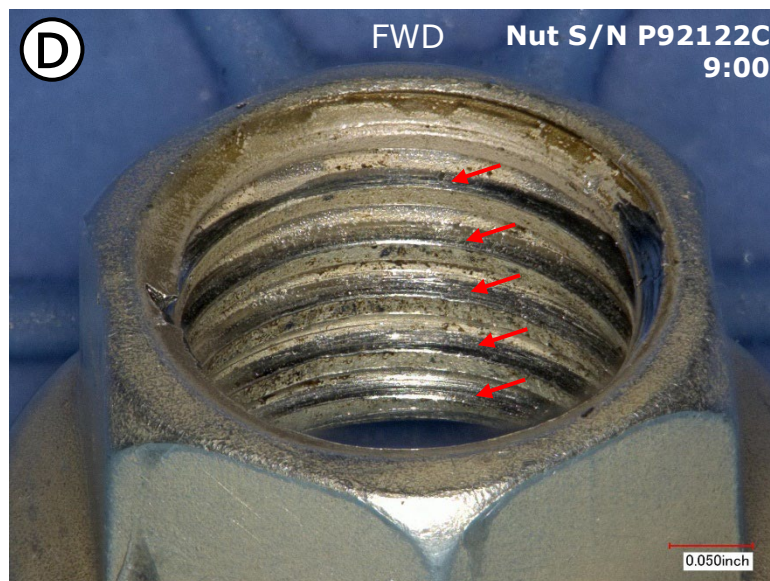
Wear was observed on the threads of the nut (Figures 18-19). The wear marks were more predominant on the forward side of the threads and in areas aligned with locking tool marks. On the forward side of the threads, wear marks were observed throughout most of the thread circumference. On the aft side of the threads, non-uniform wear marks were observed on the thread surfaces. Areas exhibiting little to no wear on the aft side of the threads were observed in multiple locations (Figure 19).

**Figure 18.** (A-D) Digital microscope images showing the condition of the threads as viewed from the forward side of the nut from TPE331 engine S/N P92122C. The red arrows identify wear on the threads that had penetrated through the silver plating.

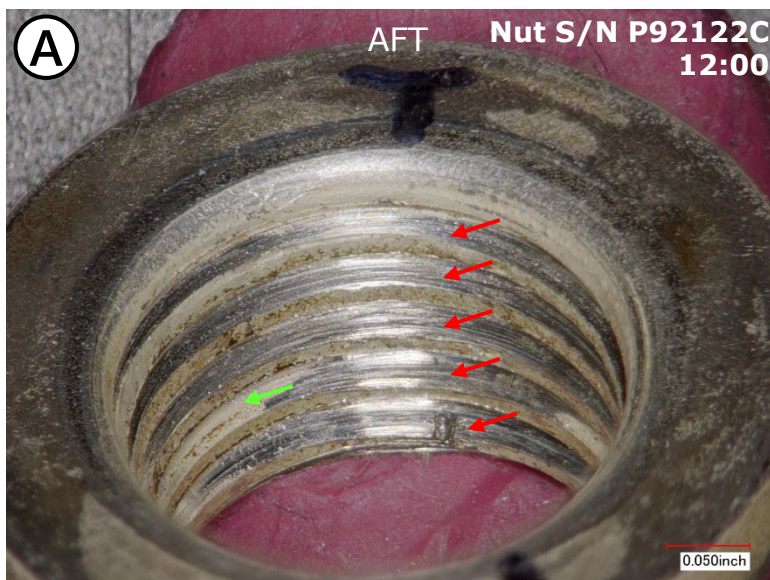
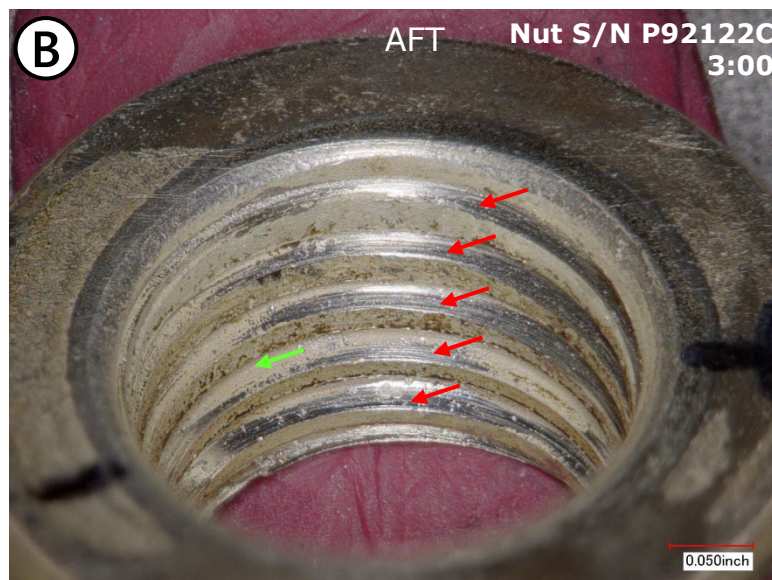
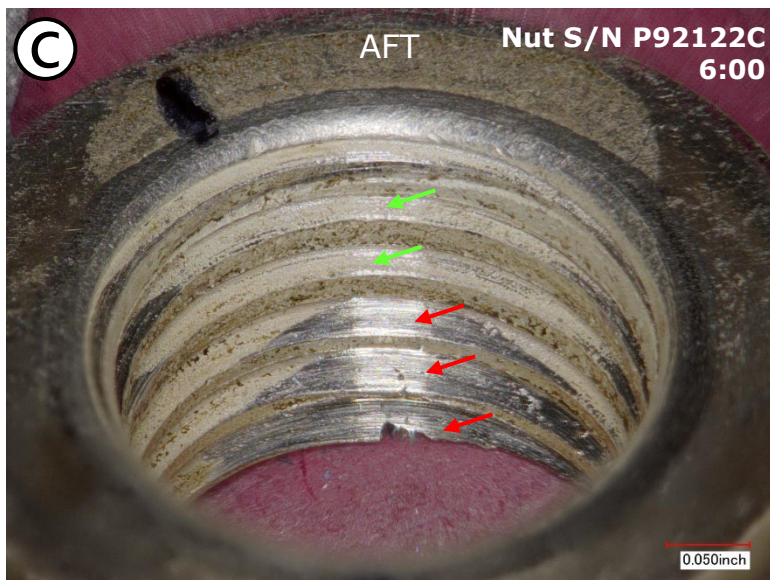
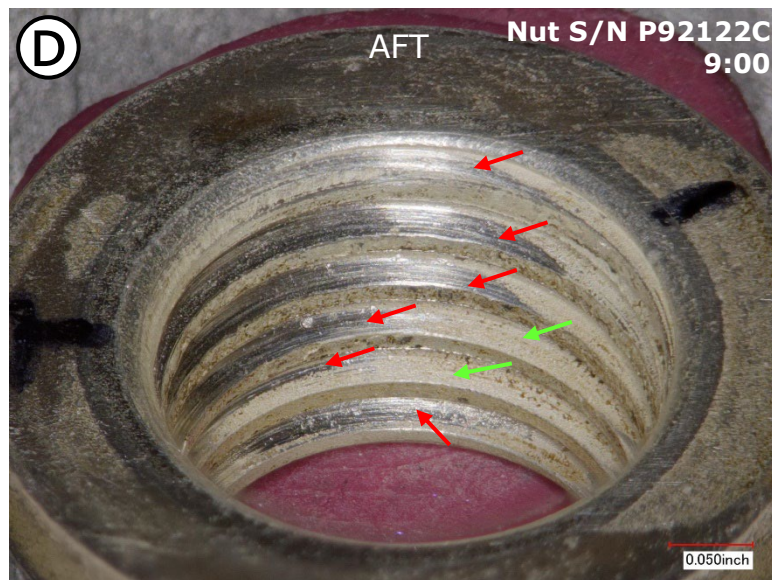
**Figure 19.** (A-D) Digital microscope images showing the condition of the threads as viewed from the aft side of the nut from TPE331 engine S/N P92122C. The red arrows identify wear on the threads that had penetrated through the silver plating. Note that the contact on the aft side of the thread was not uniform around the circumference (green arrows).

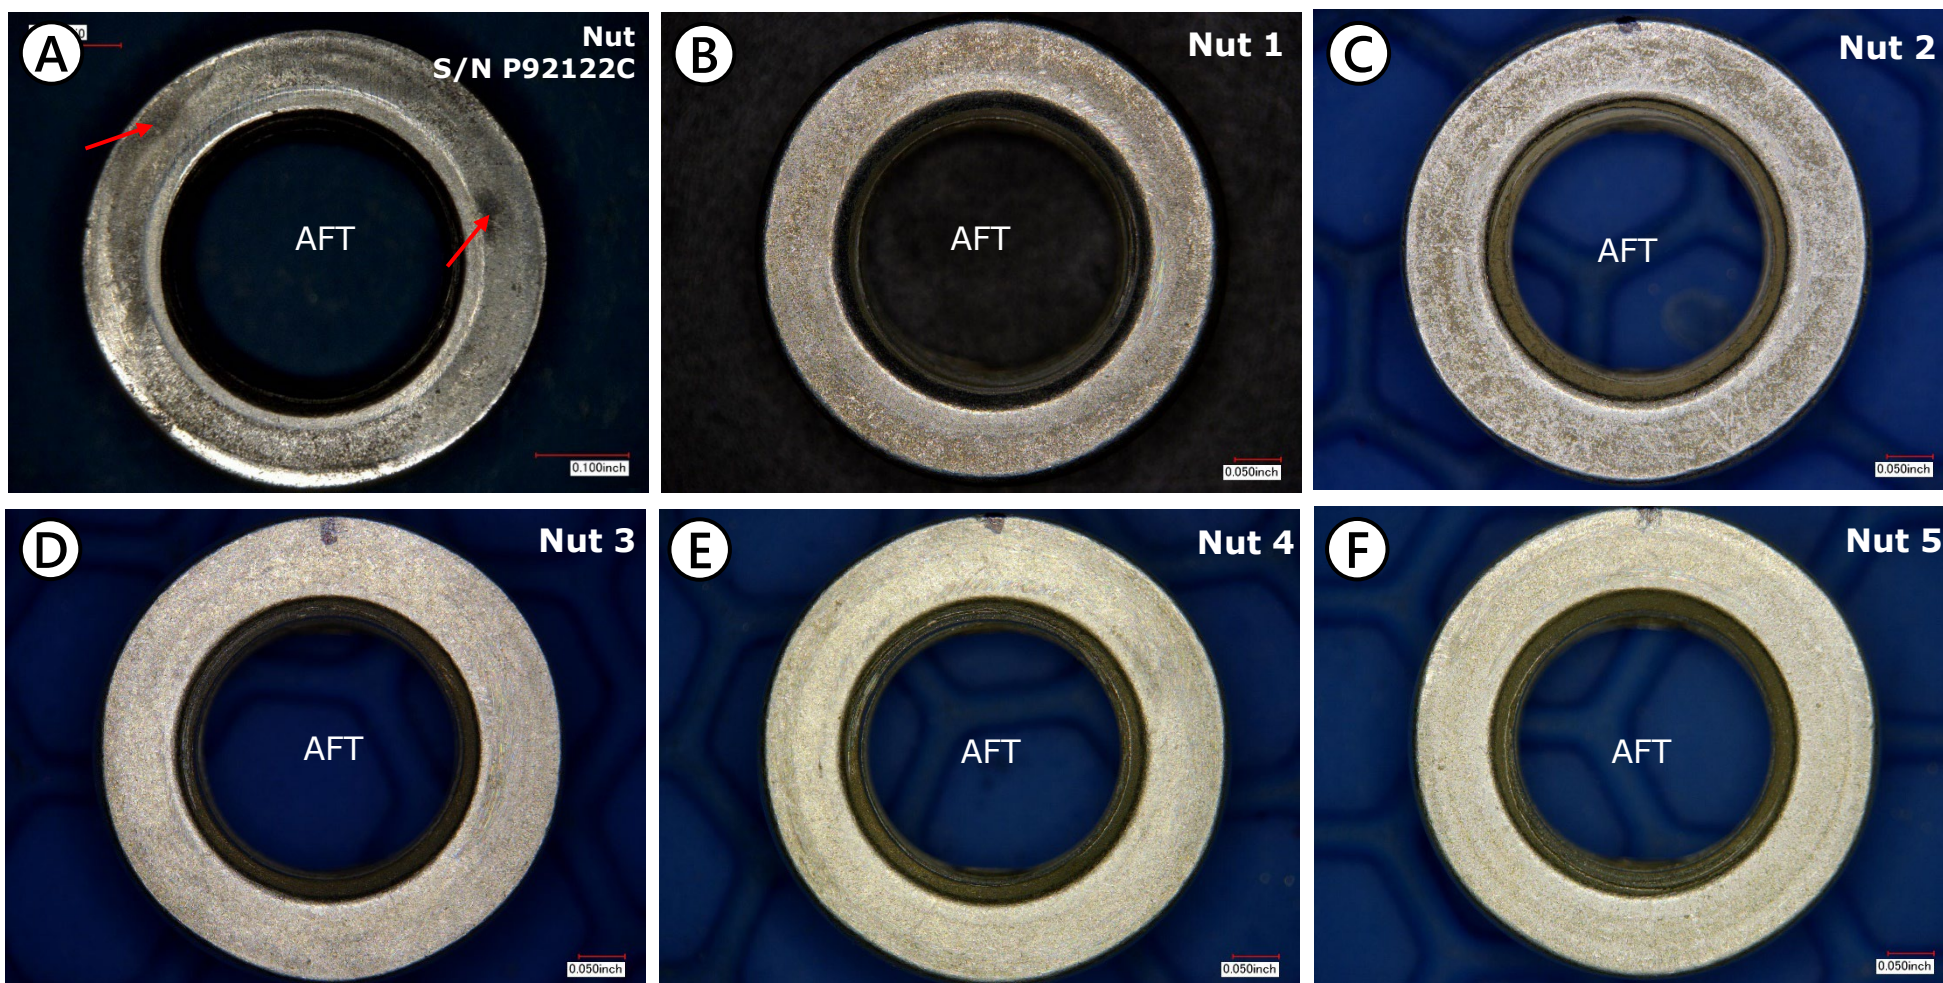
**Figure 33.**

No notable wear was observed on the aft side of Nuts 1-5 compared to the nut from TPE331 engine S/N P92122C (Figure 33). Elemental dot maps produced from analysis of the aft sides of the submitted nuts revealed that the silver plating on Nuts 1-5 was present throughout the surface (Figure 34). For the nut from TPE331 engine S/N P92122C, the element dot map revealed regions where the silver plating had worn away (Figure 34A). Scanning electron microscope (SEM) examination of the worn regions of the nut revealed a matted appearance with no clear wear directionality (Figure 35).

(A-F) Digital microscope images showing the aft sides of the submitted nuts. Wear was observed on the surface of nut S/N P92122C (red arrows in (A)). Elemental dot map images of the aft sides of the nuts are shown in Figure 34.

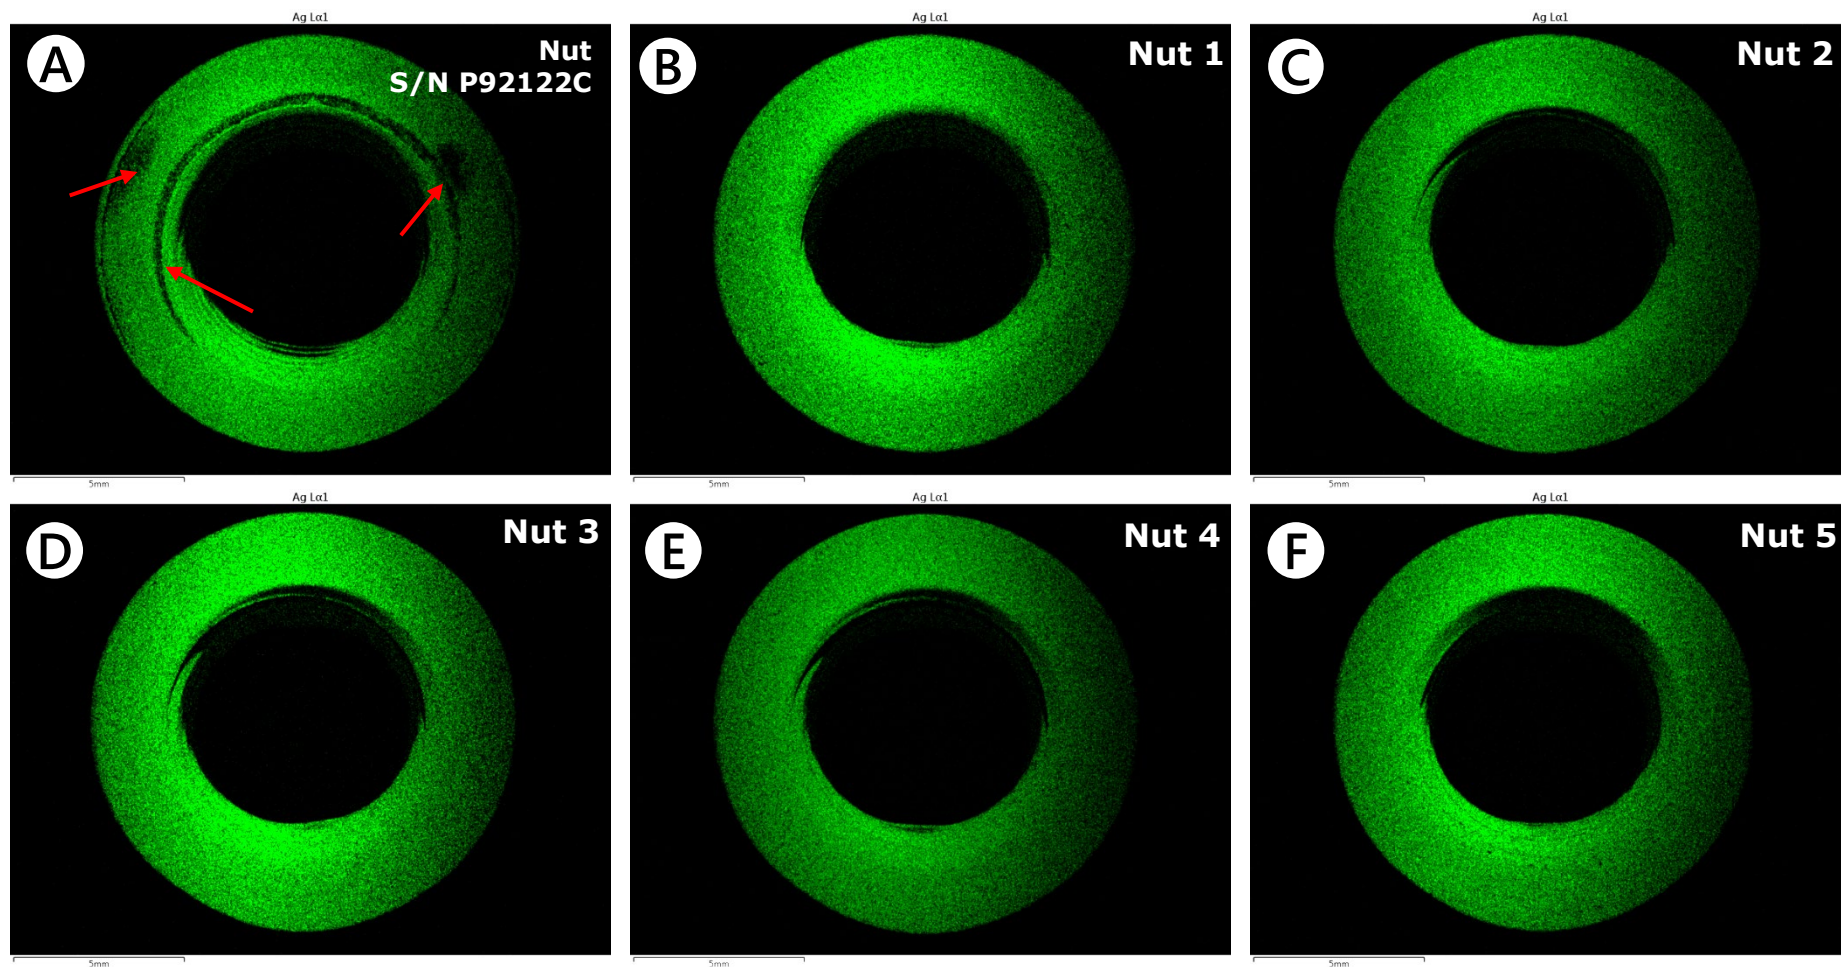
**Figure 34.**

(A-F) Elemental dot maps showing the silver concentration on the aft sides of the submitted nuts (reference Figure 33). The green colored regions in each photo indicate the presence of the silver plating. The red arrows in (A) identify areas where the silver plating had worn away.

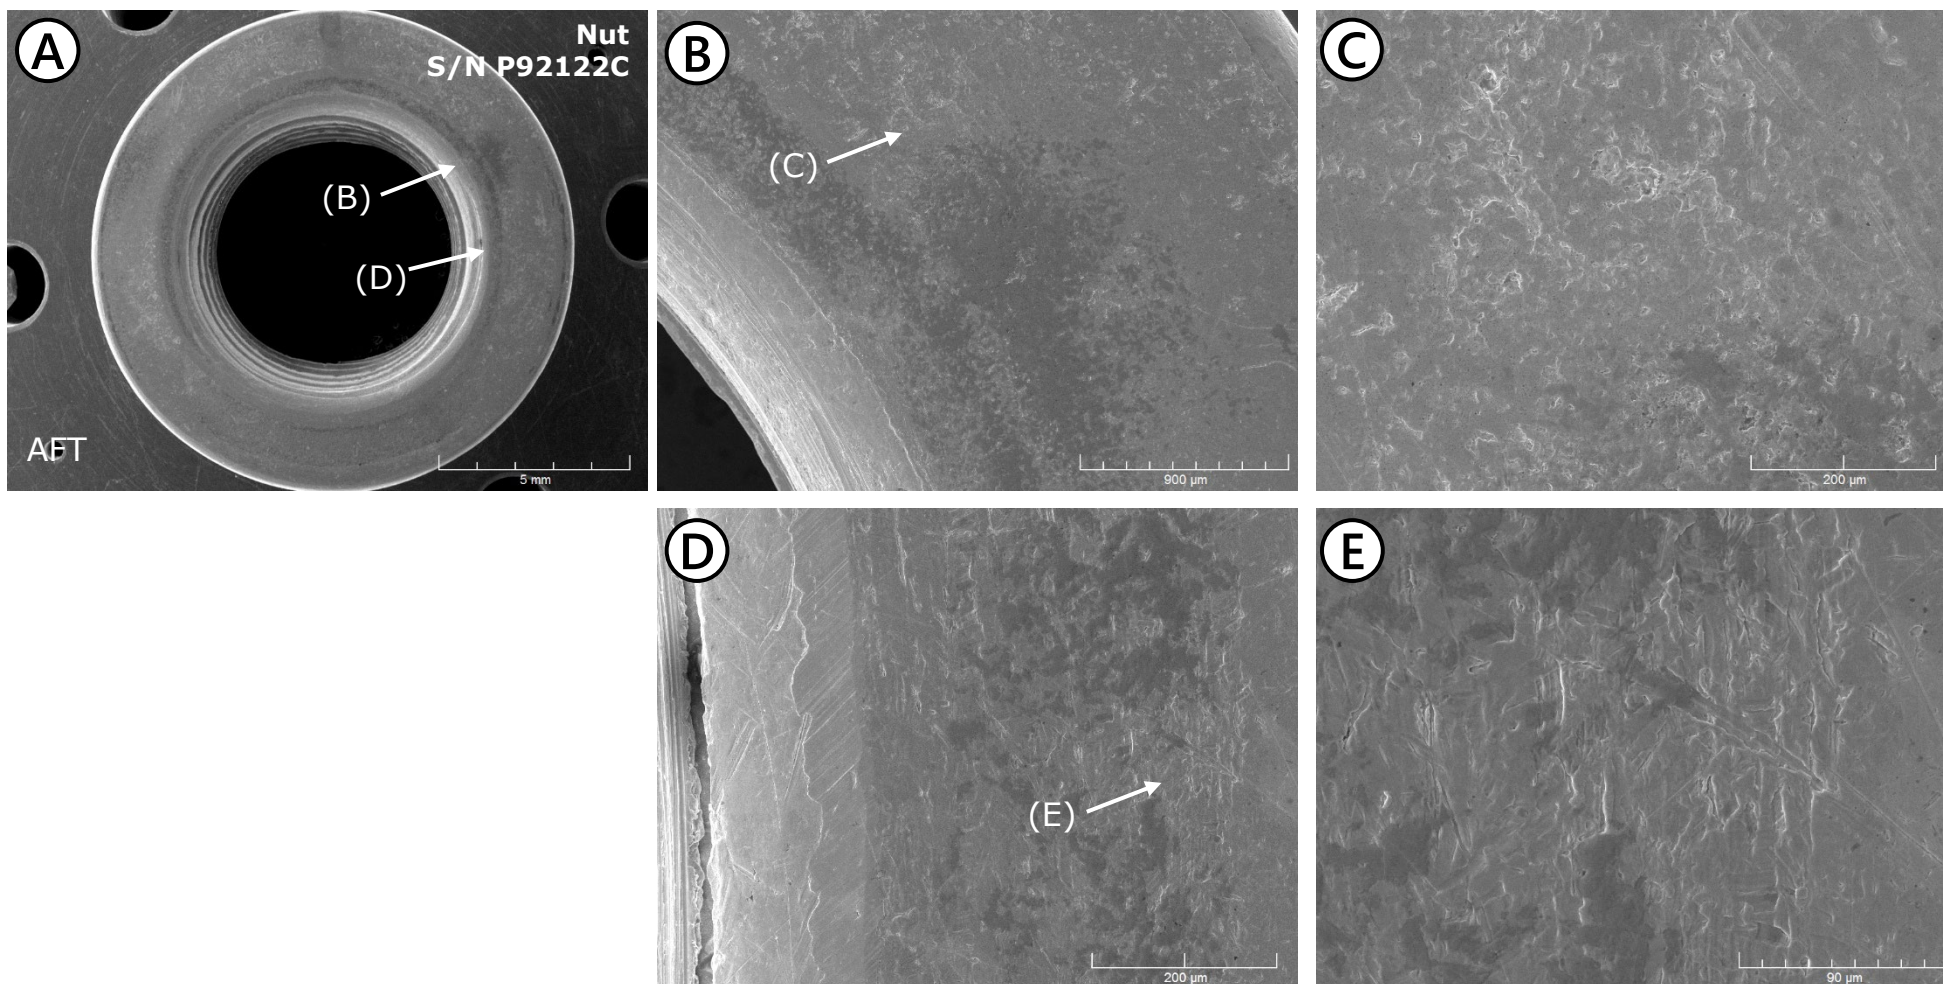
**Figure 35.**

(A-E) Secondary electron (SE) scanning electron microscope (SEM) images showing the condition of the aft surface of the nut from TPE331 engine S/N P92122C. The surface condition appeared matted and no clear wear directionality was observed.
