**NATIONAL TRANSPORTATION SAFETY BOARD**  
**Office of Aviation Safety**  
**Washington, D.C. 20594**

**POWERPLANTS GROUPCHAIRMAN'S FACTUAL REPORT**

**NTSB No: CEN21LA287**

Aircraft: Grumman G-164B airplane, registration number N62375

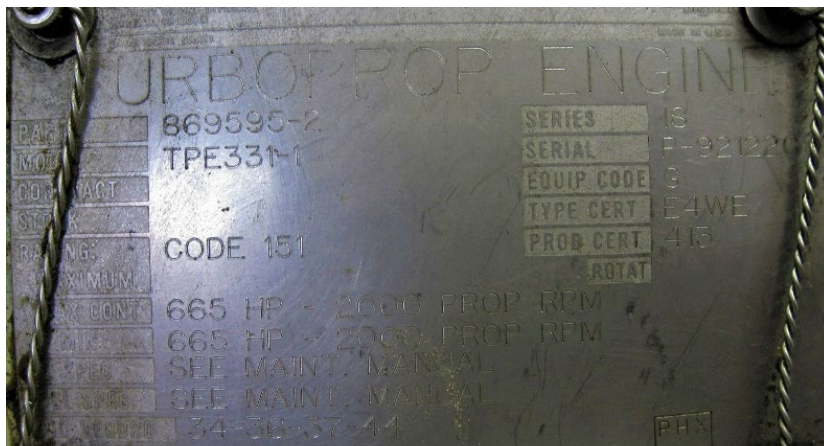
**PHOTO 1: ENGINE DATA PLATE**

According to the data plate, which is affixed to the engine's accessory case, the engine serial number (ESN) was P-92122C (**PHOTO 1**). Based on the maintenance records and the Hobbs meter in the airplane, the calculated time since new (TSN) and time since overhaul (TSO) of the engine at the time of the accident was 21,012.5 hours and 18,452.5 hours respectively.

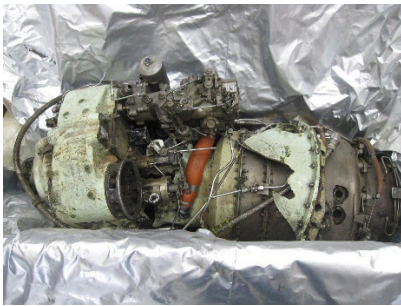
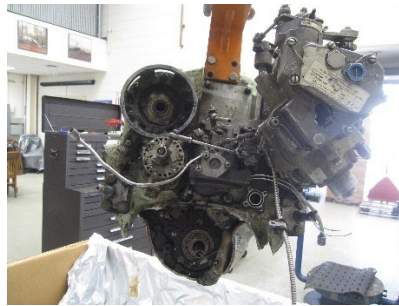
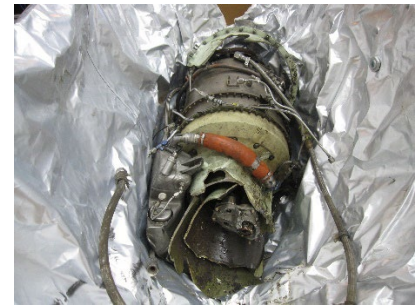
The engine was removed from its shipping container (**PHOTOS 6, 7, and 8**). The engine was received in essentially two separate sections: the gear reduction section and the gas generator section (compressor-through-turbine). No sign of an engine fire or uncontainment was noted.

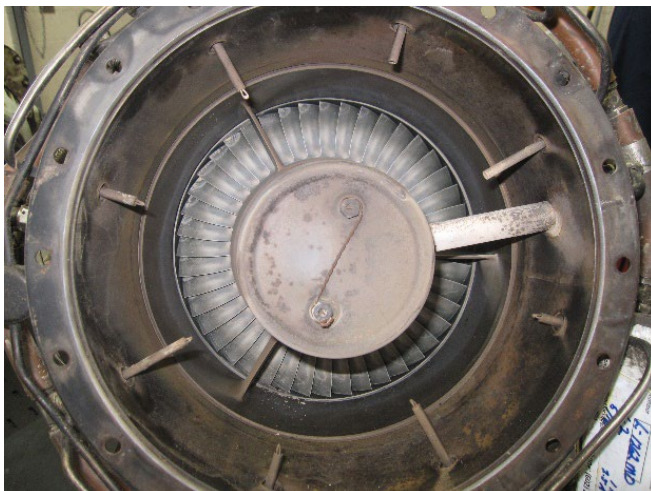
**PHOTO 9: STAGE 3 TURBINE BLADES INTACT**

Looking through the exhaust, the stage 3 turbine blades were visible; they all appeared intact, full length, and undamaged (**PHOTO 9**). Looking through the air inlet, the stage 1 compressor impeller blades were visible with no sign of significant impact or ingestion damage; however, debris/dirt was noted in the impeller. The stage 1 impeller shroud exhibited what appeared to be static impact marks (**PHOTO 10** red arrows).

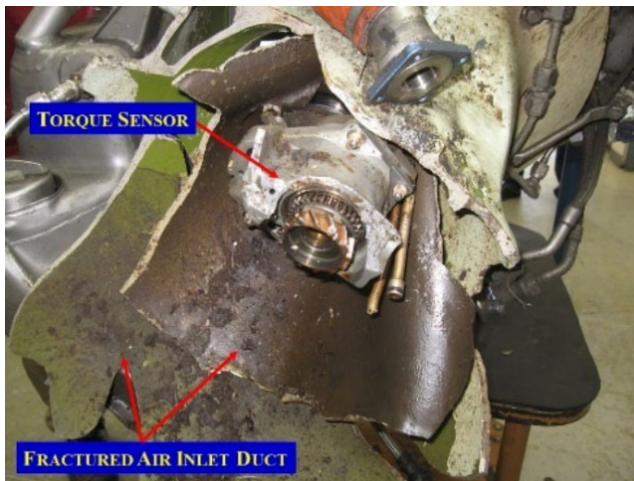
**PHOTO 11: TORQUE SENSOR INSTALLED**

The gas generator section was placed on a table exhaust end down. The air inlet duct was fractured into multiple pieces and a portion of the torque sensor assembly remained still attached (**PHOTO 11**); the other half of the torque sensor assembly remained attached to the accessory case. The fuel nozzle and ignitor, along with their respective bosses, were pulled out from the combustion plenum at the 12:00 o'clock position. What remained of the torque sensor assembly was removed; the helical gear exhibited damage/smearing to the tops of teeth but was otherwise intact (**PHOTO 12**). The compressor bearing was visible, it appeared undamaged, and the ball bearings were shiny and round. The compressor bearing rotated by hand with some drag. A wrench was placed on the compressor bearing retaining nut and the compressor and turbine rotated in unison, confirming continuity of the gas generator section. The gas generator section was not disassembled further based on the finding that: 1) no damage was observed to the stage 1 impeller blades and stage 3 turbine blades, 2) the compressor and turbine bearing rotated freely, and 3) compressor and turbine rotated in unison.

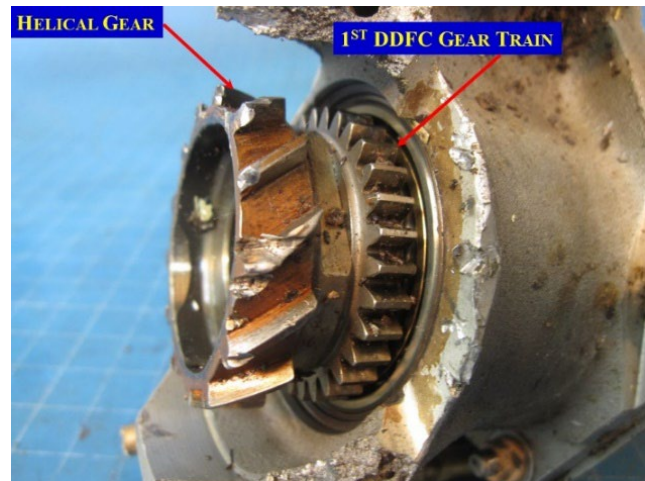
**PHOTO 12: HELICAL GEAR TEETH DAMAGE**

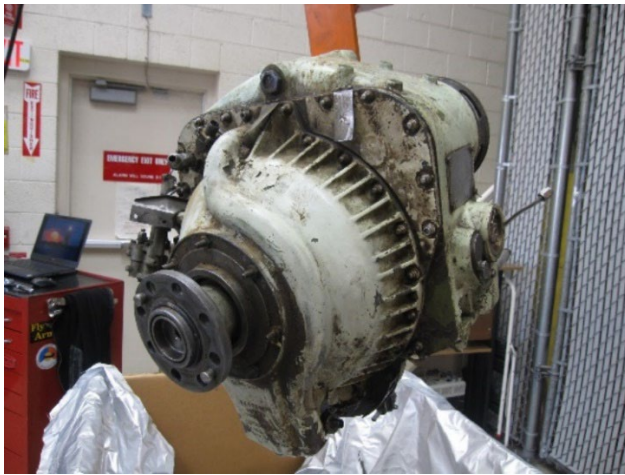
**PHOTO 13: PROPELLER AND OUTPUT/NOSE CONE**

The gear reduction section was placed in a disassembly stand. The propeller front flange was intact and undamaged, the propeller locating pins were still present, and the output/nose cone assembly was intact and undamaged (**PHOTO 13**). The output/nose cone assembly was removed to expose the propeller shaft, the planetary gear, the sun gear front splines, the ring gear/hub, and the propeller shaft thrust bearing. The propeller shaft thrust ball bearing outer race is secured to the output/nose cone and the propeller shaft spun freely within the output/nose cone assembly; no further disassembly was performed to access the propeller shaft thrust bearing condition. The propeller shaft was intact, in good condition, and exhibited a very slight and small visual (no depth to the mark) rotational mark; the mark was localized and not circumferentially around the entire shaft (**PHOTO 14**). The ring gear/hub was intact, in good condition, and did not exhibit any distinguishing marks. The planetary gear set was intact, in good condition, all the gears spun freely, and did not exhibit any distinguishing marks.

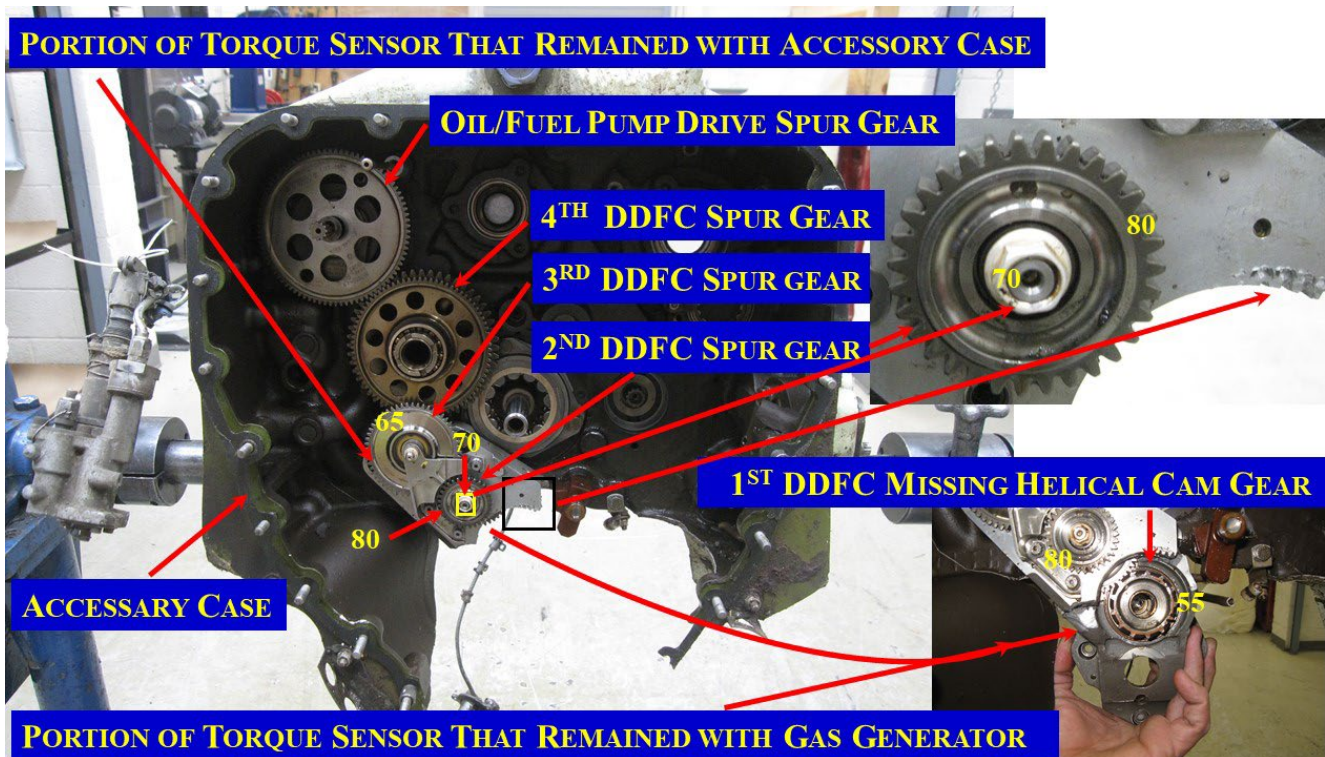
The bottom portion of the accessory case was fractured and missing; the fracture location was coincident with where the torque sensor assembly was located (**PHOTO 15**)<sup>5</sup>. The 2<sup>nd</sup> direct drive fuel control (DDFC) is comprised of a front and rear spur gear supported by a duplex bearing and a splined shouldered shaft (PN 3103405-3) with a forward threaded end to accept an ovalized self-locking nut (**FIGURE 5** and **PHOTO 16**). The front 2<sup>nd</sup> DDFC spur gear was found loose and disengaged from the splined shouldered shaft and therefore disengaged from rear 2<sup>nd</sup> DDFC gear; they both should rotate together but when one was rotated the other did not. Both the front and rear 2<sup>nd</sup> DDFC spur gears were intact, and their gear teeth were in good condition; the self-locking nut that secures the front spur gear to the splined shouldered shaft was found loose with no torque (See **PHOTO 15**, yellow box, item 70). Comparing the self-locking nut from the event torque sensory assembly with that of an exemplar one revealed that the number of exposed threads on the splined shouldered shaft were not the same. On the event torque sensor assembly, no threads were exposed<sup>6</sup> indicating that the self-locking nut was at the very end of the splined shouldered shaft threads (**PHOTO 17**, left side) while on the exemplar torque sensor assembly, several exposed threads were observed (**PHOTO 17**, right side).

**PHOTO 15: FRACTURED PORTION OF TORQUE SENSOR ASSEMBLY AND ACCESSORY CASE**

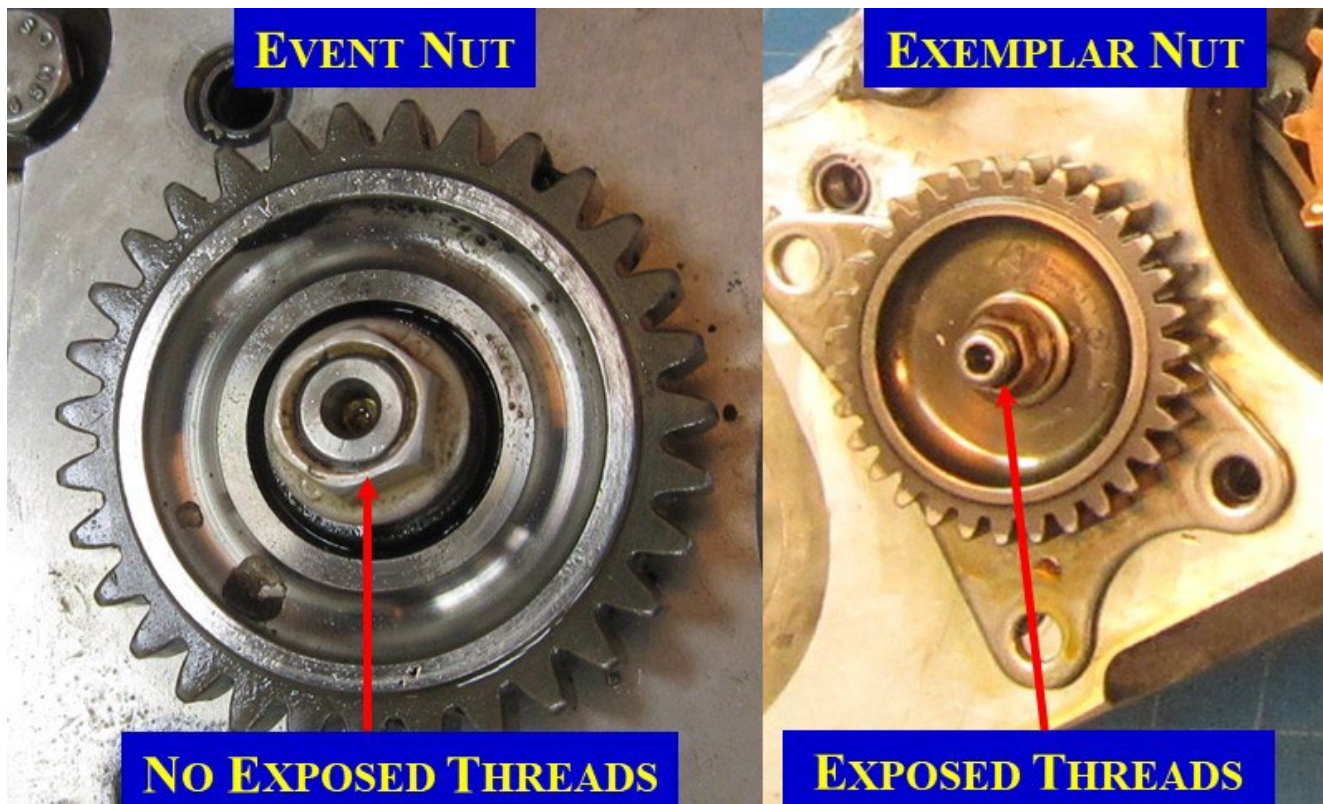
<sup>6</sup> Typically, for threaded fasteners, after they are installed and torqued to the proper requirements, they should protrude at distance of a least one thread past the nut. A good rule of thumb to have between 2 to 3 full threads exposed. In some applications, the exposed thread is specified; however, according to the torque sensor assembly overhaul manual, no exposed thread number or length requirement is provided. Instead, the self-locking nut should be torqued to 200 inch-pounds (22.6 Newton meters)

**PHOTO 17: SPLINED SHOULDERED SHAFT EXPOSED THREADS WITH SELF-LOCKING NUT INSTALLED**

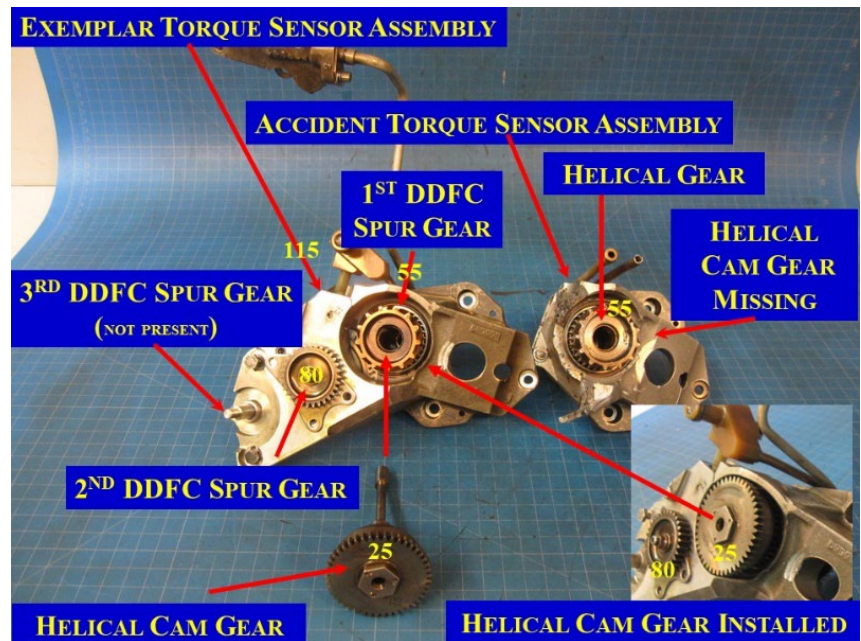
**PHOTO 18: EXEMPLAR AND EVENT TORQUE SENSOR ASSEMBLY**

The helical cam gear was missing from the torque sensor assembly and was not recovered (**PHOTO 18** bottom corner shows an exemplar helical cam gear installed). The 3<sup>rd</sup> DDFC was removed to facilitate removal of the remaining portion of the torque sensor assembly that was attached to the accessory case. Two bolts secured what remained of the torque sensor assembly to the accessory case. Both bolts had their anti-rotating lock-tabs installed the ends flared over; when a torque check was performed both were finger tight (no torque). The bolts were removed, and both appeared to be deformed (no longer straight). Examination of the accessory case helical inserts revealed that the insert threads appeared to be satisfactory, and the inserts had not pulled out of the case.

The splined shouldered shaft (PN 3103405-3) - item 85 in **PHOTO 16** and **FIGURE 5** was not replaced and the torque sensor housing (PN 3103583-3) - item 115 (**PHOTO 18** and **FIGURE 5**) was provided in a serviceable condition.

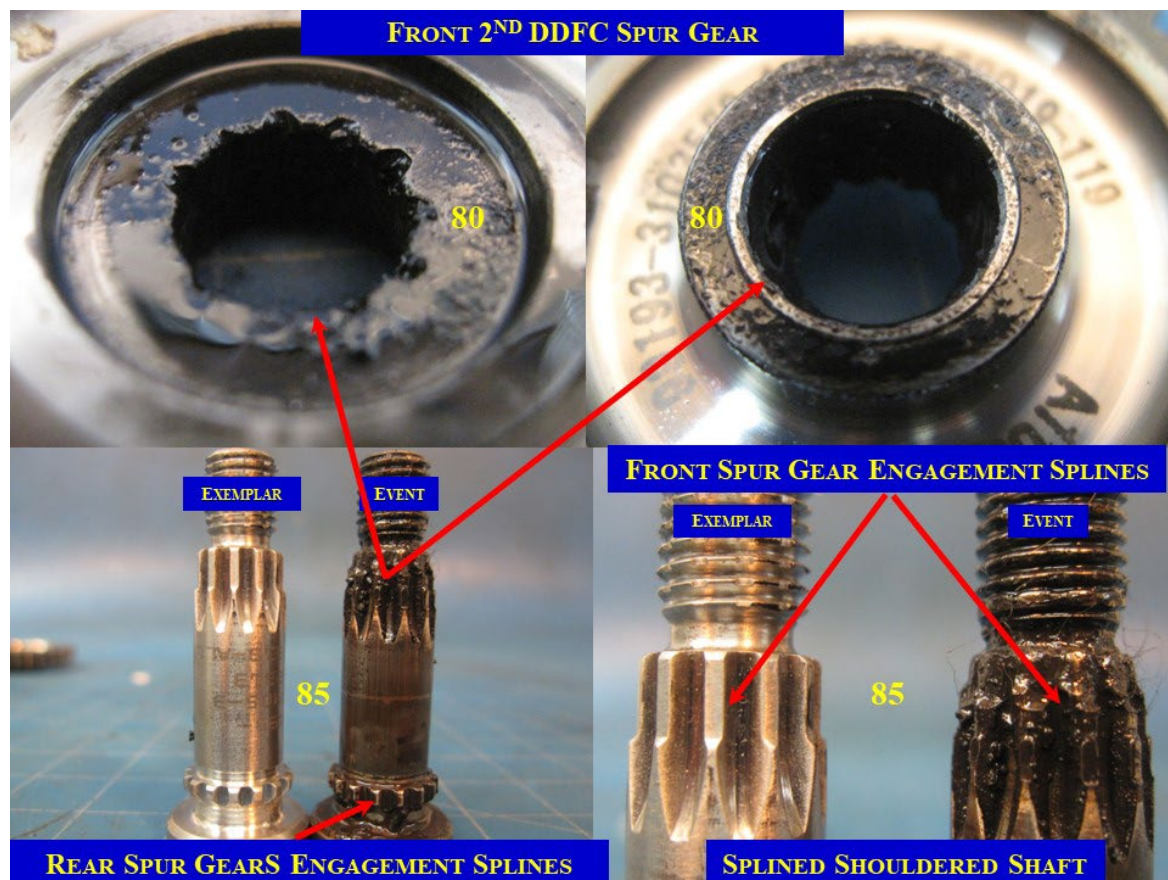
Disassembly of the 2<sup>nd</sup> DDFC revealed the following: 1) gear teeth on the forward and aft spur gears appeared in good condition and undamaged, 2) the rear spur gear internal spline teeth appeared to be present and undamaged, 3) front spur gear internal splines teeth appeared to be heavily damaged (**PHOTO 19**, top row), 4) the splined shouldered shaft rear external spline teeth that engage with the rear spur gear were in good condition and undamaged (**PHOTO 19**, bottom right), and 5) the splined shouldered shaft external forward spline teeth that engage with the front spur gear were heavily damaged.

**PHOTO 19: 2<sup>ND</sup> DDFC FRONT SPUR GEAR AND SPLINED SHOULDERED SHAFT DAMAGE**

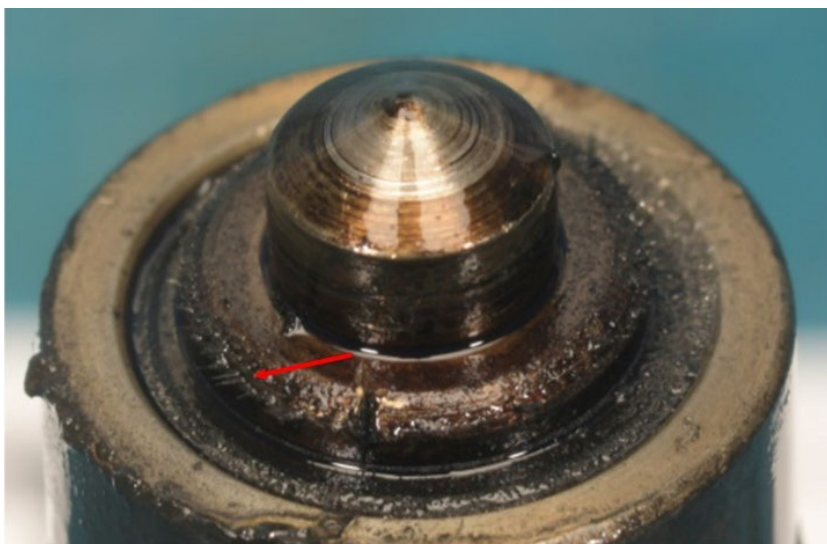
The magnetic chip detector (MCD) was removed and fine hair-like ferrous material was noted on the tip (**PHOTO 20**).

**PHOTO 20: FUZZ ON THE MCD** (red arrow)

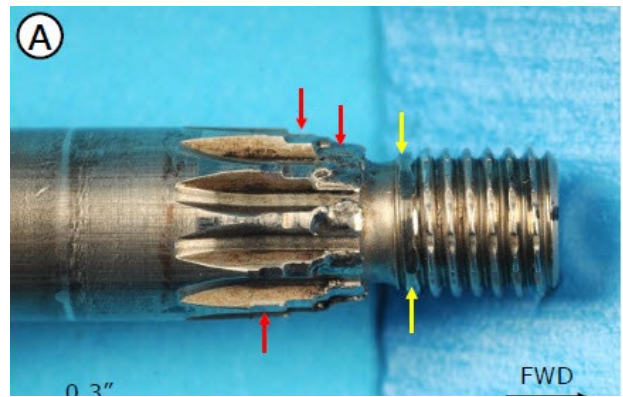
The splined shouldered shaft was cleaned, and the external forward spline teeth exhibited stepped wear and deformation in the clockwise direction/loading direction (forward looking aft) about  $\frac{2}{3}$  of the axial length near the front spline teeth consistent with meshing with the fretted internal spline teeth of the 2<sup>nd</sup> DDFC front spur gear (**PHOTO 25**, red arrows). Wear and deformation were also observed on the last (rearward) threads consistent with contact with the worn threads of the self-locking nut (**PHOTO 25**, yellow arrows). The external aft spline teeth were undamaged and exhibited normal meshing wear on the pressure face/loaded flank side of the spline's teeth consistent 2<sup>nd</sup> DDFC rear spur gear normal engagement. The aft face of the splined shouldered shaft face exhibited fretting consistent with contact of the rear aft face of the 2<sup>nd</sup> DDFC rear spur gear. Dimensional inspection of the splined shouldered shaft away from the damaged region showed it to be consistent within the manufacturing drawing; the average hardness was also with the specified drawing range. **PHOTO 26** shows a side-by-side comparison of an exemplar and event splined shouldered shafts highlighting the forward spline teeth. The drawing calls out a single step change in the forward splines (**PHOTO 26**, black arrows). The event splined shoulder shaft exhibited multiple step changes to various depths (**PHOTO 26**, red arrows) with the most forward part of the spline almost completely obliterated.

**PHOTO 25: SPINED SHOULDERED SHAFT  
FRONT SPLINE AND THREAD DAMAGE**

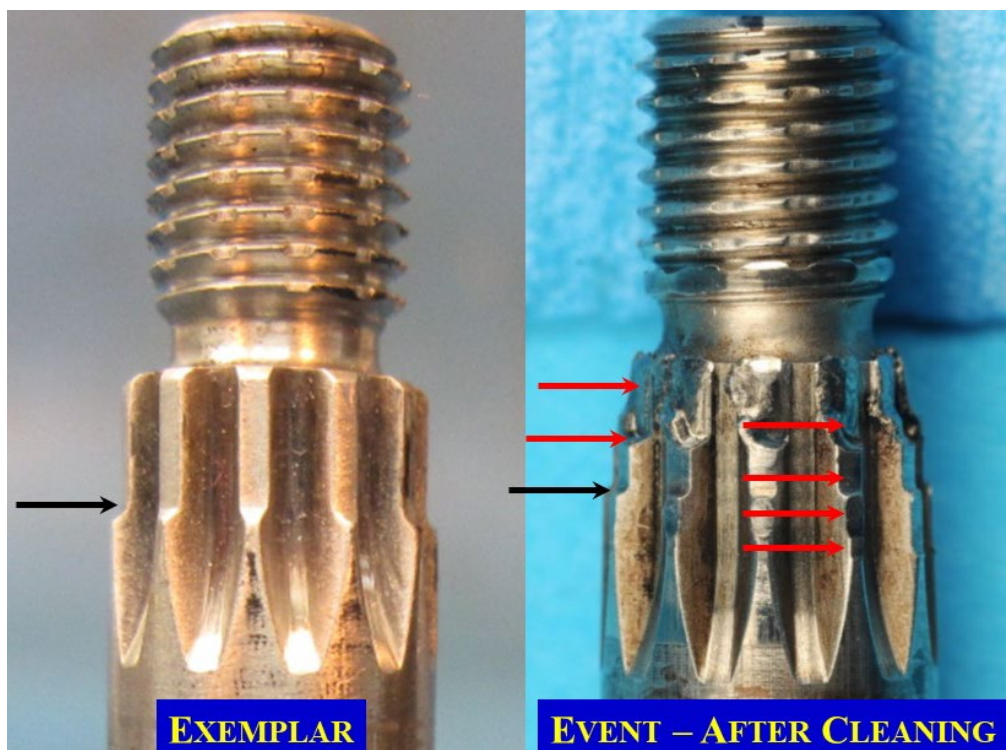
**PHOTO 26: MULTIPLE STEP CHANGES IN THE EVENT FORWARD SPLINE TEETH**

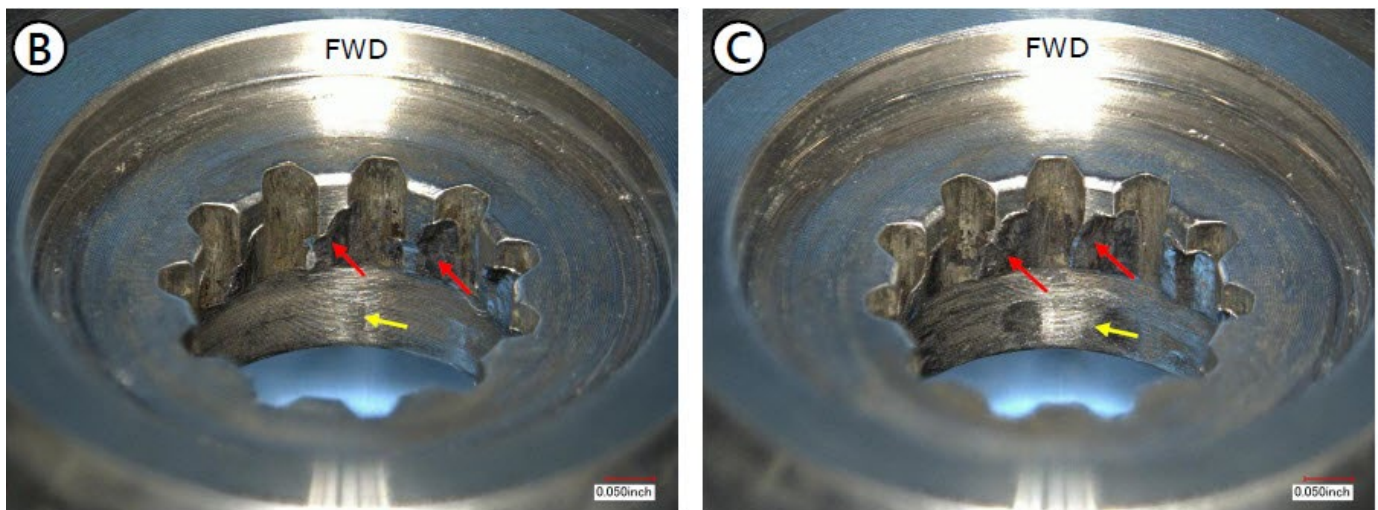
The aft side of the front spur gear exhibited fretting wear and part markings transfer consistent with contact with the duplex bearing. Wear and deformation of the external gear teeth were noted on the pressure face/loaded flank side while light contact marks were noted on the inactive/unloaded flank side; the contact marks were consistent with the gear teeth normal meshing with the 3<sup>rd</sup> DDFC spur gear teeth. The internal spline teeth exhibited wear and deformation in the counterclockwise direction/loading direction (forward looking aft) about  $\frac{2}{3}$  of the axial length near the aft end consistent with meshing with the fretted external spline teeth of the splined shouldered shaft (**PHOTO 27** - red arrows). Contact marks on the inner diameter (ID) of the front spur gear were consistent with contact with the splined shouldered shaft (**PHOTO 27** - yellow arrows); the splined shouldered shaft exhibited similar marks. The forward side of the front spur gear exhibited fret wear consistent with contact from the self-locking nut washer. The average hardness of the front spur gear was within the specified drawing range.

**PHOTO 27: 2<sup>ND</sup> DDFC FRONT SPUR GEAR INTERNAL SPLINE TEETH DAMAGE**

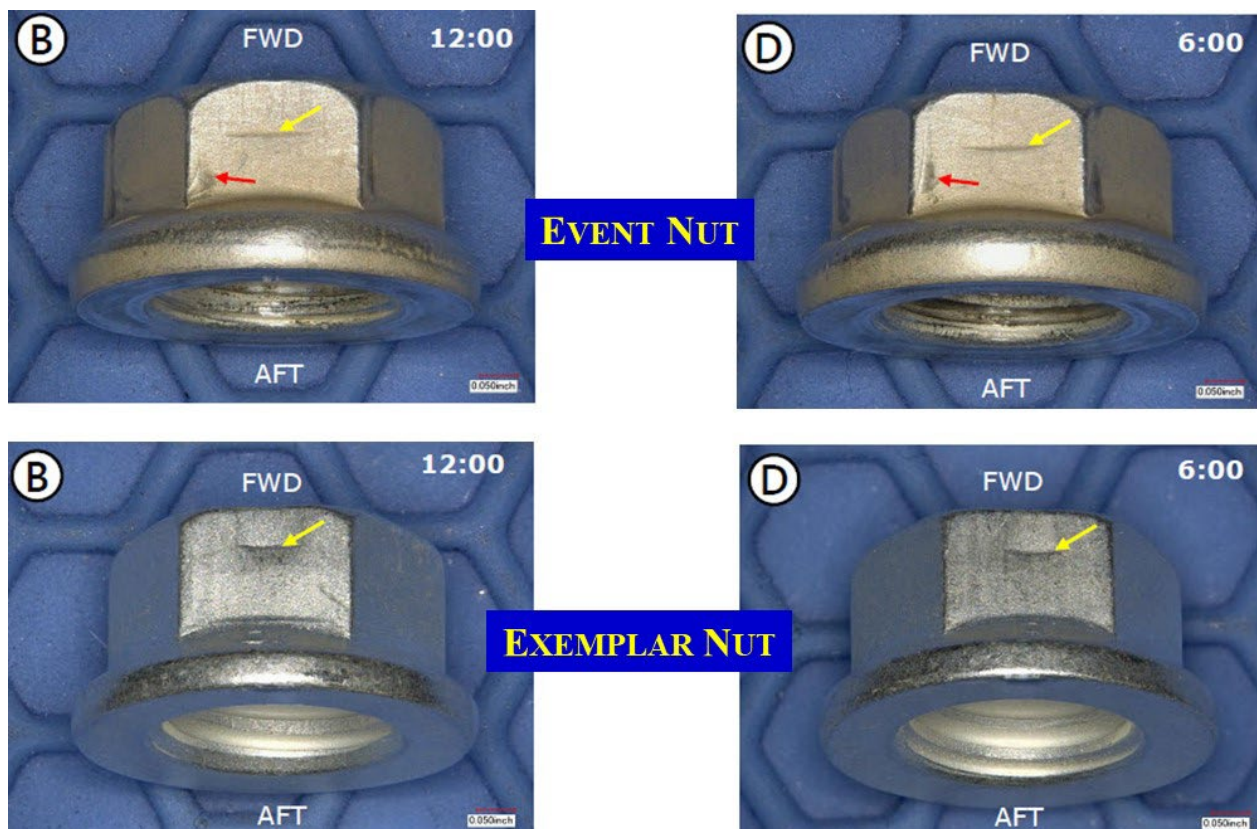
The self-locking nut exhibited distinctive marks on two of the wrenching flats consistent with tool locking imprint marks as specified. An exemplar new self-locking nut showed the same tool locking imprint marks (**PHOTO 28** - yellow arrows). Wear marks were observed on one side of each (**PHOTO 28** - top row red arrow) wrenching flat consistent with contact with installation/torque tool. Wear marks were observed on the aft face of the self-locking nut consistent with contact with the mating washer (**FIGURE 5**, item 75).

**PHOTO 28: EVENT AND EXEMPLAR SELF-LOCKING NUTS WITH LOCKING TOOL MARKS**

The internal threads of the self-locking nut exhibited wear that penetrated through the silver plating predominately on the forward/pressure face/loaded flank side of the threads in the areas aligned with the locking tool mark. The aft/inactive/unloaded flank side of the threads exhibited non-uniform wear that had penetrated through the silver plating with some areas of little to no wear (nickel plating intact) observed at multiple locations. The
