## RECORD OF CONVERSATION

**Date: August 11, 2021**  
**Person Contacted: Mr. Ron Schwachenwald (Federal Aviation Administration Inspector)**  
**NTSB Accident Number: CEN21LA288**

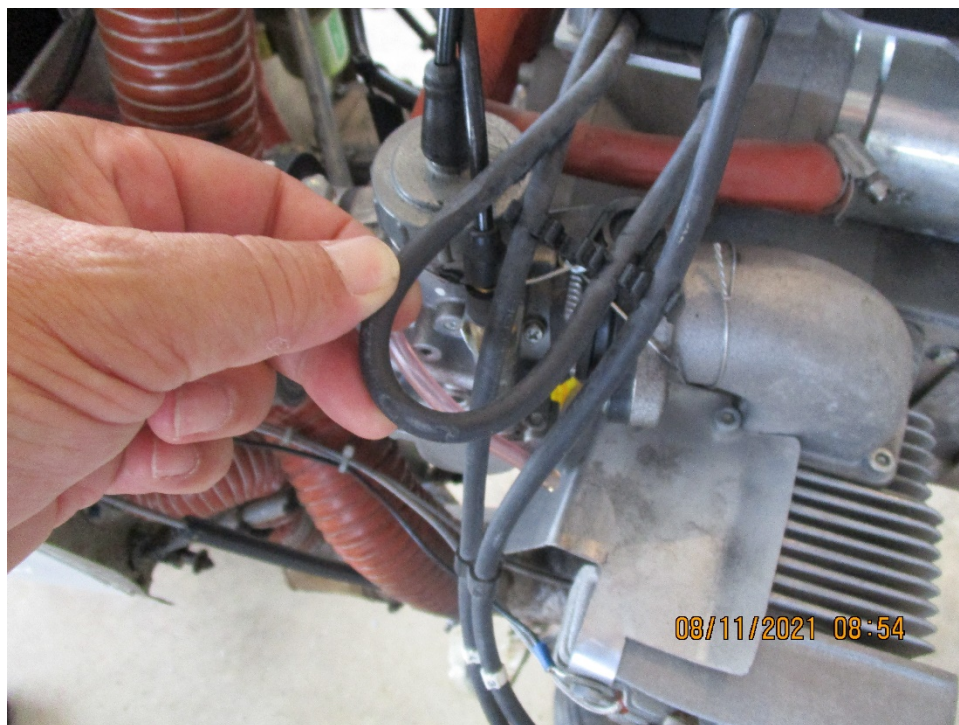
*Figure 3: Ignition Harness*

- The area surrounding the crack exhibited features consistent with 'dry rot.'
  - The crack was not observed through the protective sleeve.
- The ignition harness exhibited some chaffing but was otherwise unremarkable.
  - The ignition leads were unremarkable.
- The fuel tank was located behind the engine; it was not breached.
  - About 7-8 gallons of fuel remained within the fuel tank.
- Mr. Schwachenwald provided the below photos of the examination:

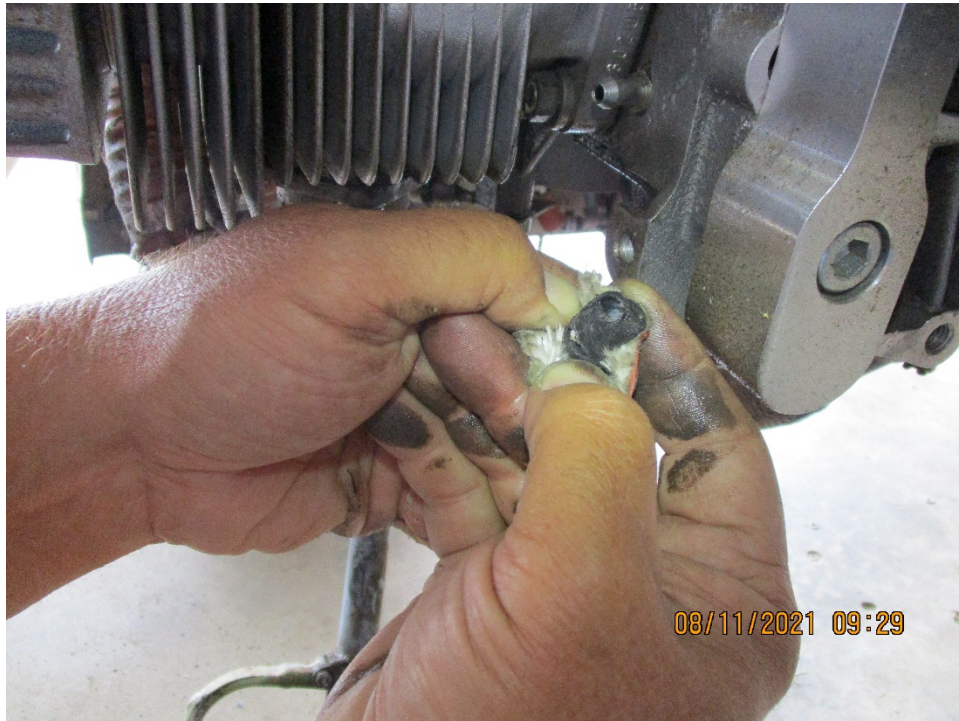
*Figure 4: Pressure Vacuum Link*

- The air filters were clear of debris.
  - There were no obvious anomalies with the carburetors.
- The pressure vacuum line between the manifold and fuel pump was removed and examined. The protective sleeve was pulled back and a crack was revealed.

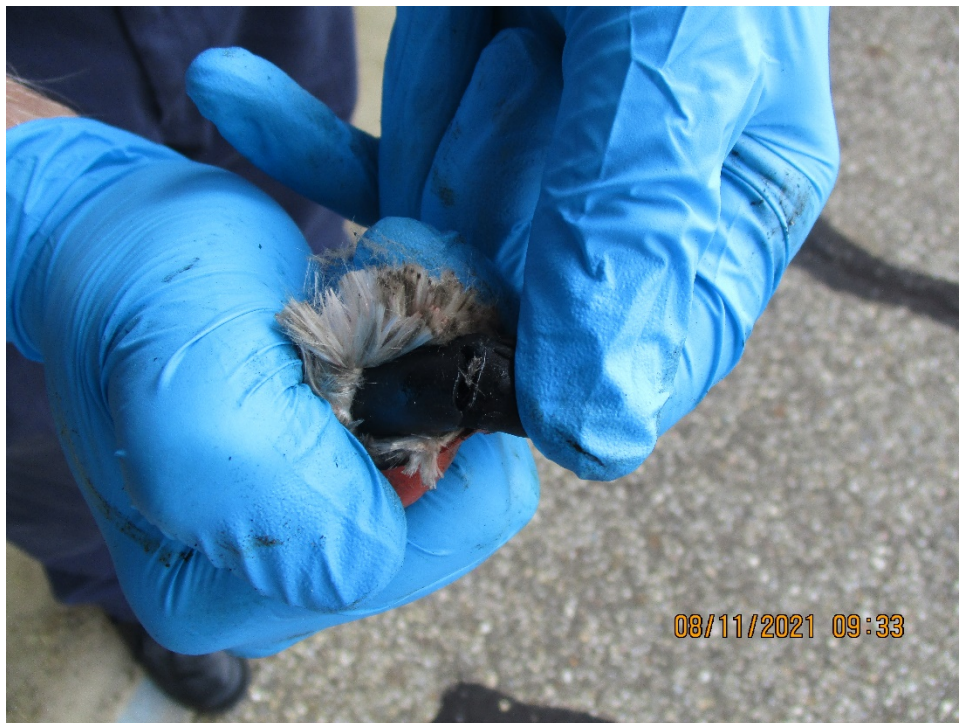
- The crack was observed in an area where the hose bends as it enters the engine

*Figure 5: Crack in Pressure Vacuum Line*

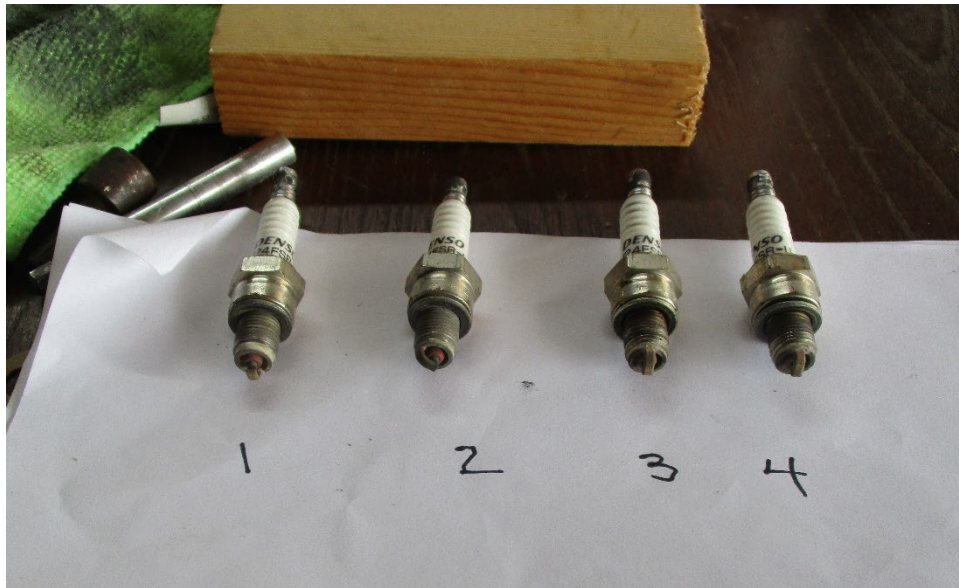
*Figure 6: Spark Plugs*

- The spark plugs were removed from the engine, and they exhibited features consistent with normal operations.
  - The deposits were a light tan color.
  - One spark plug was bent consistent with impact damage.
