**NATIONAL TRANSPORTATIONS SAFETY BOARD**  
**Office of Aviation Safety**  
**Washington, DC 20594**

**SUMMARY OF ENGINE/AIRFRAME EXAMINATION**

-- CEN21LA293 --

Aircraft: N4216J, Piper PA28

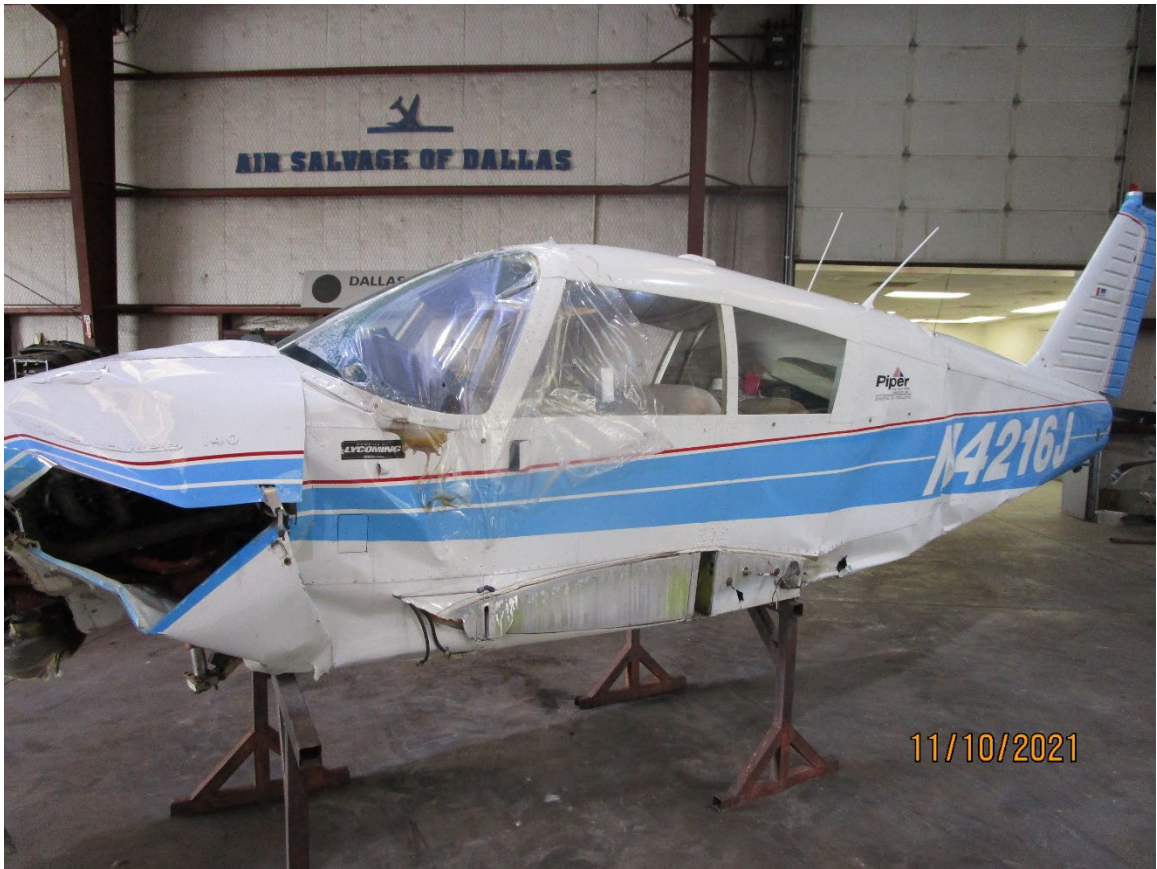
Fuselage on stands

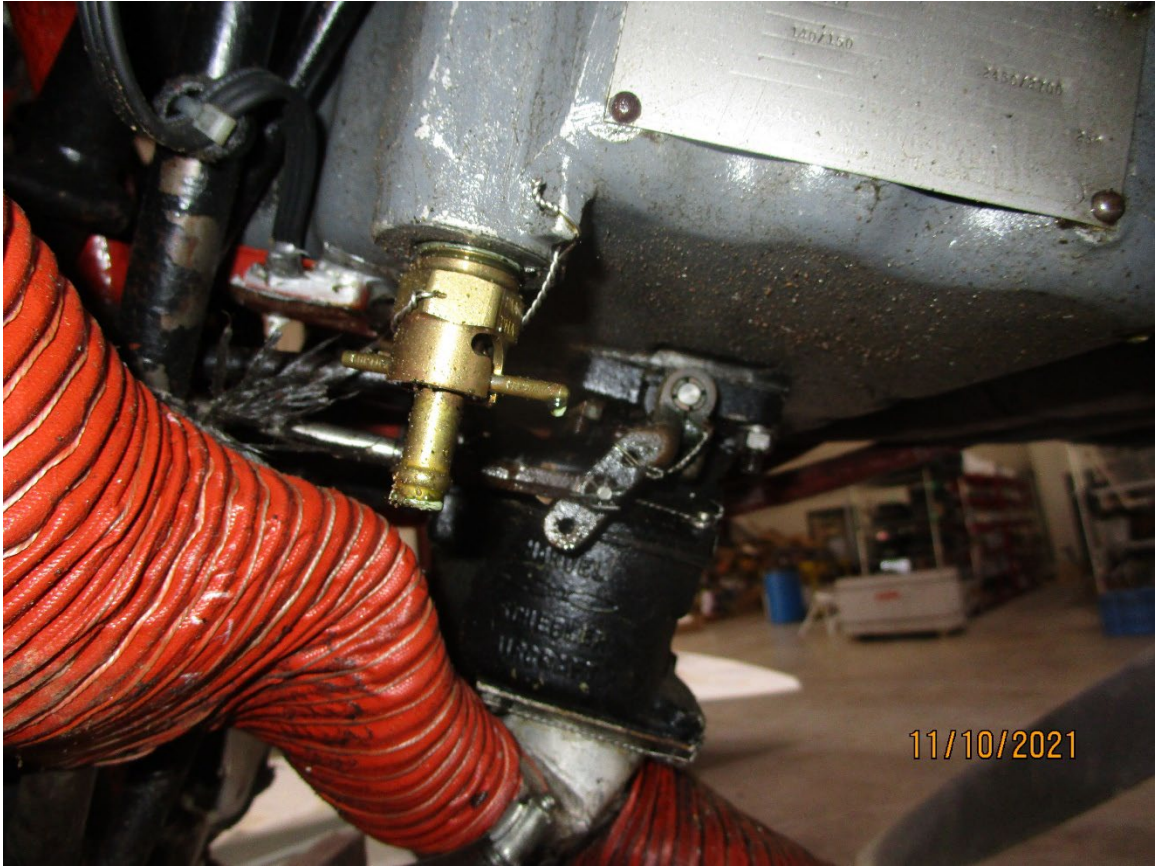
- Throttle and mixture controls were connected to the carburetor
- Engine rotated by hand
  - Continuity thru the valve train to the accessory section noted
  - Left Magneto impulse coupling, very faint
    - Impulse coupling "loose"
  - A cylinder thumb suction and compression test – good
- Spark was observed on top set of sparkplugs
- Timing was 25 degrees right mag, and about 20 degrees left mag BTC
- Scat tubing on engine's induction feed
  - Tubing crushed during accident – unable to determine if tubing was collapsing before accident

Scat house, running to the carburetor
