## **Examination Summary**

NTSB ACCIDENT NUMBER: CEN21LA316

AIRCRAFT REGISTRATION/AIRCRAFT TYPE: N5340R, Cessna 172

**Post-Accident Engine Examination Summary**

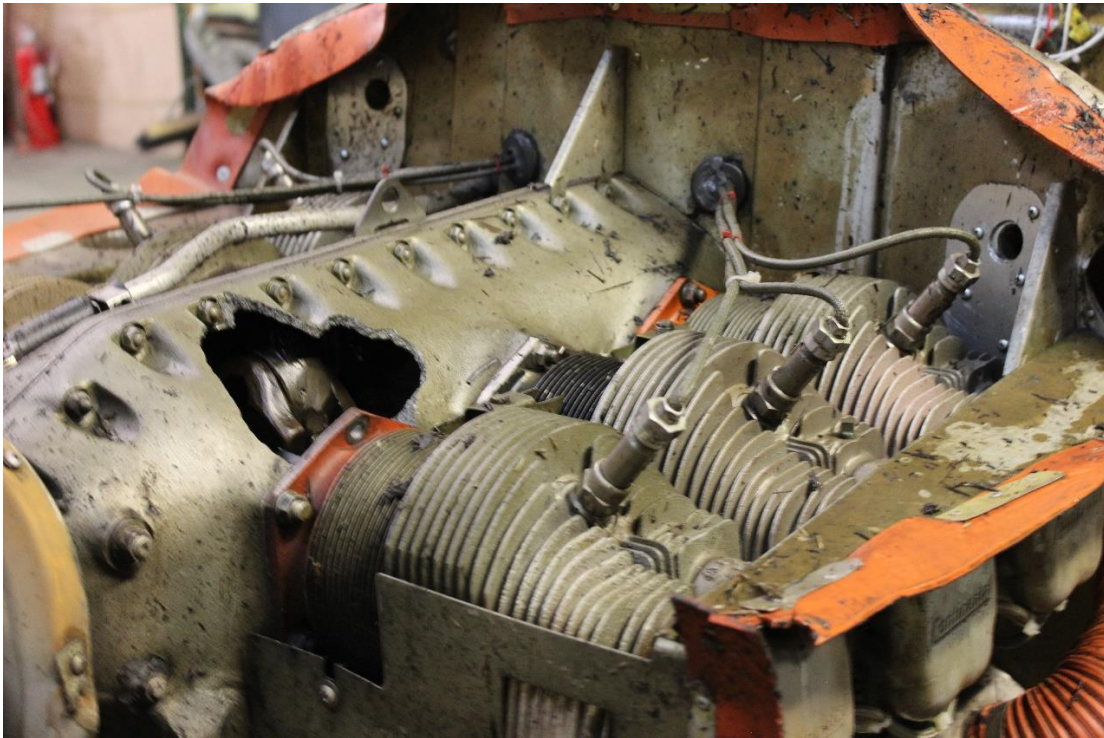
*Photo 1: Aircraft Engine*

- The engine presented with a hole in the top of the engine case adjacent to the number 6 cylinder.

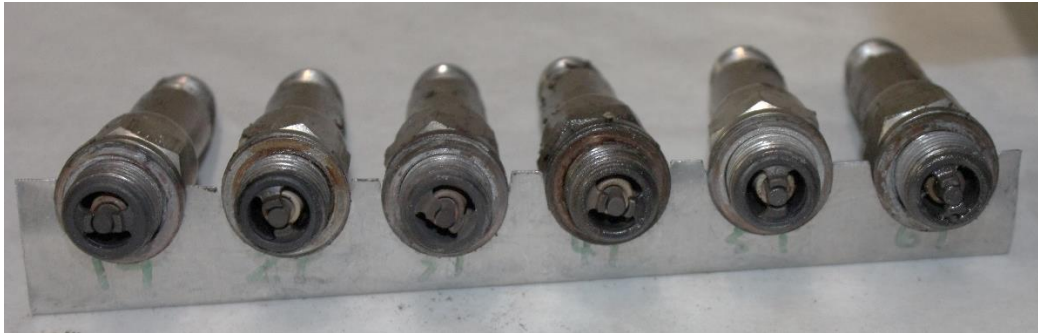
*Photo 2: Top Spark Plugs*

- The spark plugs and leads were checked for tightness prior to removal. All leads were tight except the top spark plug lead from the No. 5 cylinder which was about 1/3 turn loose. All spark plugs were confirmed tight and then removed for closer inspection.
- The top spark plugs and bottom spark plugs were different types but consistent. All tops were consistent with massive type plugs and the bottom plugs were all consistent with fine wire plugs.

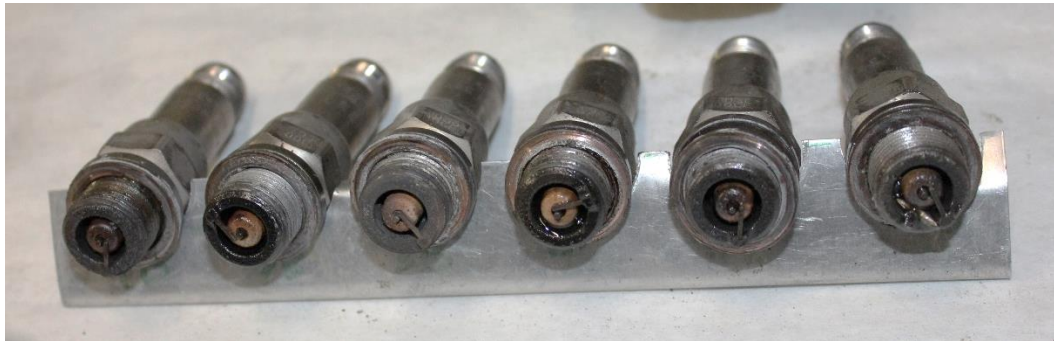
*Photo 3: Bottom Spark Plugs*

- All plugs appeared unremarkable
- The cylinders were removed for an internal inspection of the engine.
- All cylinders except for the No. 5 cylinder were easily removed.
- The No. 5 cylinder was difficult due to mechanical impact damage, so the engine case was separated with the cylinder still attached.
- Upon inspection, it was discovered that the connecting rod for the No. 6 piston had fractured at the end cap with the separated pieces found in the oil sump.
- The cylinder was later removed with the piston still inside and sent to the NTSB Materials Laboratory for further inspection. See the Materials Laboratory factual report for more information concerning the failure of the connecting rod.
