# NATIONAL TRANSPORTATION SAFETY BOARD

## MATERIALS LABORATORY FACTUAL REPORT

Report No. 22-016

Place : Eagle Butte, SD  
Date : July 11, 2021  
Vehicle : Cessna 172F, N5340R  
NTSB No. : CEN21LA316  
Investigator : Shaun Williams, AS-CEN

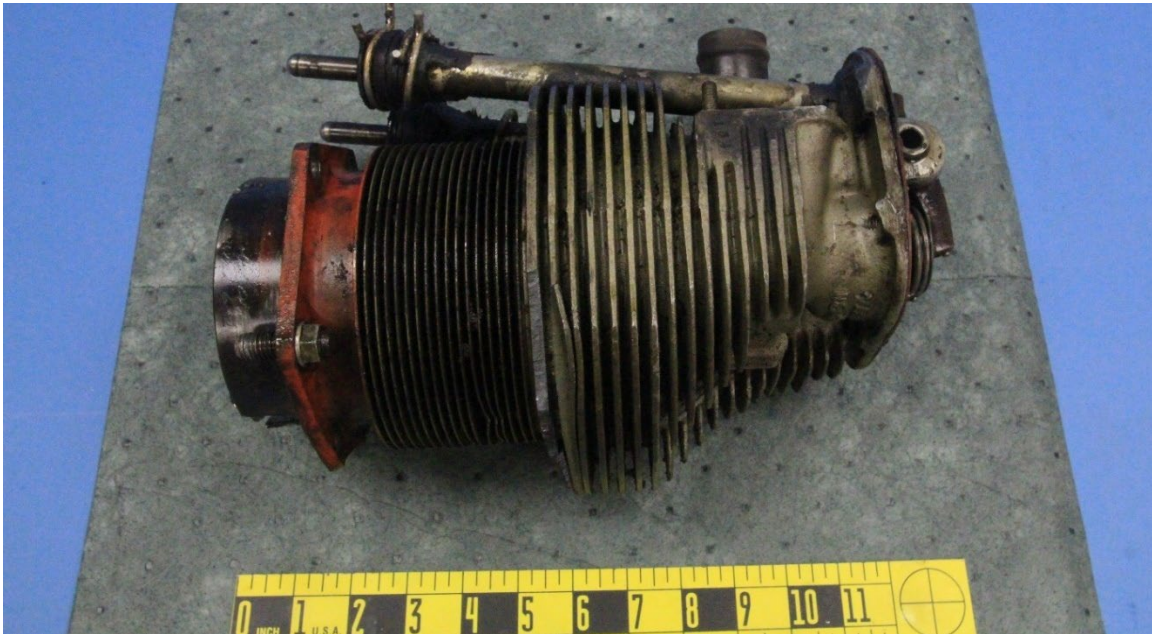
The cylinder assembly is shown from different angles in Figures 1 through 3. Several of the cooling fins of the cylinder exterior had been deformed from bending, as exemplified in Figure 1. The fins, as well as the other assembled components, exhibited dark-colored deposits, consistent with oils and greases, as shown in Figure 2.

Figure 1 – View of the cylinder exterior, showing deformed fins.

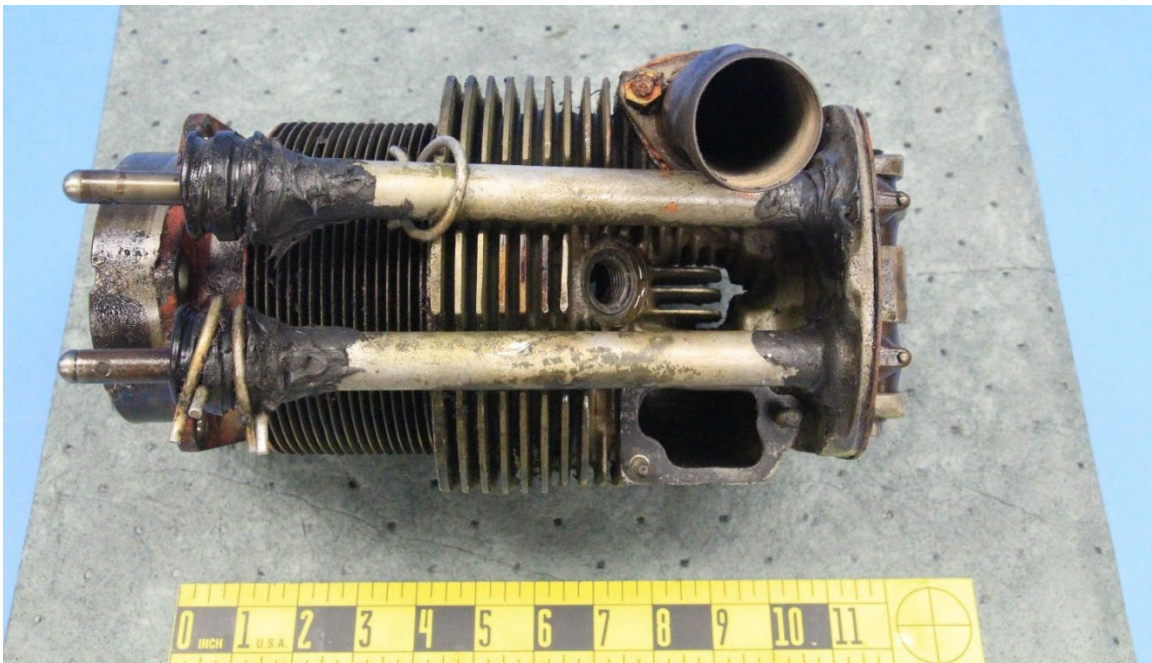
Figure 2 – The cylinder as received, viewed from the exhaust and intake manifolds.

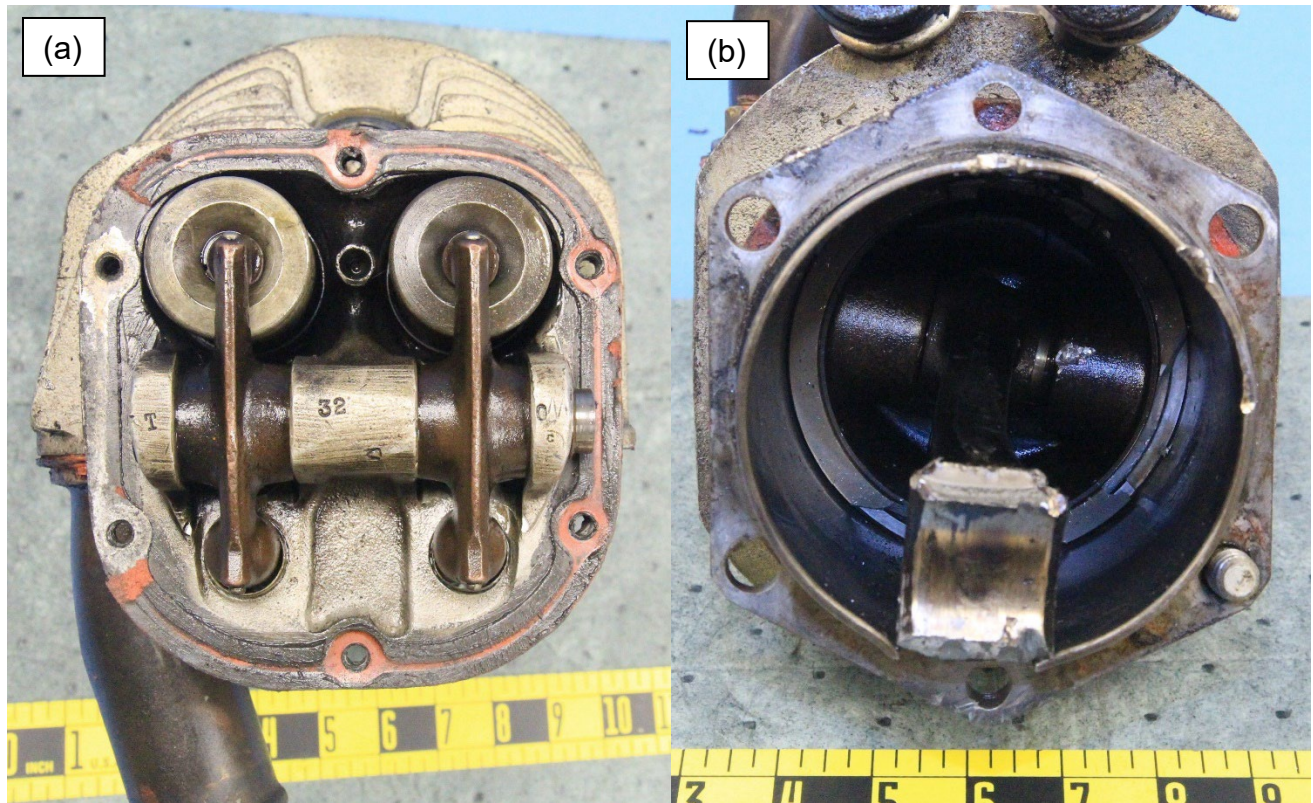
The oil cover on the top of the cylinder assembly had been removed prior to receipt at the NTSB. As shown in Figure 3a, the rockers, retainers, and springs were still intact, and the parts exhibited no indications or witness marks suggesting damage to these

components. However, as shown in Figure 3b, the underside or skirt opening of the cylinder did exhibit damage, consistent with fracture of the connecting rod.

The connecting rod was still attached to the piston via the piston pin, and these were still jammed inside the cylinder bore, as received. The cylinder skirt exhibited outward bending deformation and tearing, located 180° from each other, as well as along the rocking locations of the connecting rod. The width of these impacts and tears were consistent with the flange width of the neck of the connecting rod remnant. These features were consistent with the flanges of the connecting rod impacting the cylinder after fracture.

Figure 3 – View of the cylinder from (a) the rocker arms and (b) the skirt, showing the remnants of the connecting rod.

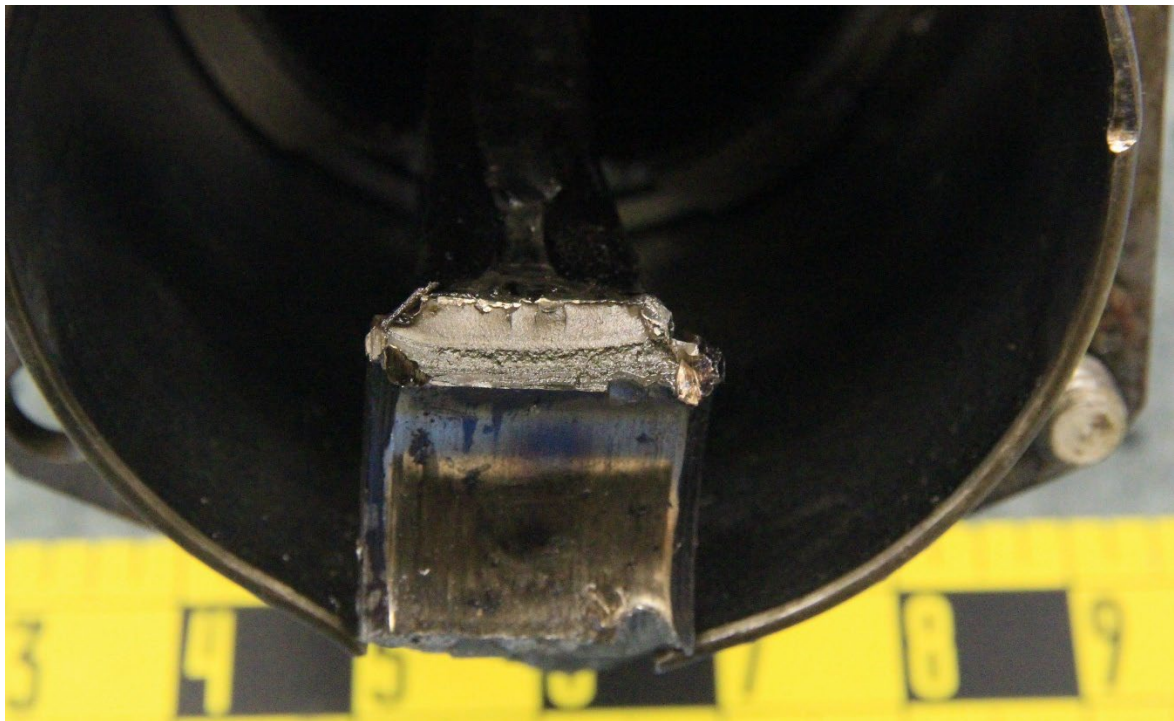
Figure 4 shows a closer view of one of the fracture surfaces on the connecting rod. This fracture surface exhibited two distinct regions, one with a flatter, smoother area, and one with a rougher, duller area. As such, the piston was removed from the cylinder, and the subassembly was undone to isolate the connecting rod remnant.

Figure 4 – Closer view of the connecting rod remnant from the cylinder skirt, showing the fracture surface.

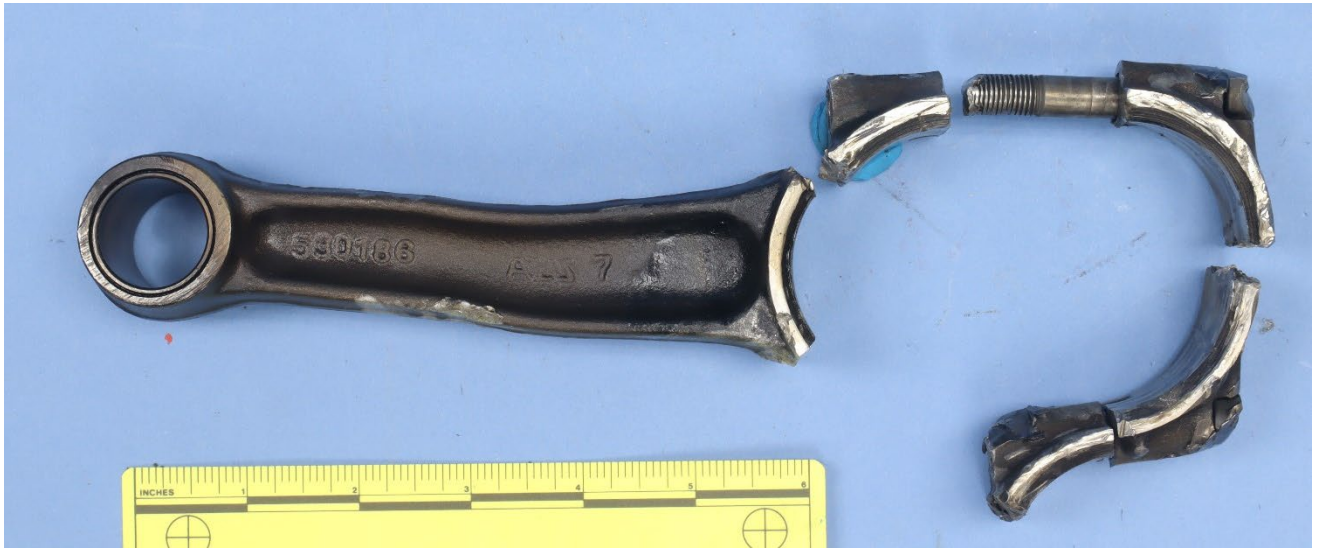
Figure 5 and Figure 6 show the removed connecting rod positioned next to the smaller fragments of the rod and cap, received separately. The markings on the connecting rod web stated, "530186 AES 7". The rod had fractured in two places, near the H-shaped neck transition to the crankshaft bore yoke. The connecting rod cap had fractured in the location facing opposite from the rod body. Each attachment bolt had also fractured, although they were still jammed into their respective rod cap remnants.

Figure 5 – View of the reconstructed connecting rod and cap remnants, after removal from the cylinder.

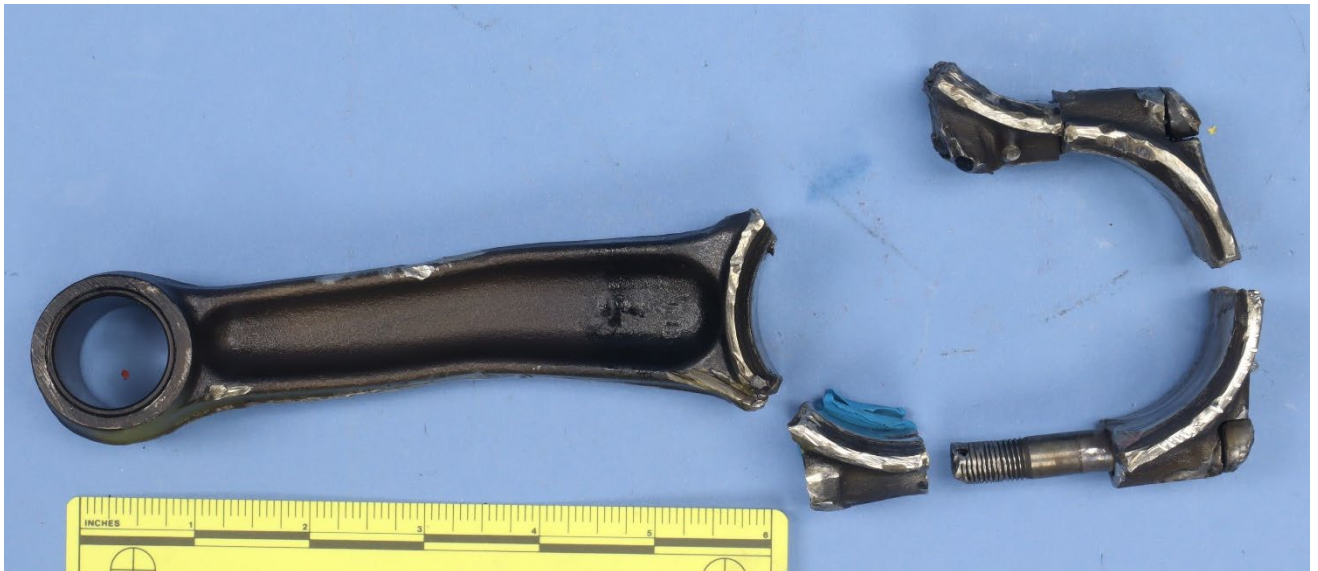
Figure 6 – View of the connecting rod remnants, viewed opposite shown in Figure 5.

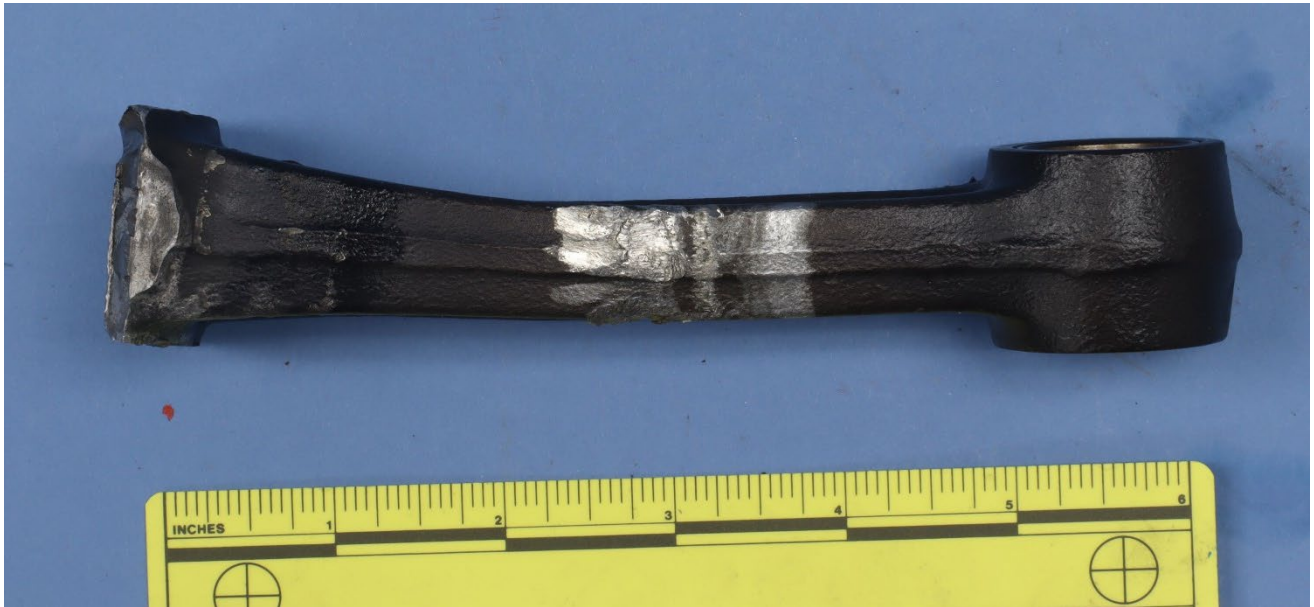
Figure 7 shows the connecting rod viewed from the side. The rod had bent out of plane perpendicular to the web direction. In addition, the opposite surfaces of the rod exhibited gouge and rubbing marks at the bend location. These witness marks, having worn off the surface material, were reflective relative to the rest of the connecting rod surface. These features were consistent with repeated contact against the cylinder skirt.

Figure 7 – View of the connecting rod from the flange, showing bending deformation and gouging and wear marks.

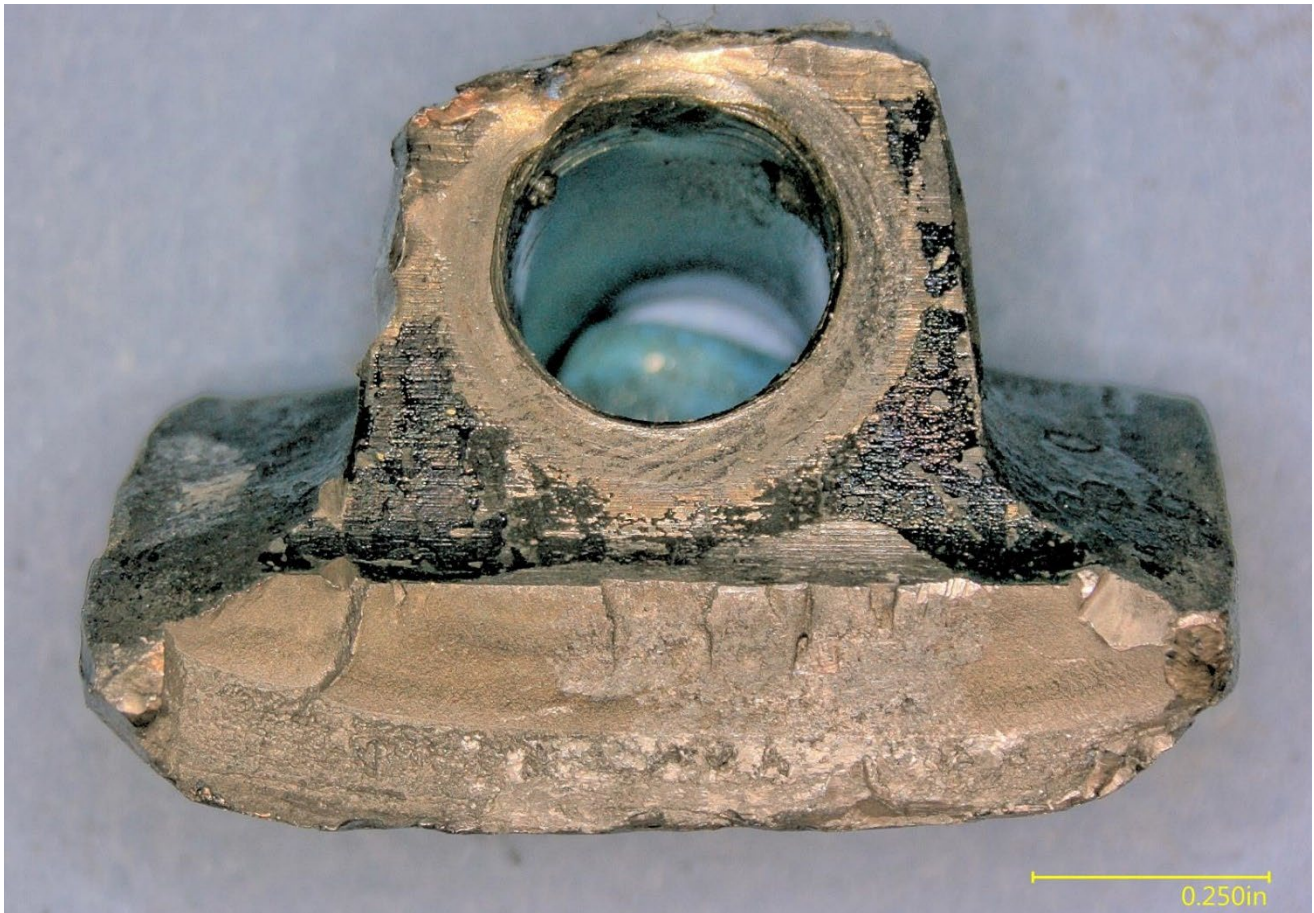
One of the liberated connecting rod remnants was sectioned and cleaned with acetone to facilitate examination of the fracture surface. Figure 8 shows the mating side of the fracture surface displayed in Figure 4. This surface exhibited two distinct fracture regimes. In the upper half of the area displayed in Figure 8, the fracture surface exhibited ratchet marks and crack arrest marks, consistent with progressive cracking, later determined to be fatigue. The middle of the fracture surface exhibited a flatter, mottled texture. This was consistent with rubbing and impact of the fracture surface, typical of post-fracture damage from interaction with adjacent metallic parts.

Figure 8 – View of the connecting rod fracture surface.

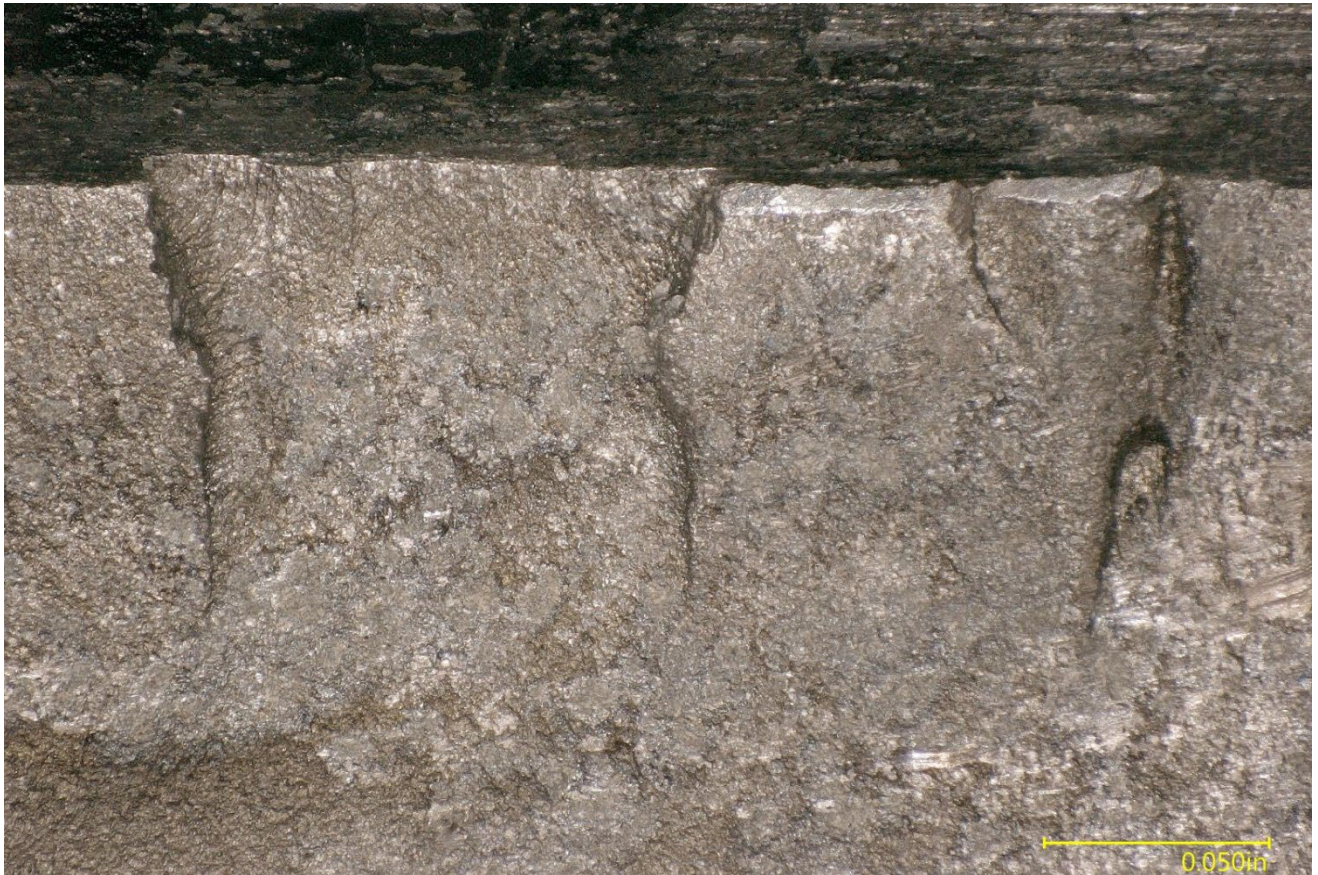
Figure 9 shows a closer view of the ratchet marks, indicative of the merging of multiple cracks progressing inward (downward in the figure). These marks were consistent with multiple crack initiation sites, located along the outer surface of the connecting rod near the attachment bolt hole. Figures 10 and 11 show an angled view of some of the crack initiation sites. This figure demonstrates some of the parallel machine marks on the surface, which were deep enough to deflect light and retain oil prior to cleaning.

Figure 9 – Closer view of the connecting rod fracture surface, showing parallel ratchet marks consistent with multiple fatigue crack initiation sites.

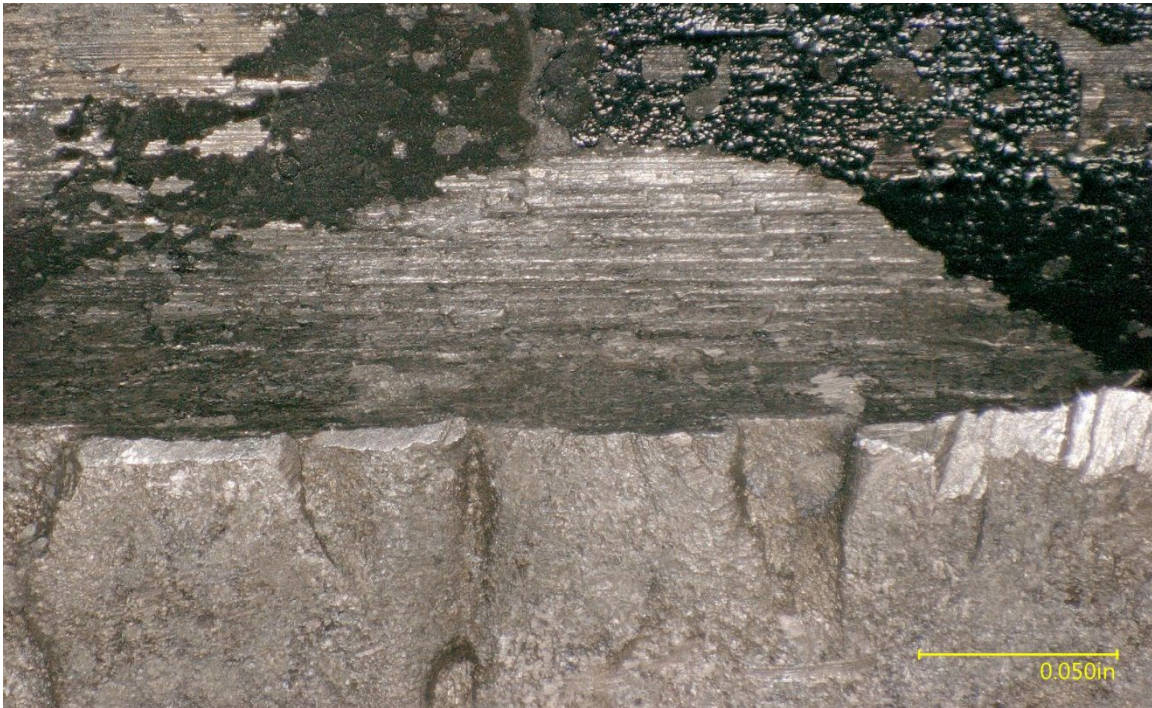
Figure 10 – View of the external connecting rod surface at the crack initiation sites, showing marks on the surface.

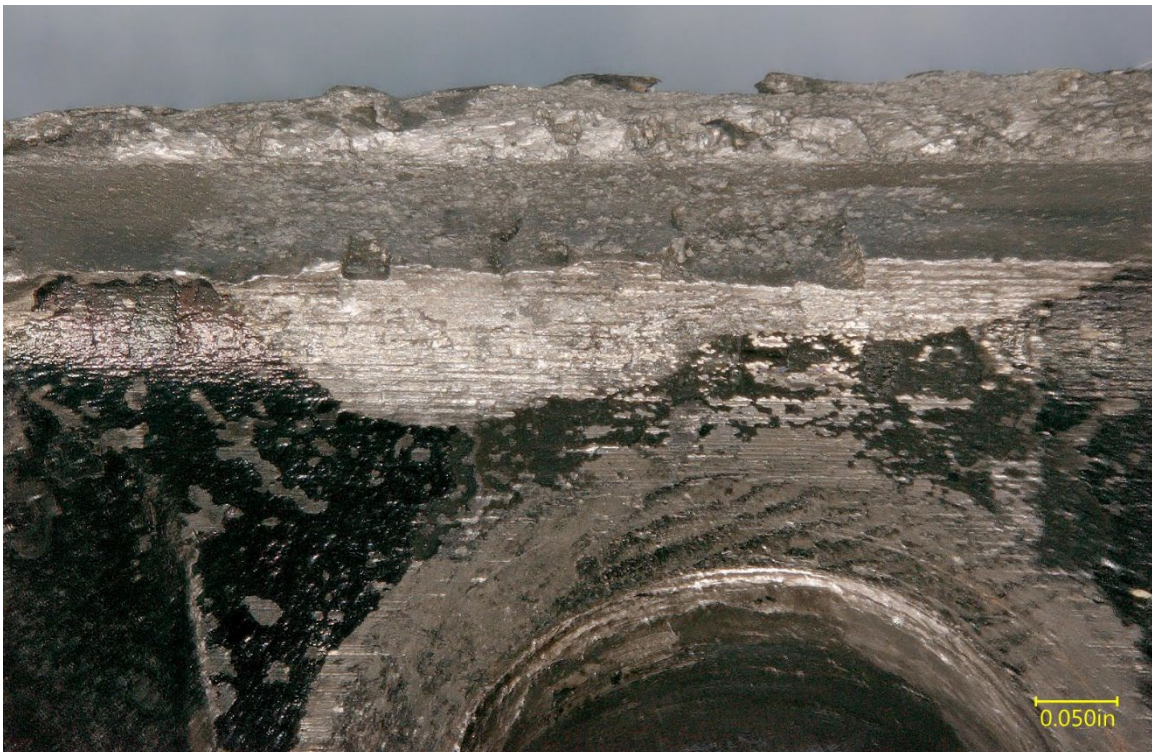
Figure 11 – Opposite view of the fatigue crack initiation sites on the connecting rod.

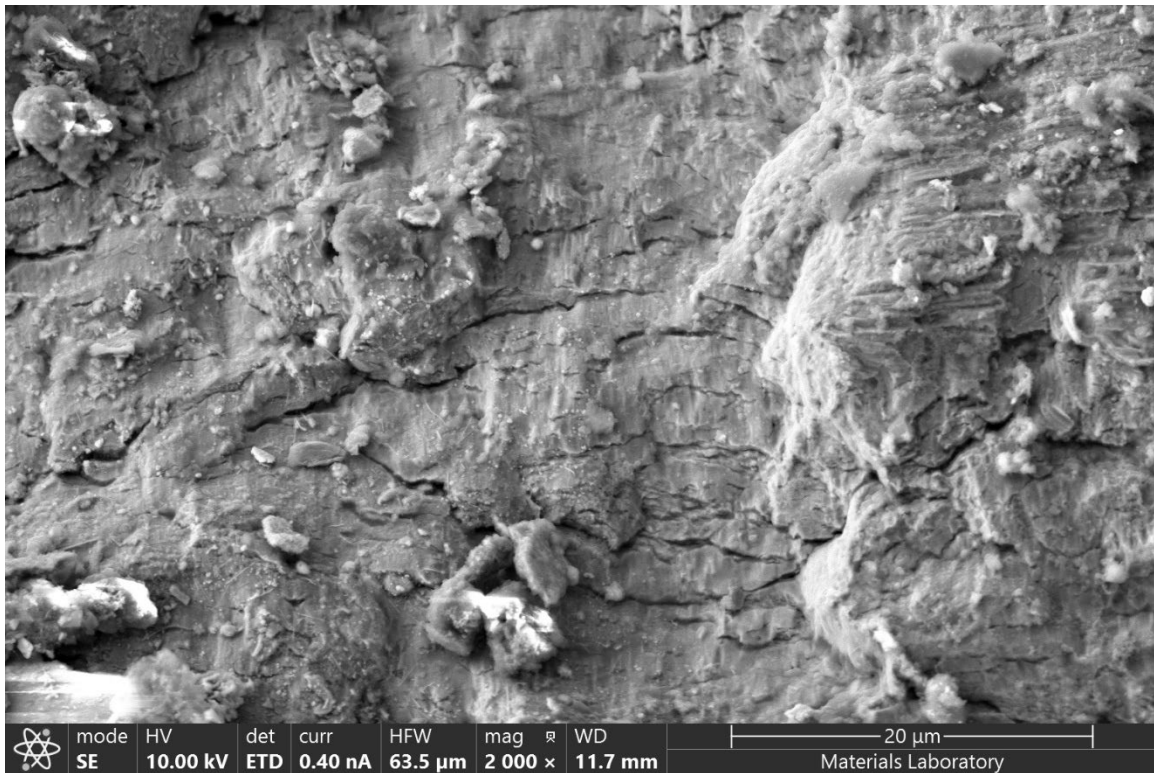
The connecting rod fracture surface was examined using a field emission scanning electron microscope (SEM). As typified in Figure 12, the progressive region of the fracture

surface exhibited fatigue striations, consistent with fatigue crack propagation. While much of the fracture surface had been damaged from post-fracture smearing, fatigue striations were prevalent throughout the surface. As can be seen in isolated areas in Figure 13, fatigue striations were present adjacent to the initiation sites. Figure 14 shows some of these striations. Outside of the fatigue crack, dimpled rupture was observed—these features were consistent with subsequent overstress fracture (see Figure 15).

Figure 12 – Secondary electron (SE) micrograph of fatigue striations on the fracture surface.

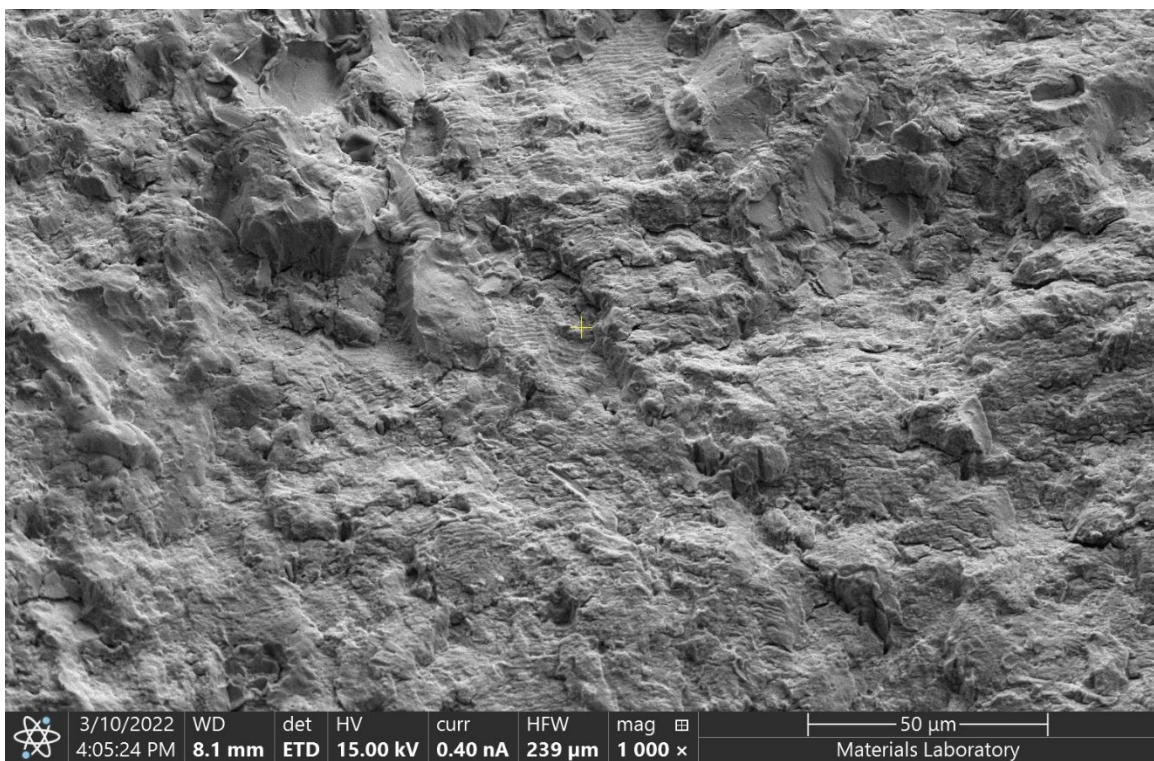
Figure 13 – SE micrograph of the fracture surface near an initiation site.

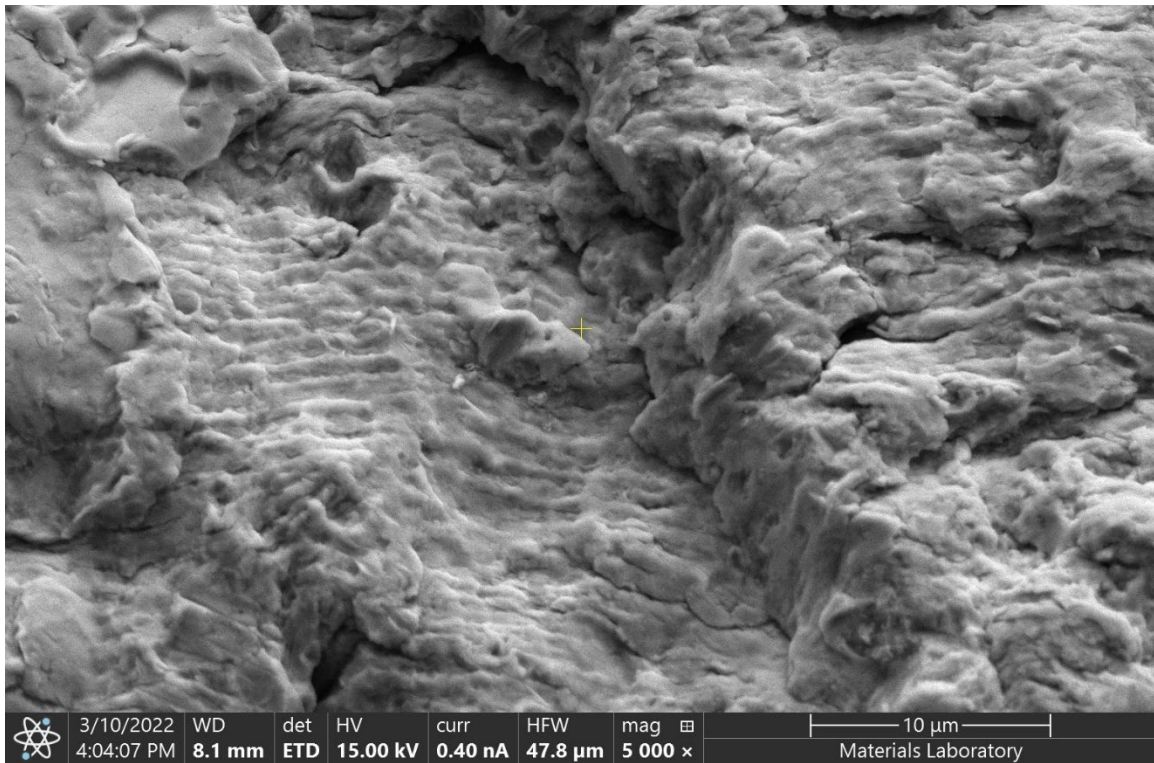
Figure 14 – SE micrograph of fatigue striations in the region in Figure 13.

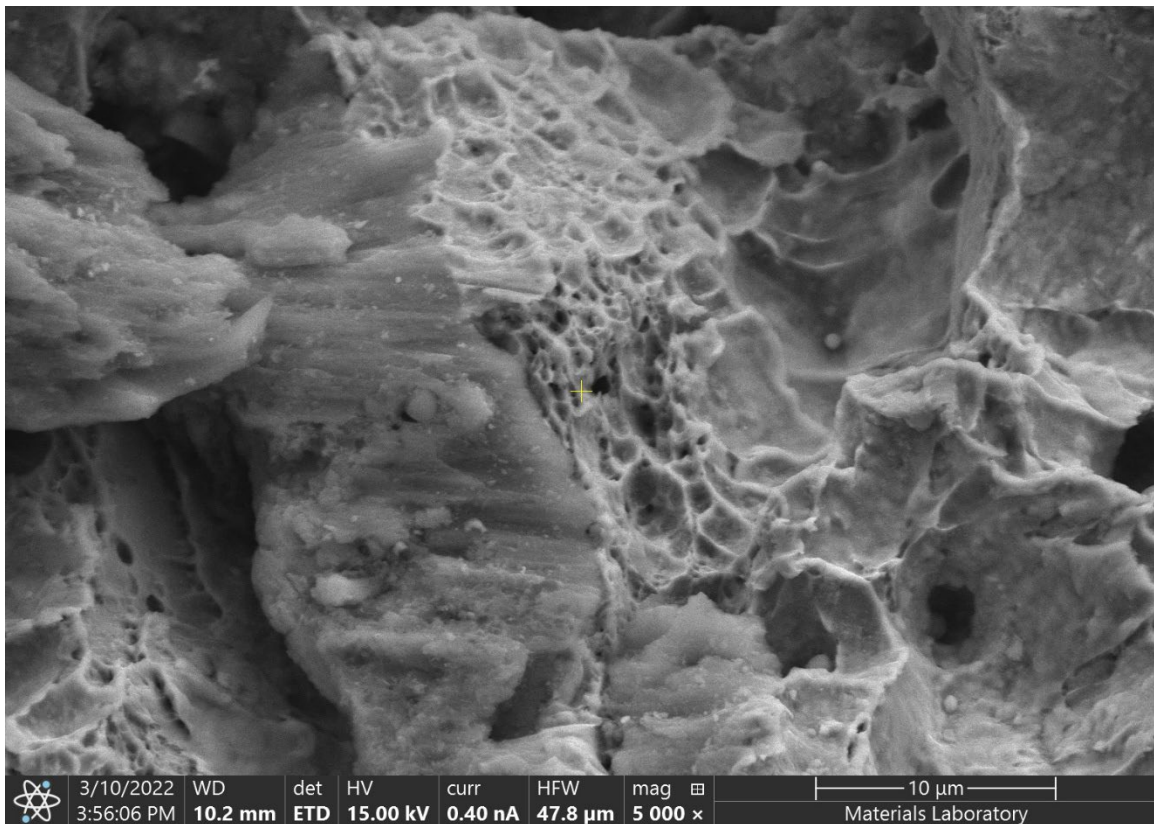
Figure 15 – SE micrograph of dimpled rupture outside the fatigue crack.

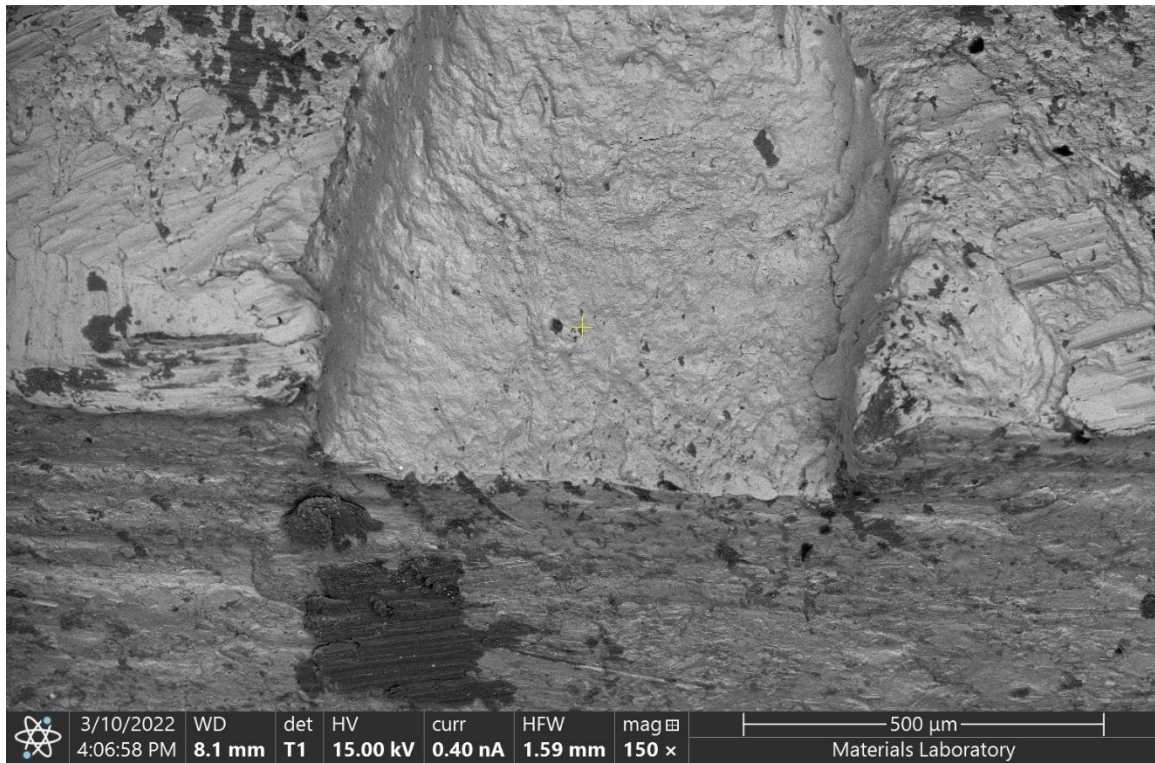
Figures 16 and 17 show one of the fatigue crack initiation sites of the connecting rod. These figures exemplify the ratchet marks bounding this fatigue crack and show the river patterns emanating from the initiation site at the edge. Closer examination of the edge with the initiation site did not reveal any features of note. As shown by the lack of contrast in Figure 16, there were no dissimilar materials consistent with a corrosion pit or inclusion at that location.<sup>2</sup> However, similar to the visual image of the connecting rod outer surface in Figure 11, Figure 16 and Figure 17 show the parallel surface marks. These marks, which were also parallel to the fracture surface, were collocated with the fatigue crack initiation sites.

Figure 16 – Backscattered electron (BE) micrograph of a fatigue crack initiation site.

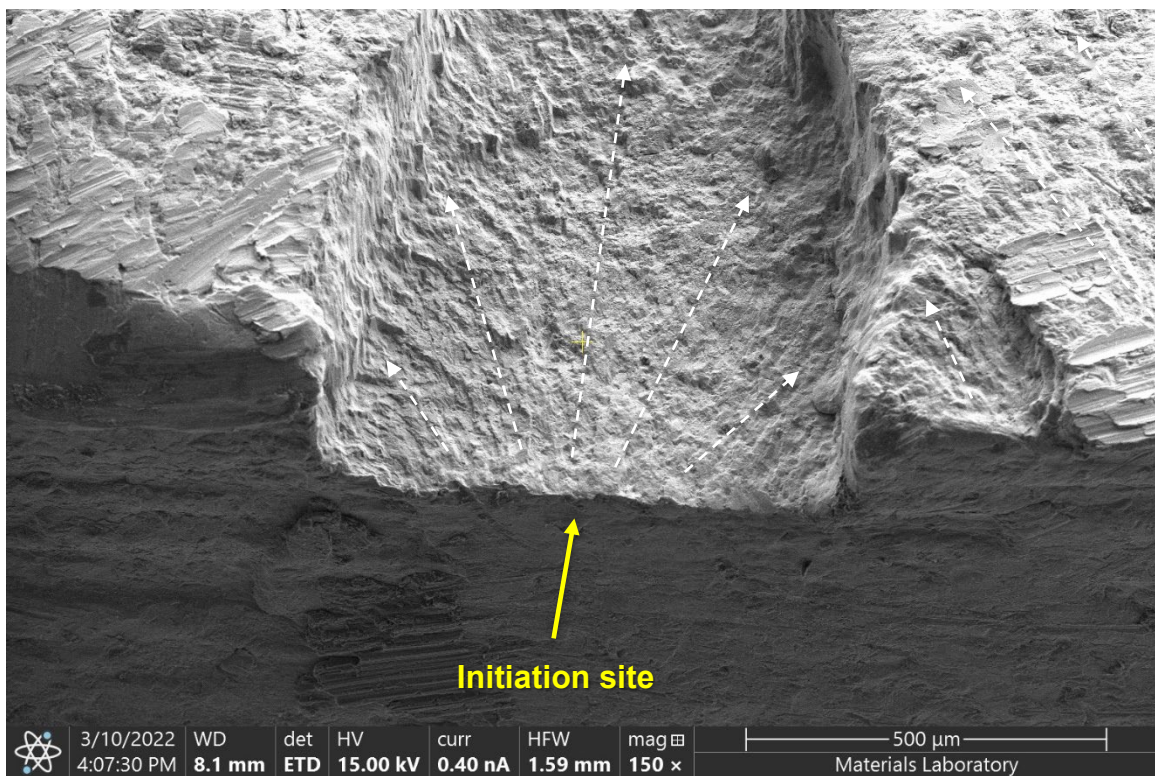
Figure 17 – SE micrograph of the initiation site in Figure 16.

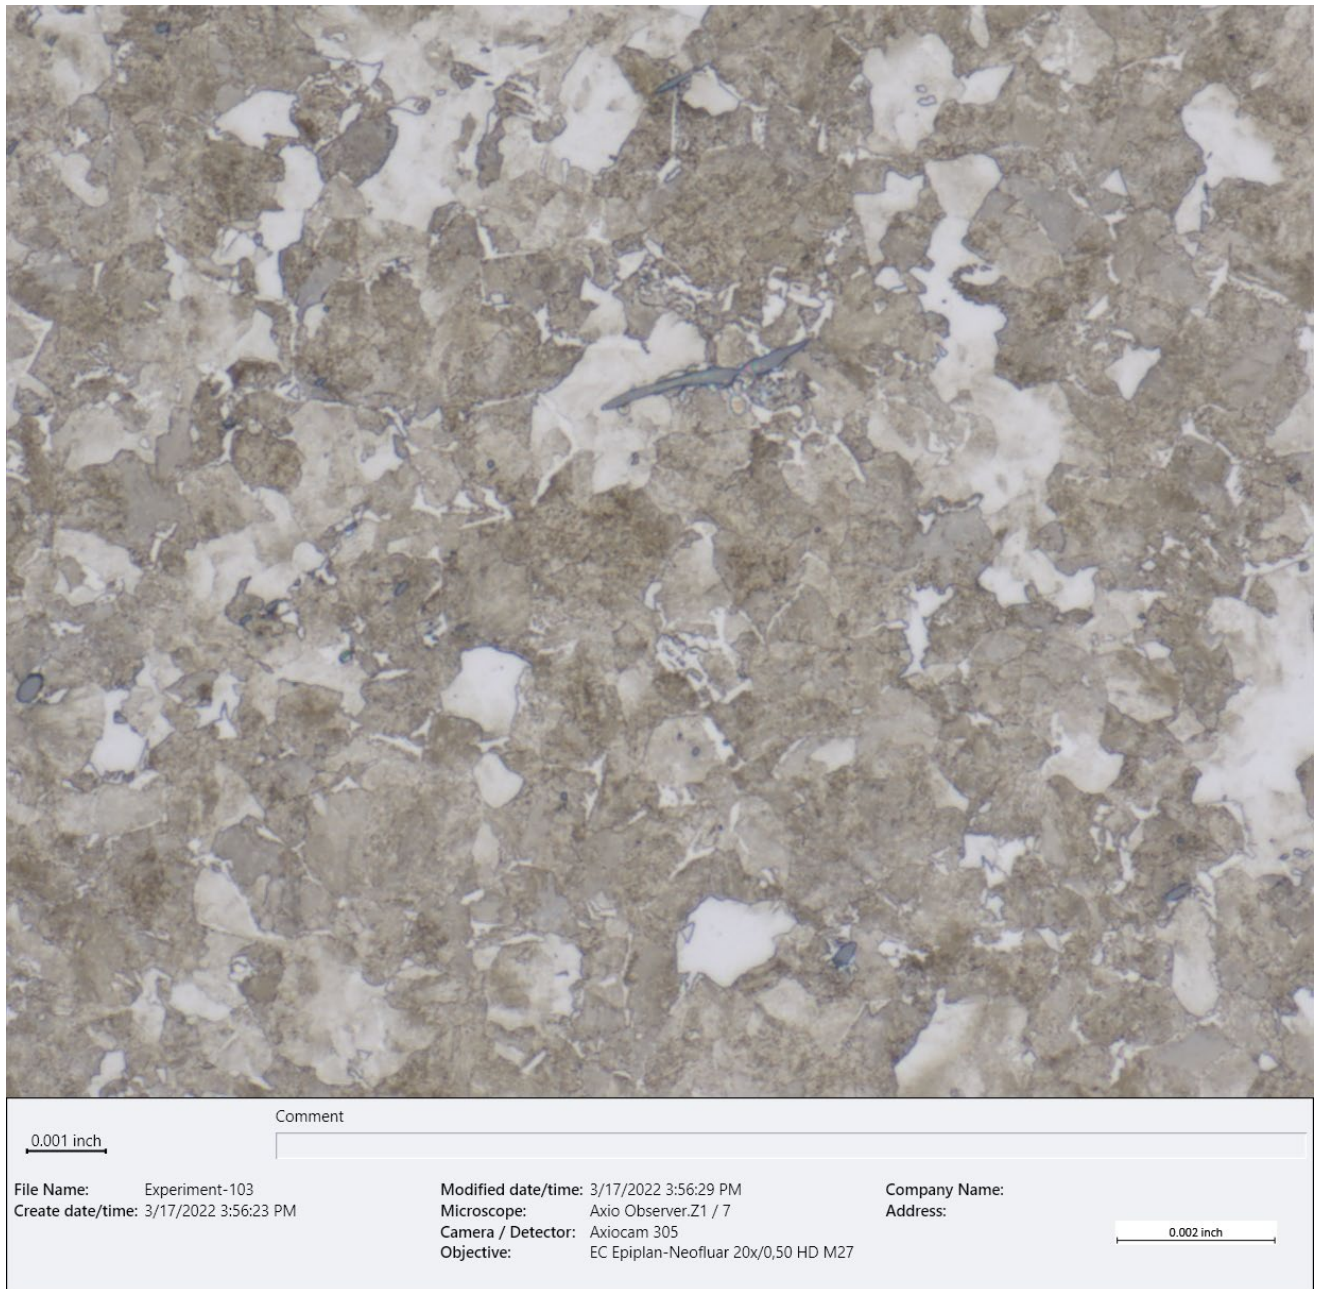
One of the fracture surfaces was cross-sectioned, mounted, polished, and etched with a 2% nital solution.<sup>3</sup> Figure 18 shows a typical area of the core microstructure of the connecting rod. This micrograph shows the generally equiaxed grain structure, with grains of fine unresolved pearlite, ferrite, and proeutectoid ferrite around the pearlite grains.

Figure 18 – Bright-field (BF) optical micrograph of a typical area of the connecting rod microstructure (~500X, etched 2% nital).

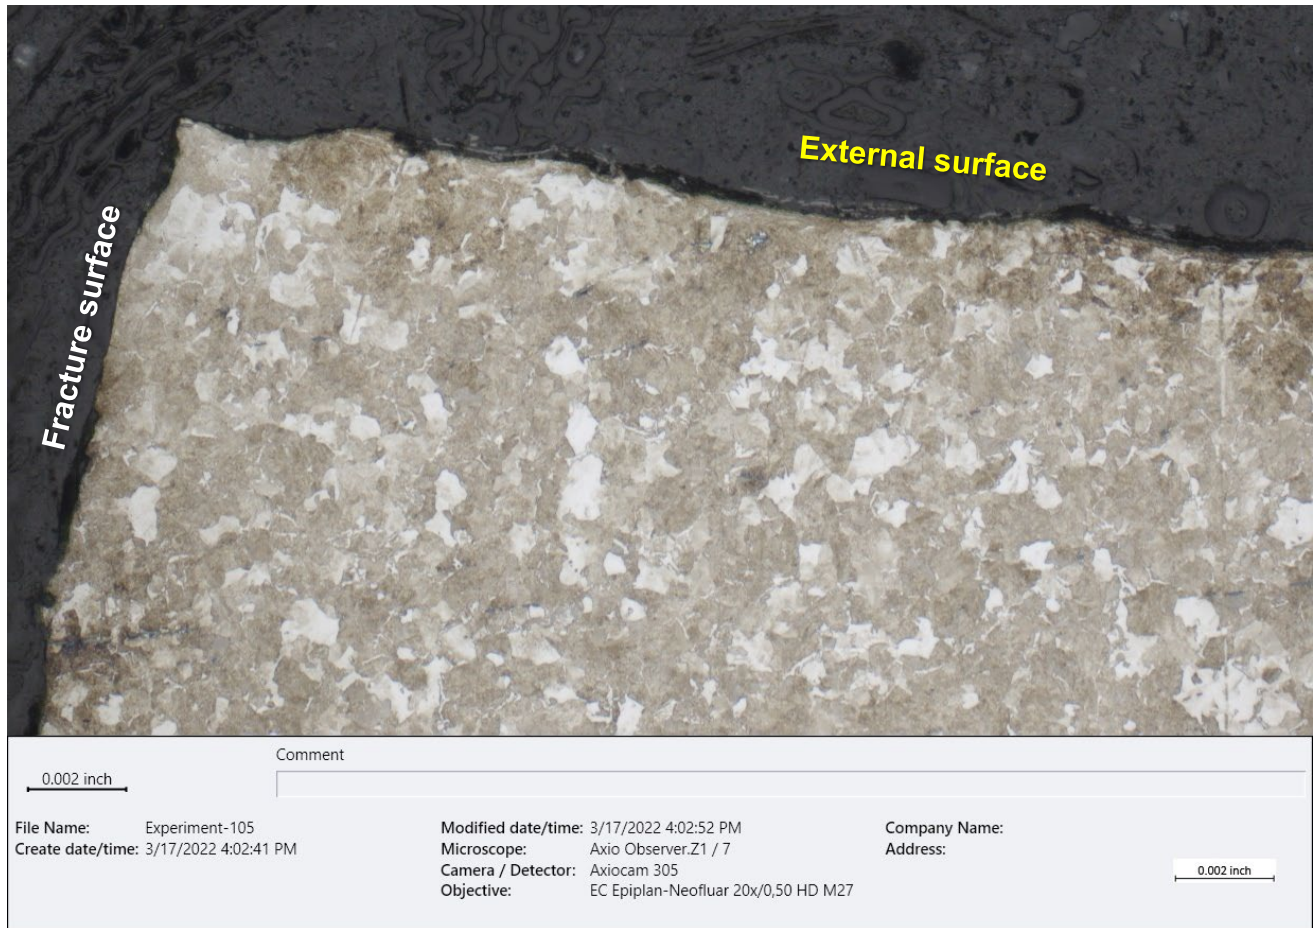
Figures 19 and 20 show a cross section through the edge with the crack initiation sites. As depicted in the figures, the surface exhibited undulations, consistent with some of the marks on the outer surface of the connecting rod in Figure 16. In these micrographs, there were no indications of parallel or branched cracks. Other areas of the outer surface of the connecting rod exhibited areas with a white layer along with underlying deformed and flattened grains (Figure 21). These features were consistent with an untempered martensite layer, which can be caused by grinding, sliding, or other high frictional heat input to the surface, such that the microstructure was deformed and changes phase upon heating above 1350 °F (727 °C).

Figure 19 – BF optical micrograph of a cross-section of the fracture surface with the crack initiation surface (~200X, etched 2% nital).

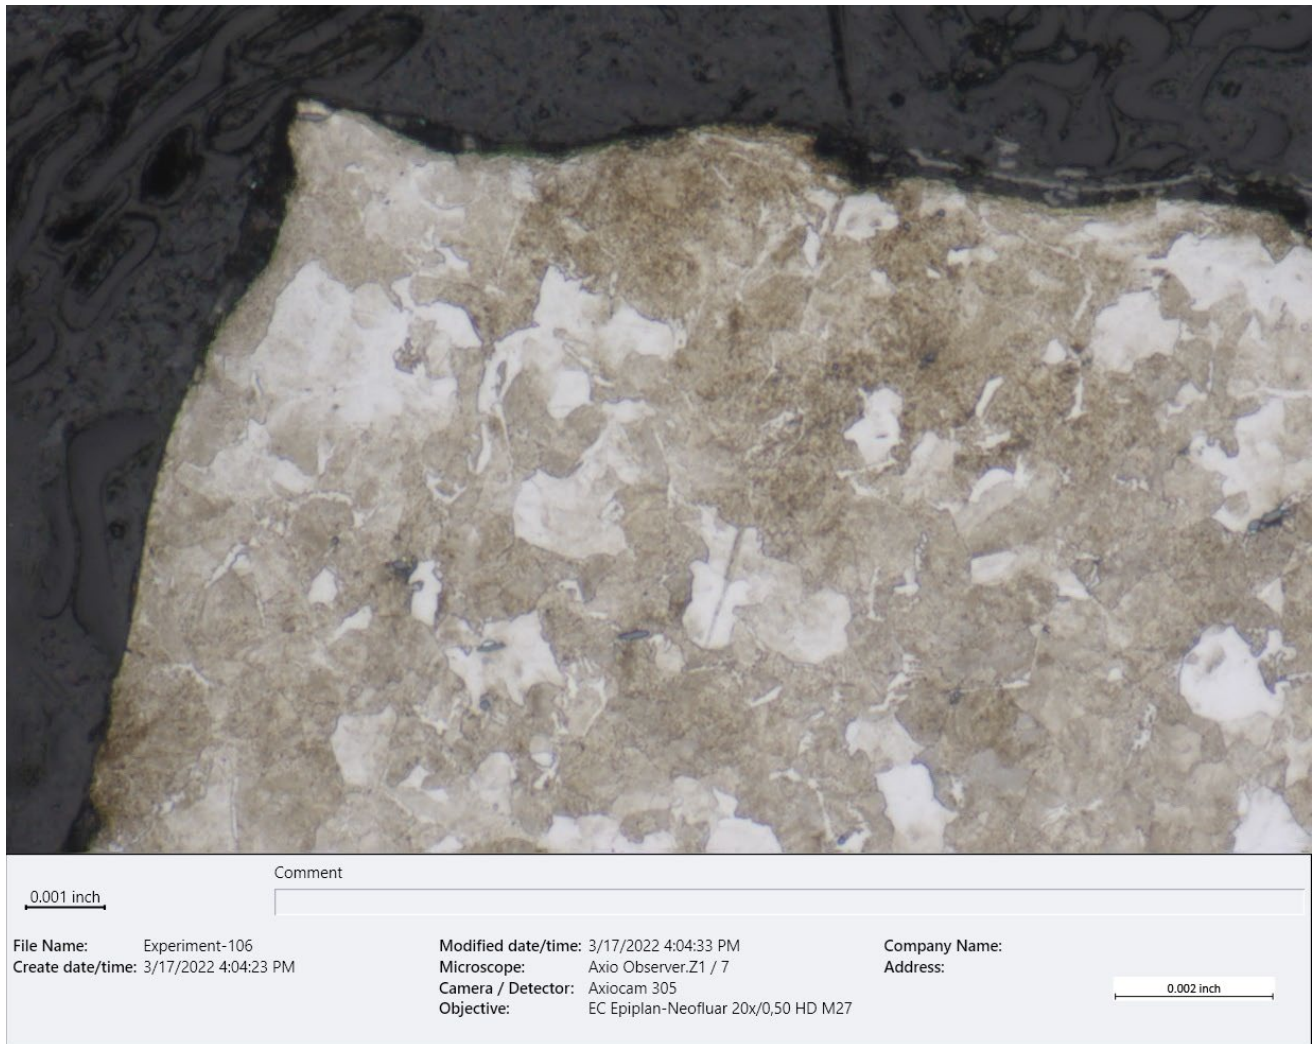
Figure 20 – BF optical micrograph of a cross-section of the fracture surface with the crack initiation surface (~500X, etched 2% nital).

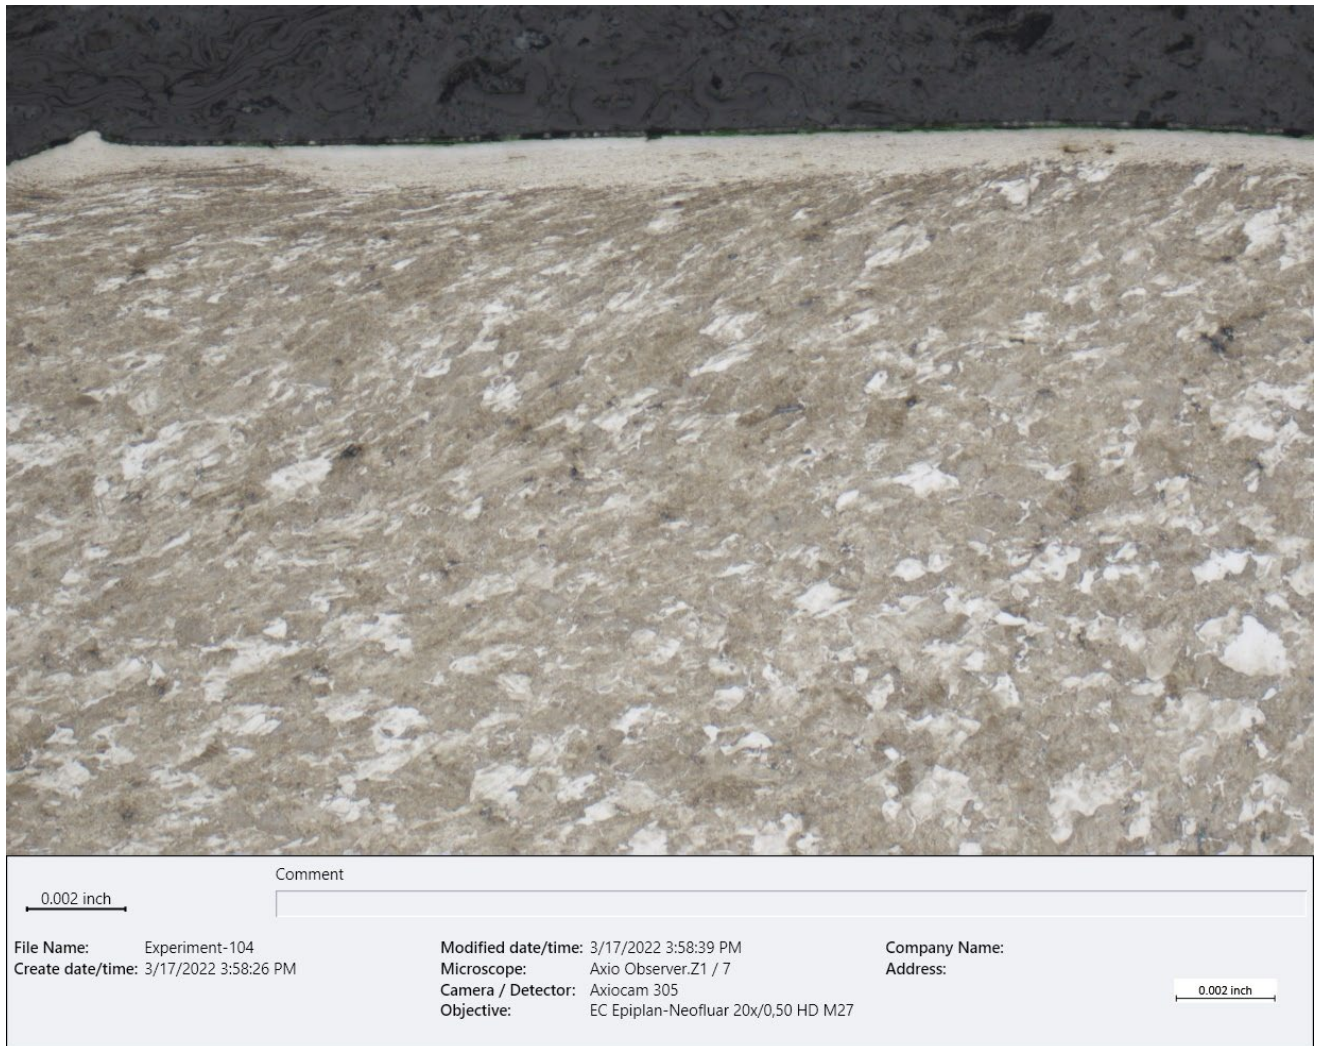
Figure 21 – BF optical micrograph of a distressed area of the connecting rod surface, showing deformed grains and untempered martensite (~200X, etched 2% Nital).
