# National Transportation Safety Board

CEN21LA329

## **POWERPLANT TEARDOWN EXAM**

Location: Amana, Iowa  
Date: July 19, 2021  
Time: 1410 central daylight time  
2110 UTC  
Airplane: Grumman G-164B, Registration N8422K

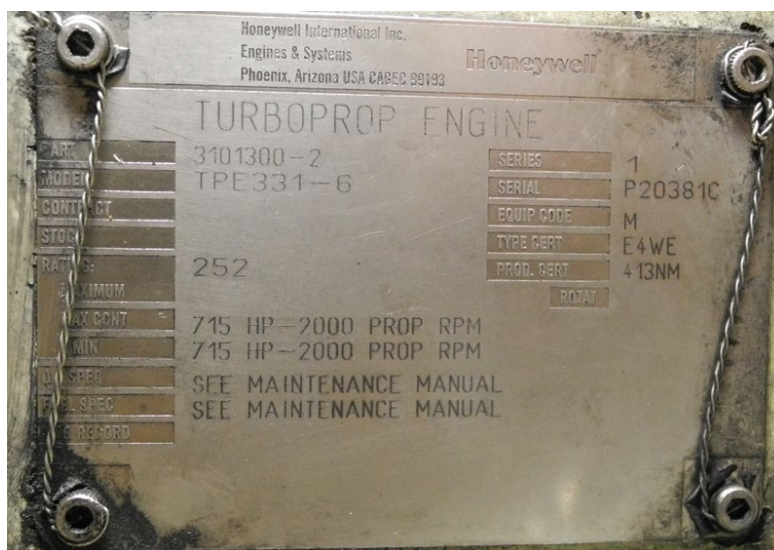
Photo 1: Engine Data Plate

According to the data plate, which is affixed to the accessory gear box case, the engine serial number (ESN) was P20381C (Photo 1). According to the engine logbook, as of April 12, 2019, the accident the engine had accumulated 14,715.6 hours, time since new (TSN).

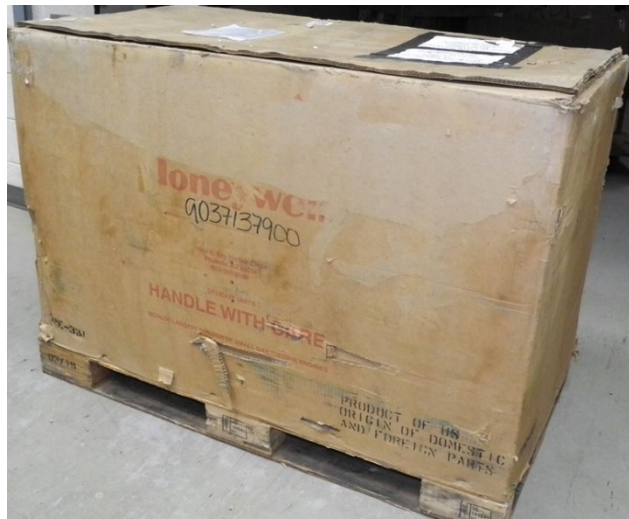
Photo 3: In the box

The engine was removed from its shipping container (Photo 2, Photo 3, and Photo 4) on August 1, 2022, with persons from the FAA, NTSB, and Honeywell in attendance. All sections were intact and boxed with an oil sample. Some minor leakage was noted in the exhaust section. A small dripping leak was seen at the elbow in the fuel drain return to the fuel control unit.

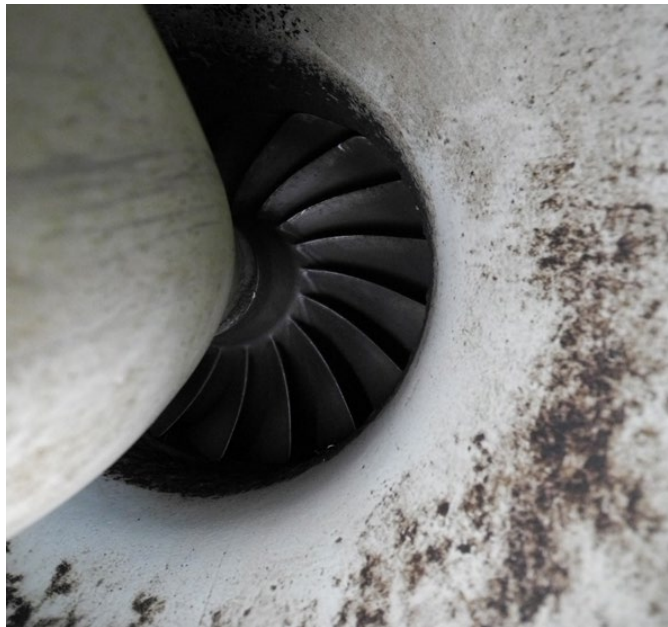
Photo 5: Compressor inlet

The propeller governor was in place and intact. Compressor intake was dirty (Photo 5). There was no visible damage to the 1<sup>st</sup> stage impeller (Photo 6).

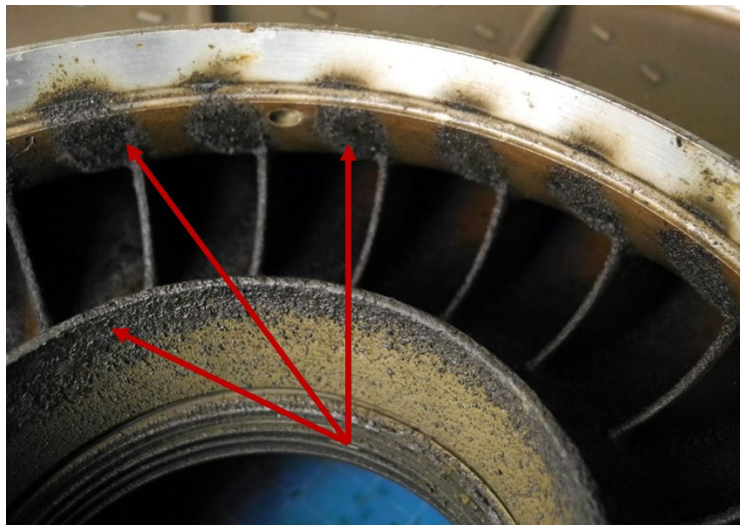
Significant earthen debris was present throughout the compressor consistent with continuous engine rotation during impact. The shroud lines of the vanes were predominantly coated with a thick, black earthen debris. The debris consisted of burnt fibrous and earthen material (Photo 7). Some rubbing/scuffing was present on exducer.

Photo 7: Debris along the compressor shroud lines.

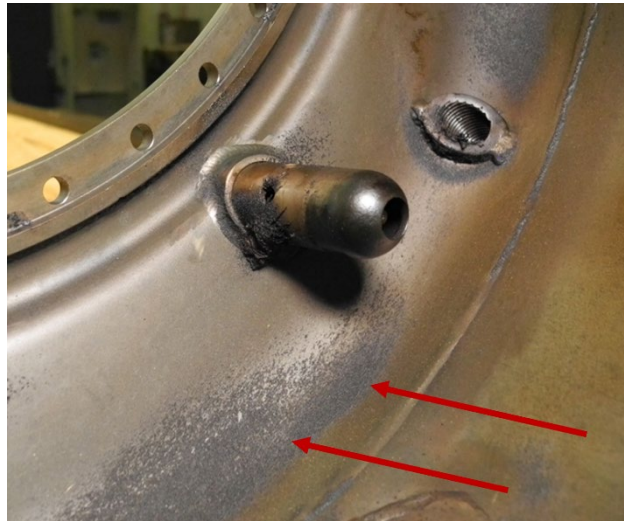
With the outer turbine case removed, significant buildup of dirt and burnt, earthen debris was present in all the air supply nozzles, or swirlers, consistent with engine operation during impact. (Photo 8 and Photo 9).

Photo 8: Debris inside the turbine casing

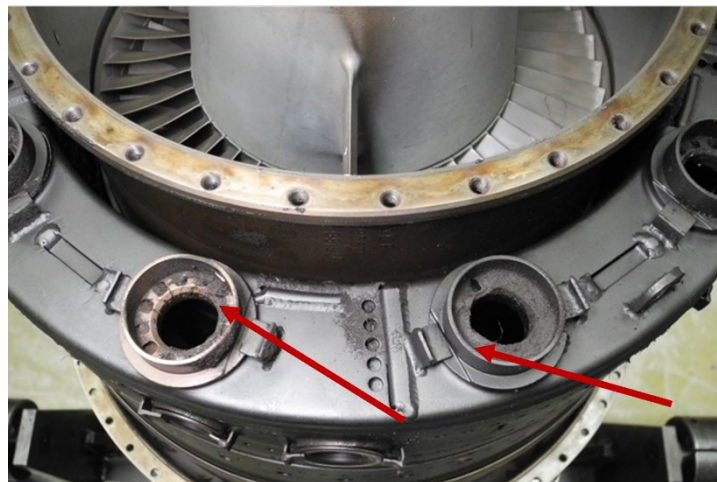
Photo 9: Debris in the air inlets

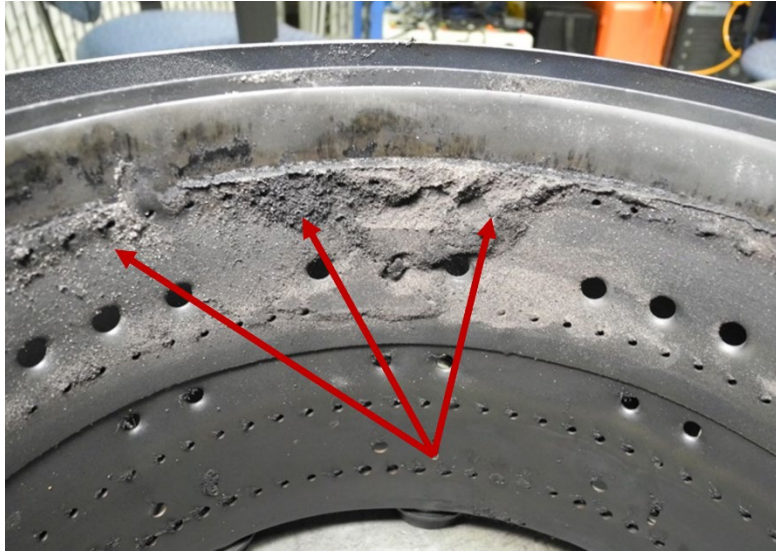
There was also deposits of burnt debris on the inner liner (Photo 10). Some of the debris shook loose during disassembly (Photo 11).

Photo 10: Burnt debris on the inner combustion liner.

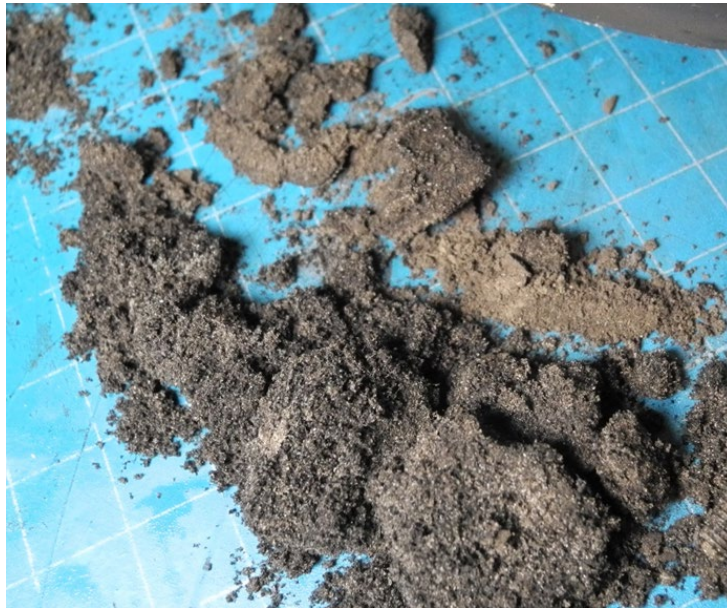
Photo 11: Sample of burnt debris from the engine.

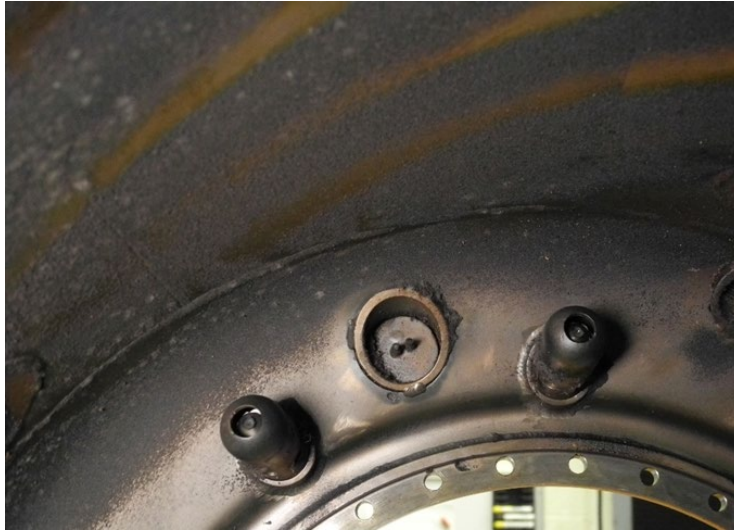
Both the Interstage Turbine Temperature (ITT) and Exhaust Gas Temperature cables were present. A previous bulletin from Honeywell directed removal of the ITT and replacement with the EGT harness. Once opened, the ITT was observed to be cut and capped inside the turbine (Photo 12).

Photo 12: Capped ITT wiring

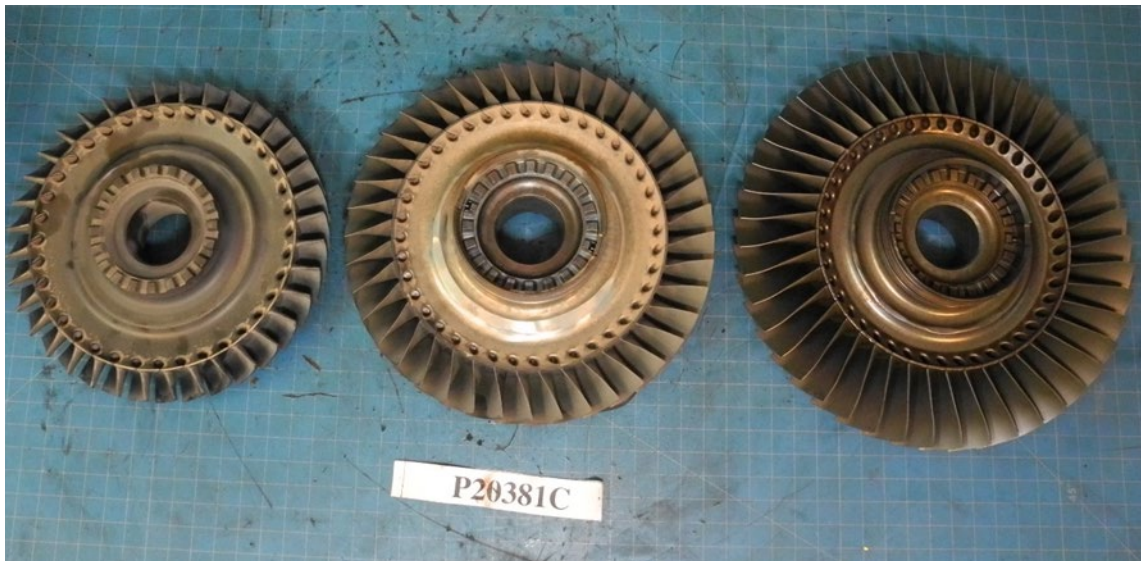
Photo 13: Turbine wheels

All nozzles were clean and undamaged. All three turbine wheels were intact and undamaged (Photo 13).

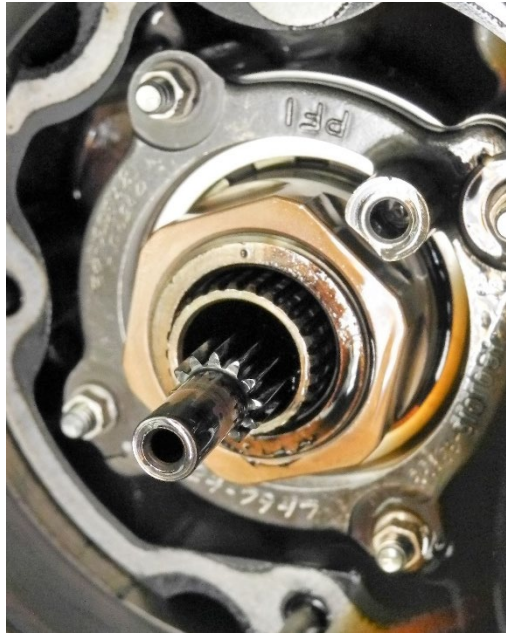
In an effort to validate the previous report from the test cell of low torque, a turbine lock was installed at the aft end of the 3<sup>rd</sup> turbine wheel, and rotation of the starter-generator shaft attempted. As a single-shaft engine directly geared to the accessory gearbox, no rotation should be possible if the engine was intact; however, the accessory gearbox was able to rotate with the turbine locked in place, confirming a discontinuity in the drive system.

When the scavenge pump was removed, the aft end of the torsion shaft was found free and resting at the 6-o'clock position against the splined end of main shaft (Photo 14). Honeywell retained the torsion shaft for metallurgical analysis, the results of which are available in the docket.

Photo 14: Torsion shaft resting at 6 o'clock position.
