## RECORD OF CONVERSATION

**Date: 07/28/2021**  
**Person Contacted: FAA Inspector Cull**  
**RE: CEN21LA335**

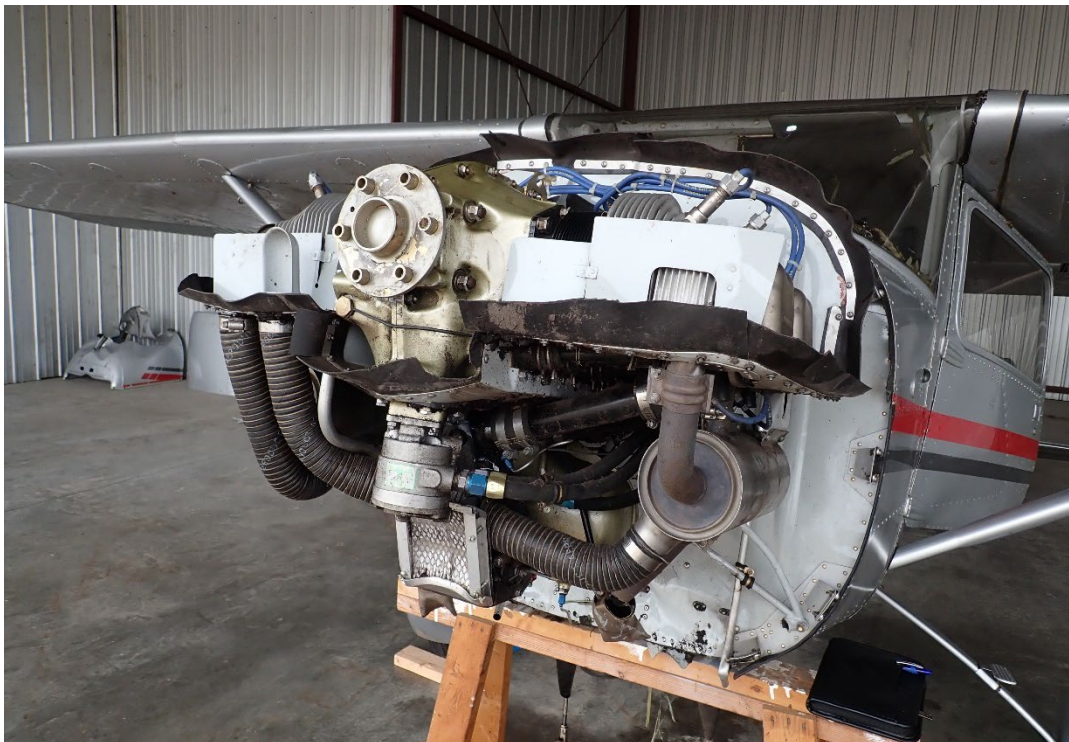
Inspector Cull reported the airplane sustained substantial damage to the engine firewall and engine mount (see photograph below). The inspector also noted a 4-port USB power supply adapter was plugged into a power port just below the flap switch.
