**Postaccident Photos**  
Courtesy of the Federal Aviation Administration

I. N747JG (RV-8)

**II. N977RV**

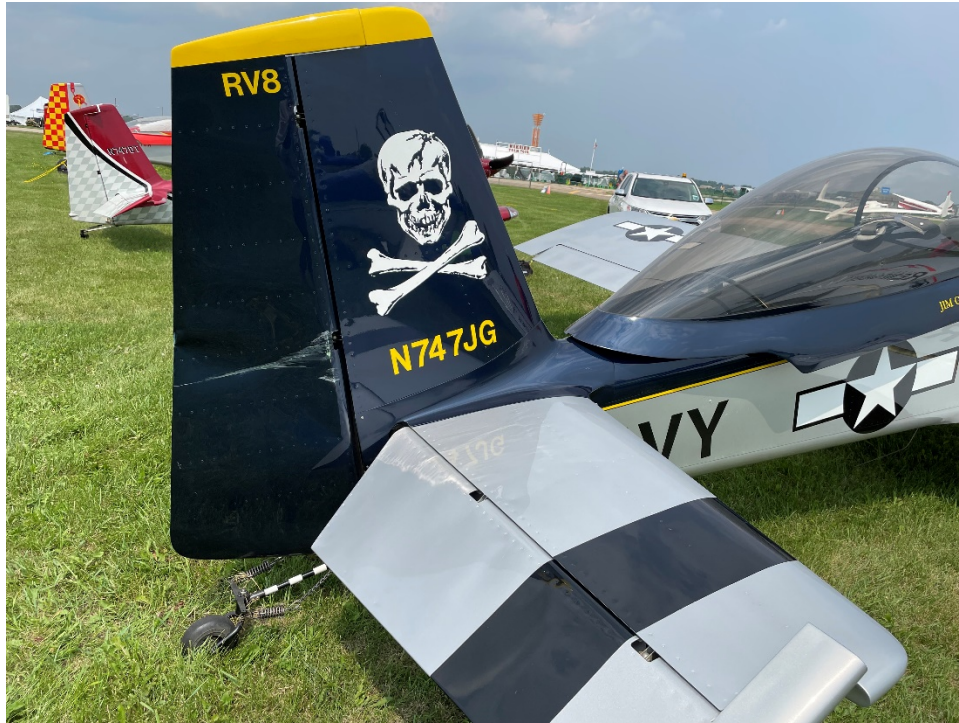
*Figure 1: Rudder Damage*

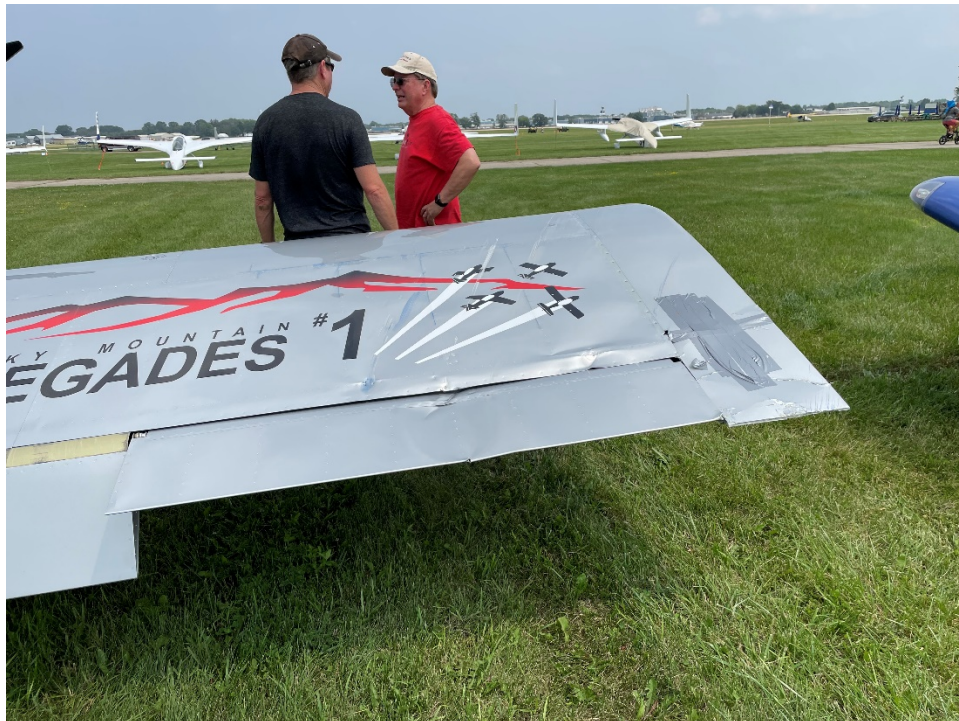
*Figure 2: Right Wing and Aileron Damage.*

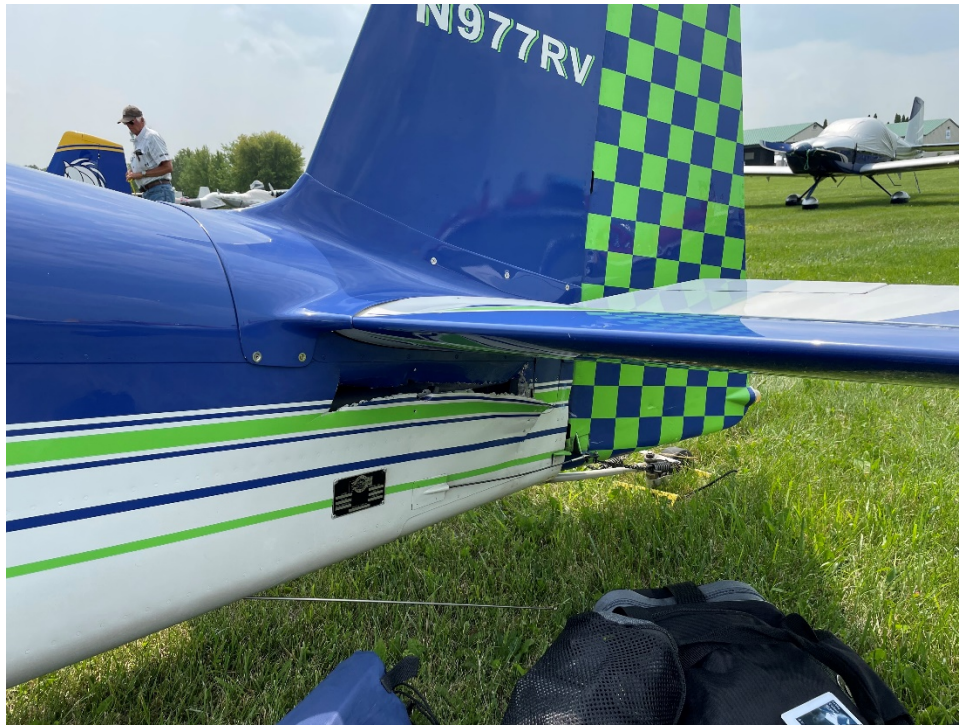
*Figure 3: Aft Fuselage Damage*

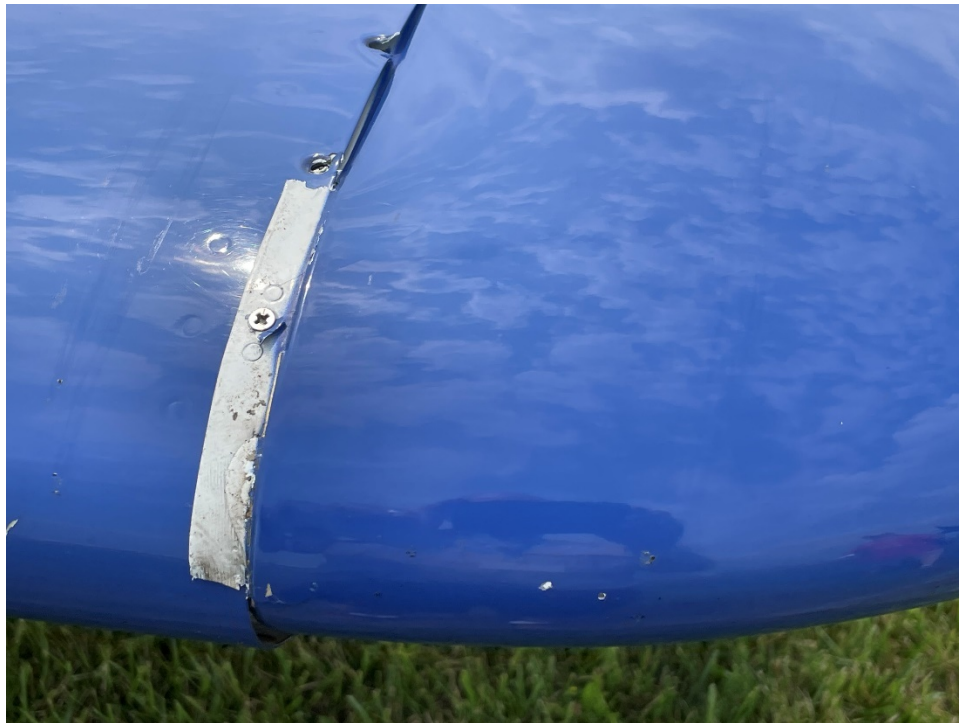
*Figure 4: Left Wingtip*

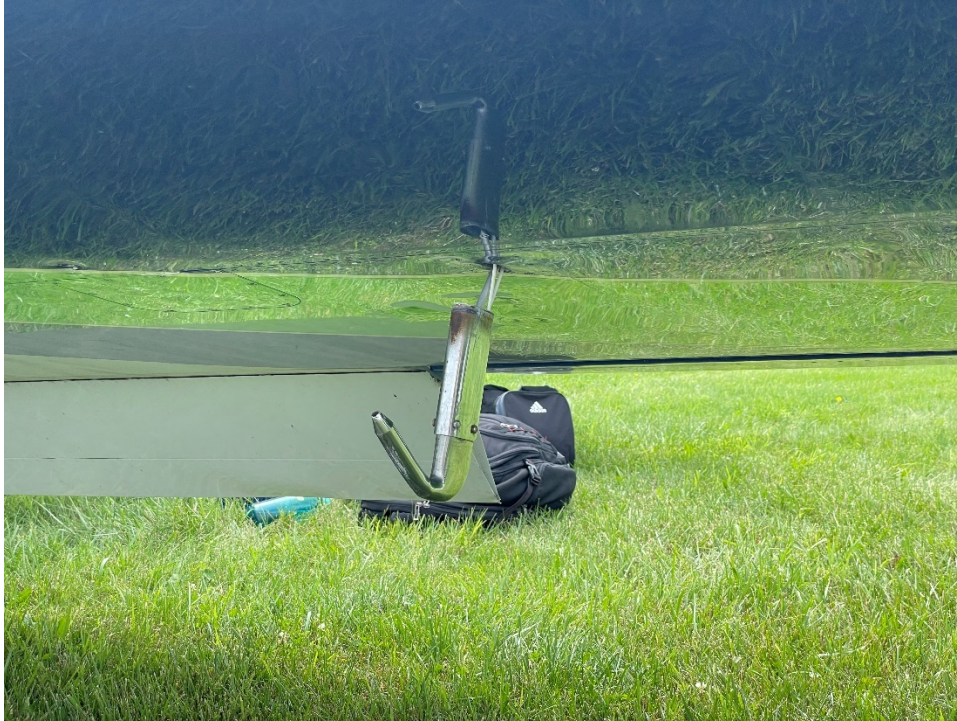
*Figure 5: Lower Left Wing Damage*
