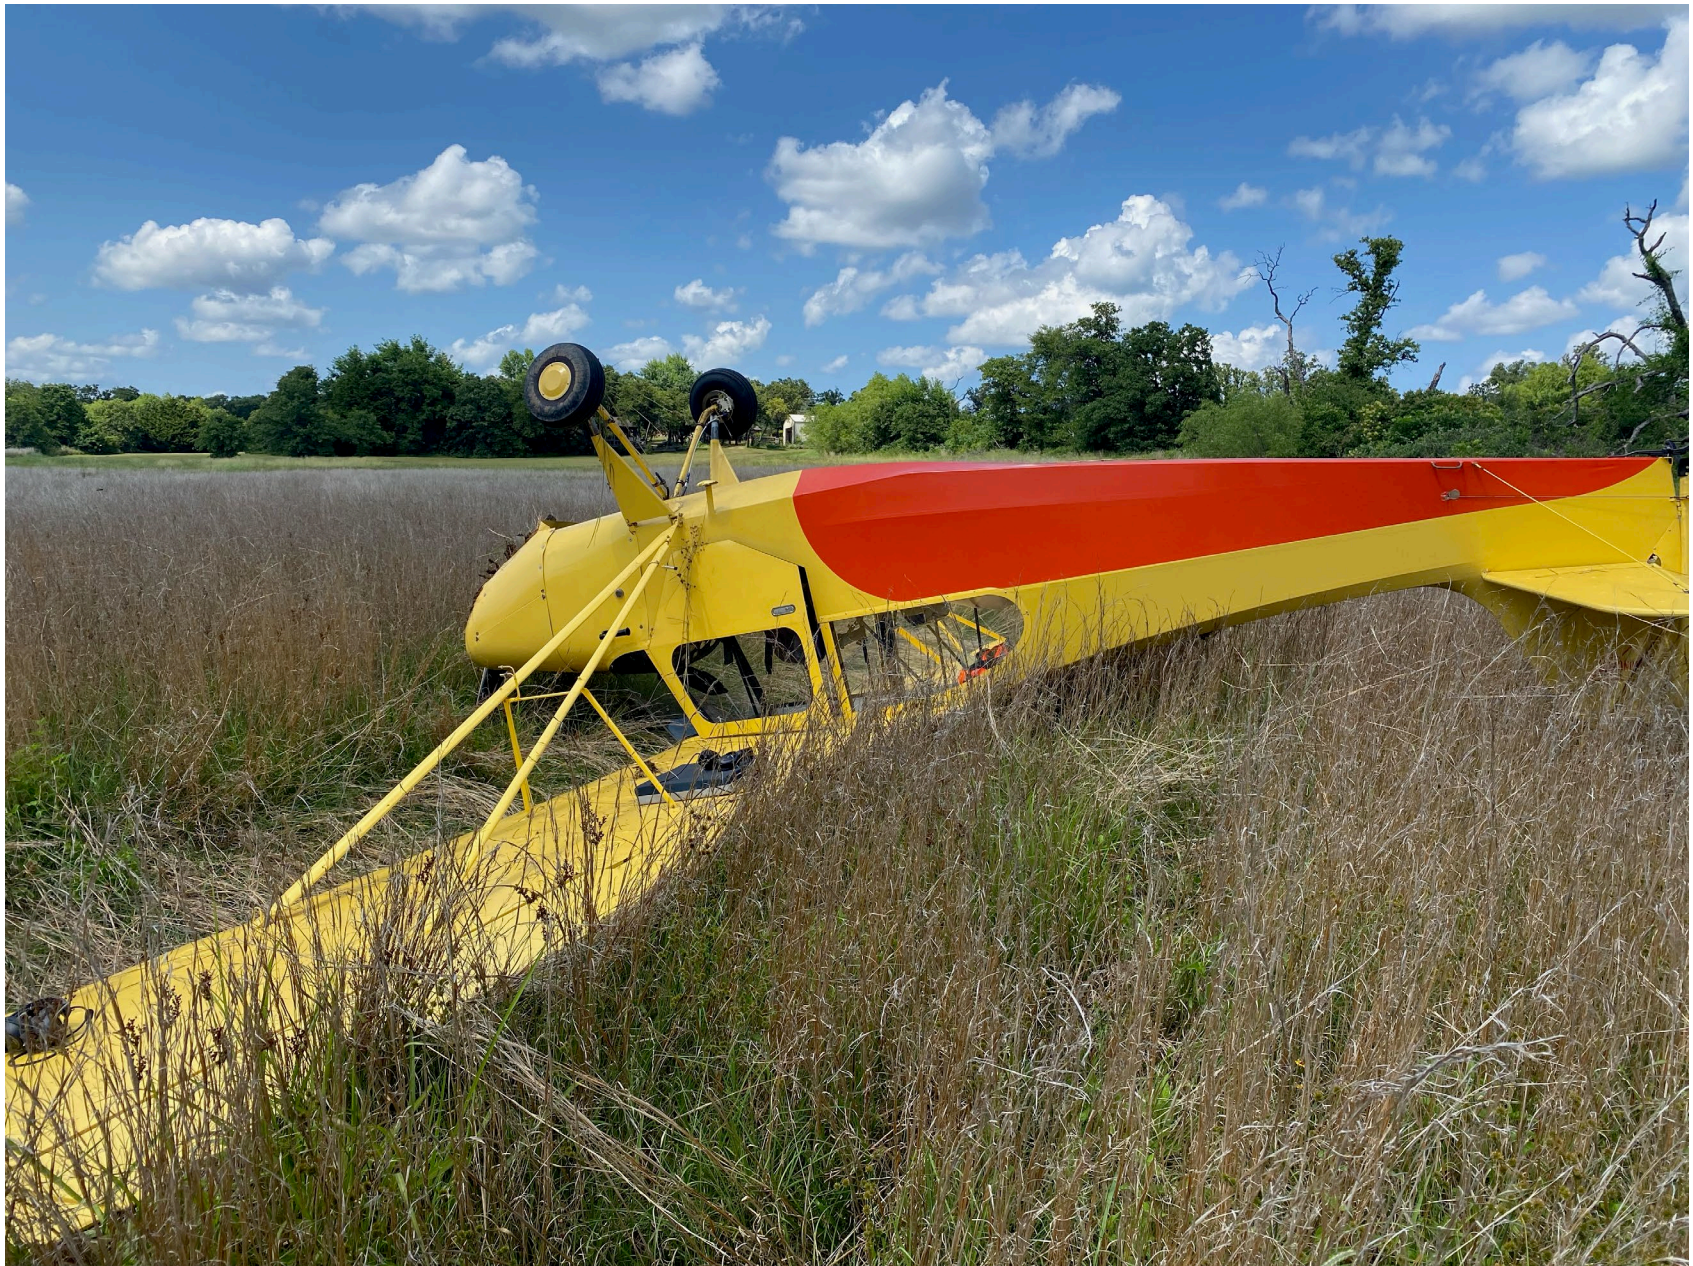
**Photo 1 – Right side of inverted airplane in a field (Courtesy of owner)**

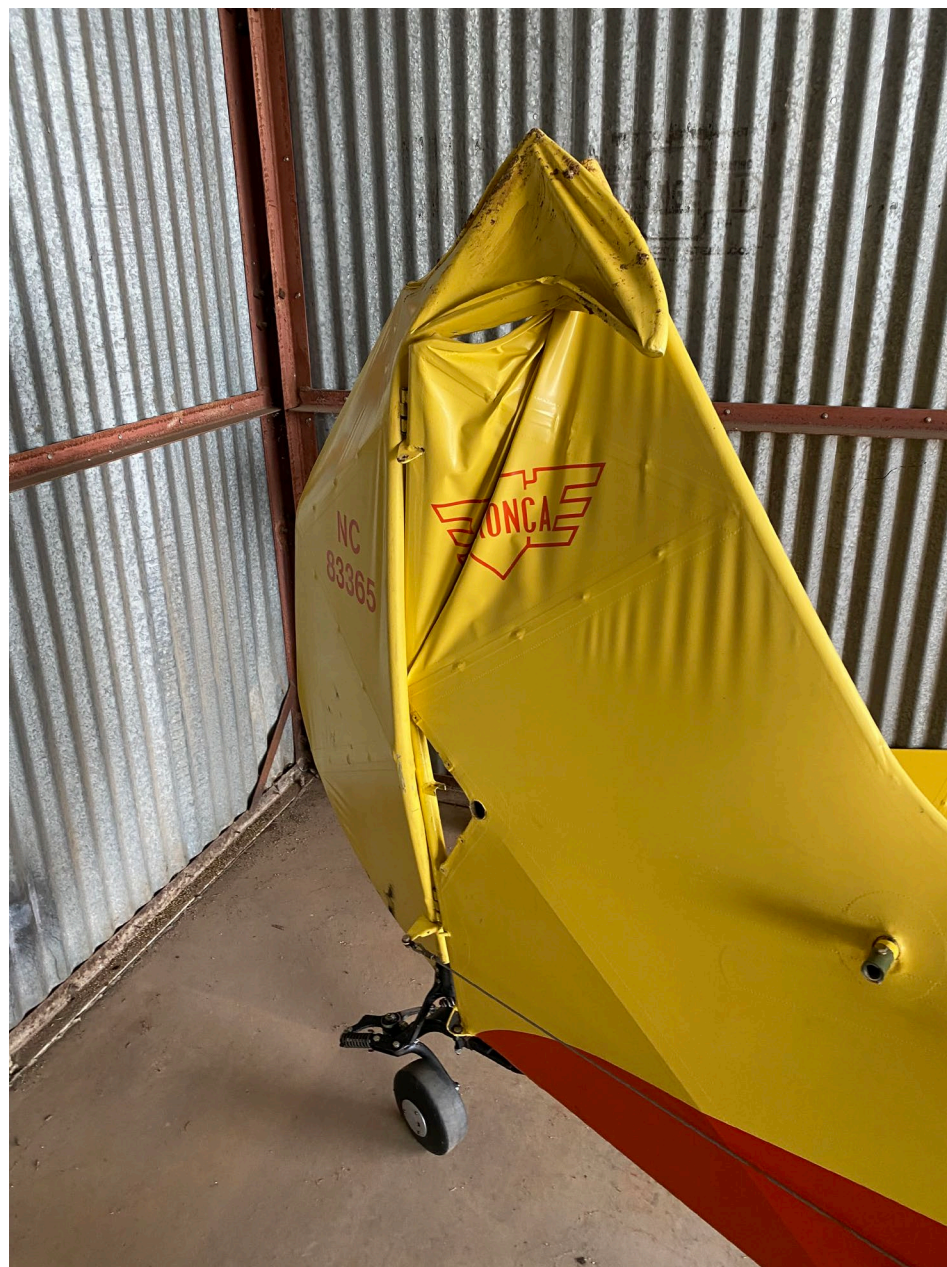
**Photo 2 – Damage to vertical stabilizer and rudder (Courtesy of owner)**

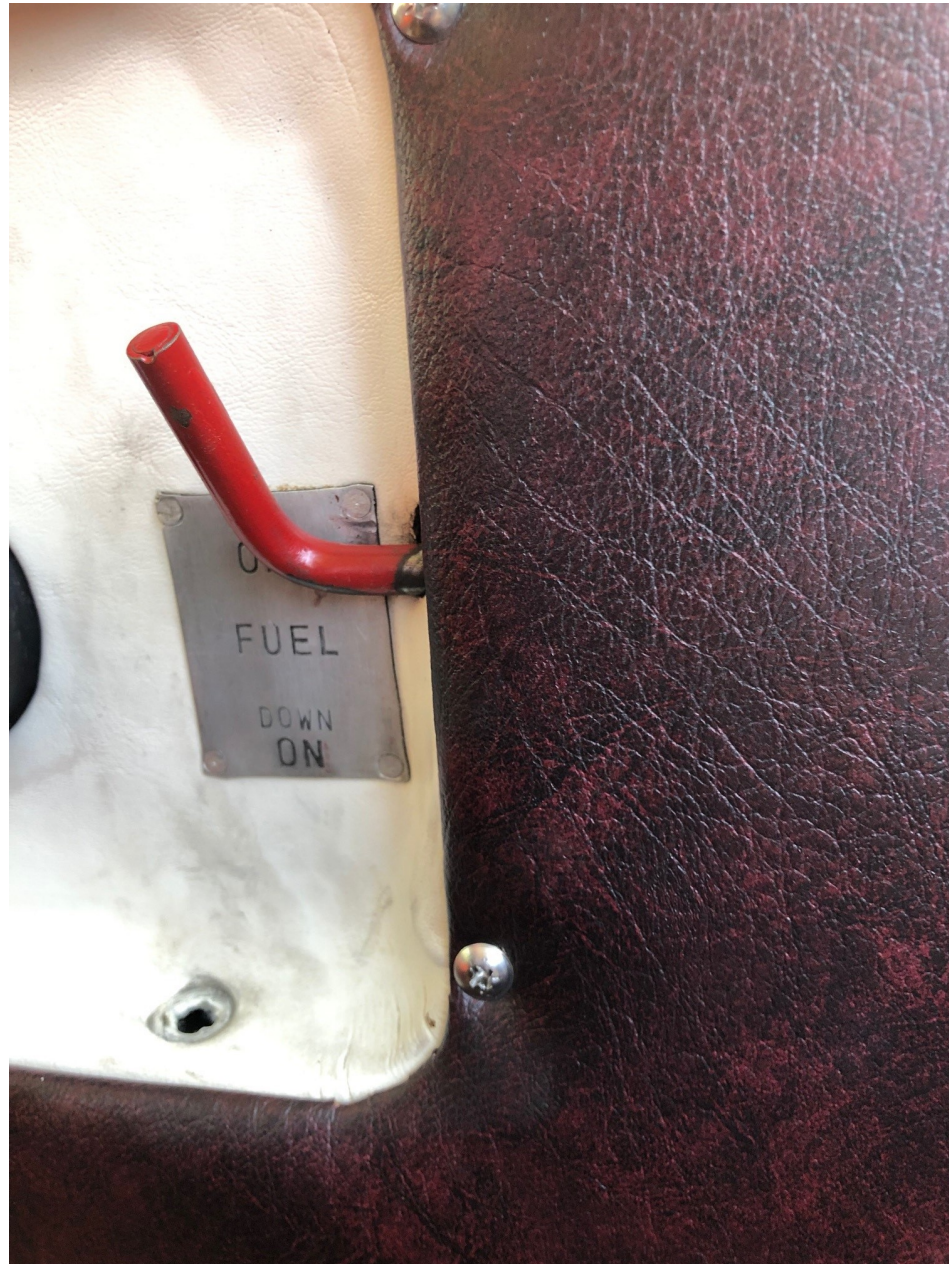
**Photo 3 – Carburetor heat control missing (Courtesy of owner)**
