## RECORD OF MEMORANDUM

**Date: July 22, 2021**  
**Person Contacted: Mr. Ray Griffith (Pilot)**  
**NTSB Accident Number: WPR21LA339**

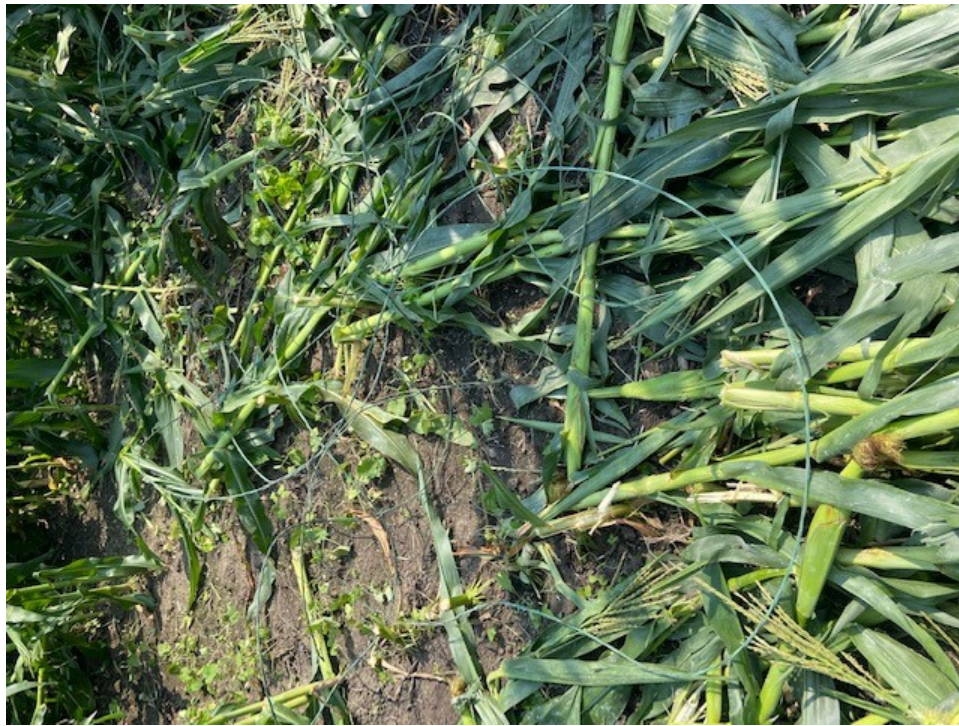
*Figure 4: The Wire*

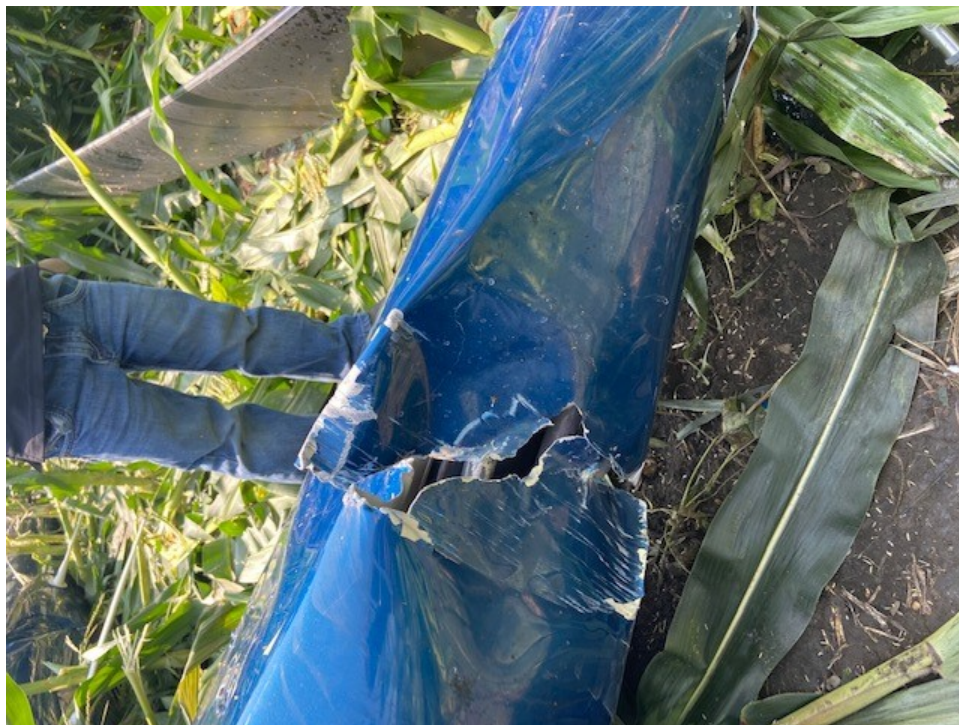
*Figure 5: Damage to the Mast Housing*

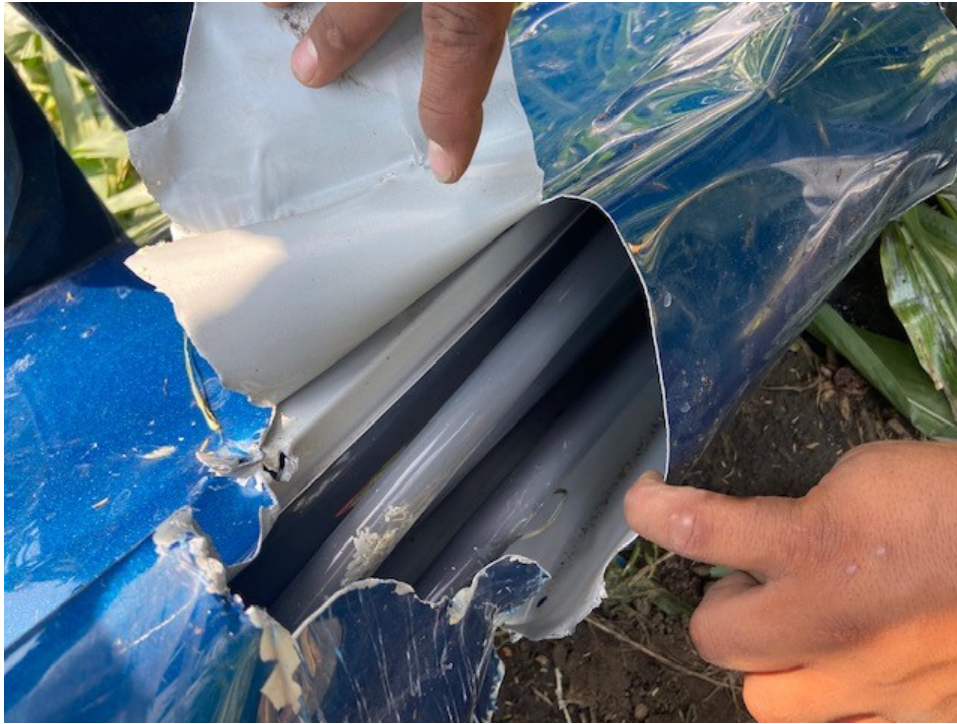
*Figure 6: A Fragment of Wire was Located Inside*
