| <b>HPH spol.s r.o.</b><br>Čáslavská 234<br>CZ284 01 Kutná Hora<br>Czech Republic<br>Tel/Fax 00420-327 512633<br>e-mail : info@hph.cz | <b>Service bulletin</b> | No.: G304MS – 12b)<br>G304 S – 12b)<br>G304eS – 12b) |
| Type: | Type Certificate No.: EASA.A.030<br>Model: Glasfűgel 304 MS, 304 S, 304eS | |
| Subject: | Elevator control rod in vertical stabilizer P/N: 304S-46-12. | |

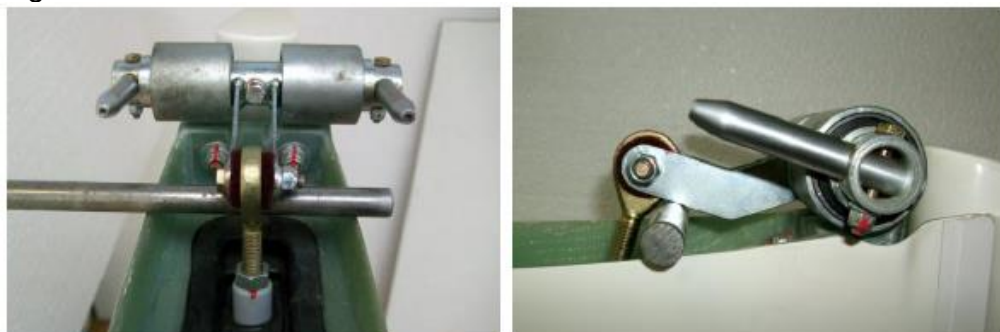
**Fig. 1**

- a) Install horizontal stabilizer, check elevator deflection in accordance with Table1. Note readings. Remove horizontal stabilizer.
- b) With horizontal stabilizer removed, lock elevator control lever on top of vertical stabilizer by using a steel rod or tube (Ø12 to 16 mm – 0.47 to 0.63 in.) in the „lever-up “-position (control stick fwd.) (see Fig 1)

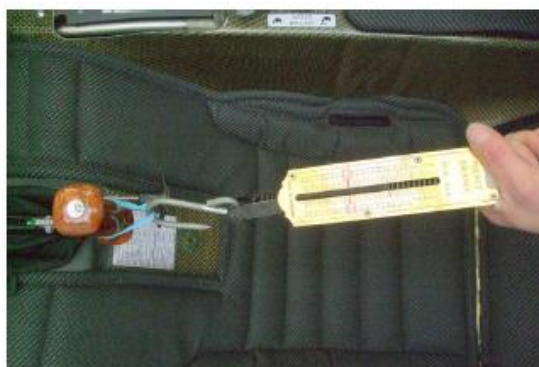
**Fig. 2**

- c) By using a spring scale, apply a force of 150 N for minimum10 seconds to the stick in aft direction. Position the scale at middle of the hand grip. (see Fig 2)

- d) After removal of locking rod, install horizontal stabilizer. Check elevator deflection i.e., Table 1. Positive result means identical readings between measurements. In case of different readings between measurements before and after the pull-test, Action 2 must be carried out before next flight.

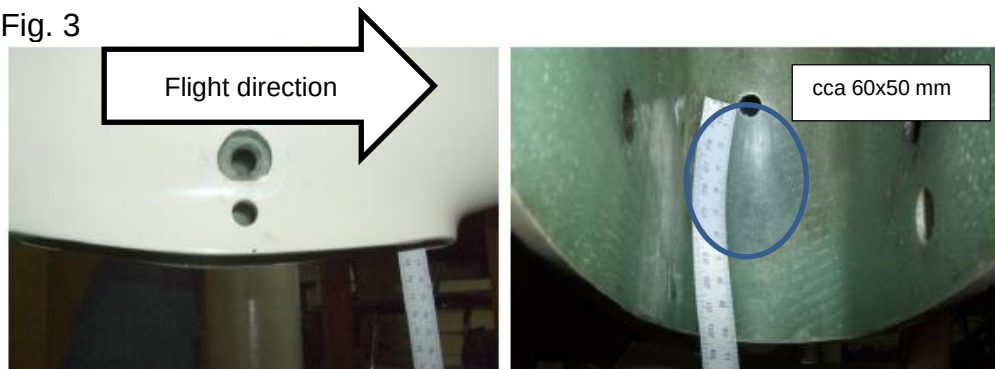
Fig. 3

- a) Remove tail wheel. Made inspection hole of diameter 12mm through the fender at position 105 mm from the front edge of the fender (see Fig 3) extend the opening (if necessary!) up to cca 60x50 mm. Check presence of the drainage hole at the bottom of the elevator control rod through the control hole (see Fig 4) and check throughput of the drainage hole using steel bar of diameter 1.5 mm (Fig. 5). Seal the inspection hole using adhesive folie.
