# National Transportation Safety Board

CEN21LA351

## **MATERIALS LABORATORY**

Factual Report 22-087

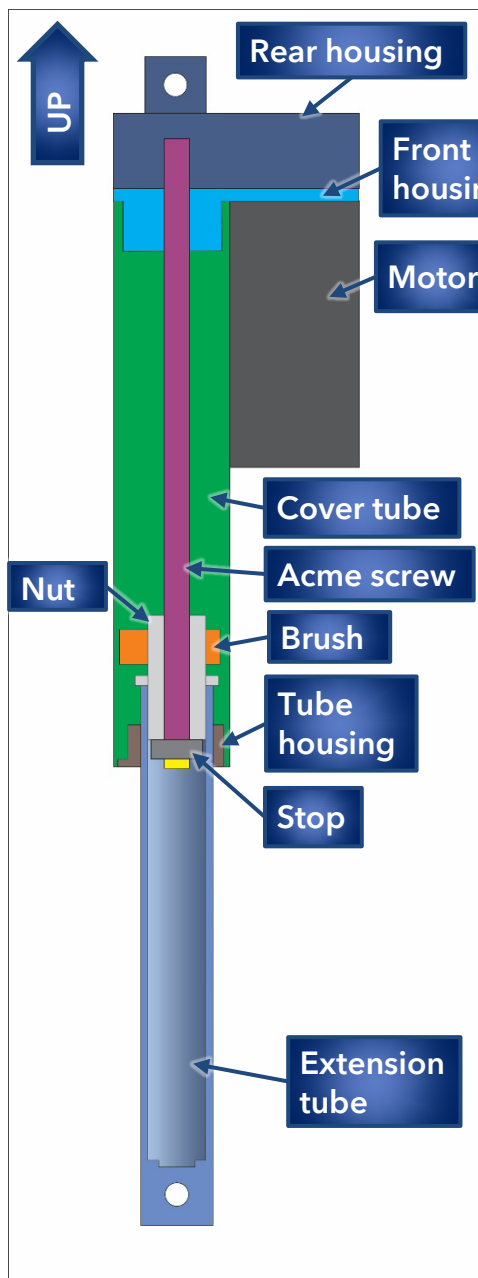
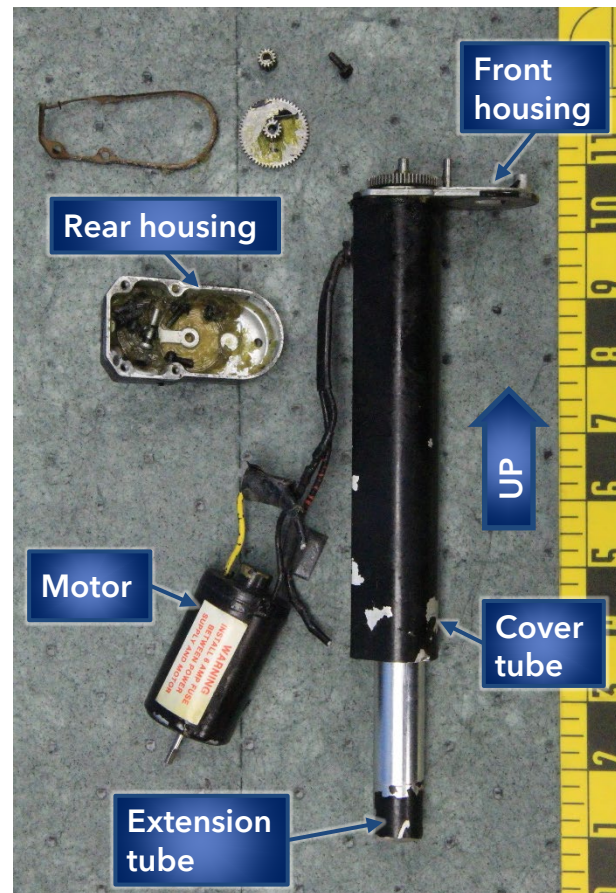
**Figure 1.** Overall view of the partially disassembled air brake actuator as received.

The submitted linear actuator is shown as received in figure 1. The linear actuator had been installed on the accident airplane to extend and retract the air brake, a hinged panel on the lower side of the fuselage. The rear housing, motor, and two gears from the rear housing had been disassembled from the actuator as shown, and the extension tube was positioned approximately halfway between extended and retracted.

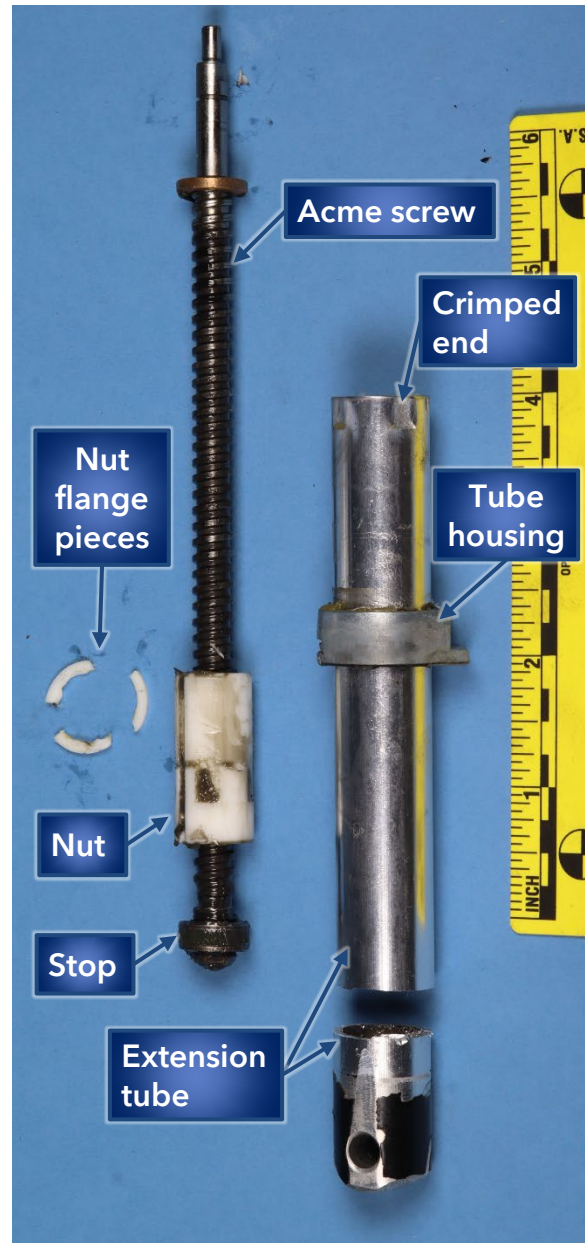
A view of the internal actuator components at this stage of the disassembly is shown in figure 4. The acme screw and the upper end of the extension tube were covered in grease. Fractured flange pieces from the nut were also recovered in the grease on the extension tube. The tube housing was retained on the extension tube and rotated and translated on the extension tube with some resistance. The nut was observed within the extension tube and slid easily along the length of the tube. The acme screw also turned easily, but it was unclear if the screw turned within the nut and/or the nut turned within the extension tube in response to the applied torque on the acme screw.

**Figure 4.** Linear actuator after disassembling the extension rod and acme screw from the cover tube.

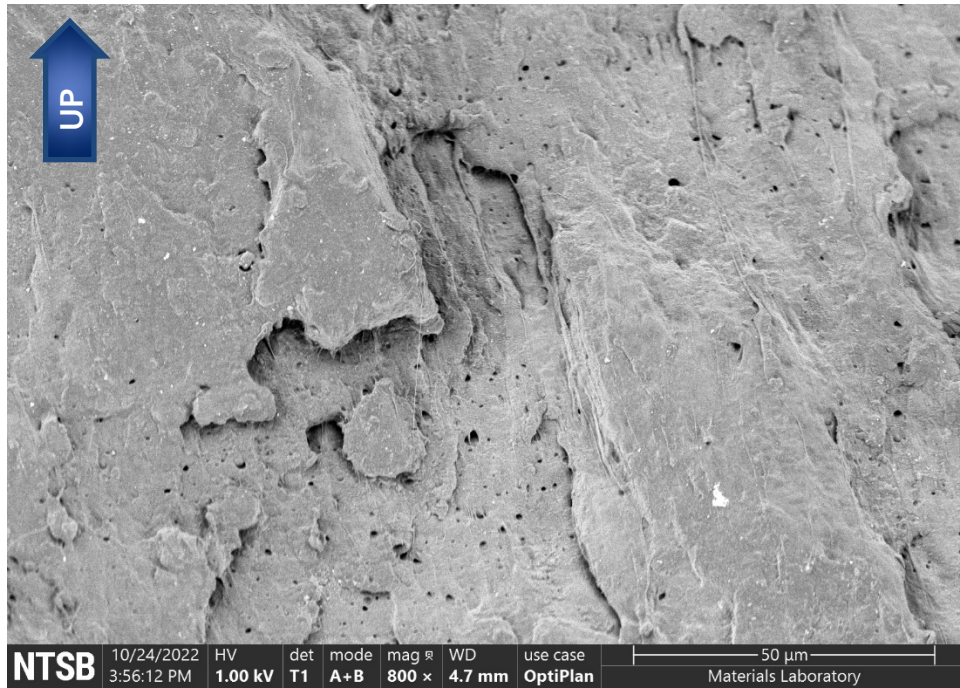
The nut flange pieces shown in figure 5 were cleaned in an ultrasonic cleaner while submerged in a solution of Alconox detergent and hot water. The cleaned fracture surfaces were then examined using a scanning electron microscope (SEM). An overall view of a typical origin area on one of the pieces and a closer view of typical fracture features near the origin area are shown in figures 9 and 10. Fractures on each of the pieces had broad origin areas on the lower side of the flange located above the crimp recesses. Near the origin area, the fracture surfaces had a rubbed appearance with tear ridges, fibrils, and elongated voids and dimple features, features consistent with overstress fracture in a plane of shear stress. The orientations

of the elongated features were consistent with the flange moving upward relative to the nut body, which was also consistent with the post-fracture sliding contact damage to the fracture surfaces from the crimped end of the extension rod. Further from the origin areas, the fracture features had rough features with tear ridges and circular voids, consistent with overstress fracture in a plane of tensile stress.

**Figure 9.** SEM image of typical fracture features on one of the nut flange fractures showing overstress features at a broad origin area.

**Figure 10.** SEM image of typical fracture features on the nut flange near the origin area shown in the previous figure.
