## CUSTOMER REPORT

Subject: Inspection and flow testing of FM-200A S/N 21422081 P/L 5020061  
Reference CEN21LA351 (N1361S)

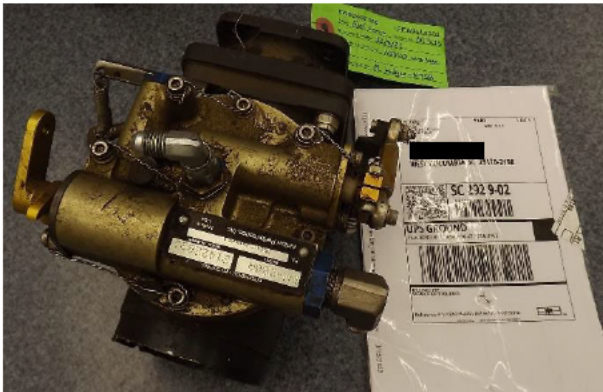
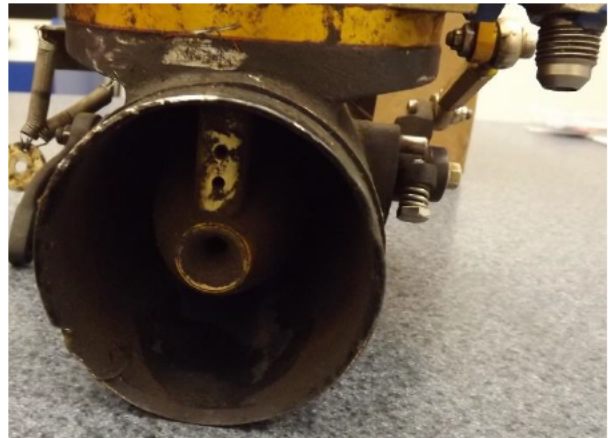
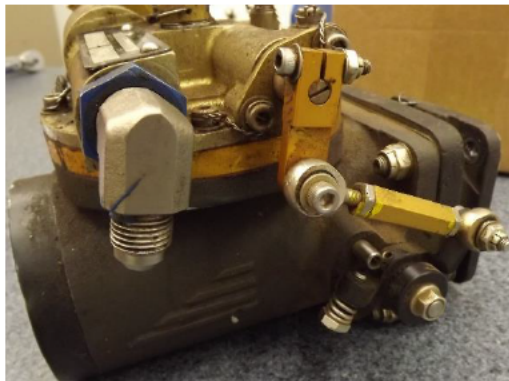
The subject fuel control was delivered by Daryl McMillan of the Columbia FSDO on March 24, 2022. Inspection of the fuel control showed much dirt in the venturi and throttle bore of the unit. The inlet filter fitting was loose. The throttle lever was loose on the throttle shaft but the teeth that engaged the lever to the shaft were engaged. There was approximately 5 to 7 degrees of radial play of the lever to the throttle shaft. All lockwire and seals were intact. A 5-degree FM-200 inlet adapter was connected to the inlet flange of the throttle body.

There were some chips and dents on the inlet of the throttle body casting. Throttle and idle valve linkage was intact and operated freely. Some sort of non-factory throttle return springs and bracket were installed on the opposite side of the throttle shaft.

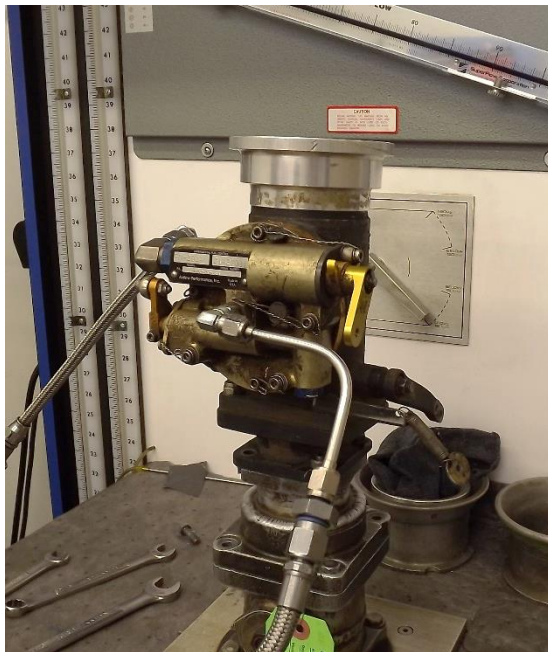
With the fuel control installed on the airbox, a wide-open throttle curve was run.

The standard air inlet was installed on the throttle body.

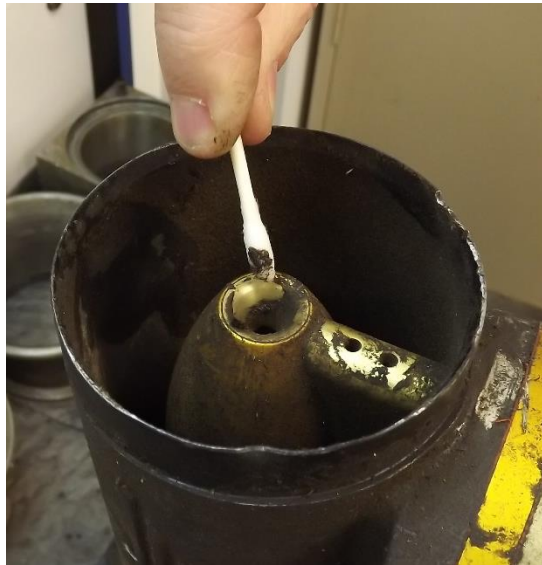
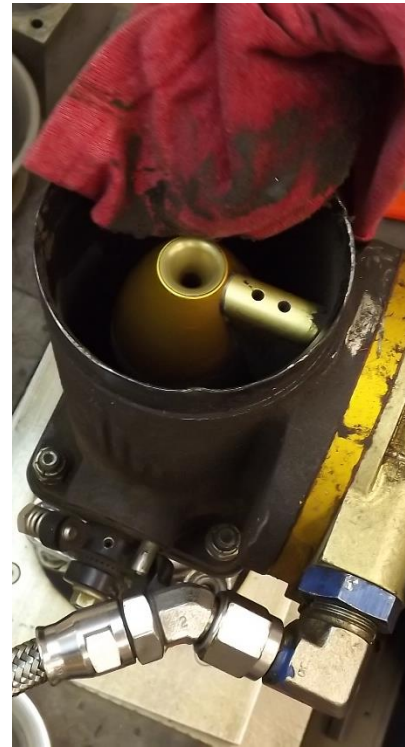
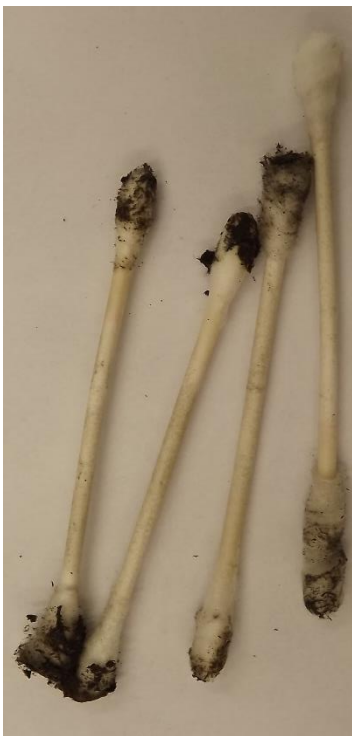
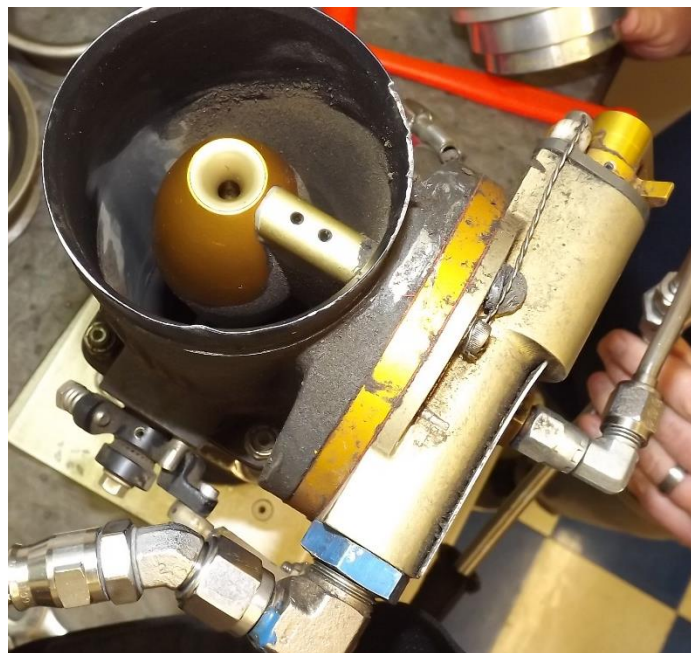
With the venturi having much dirt in the boost and main venturi, degradation of the signal generated by the venturi was evident by the leaner fuel flows. The venturi was cleaned using lacquer thinner and Q-Tips to clean the boost venturi and a wetted rag to clean the main venturi.
