# NATIONAL TRANSPORTATION SAFETY BOARD

## MATERIALS LABORATORY FACTUAL REPORT

Report No. 21-075

Place : Jeffersonville, Indiana  
Date : August 3, 2021  
Vehicle : Piper PA-28-181, N728A  
NTSB No. : CEN21LA353  
Investigator : John Brannen, AS-CEN

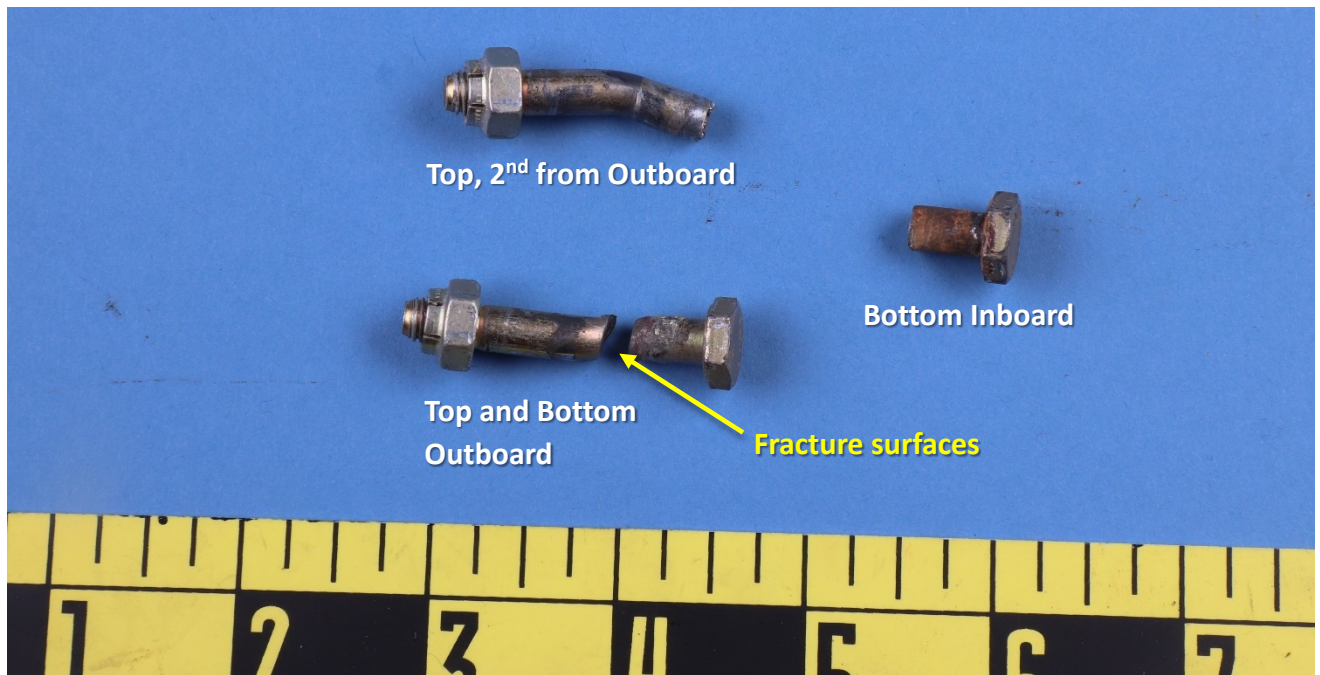
Several remnants of attachment bolts from the right main landing gear were received by the NTSB Materials Laboratory, as pictured in Figure 1. There were four fragments, labeled individually upon receipt, as demonstrated in Figure 1. Two pieces were labeled as being the top and bottom remnants of the outboard position. Another was labeled as being the top fragment, second from outboard, and the last one was labeled as being the bottom fragment from an inboard position.

Figure 1 – The four bolt remnants, as received, labeled as received.

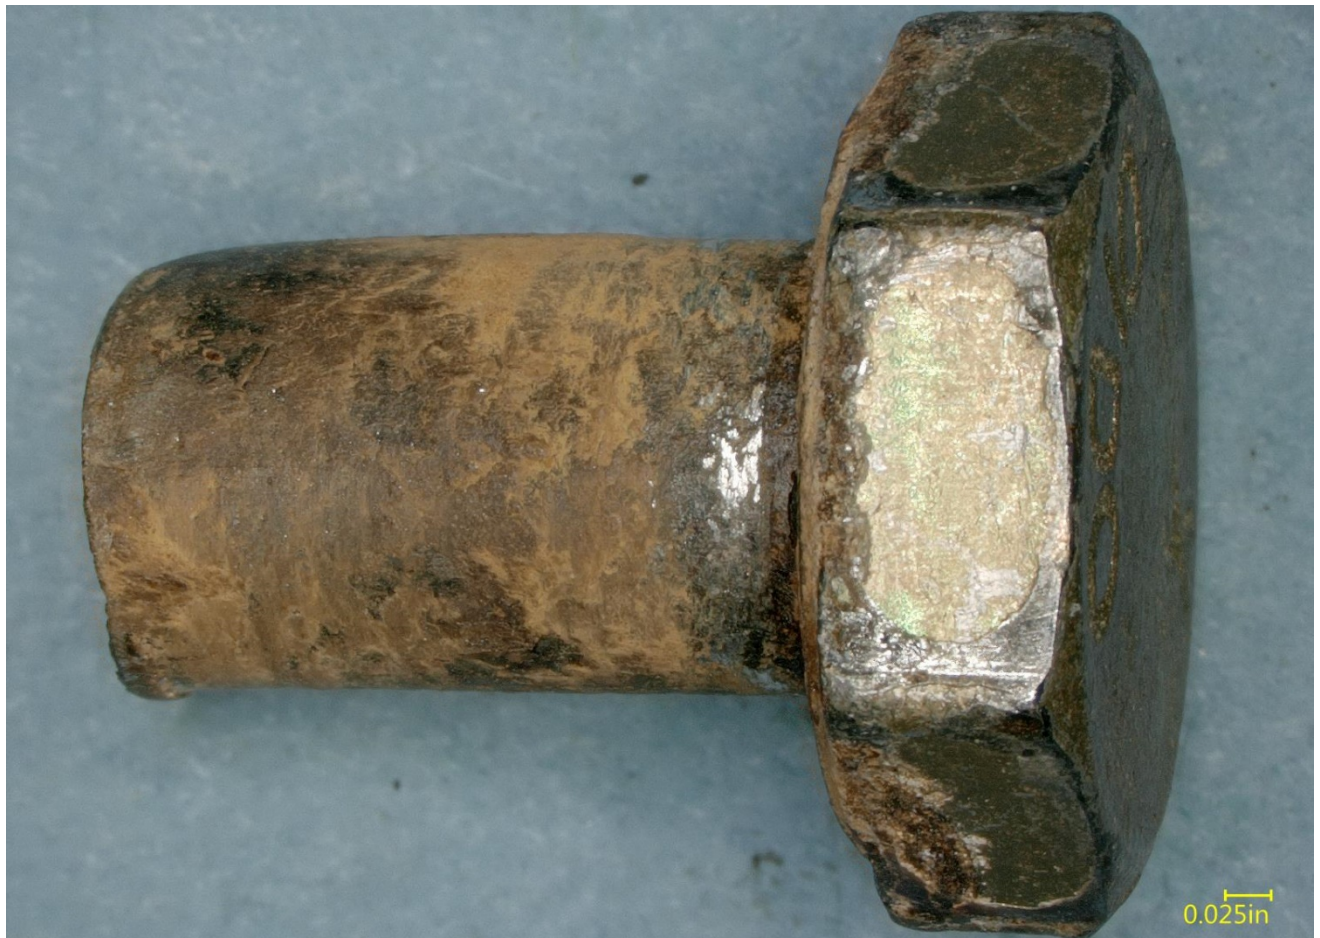
Figure 2 shows a closer view of the bottom inboard fragment. This fragment included the bolt head and part of the shaft. Figure 3 shows the markings on the bolt head,

There was some bending and shear deformation near the bolt fragment fracture surface. This included an exuded portion of material on the lower left of Figure 2. This area is shown on the image of the bolt fracture surface on the lower right of Figure 4. On the opposite side of the fracture surface (upper left of Figure 4), the edges had been beveled and exhibited rounding and streaks, consistent with shearing damage towards the lower right in the figure.

Figure 2 – Side view of the bottom inboard bolt remnant, as received.

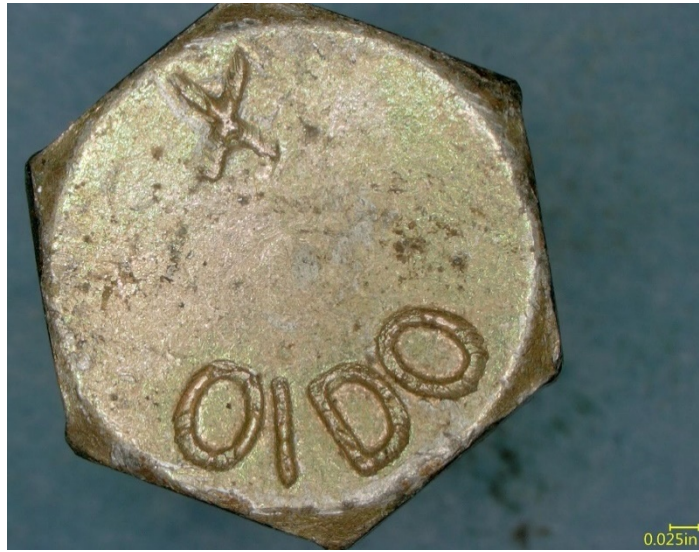
which stated, "X" and "01DO." These markings were consistent with having been manufactured by Mac Fasteners.<sup>1</sup>

Figure 3 – The head markings on the bottom inboard bolt remnant.

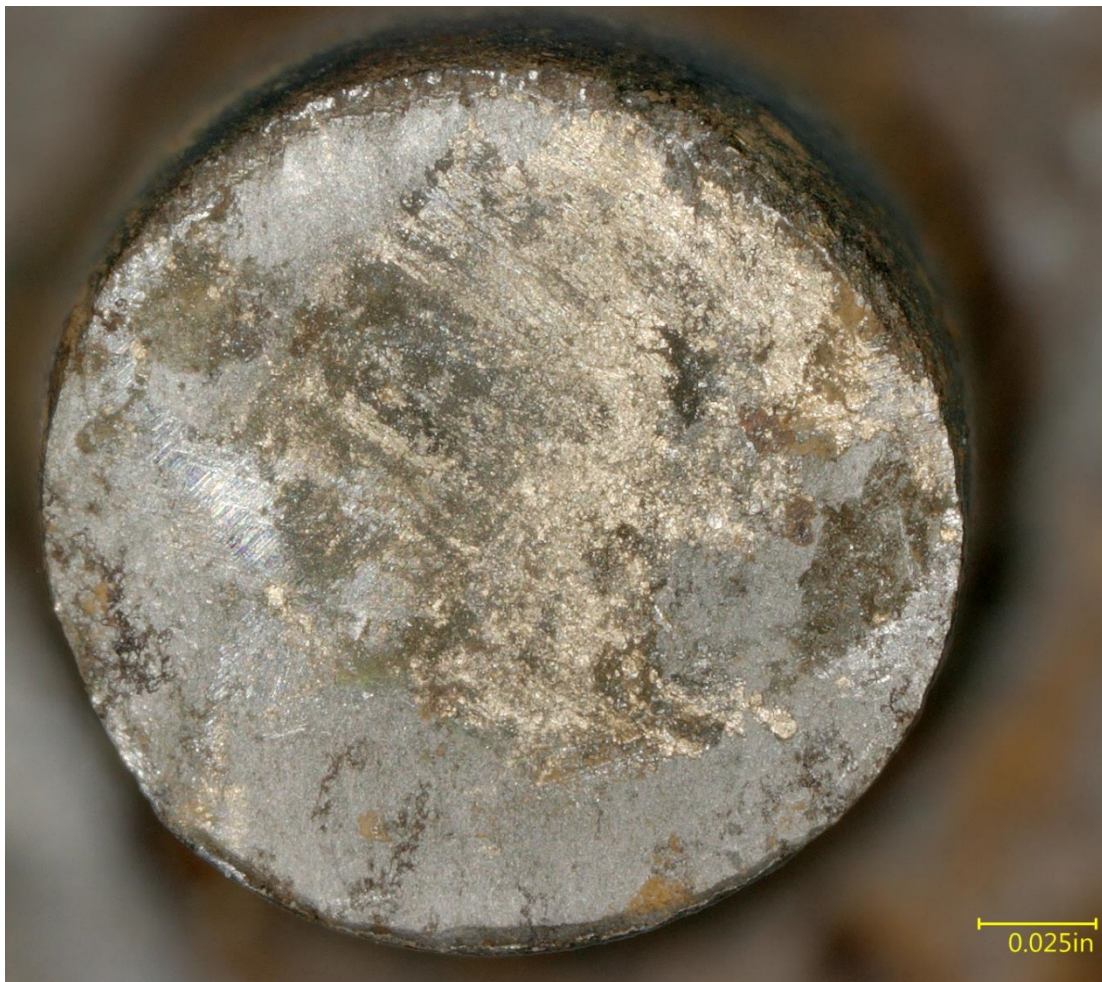
The fracture surface itself was relatively flat. Most of the fracture surface exhibited a reflective luster with randomly oriented streaks, consistent with post-fracture smearing damage. The lower left portion of the fracture surface was less damaged, and exhibited a dull, fibrous luster with rougher surface texture. The fracture surface was examined using a scanning electron microscope (SEM). Figure 5 shows a typical area of the undamaged portion of the inboard bottom bolt fracture surface. As illustrated in Figure 6, the fracture surface exhibited elongated dimpled rupture, consistent with fracture from overstress in shear.

Figure 4 – Fracture surface from the inboard bottom bolt, as received.

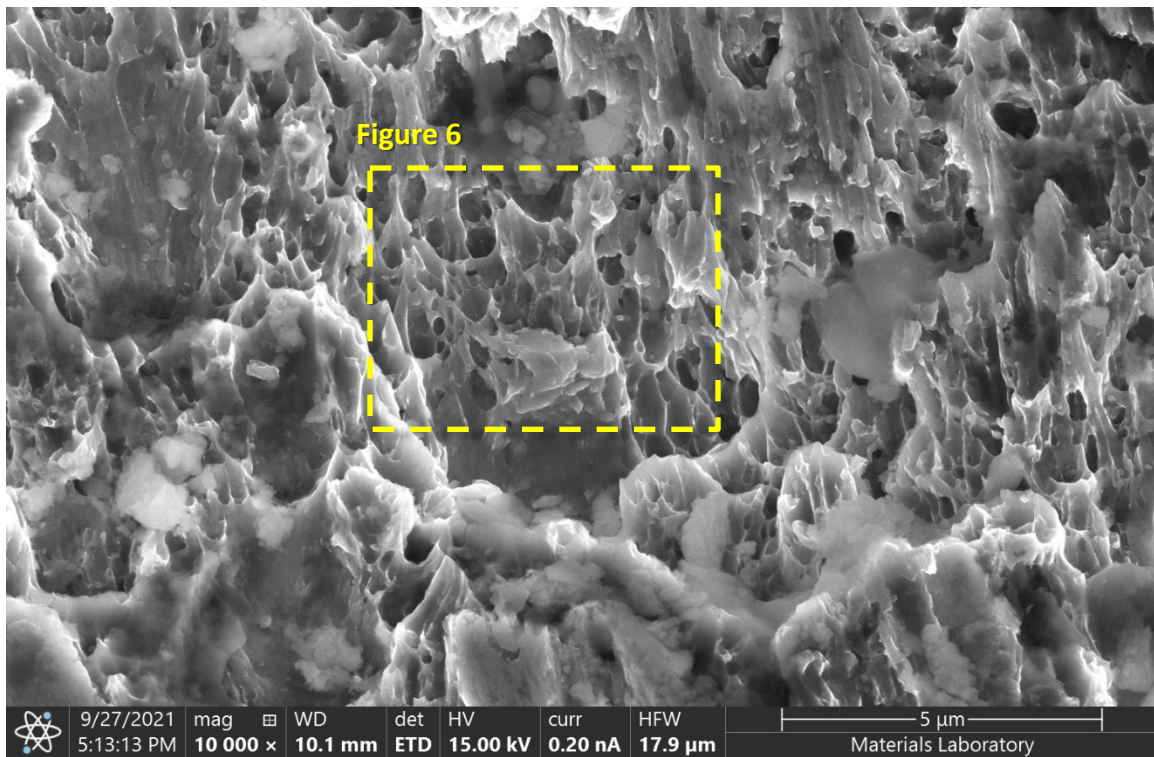
Figure 5 – Secondary electron (SE) micrograph of a typical area of the inboard bottom bolt remnant fracture surface.

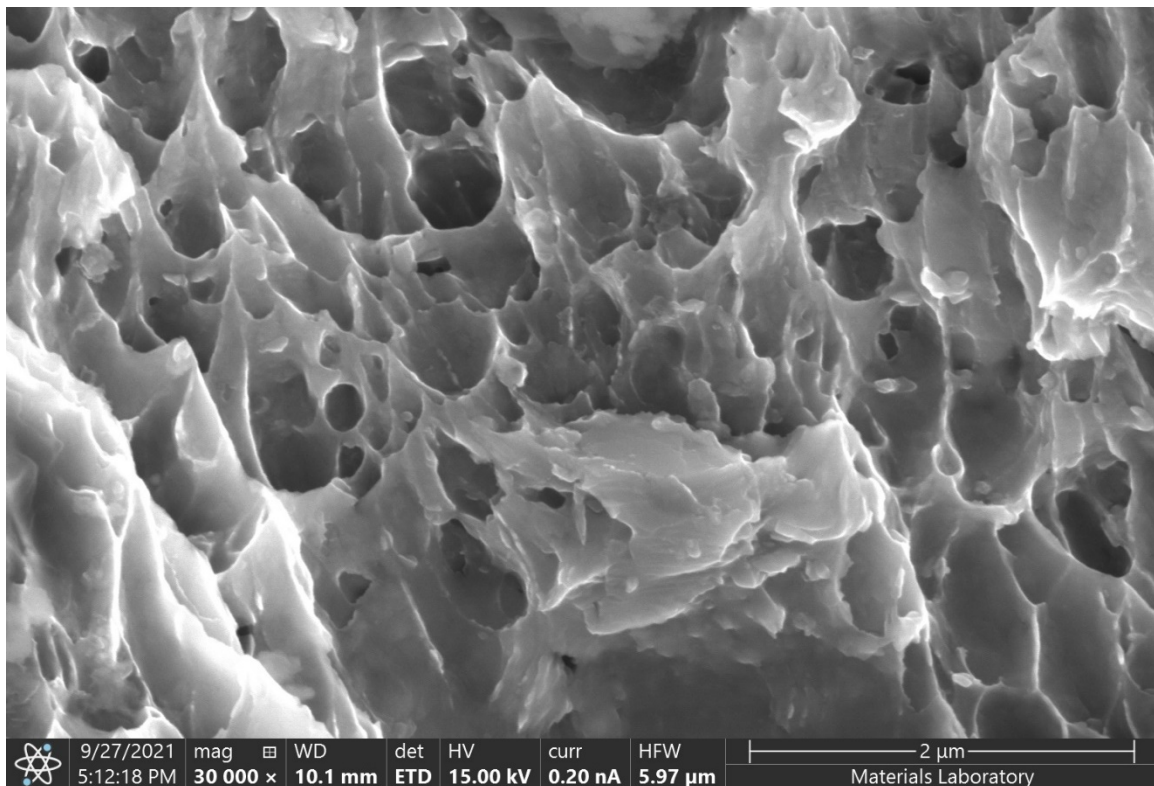
Figure 6 – SE micrograph of dimpled rupture from the boxed area in Figure 5.

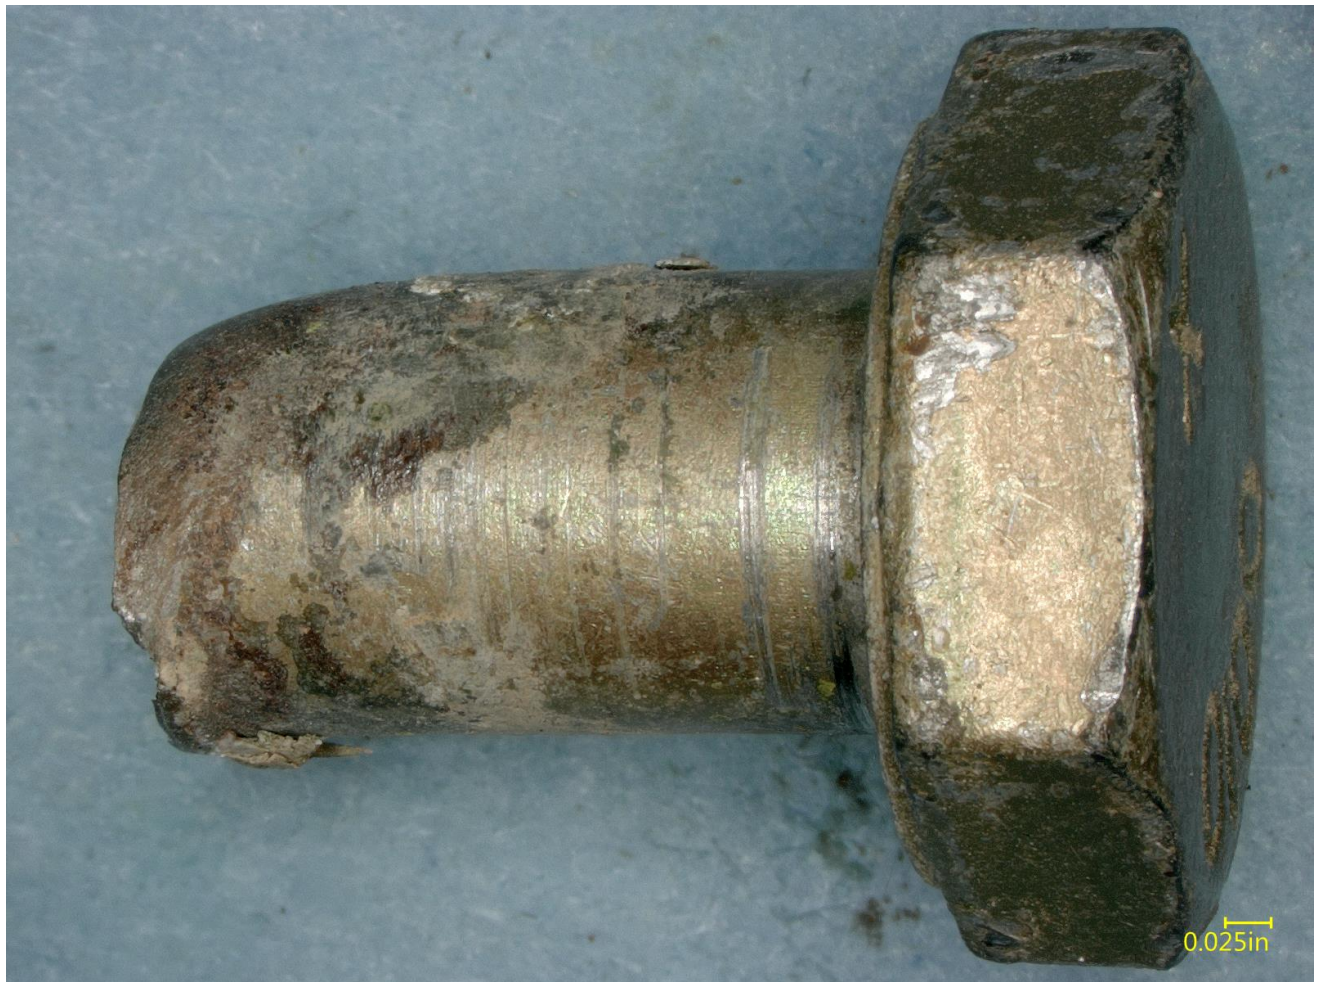
Figures 7 and 8 show the outboard bolt remnants from the bottom and top, respectively, as viewed from the side. The nut was still attached to the threaded portion of the shaft on the top remnant. The head on the bottom remnant exhibited the same markings as the inboard bolt remnant shown in Figure 3, "X" and "01DO." The bolt exhibited deformation near the fracture surfaces in the form of thinning, bending, and material displacement perpendicular to the shaft direction. In addition, the areas of the shaft closest to the head and the threaded region with the nut exhibited circumferential wear and gouging marks.

Figure 7 – Side view of the bottom outboard bolt remnant.

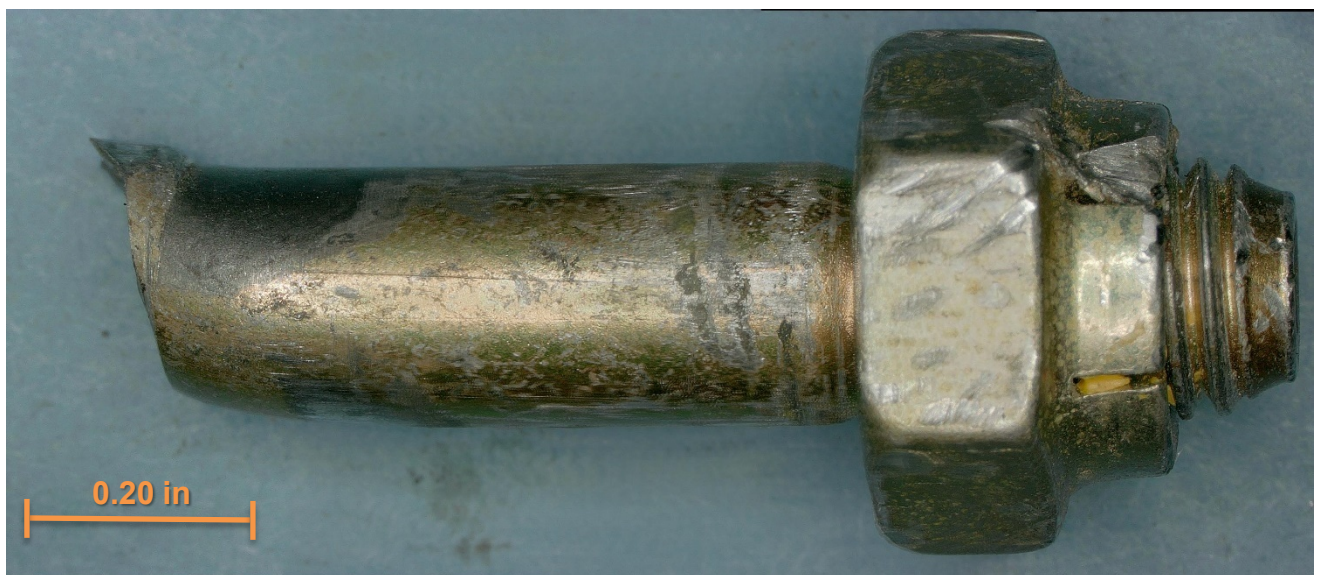
Figure 8 – Side view of the top outboard bolt remnant.

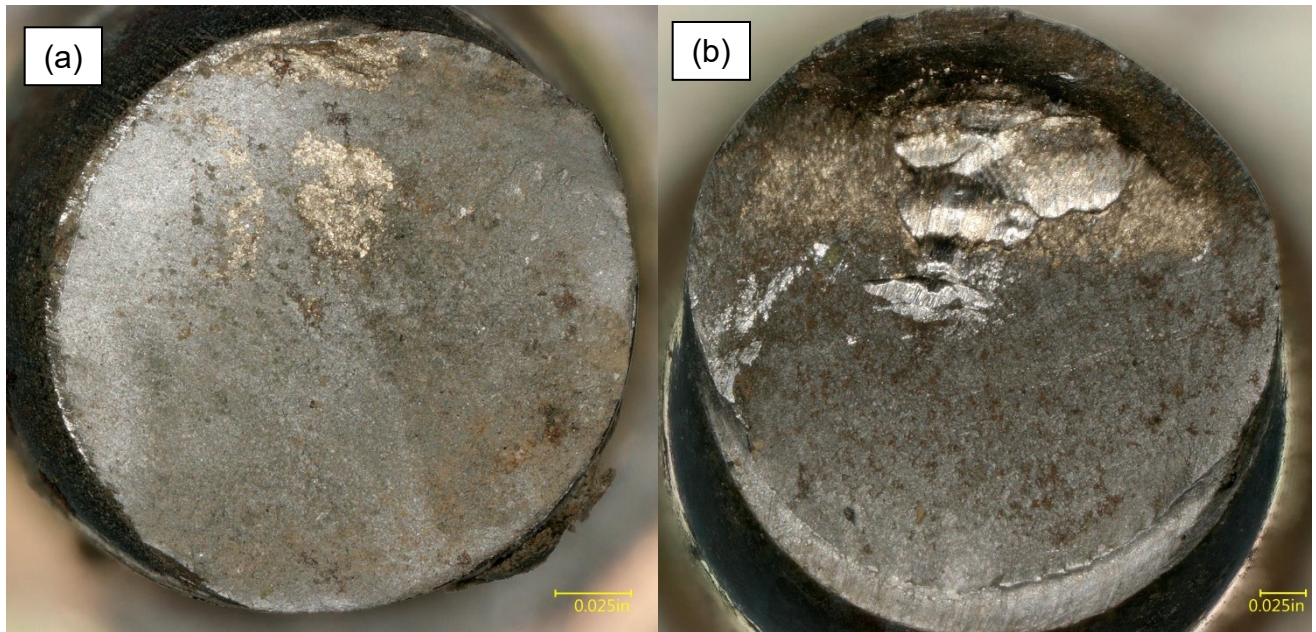
Figures 9a and 9b show the fracture surfaces from the bottom and top remnants, respectively. Both fracture surfaces exhibited a general dull, fibrous luster with a rough surface texture. With both faces, approximately half of the fracture surface was oriented perpendicular to the bolt shaft direction, and the other half was at an angled orientation. This angled protrusion on the top face had been heavily damaged by post-fracture smearing and gouging.

Figure 9 – The mating fracture surfaces of the outboard bolt remnants from (a) the bottom and (b) top faces.

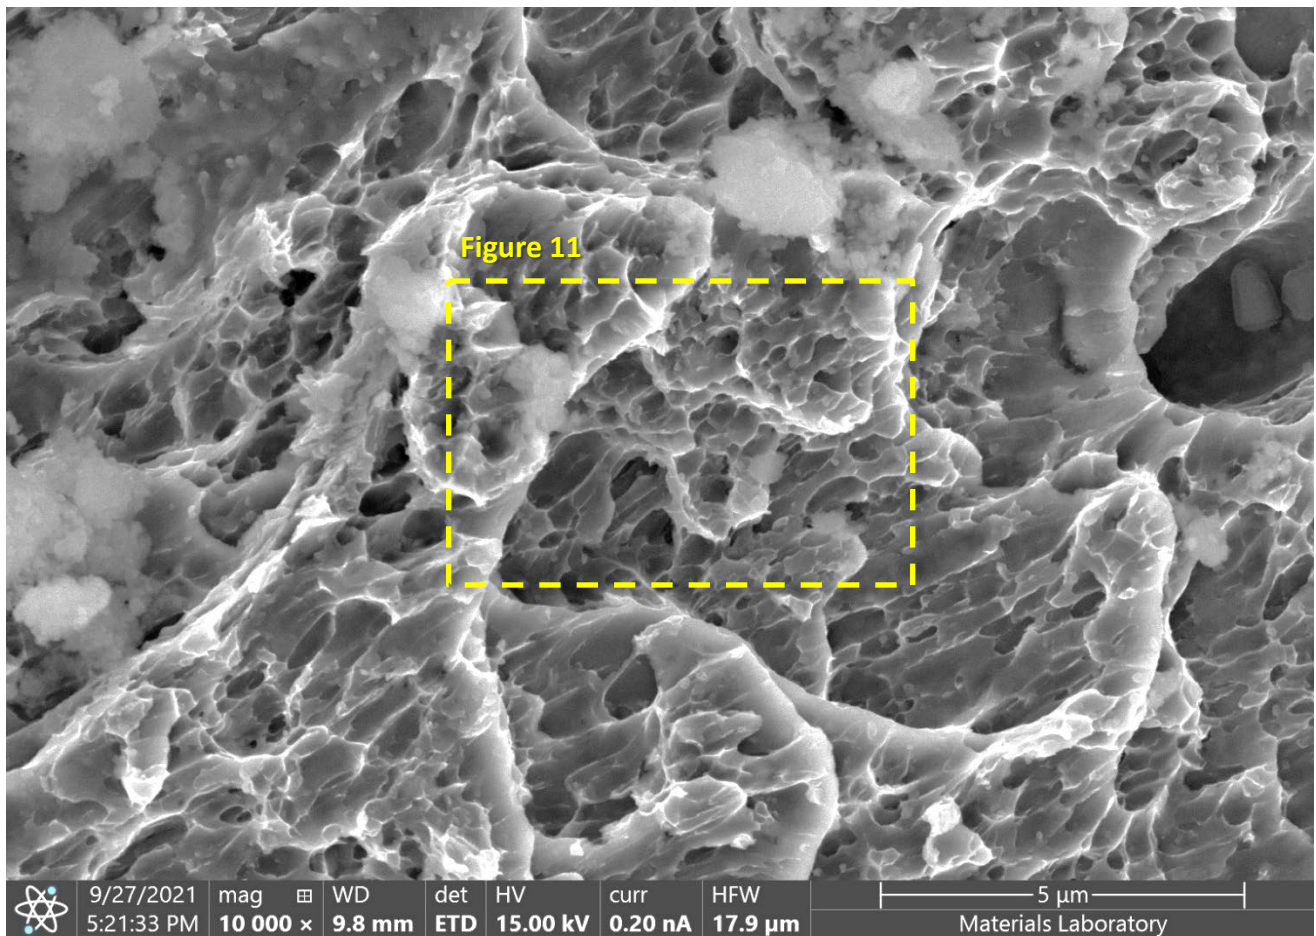
The fracture surface was examined using a SEM, showing a typical undamaged area in Figure 10. As shown in Figure 11, this area exhibited dimpled rupture, consistent with overstress fracture. These combined features were consistent with overstress fracture of the bolt in bending and shear.

Figure 10 – SE micrograph of a typical area of the top outboard fracture surface.

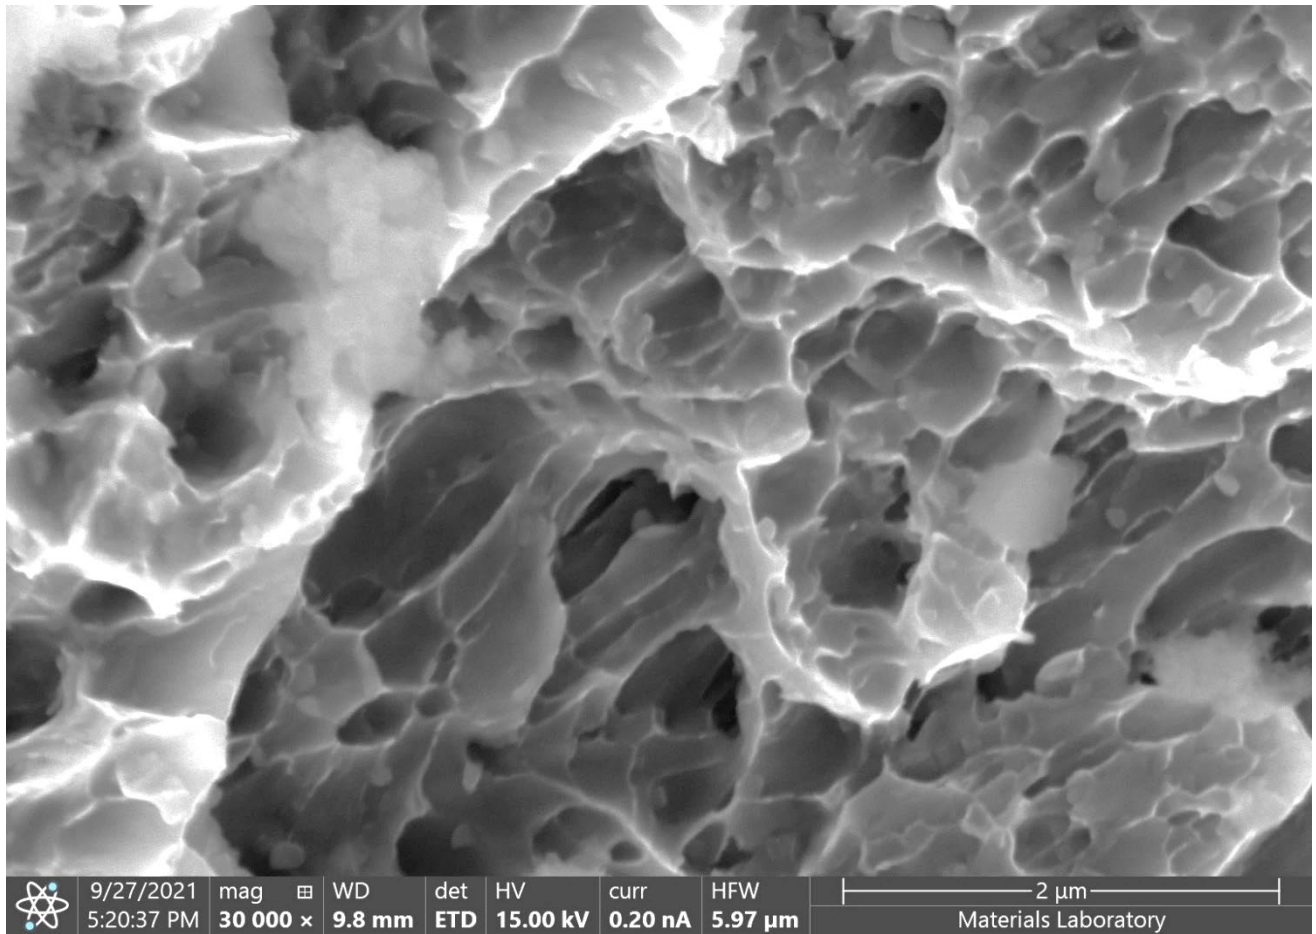
Figure 11 – SE micrograph of a closer area of the dimpled rupture in the boxed area in Figure 10.

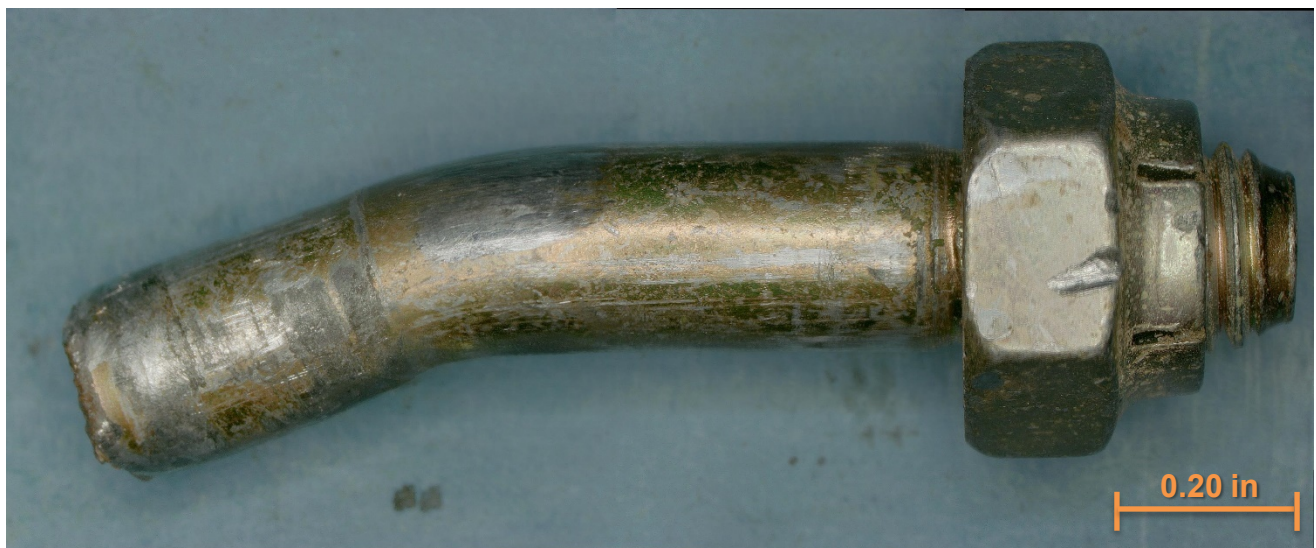
Figure 12 shows the top remnant of the fastener labeled second from outboard. The bolt had fractured along the shaft approximately 1.25 inches from the threaded region and was bent at an approximately 45° angle 1 inch from the threaded region. The bent portion

exhibited circumferential wear marks, consistent with rotation, and longitudinal wear marks, consistent with fretting or sliding.

Figure 12 also shows thinning of the shaft in the form of necking next to the fracture surface. Viewing the fracture surface in Figure 13, the surface exhibited a general cup or concave shape. The edges, consistent with shear lips, had been deformed and damaged, as exhibited by the reflective streaked areas along the periphery—these features were consistent with post fracture damage.

Figure 12 – Side view of the top bolt remnant, second from outboard.

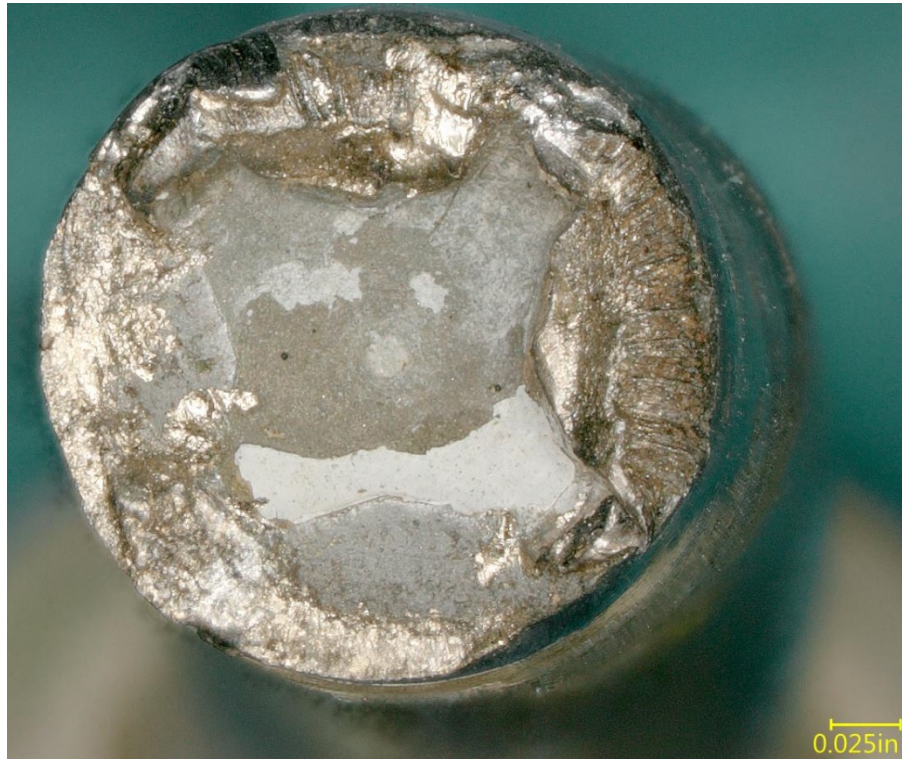
Figure 13 – View of the fracture surface of the top bolt remnant, second from outboard.

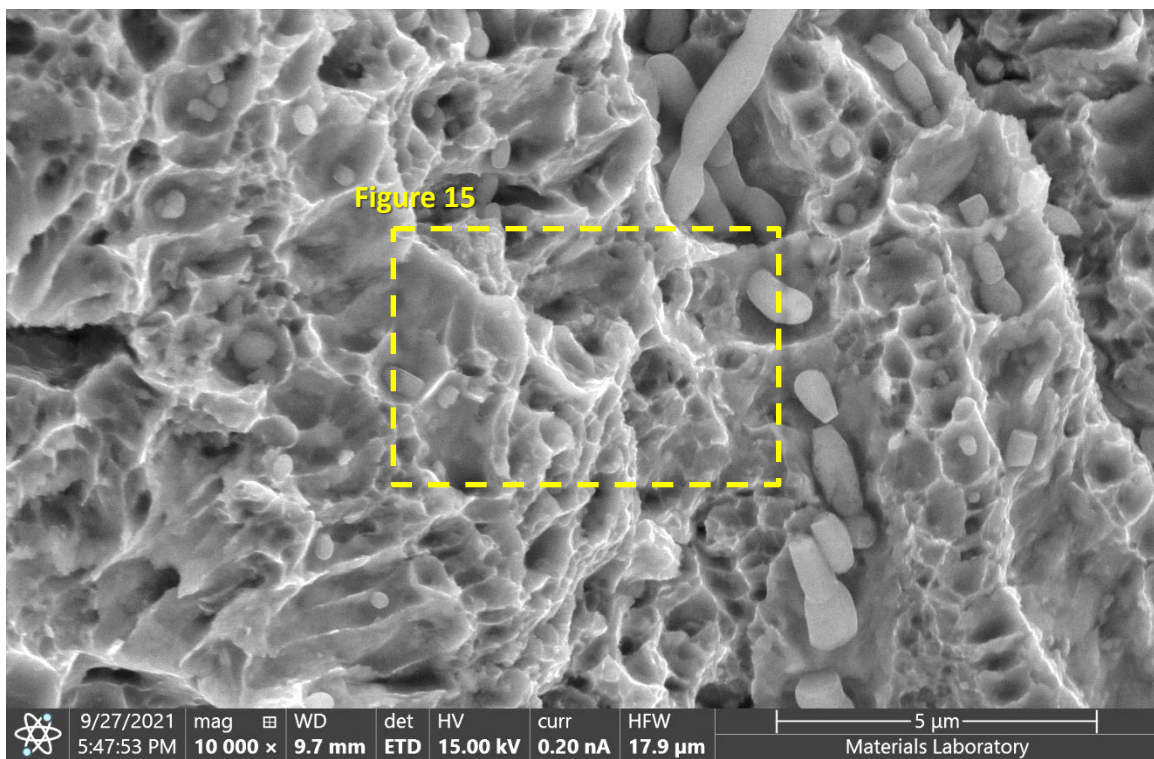
A portion of the undamaged area of the bolt fracture surface is illustrated in Figure 14. As shown in a closer view in Figure 15, these features were consistent with dimpled rupture. The combined features of this bolt remnant were consistent with having fractured from overstress in tension and bending. None of the bolt fracture surfaces exhibited features consistent with pre-existing damage, such as cracks, corrosion, or large inclusions.

Figure 14 – SE micrograph of a typical undamaged area from the fracture surface in Figure 13.

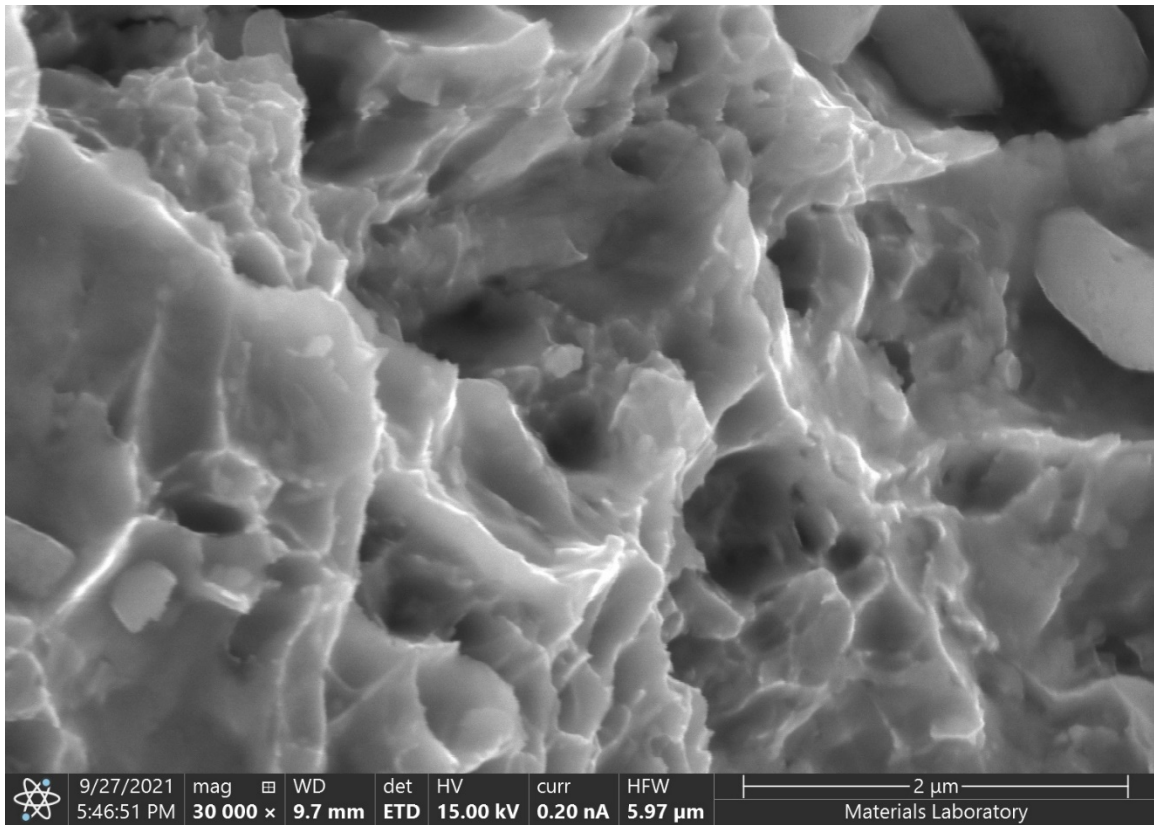
Figure 15 – SE micrograph of dimpled rupture in the boxed area in Figure 14.
