# National Transportation Safety Board

## COMPONENT EXAMINATION FACTAL REPORT

Place : Wheeling, IL  
Date : August 11, 2021  
Vehicle : Robinson Helicopter / R44 / N4043B  
NTSB No. : CEN21LA369  
Investigator: John Brannen

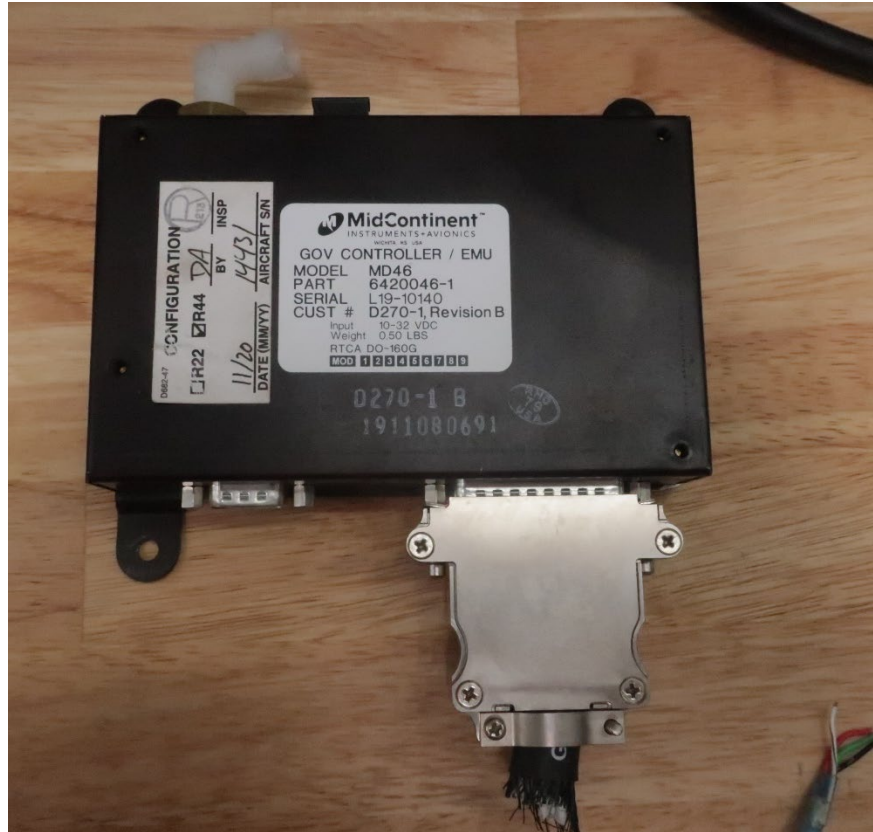
The control box lower left mounting tab was broken off, otherwise the box appeared undamaged. The MidContinent Instruments Avionics warrantee seal was intact. The 44-pin connector was attached to the box and the wire bundle leading out of the connector had been cut. The 15-pin connector port was open. The Bluetooth Universal Serial Bus (USB) antenna was in the upper USB port and the lower USB port was open. The plastic elbow for the manifold pressure was attached to the side (Figure 1).

**Figure 1.** Engine Governor Controller / EMU as received.

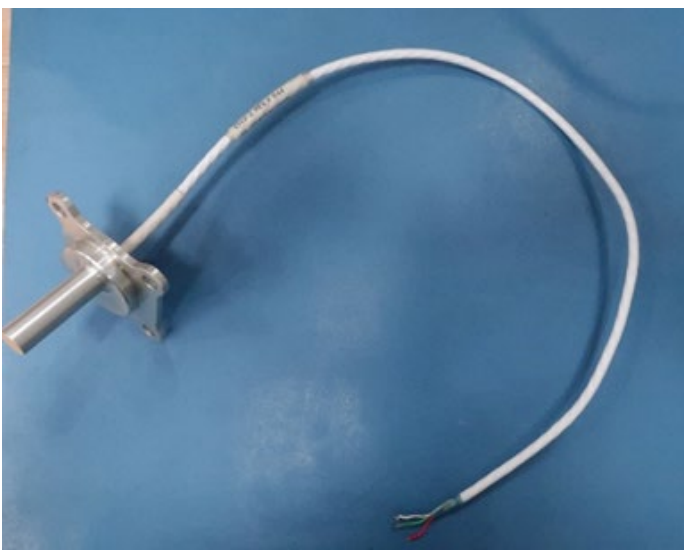
The engine rpm sensor assembly (Figure 2) was undamaged and had a 1.5 foot white electrical/signal cable protruding from the flat side. The signal cable end did not have a connector and the colored wires (4), green, black, red, white, yellow, all had bare wire tips (Figure 3). The end of the wires had been pulled from the plastic connector during the process of removing the assembly from the helicopter, giving the wire ends a “clipped” appearance. The cable was cut just below the free wire ends and the free wire ends retained. The sensor was placed on the test fixture. The rpm sensor produced a square wave signal and passed the ATP.

**Figure 2.** Engine rpm sensor.

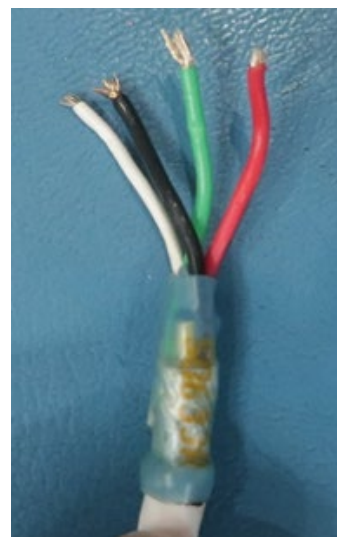
**Figure 3.** Engine rpm sensor signal cable end wires.

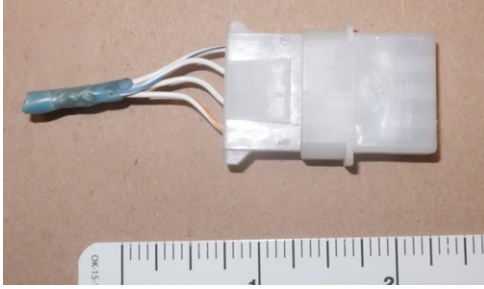
Both male and female halves of the rpm signal wire connector were examined (Figures 4 and 5). The continuity and resistance through the connector for each pin was individually checked with a multimeter. All pins had a  $0.16\ \Omega$  (ohms) resistance or better. The heat shrink bundle of the wire ends was snipped off. Continuity was rechecked and remained good on all pins while physically moving and wiggling the individual wires. Visual examination of pins and wire crimped ends showed similar crimping features on all pins and conformed with RHC crimping guidance. A magnifying glass examination showed all pins had wire strands trapped in the crimped portion of the pin. An optical microscope was used to inspect all the wire strand ends, all which were necked down with a rupture type of separation at their tips.

**Figure 4.** RPM signal cable connector (assembled).

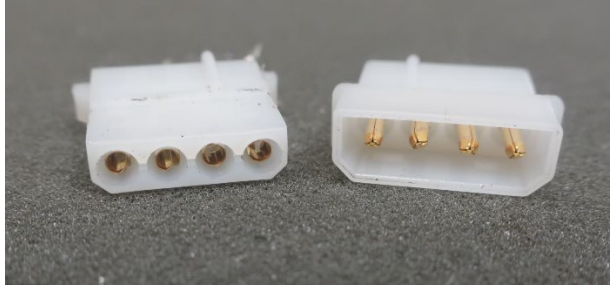
**Figure 5.** Female and male halves of the rpm signal cable connector.

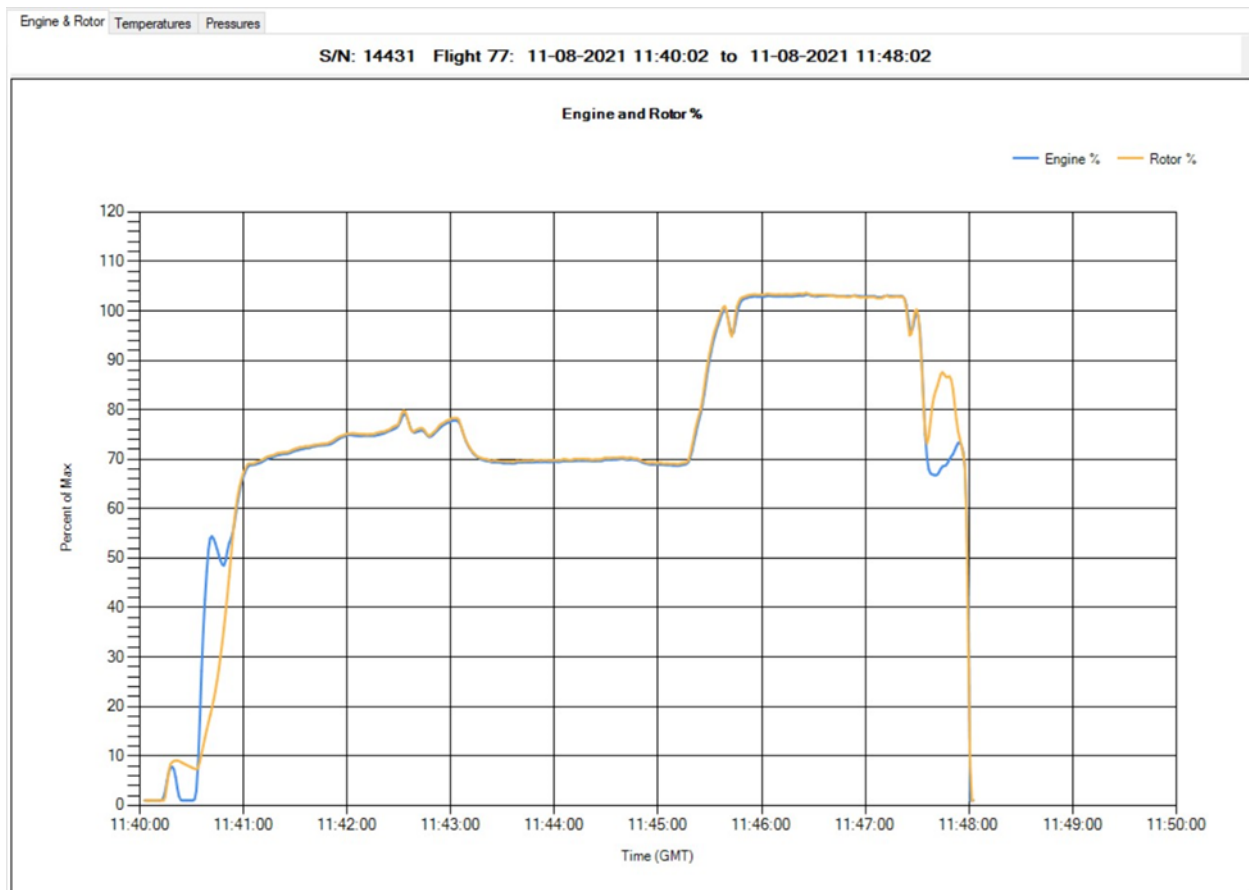
**Figure 6.** Engine and rotor rpm for the entire flight.

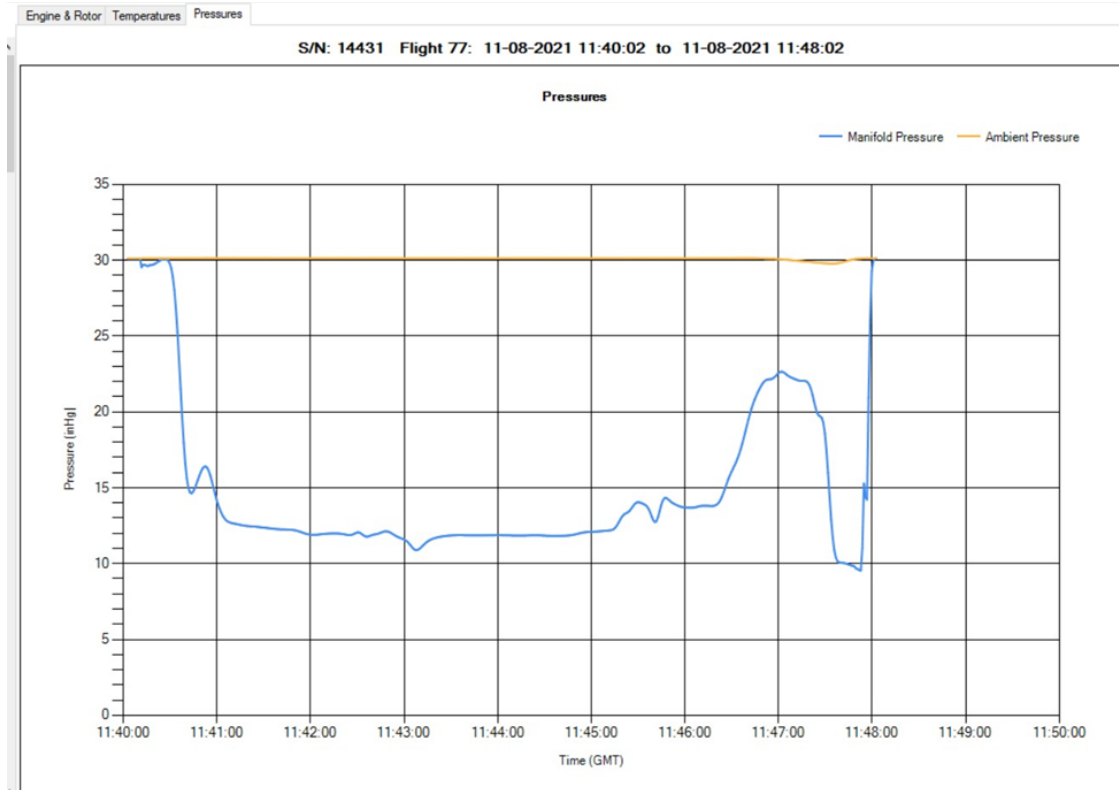
Figure 7. Manifold and ambient pressures for the entire flight.

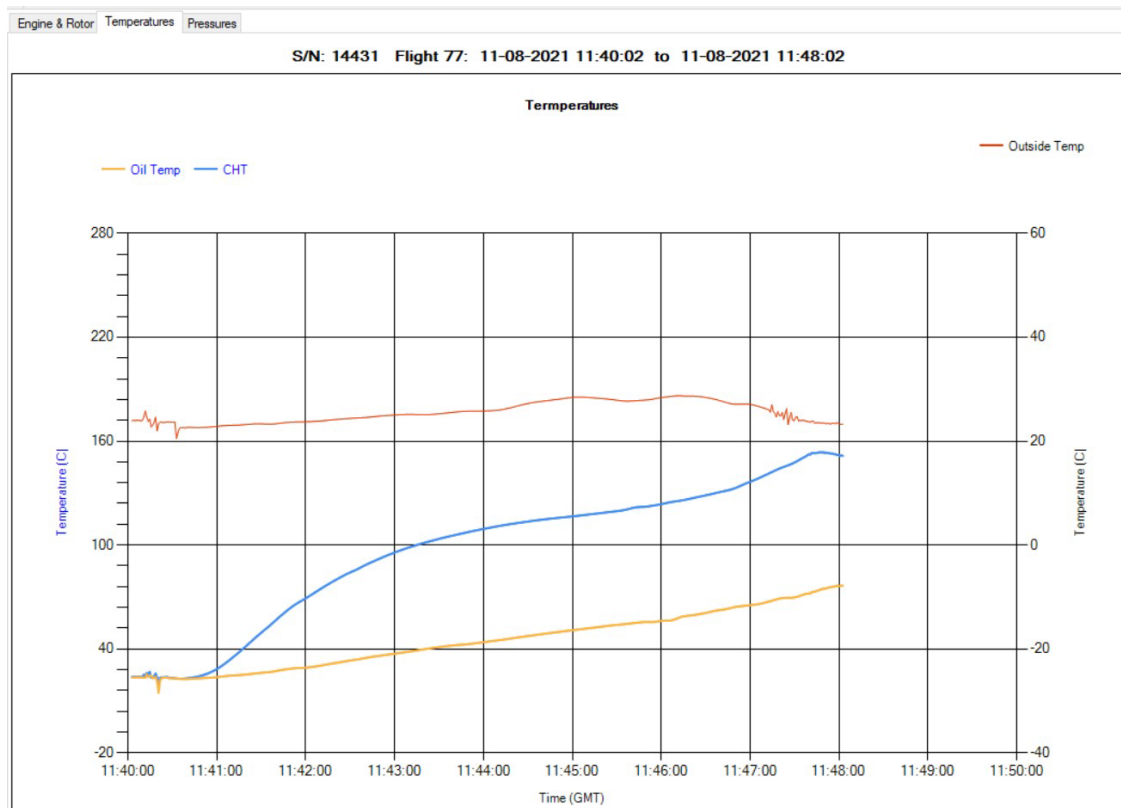
Figure 8. Engine temperatures for the entire flight.

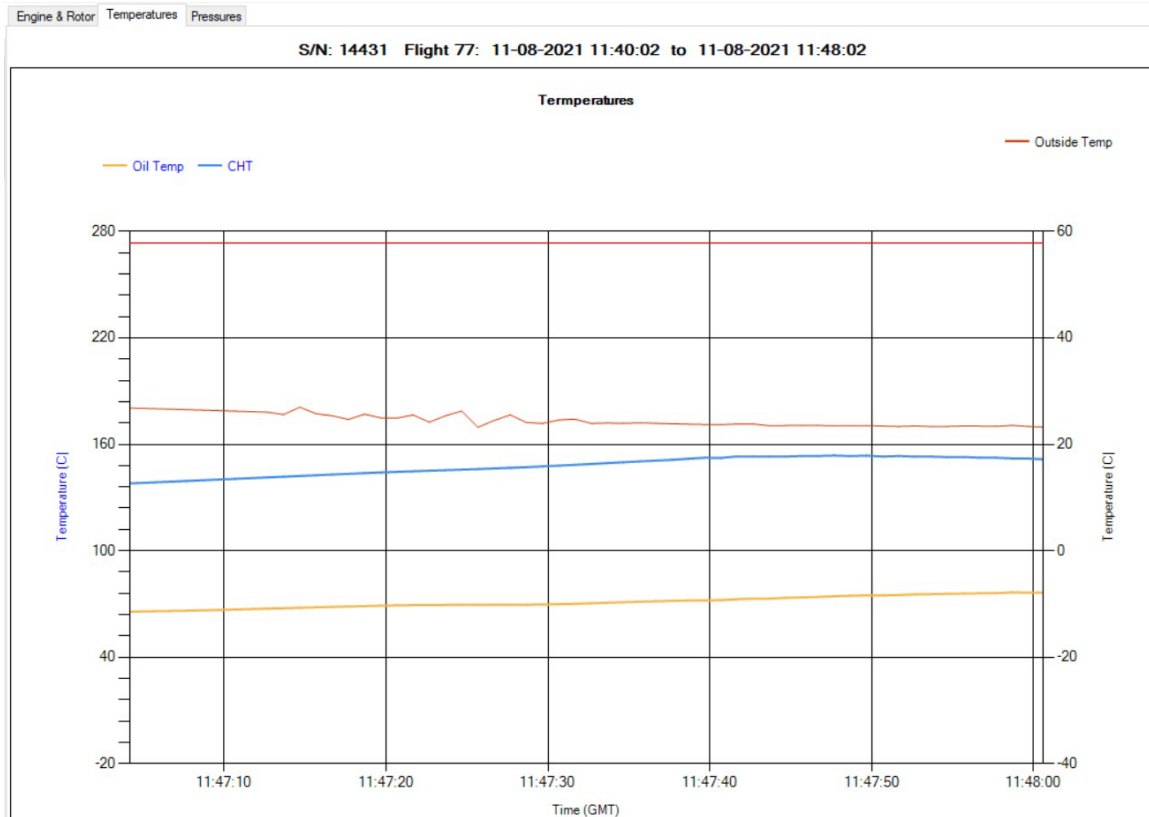
Figure 9. Engine temperatures for the last 60 seconds of the flight.

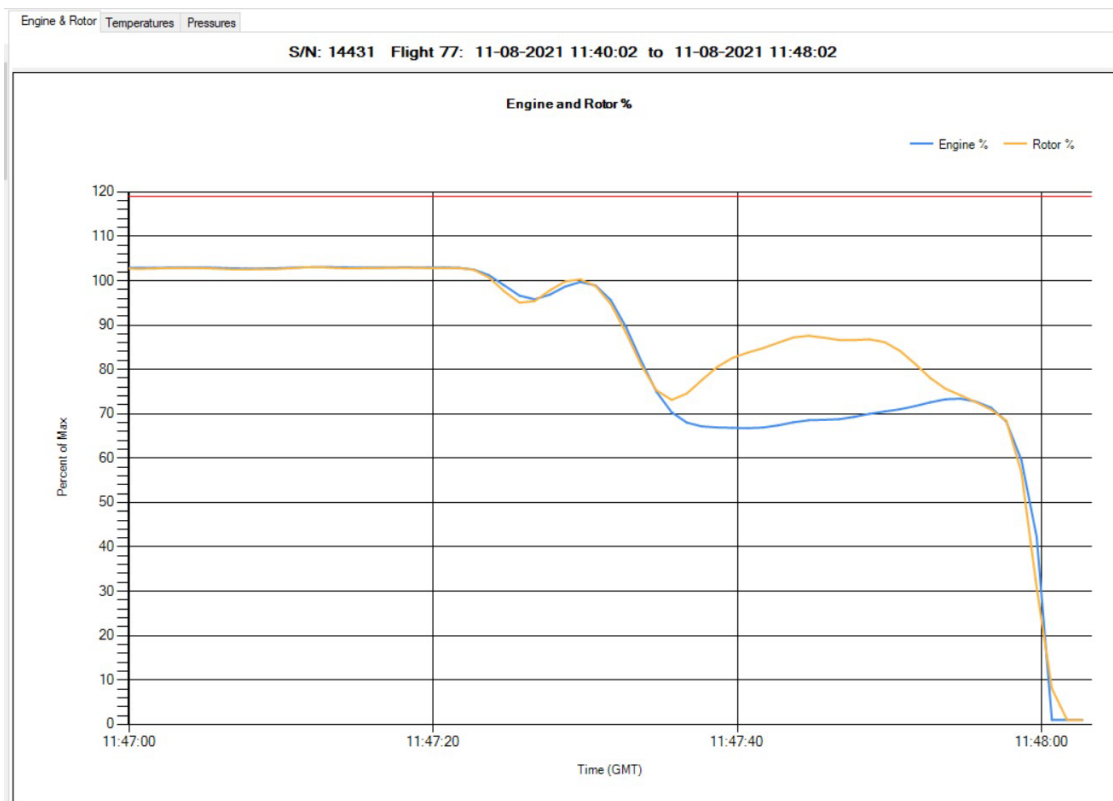
Figure 10. Engine and rotor rpm for the last 60 seconds of the flight.

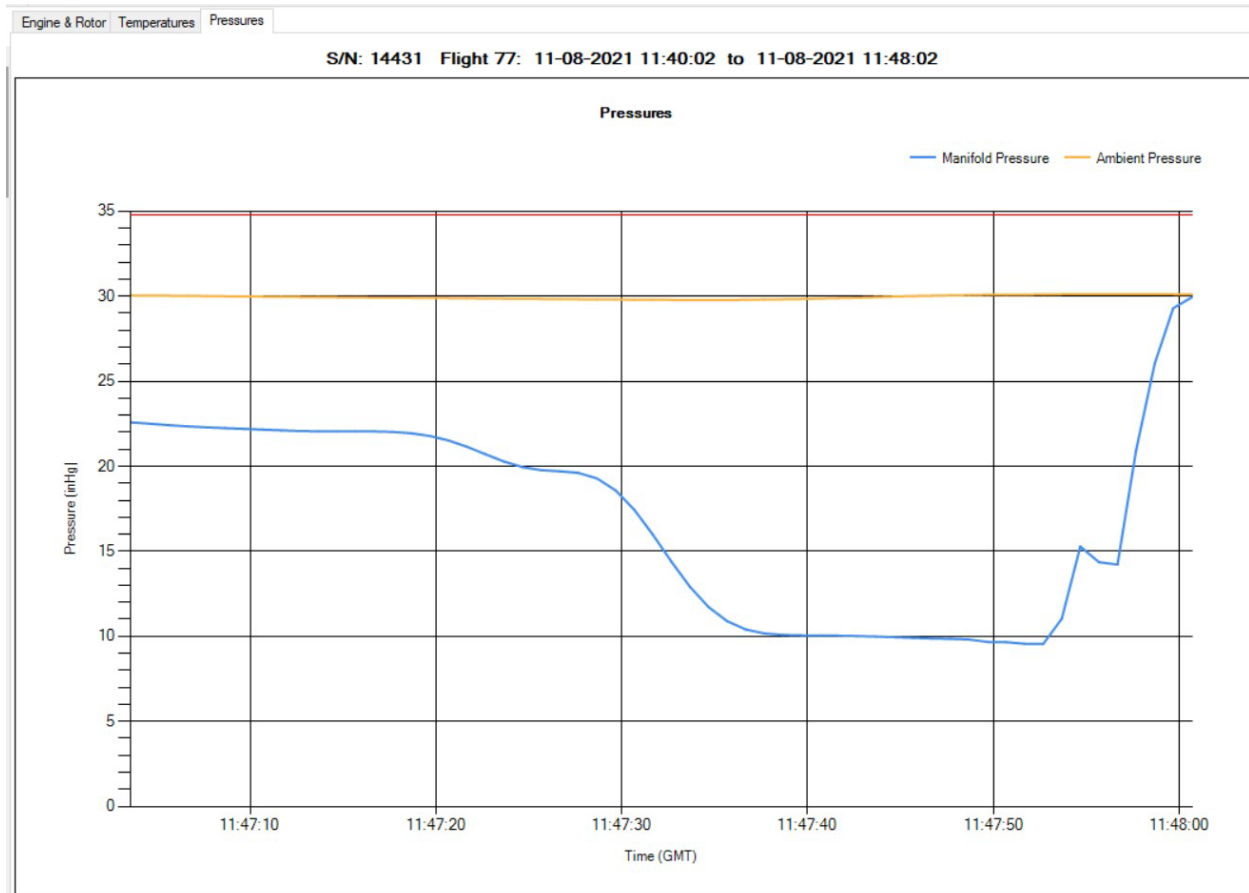
**Figure 11.** Engine pressures for the last 60 seconds of the flight.
