# National Transportation Safety Board

CEN21LA369

## **AIRCRAFT EXAMINATION**

Location: Wheeling, Illinois  
Date: August 11, 2021  
Time: 0640 cdt  
Helicopter: N4043B, Robinson R44 II

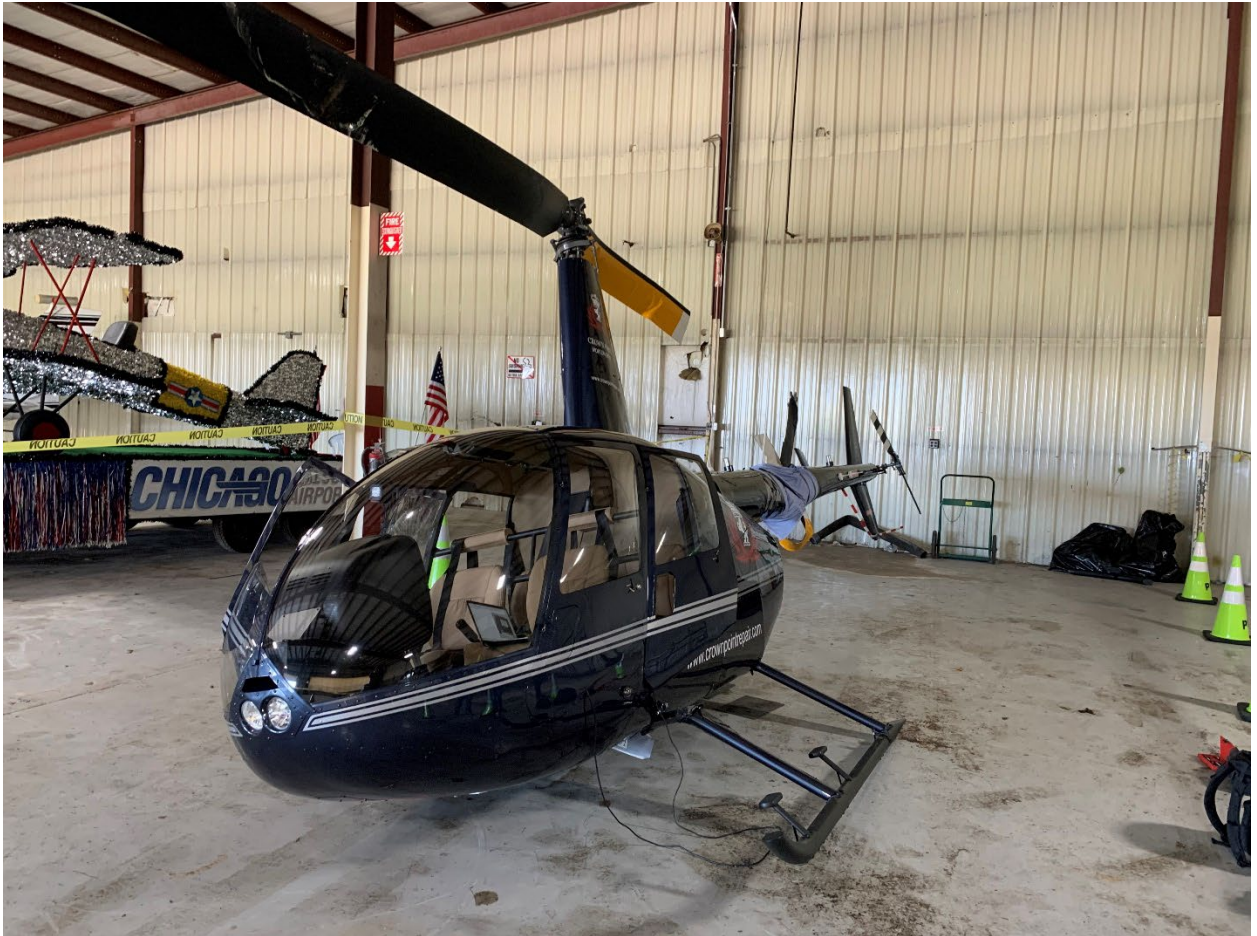
The helicopter was initially examined in a hangar at the Chicago Executive Airport on 08/16/2021. The helicopter was sitting upright but leaning to the right due to a broken right landing skid. There was significant damage to the main rotors and the tailboom had damage consistent with main rotor blade impact. The battery cable had been cut by first responders which did not allow powering up the helicopter for testing. A surrogate battery cable was installed and the helicopter's engine management unit (EMU) was downloaded of all data it contained. Subsequent to the EMU download an engine test run was performed. Before the test run, the drive belts from the engine to the rotor system were cut to prevent the rotor system from turning. The engine was started normally and run at low rpm. The test run was limited due to the excessive smoke coming from the exhaust due to the non-level attitude of the helicopter which allowed the oil to pool in the cylinders that were lower. (cylinders on the right side of the helicopter.) The engine induction SCAT tube was removed and examined for evidence of collapse. No evidence of collapse was discovered.

Figure 1. Helicopter during examination viewed from front left. (NTSB Photo)

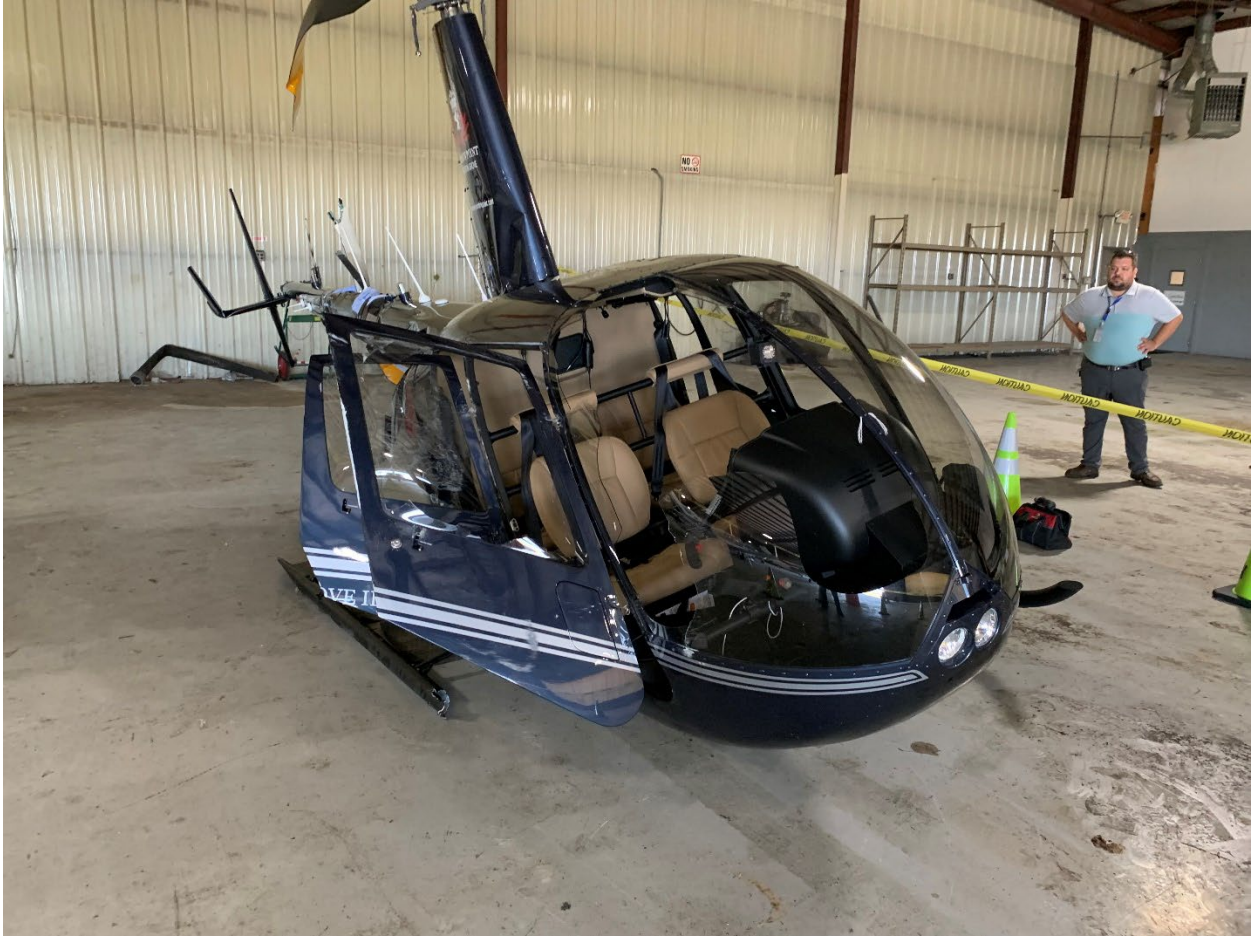
Figure 2. Helicopter during examination viewed from front right. (NTSB Photo)

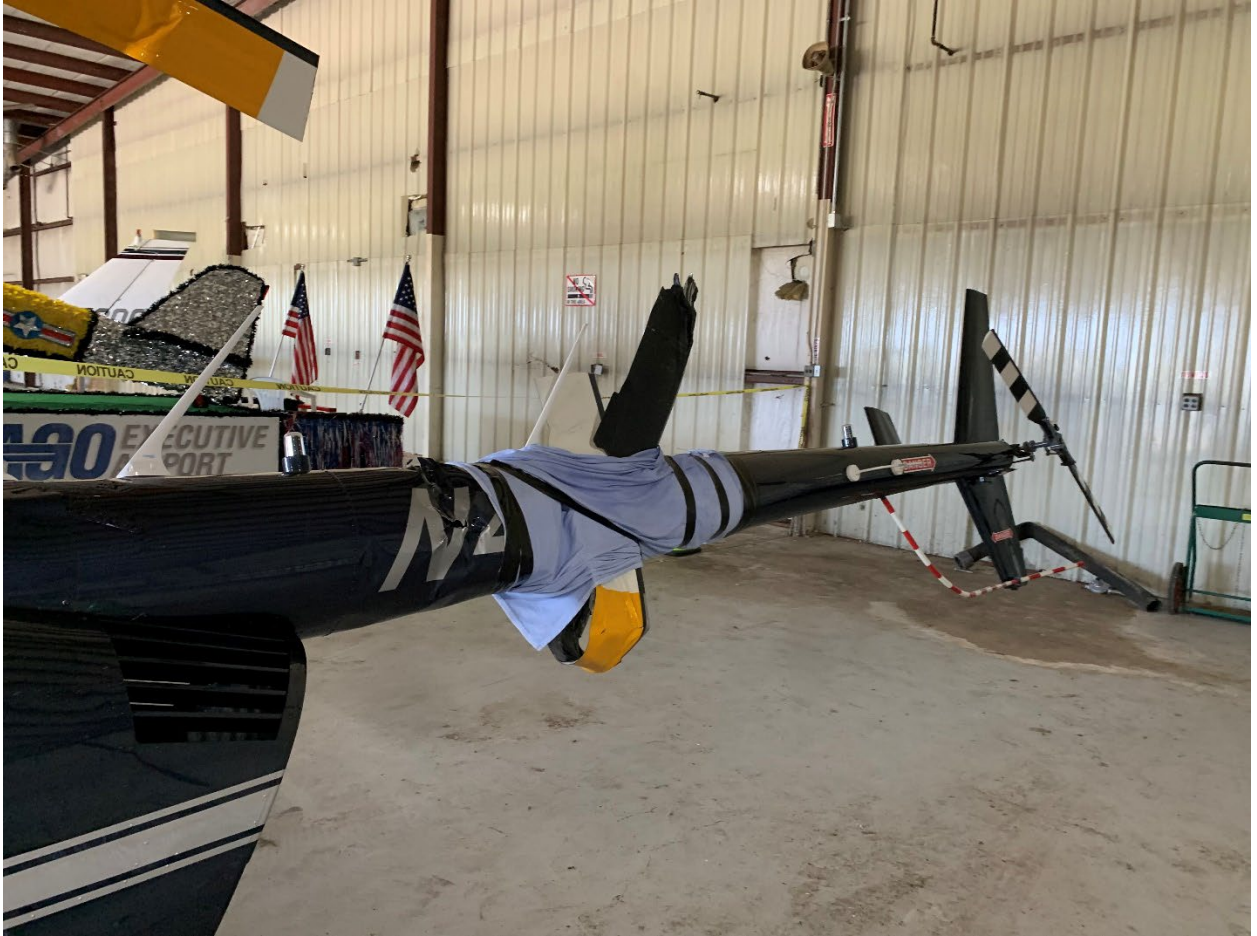
Figure 3. View of tailboom during examination. (NTSB Photo)

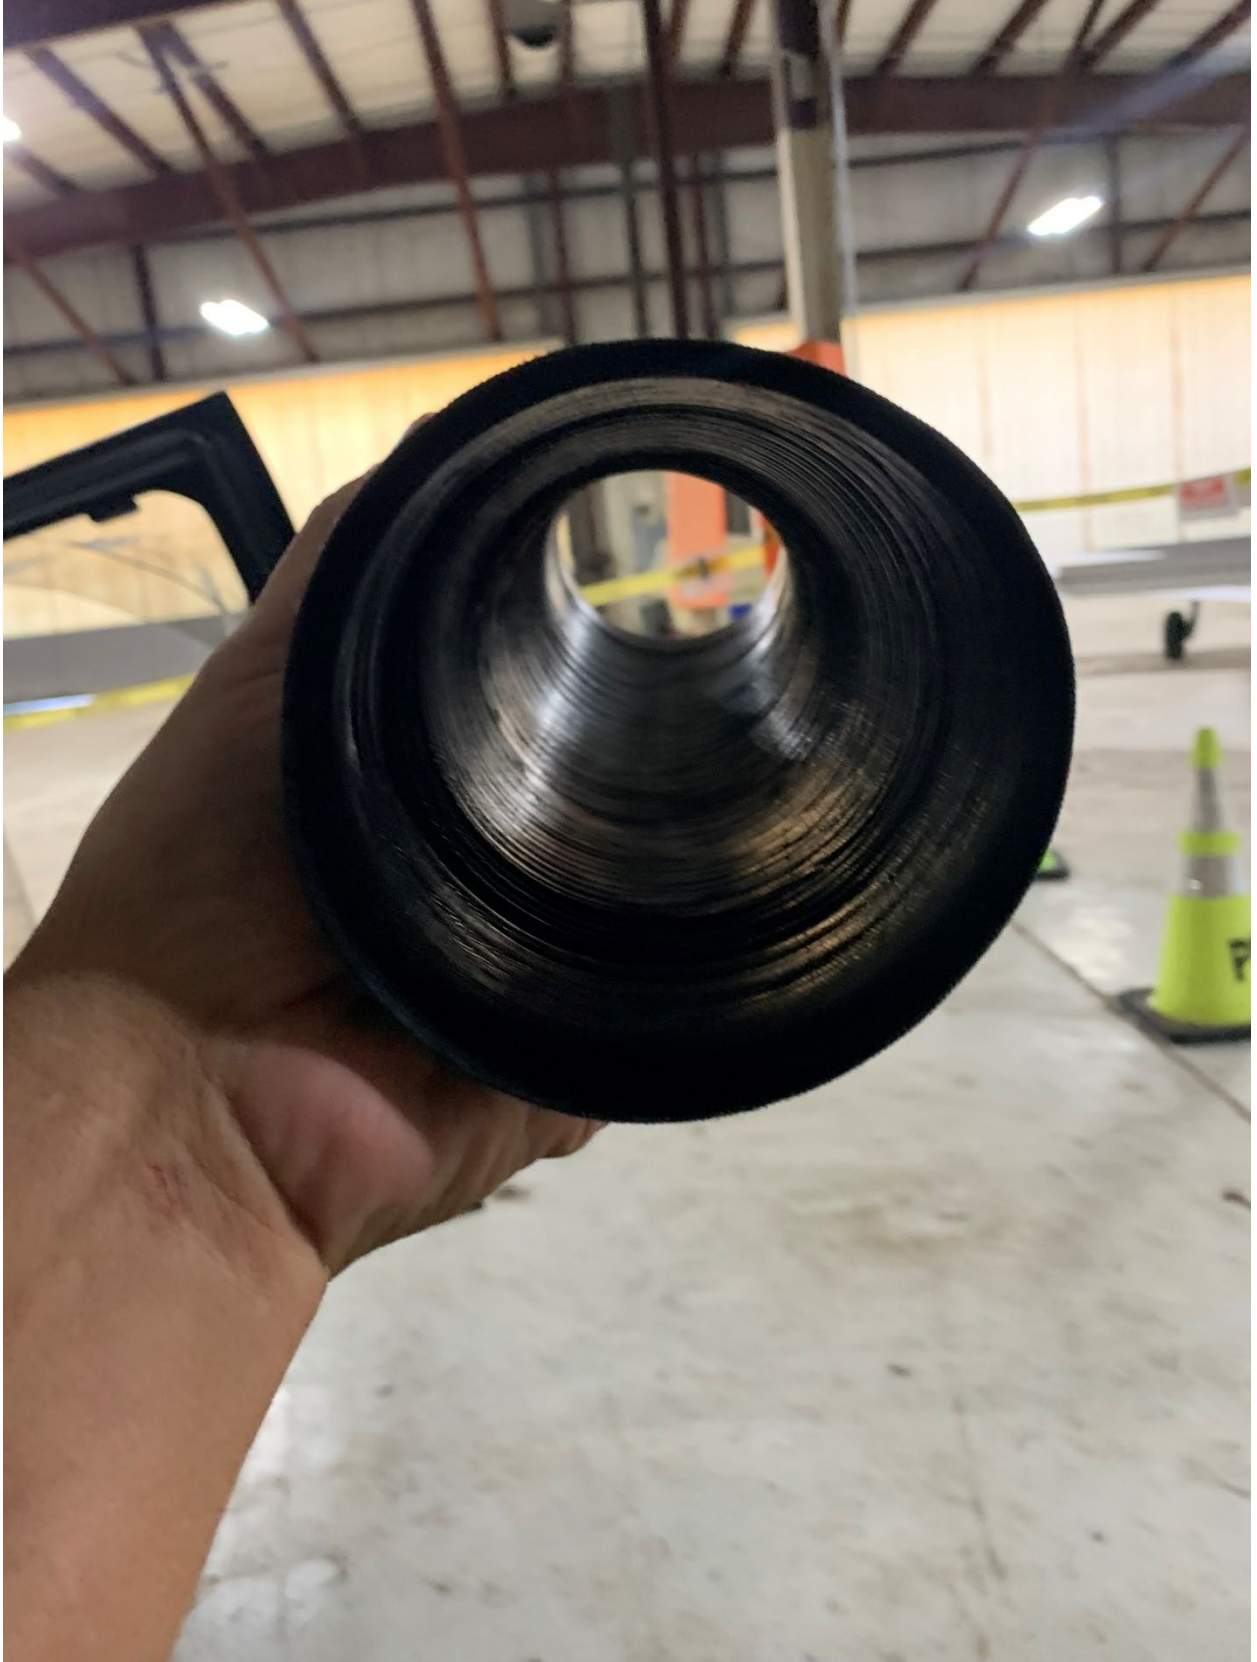
Figure 4. View of engine induction tube. (NTSB Photo.)
