## Incident of N6474Q on July 21th 2021 at approximately 21:10 pm CDT (0110Z)

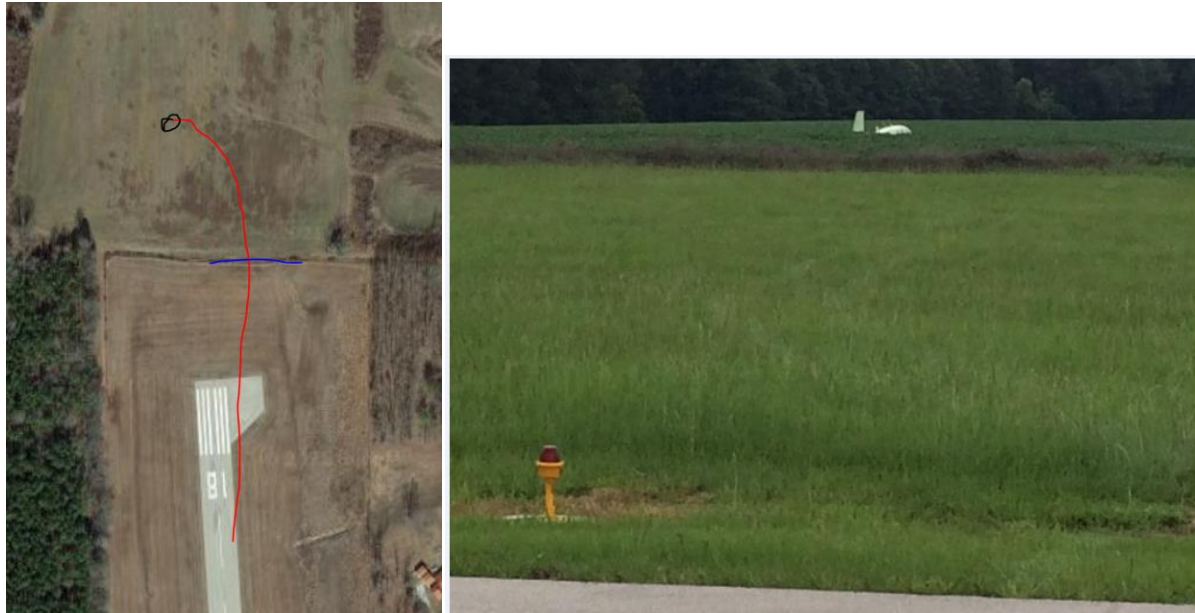
**Location of accident:** M72 (New Albany, MS) approximately 500' north of runway 36 end. See map below. The picture on the right below show the location of the airplane in relation to runway 36 end.

**Nature of accident:** on map above in red is the pass of attempted go around after landing on runway 36 without landing light or runway light due after total airplane electrical failure due to broken alternator belt. Black circle indicate final resting place of airplane. The blue indicates the location of an old wiremesh fence that was rolled up on the ground. Only a single 6' 2" diameter fence post was left standing. This post went through the left wing of the airplane as it was taking off and about 6' up in the air.

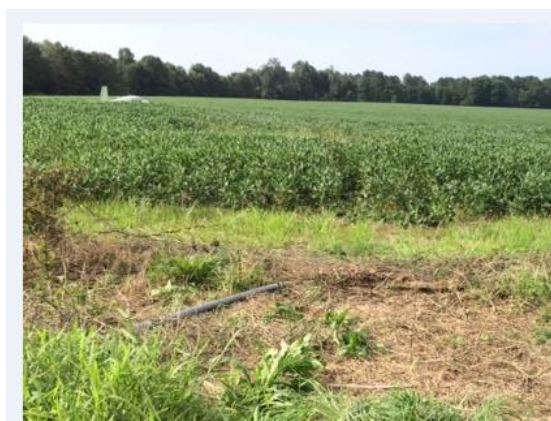
The picture below shows the airplane in relation to the fence and the fence post. (The post was still standing after the accident but was pushed down to allow access to the towing vehicle, as was the fence flattened down due to towing operation). There was no landing gear tracks on the rolled down fence as I walked through it the night of the accident, the plane flew above it.

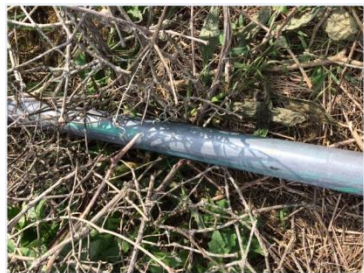
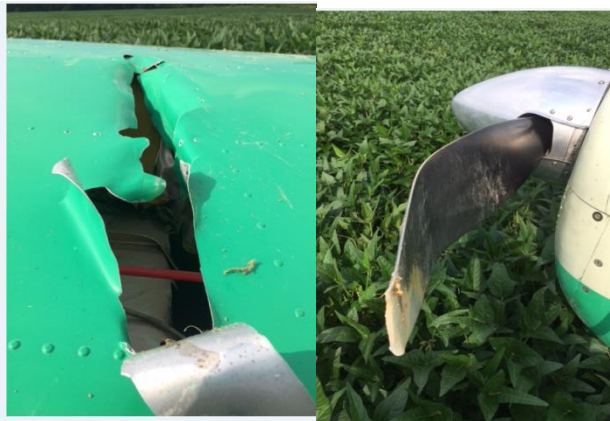
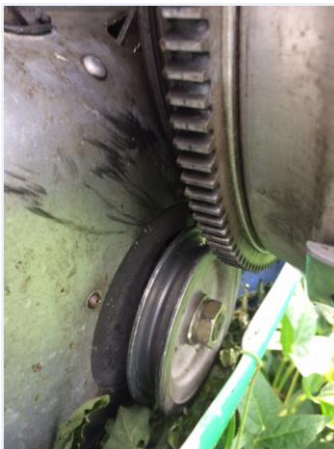
**Damages to the airplane:** below are pictures of the fence post, wing, propeller and missing alternator belt.
