On March 8, 2022, Inspectors from the CMH FSDO traveled to Midwest Corporate Air Inc., 3100 State Route 47 W, Bellefontaine, OH 43311. The purpose of the trip was to observe engine runs on N215BN, a 2007 Diamond Aircraft Industries, Inc. DA-42, serial no. 42.AC055. On 08/17/2021, at 21:15Z, N215BN lost power in both engines and crashed on departure at the end of the runway at KEDJ. There was 1 passenger on board and there were no injuries.

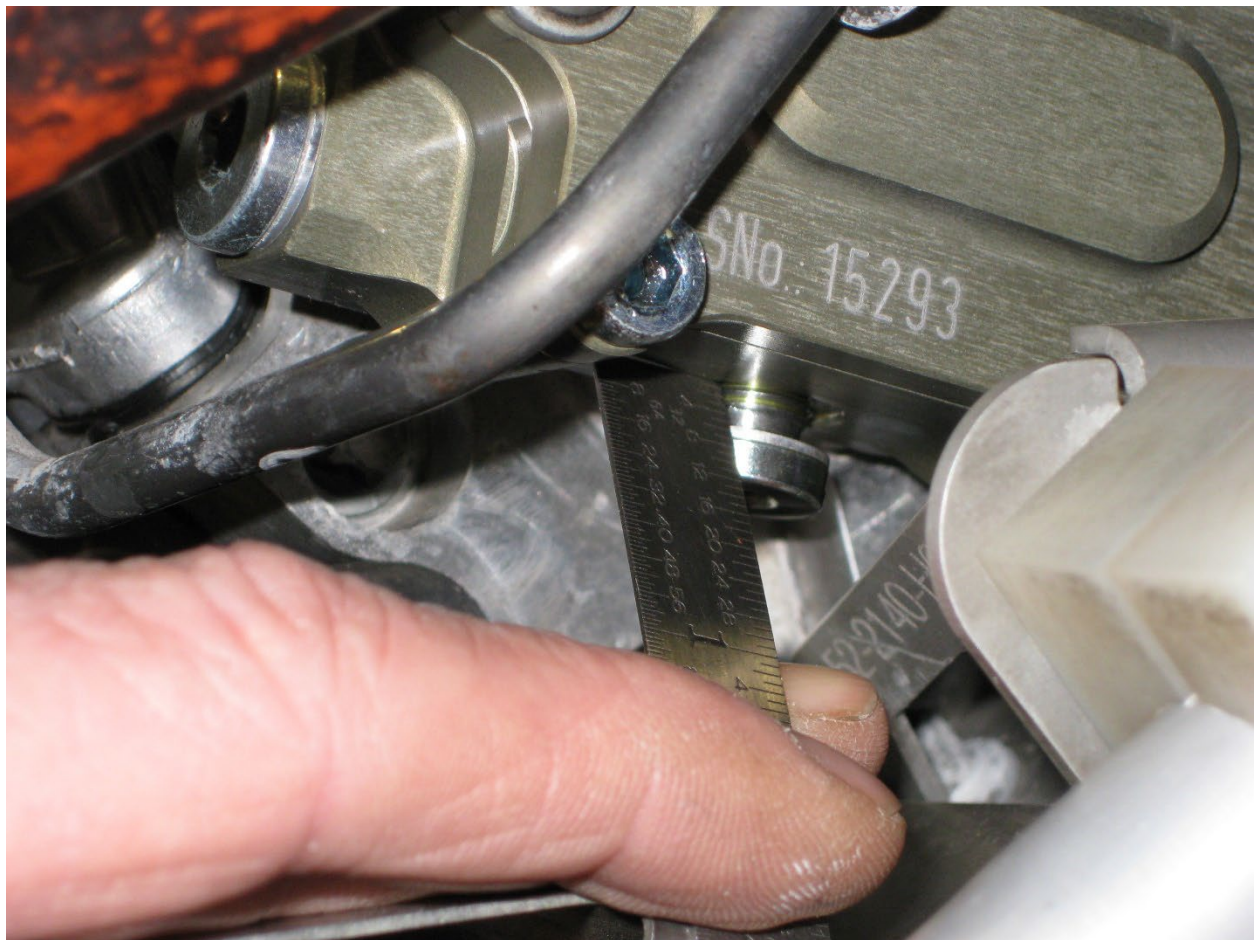
Once again, a start was attempted on the right engine but was unsuccessful. Maintenance personnel had previously observed that the bolt on the bottom of the right engine's Fuel Feed Pump (FFP) was not seated.

Right Engine Fuel Feed Pump prior to re-seating bolt.

In conclusion, it appears that after the FFP was replaced on the right engine and, prior to takeoff, the bolt on the bottom of the FFP, which fixes the position of the pressure reducing valve, worked loose and allowed air into the right engine's pressurized fuel system. A representative of Continental Aerospace Technologies GmbH was asked "When a FFP is shipped new, as a replacement part, is this bolt locked in any way?" The representative responded that "Yes the bolt is torqued with 12Nm during assembly."

After discussion, it was decided to re-seat the bolt. After the bolt was re-seated, the right engine started, and ran, normally.
