# National Transportation Safety Board

CEN21LA402

## **WRECKAGE EXAMINATION SUMMARY**

Location: Sheridan, Illinois  
Date: September 5, 2021  
Time: 1323 central daylight time (1823 UTC)  
Airplane: Murphy Renegade II, Registration No. N490DJ

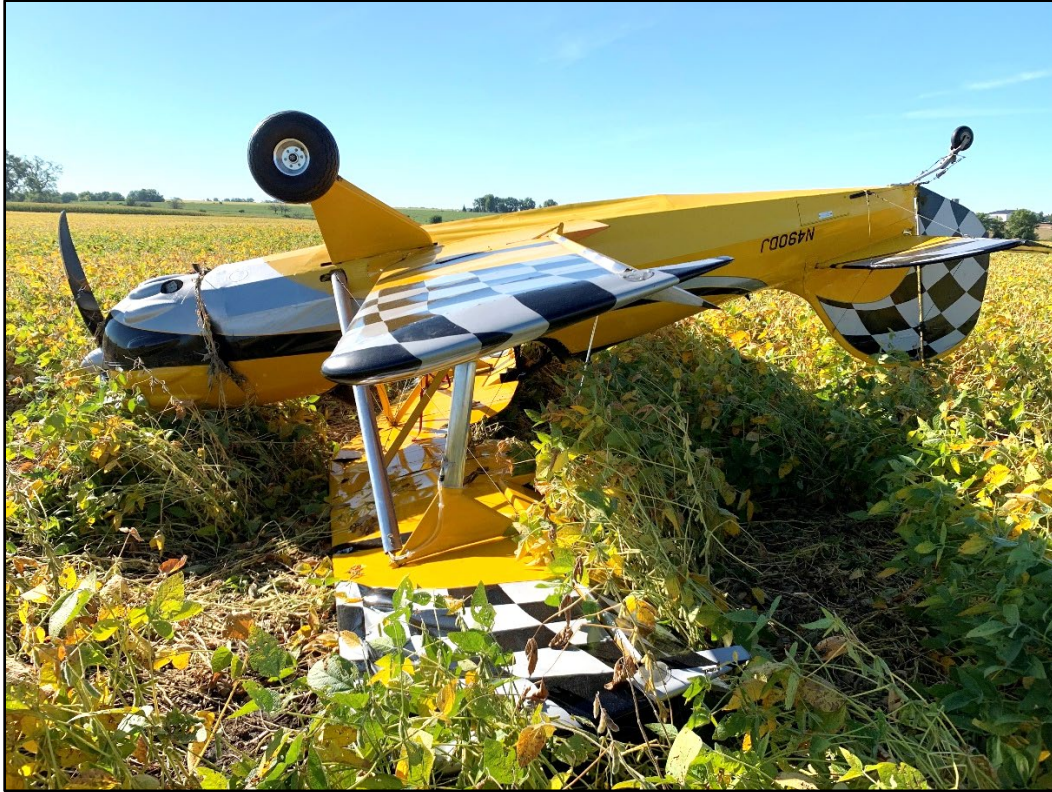
An onsite examination of the biplane airplane revealed a fractured engine mount tube and the outboard 3 ft of the upper right wing's leading edge was crushed aft. The left main landing gear wheel separated from the gear leg during the forced landing. The remaining fuselage, wings, and empennage were relatively undamaged. Flight control continuity was confirmed from the cockpit controls to each flight control surface.

**Figure 1** - Main Wreckage at Accident Site, Right Side

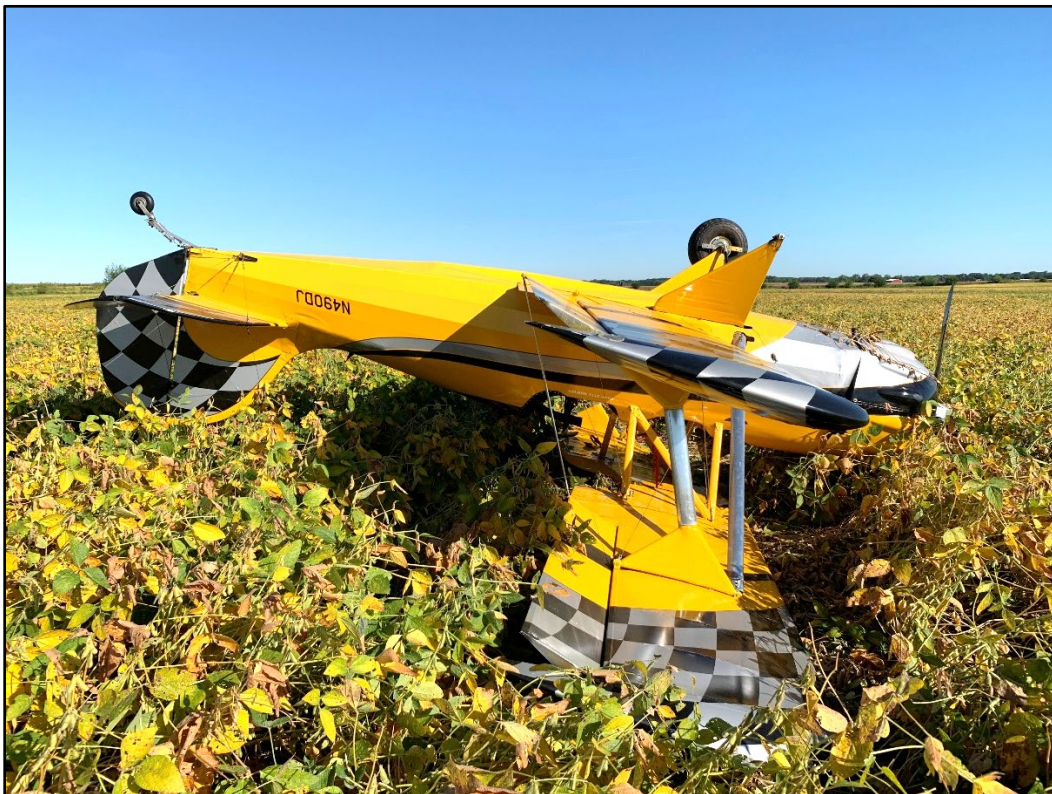
**Figure 2** - Main Wreckage at Accident Site, Left Side

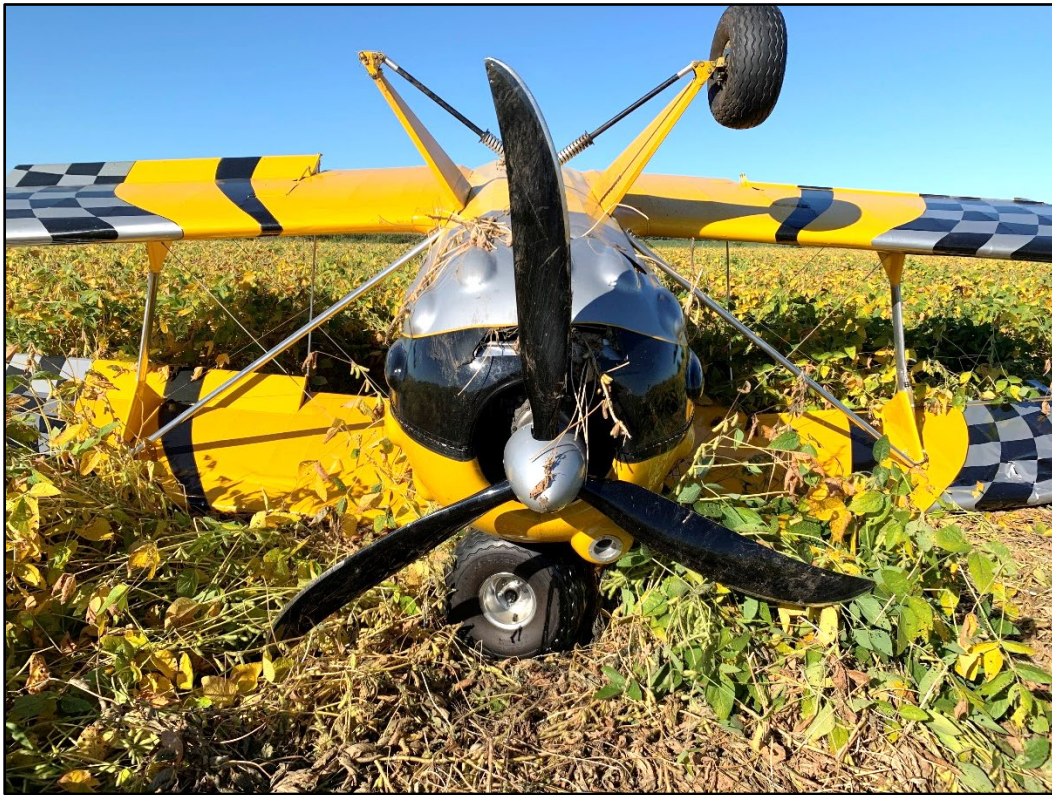
**Figure 3 - Front of Airplane and Propeller**

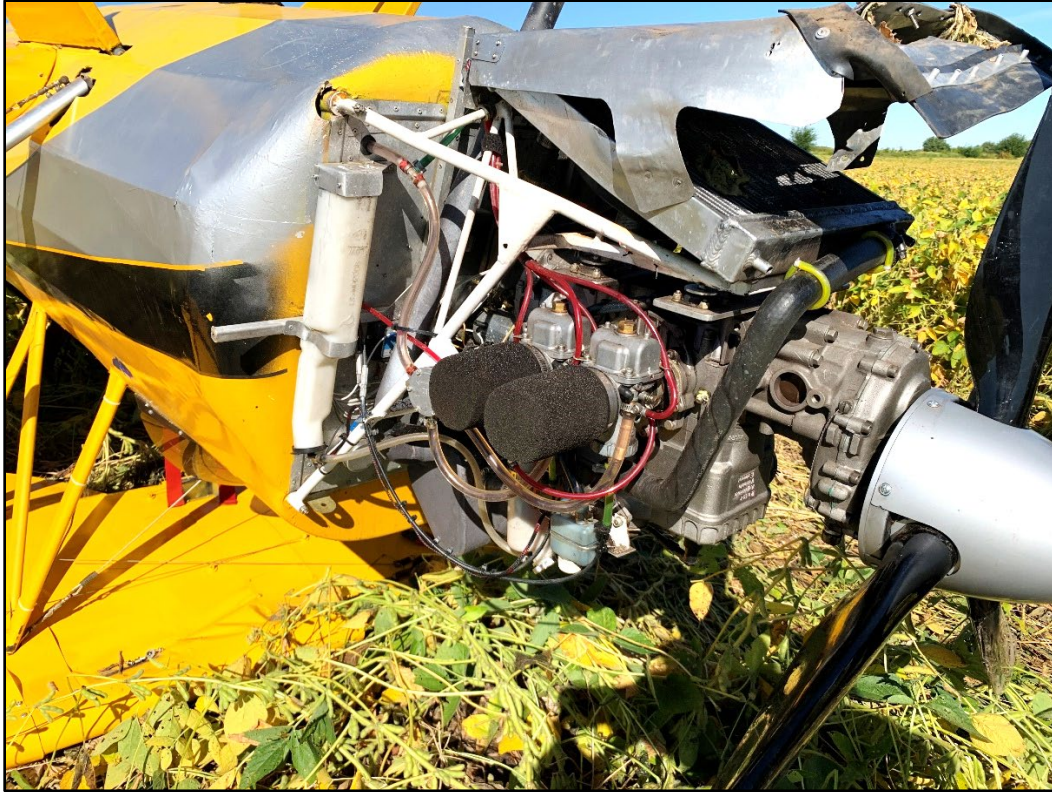
The engine remained attached to the fuselage through the engine mounts, as shown in figure 4 and figure 5. A partial teardown examination of the engine revealed that the magneto-side piston had seized in the cylinder. The piston and cylinder bore exhibited scrape marks consistent with a piston seizure, as depicted in figure 6. There was piston and ring material missing, with associated batter to the cylinder head, piston dome, and sparkplug, as depicted in figure 7. The power-takeoff piston and cylinder did not exhibit any evidence of piston seizure. Other than the magneto-side piston seizure and associated secondary damage, the engine did not exhibit any evidence of a mechanical malfunction that would prevent normal operation.

**Figure 4** - Engine, Left Side

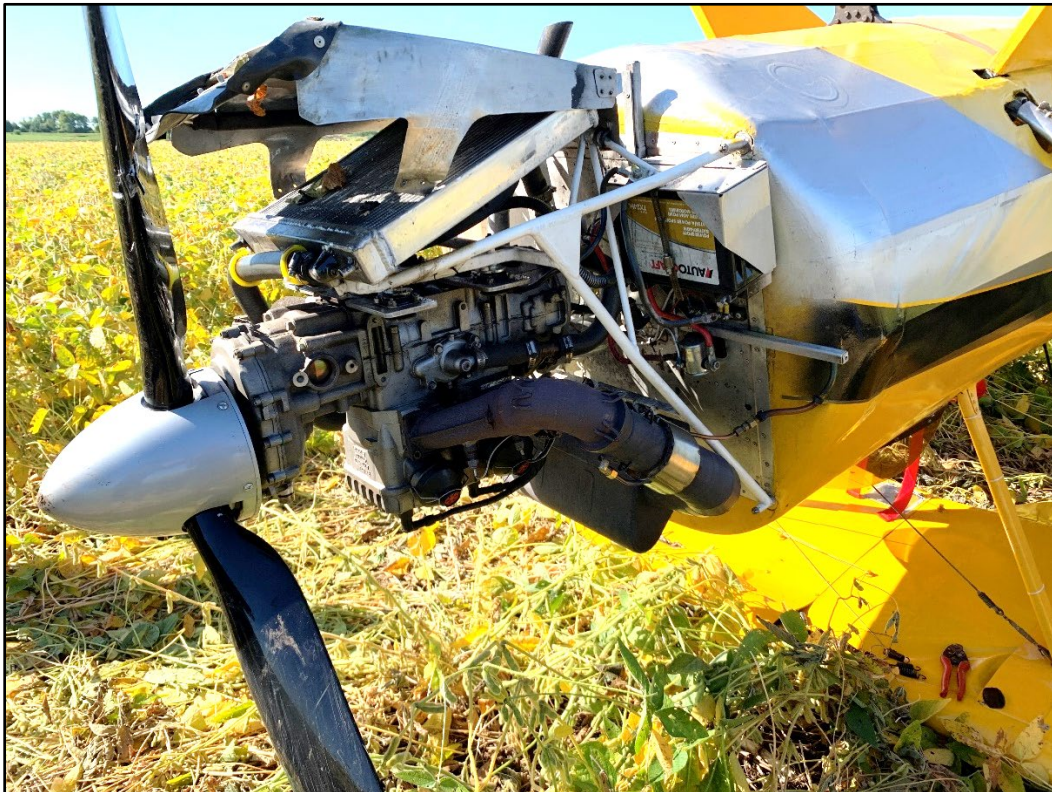
**Figure 5** - Engine, Right Side

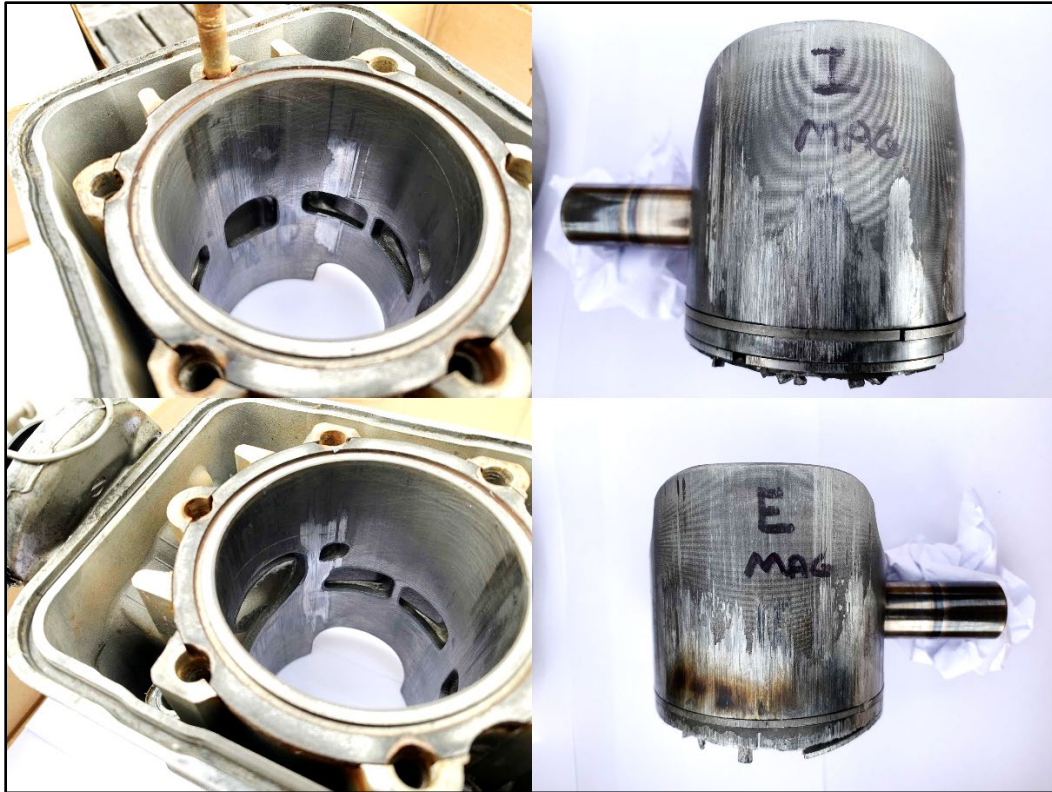
**Figure 6** - Magneto-Side Cylinder and Piston

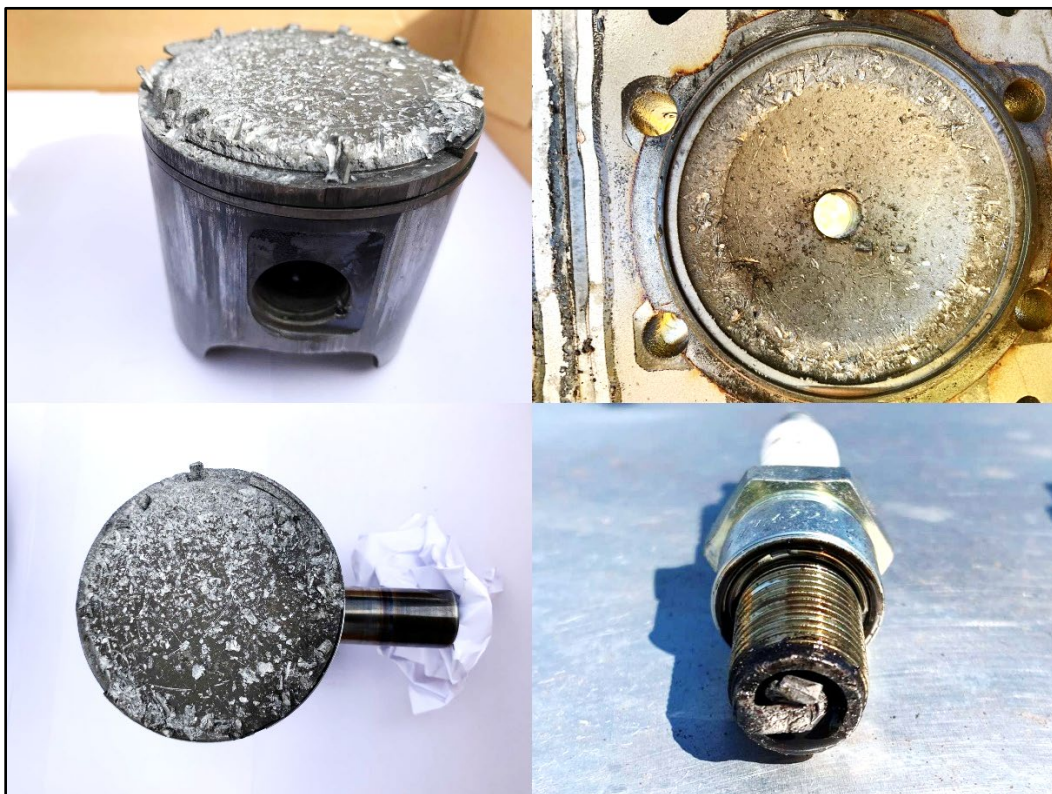
**Figure 7** - Magneto-Side Piston, Cylinder Head, and Sparkplug
