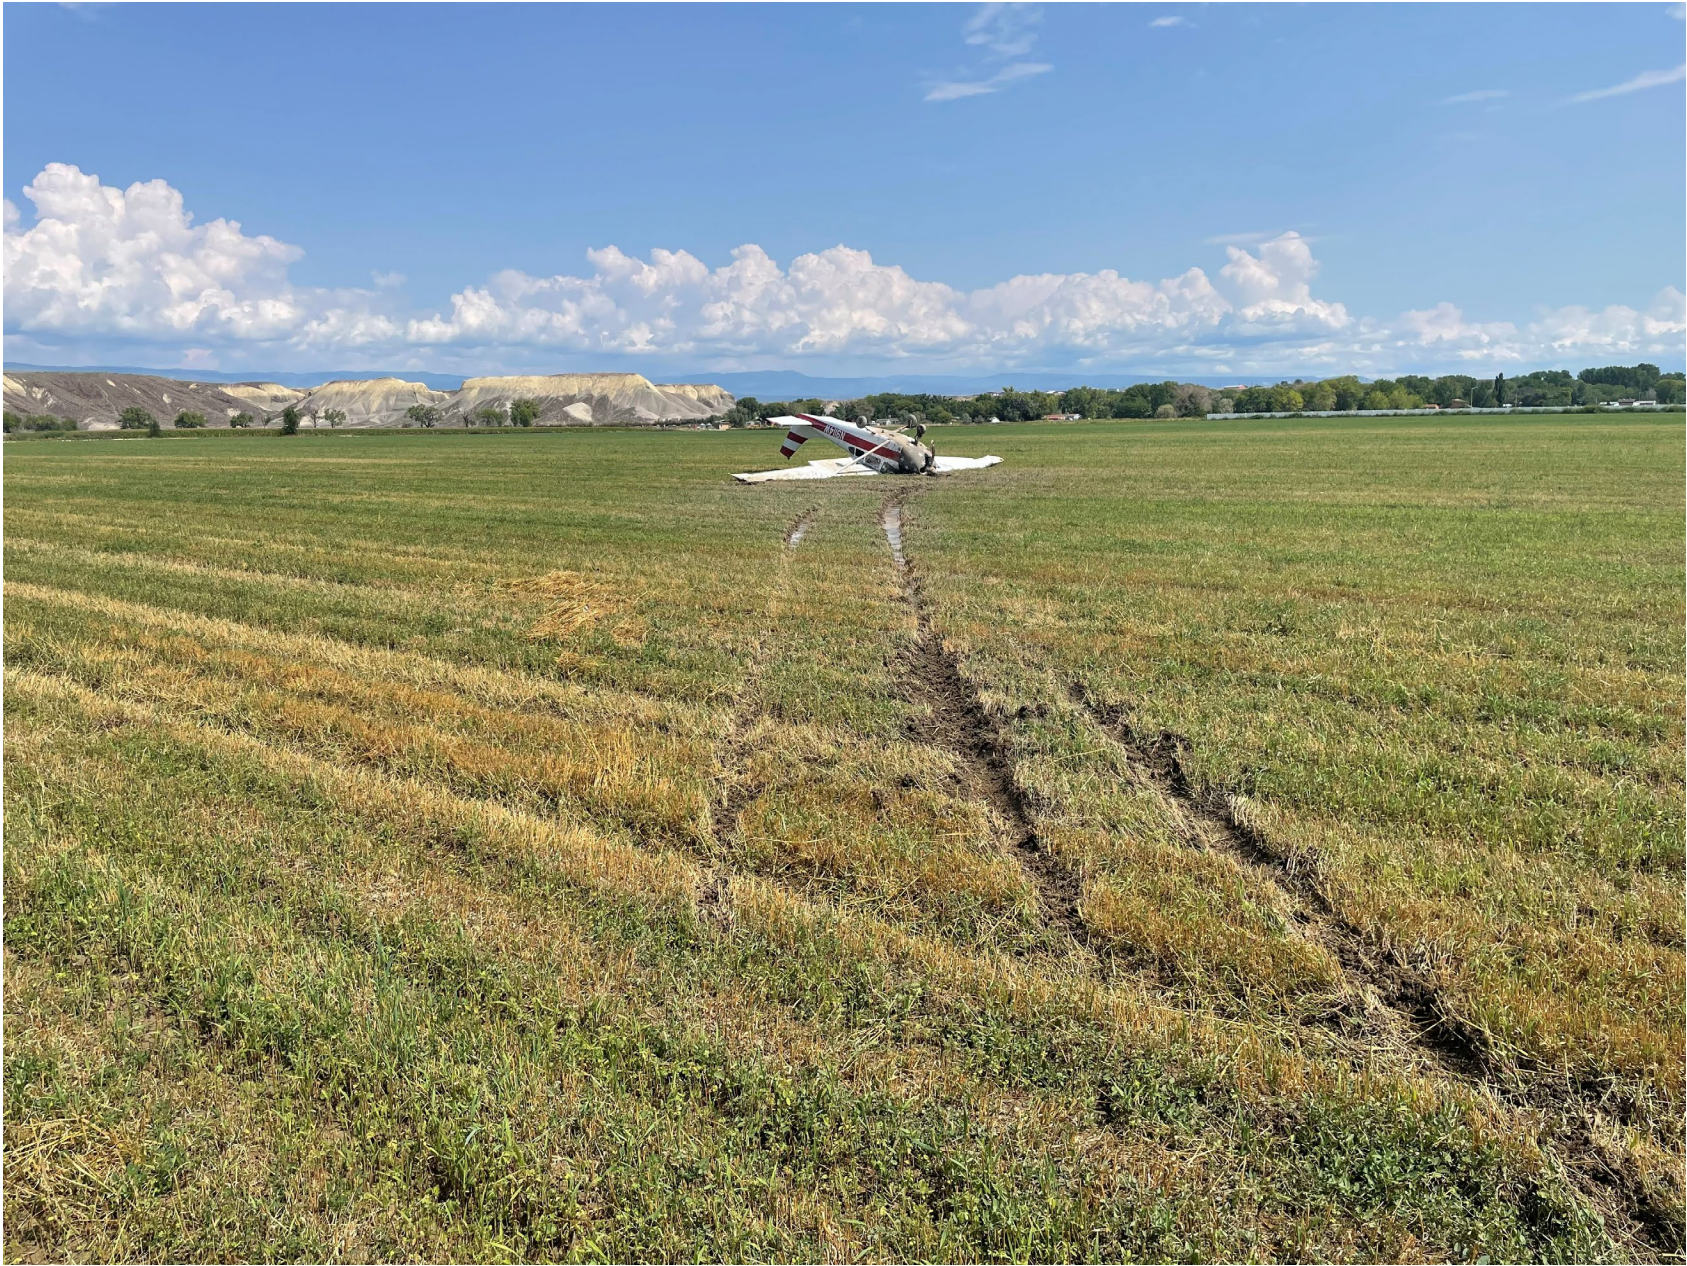
**Photo 3 – View of the main landing gear tracks in the field, just prior to where the airplane came to rest (courtesy of the operator).**

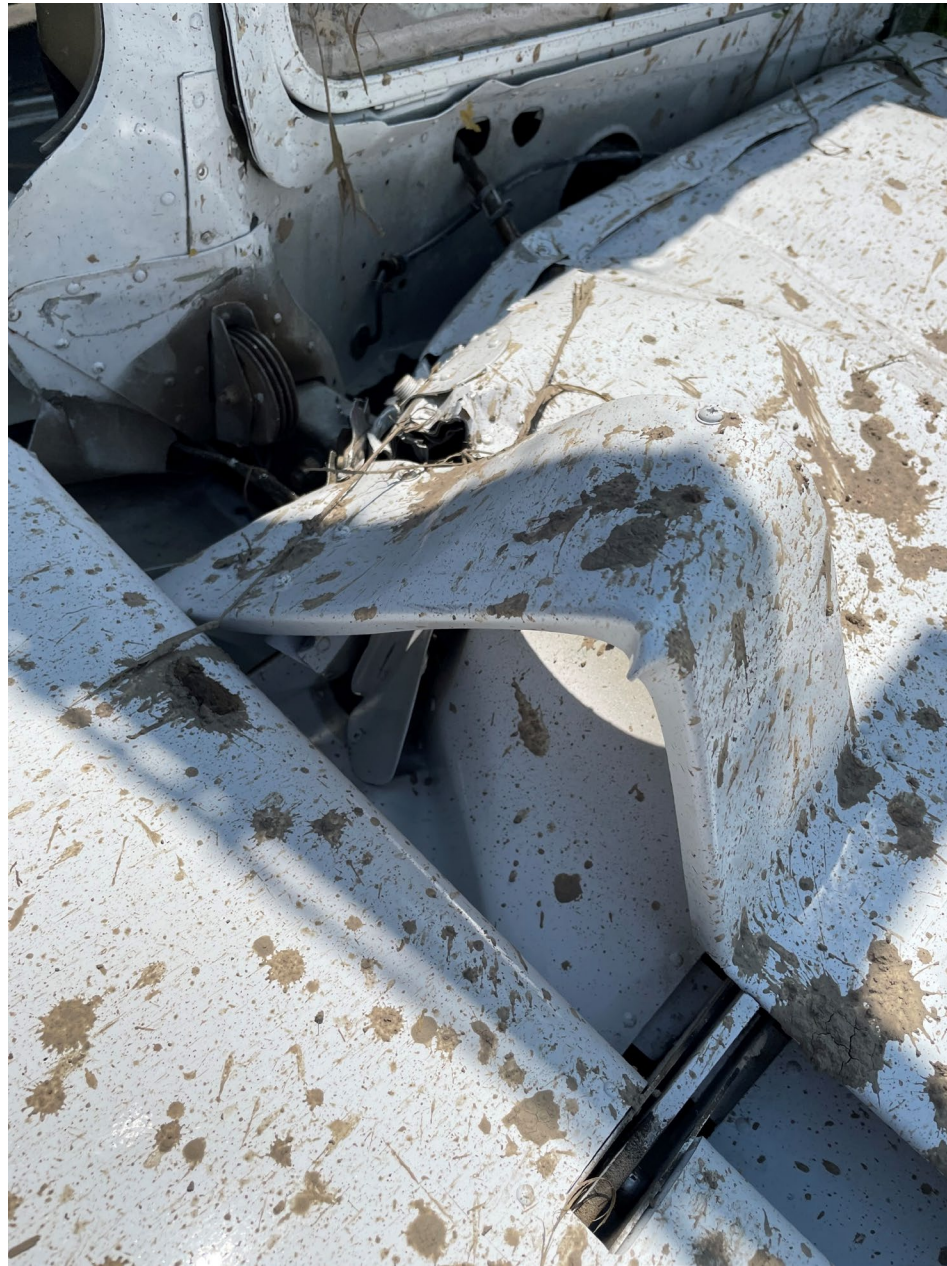
**Photo 5 – View of the substantial damage sustained to the left wing (courtesy of the operator).**

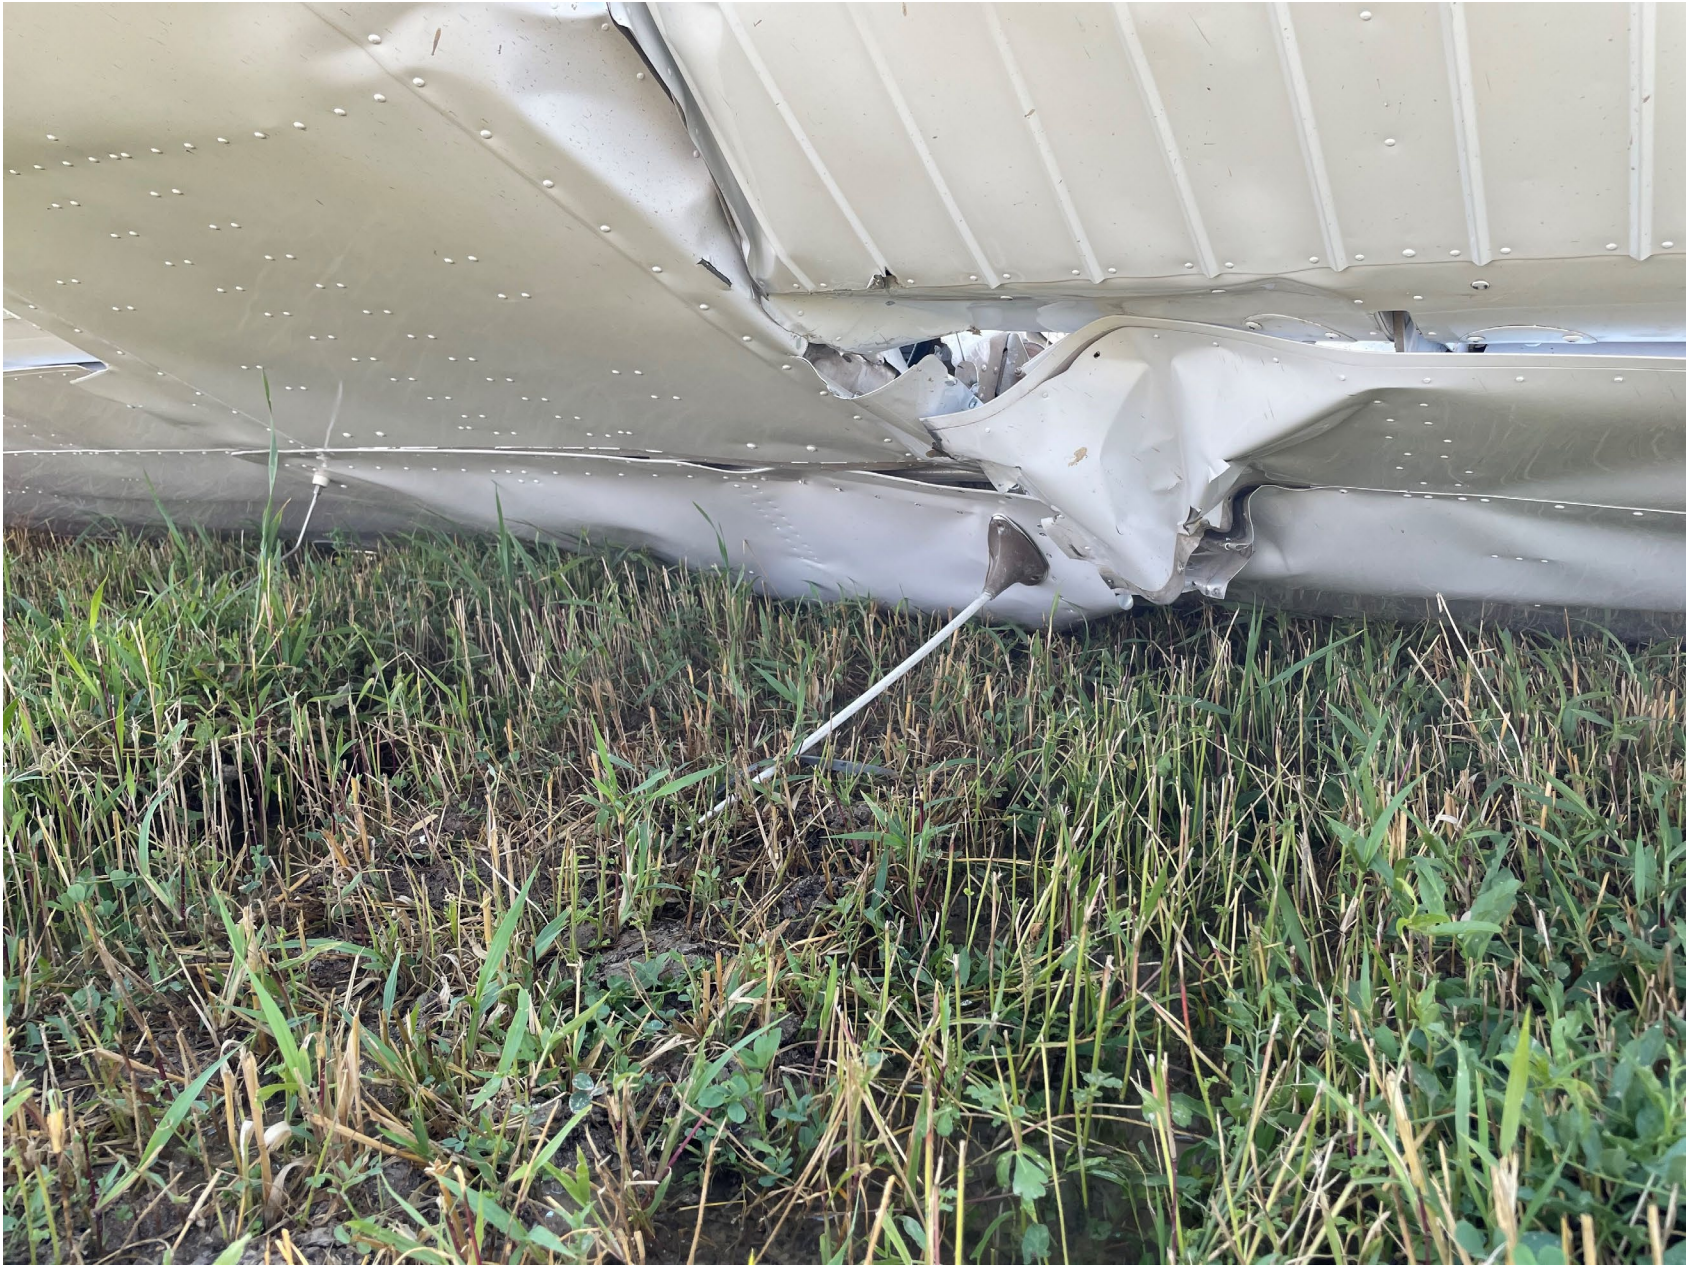
**Photo 6 – View of the substantial damage sustained to the fuselage and the left wing (courtesy of the operator).**

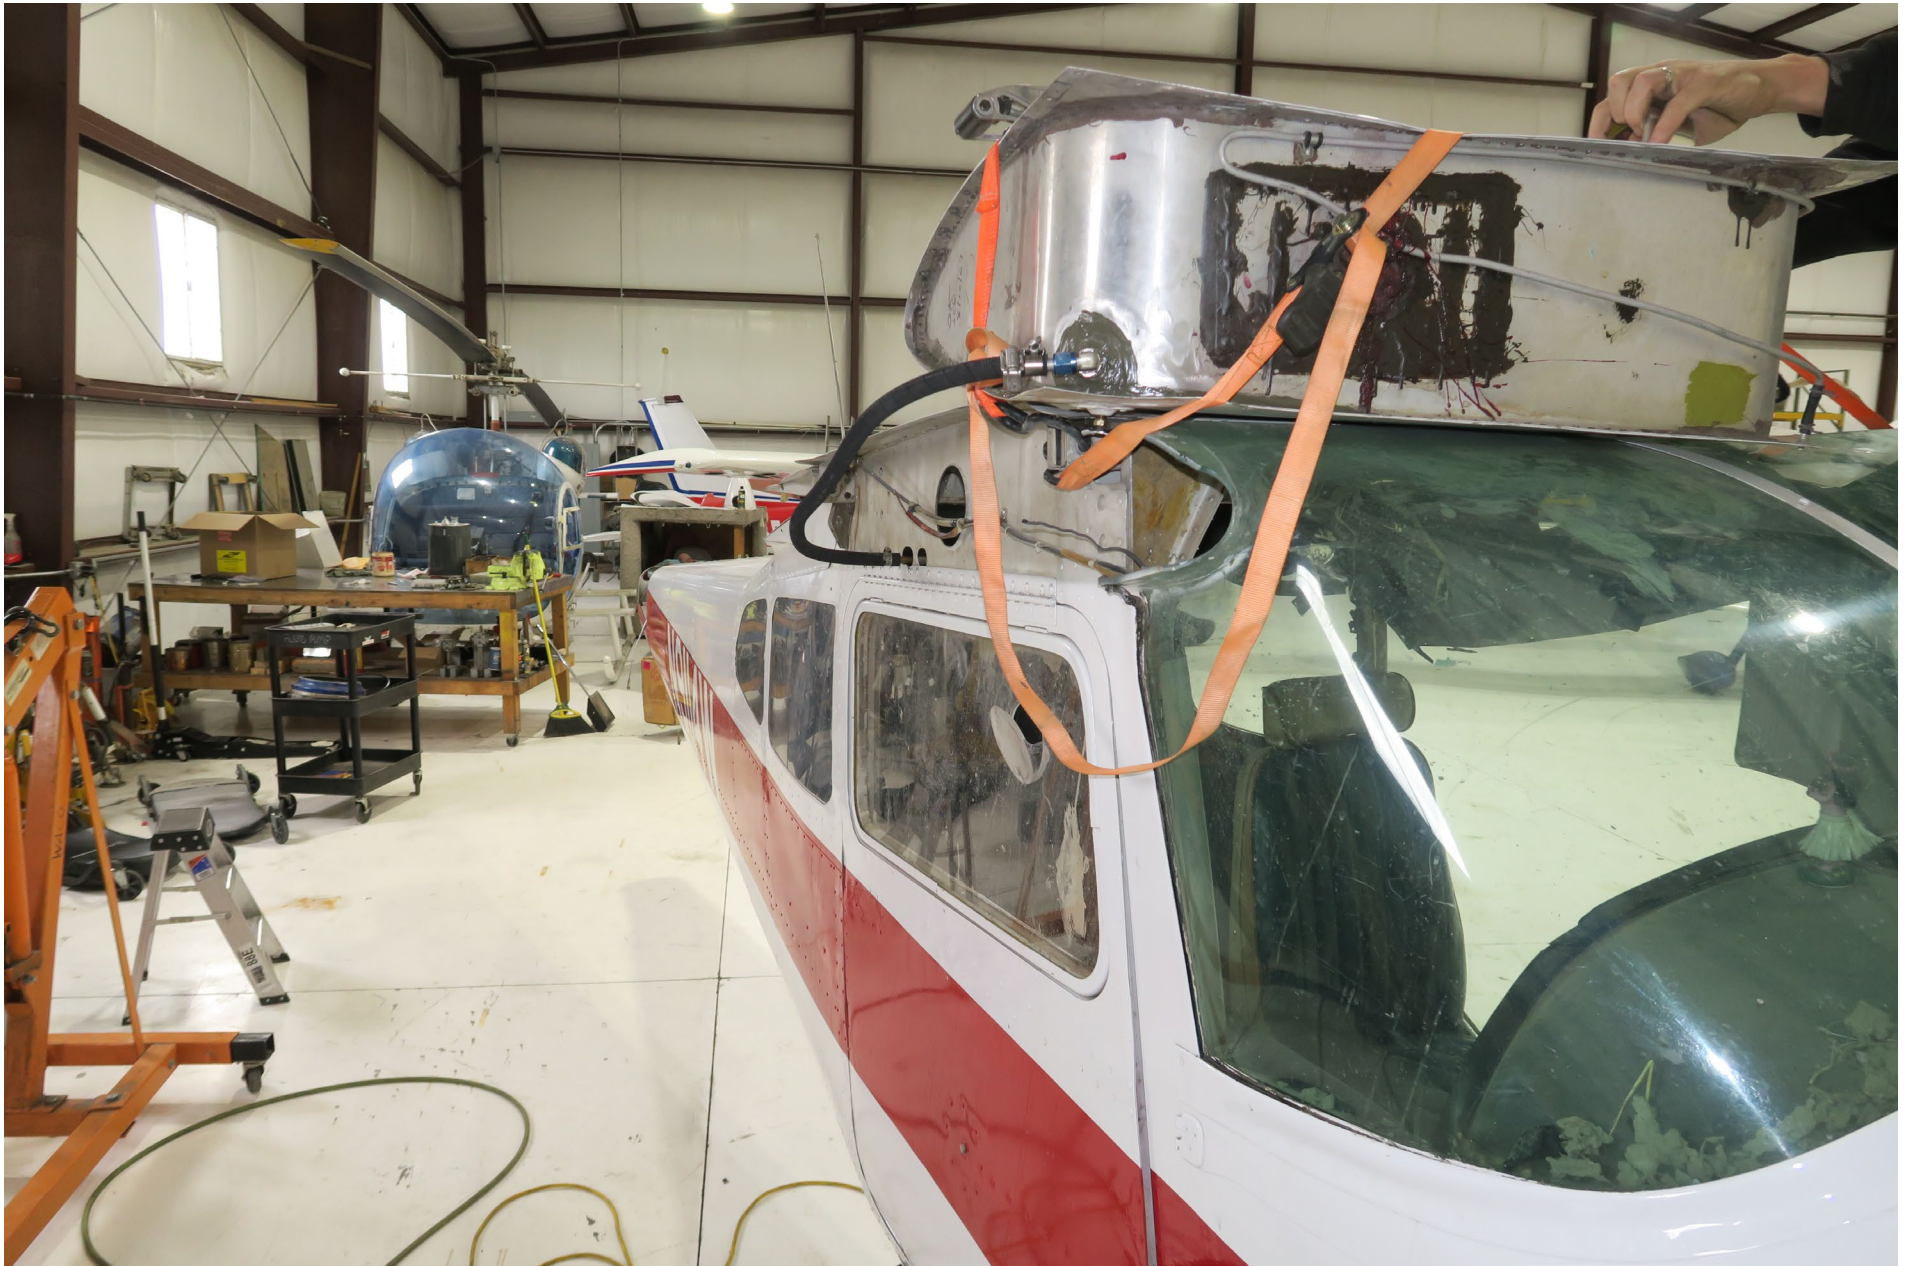
**Photo 9 – View of the fuel tank mounted on the fuselage and connected to the fuel system (courtesy of Textron Aviation).**

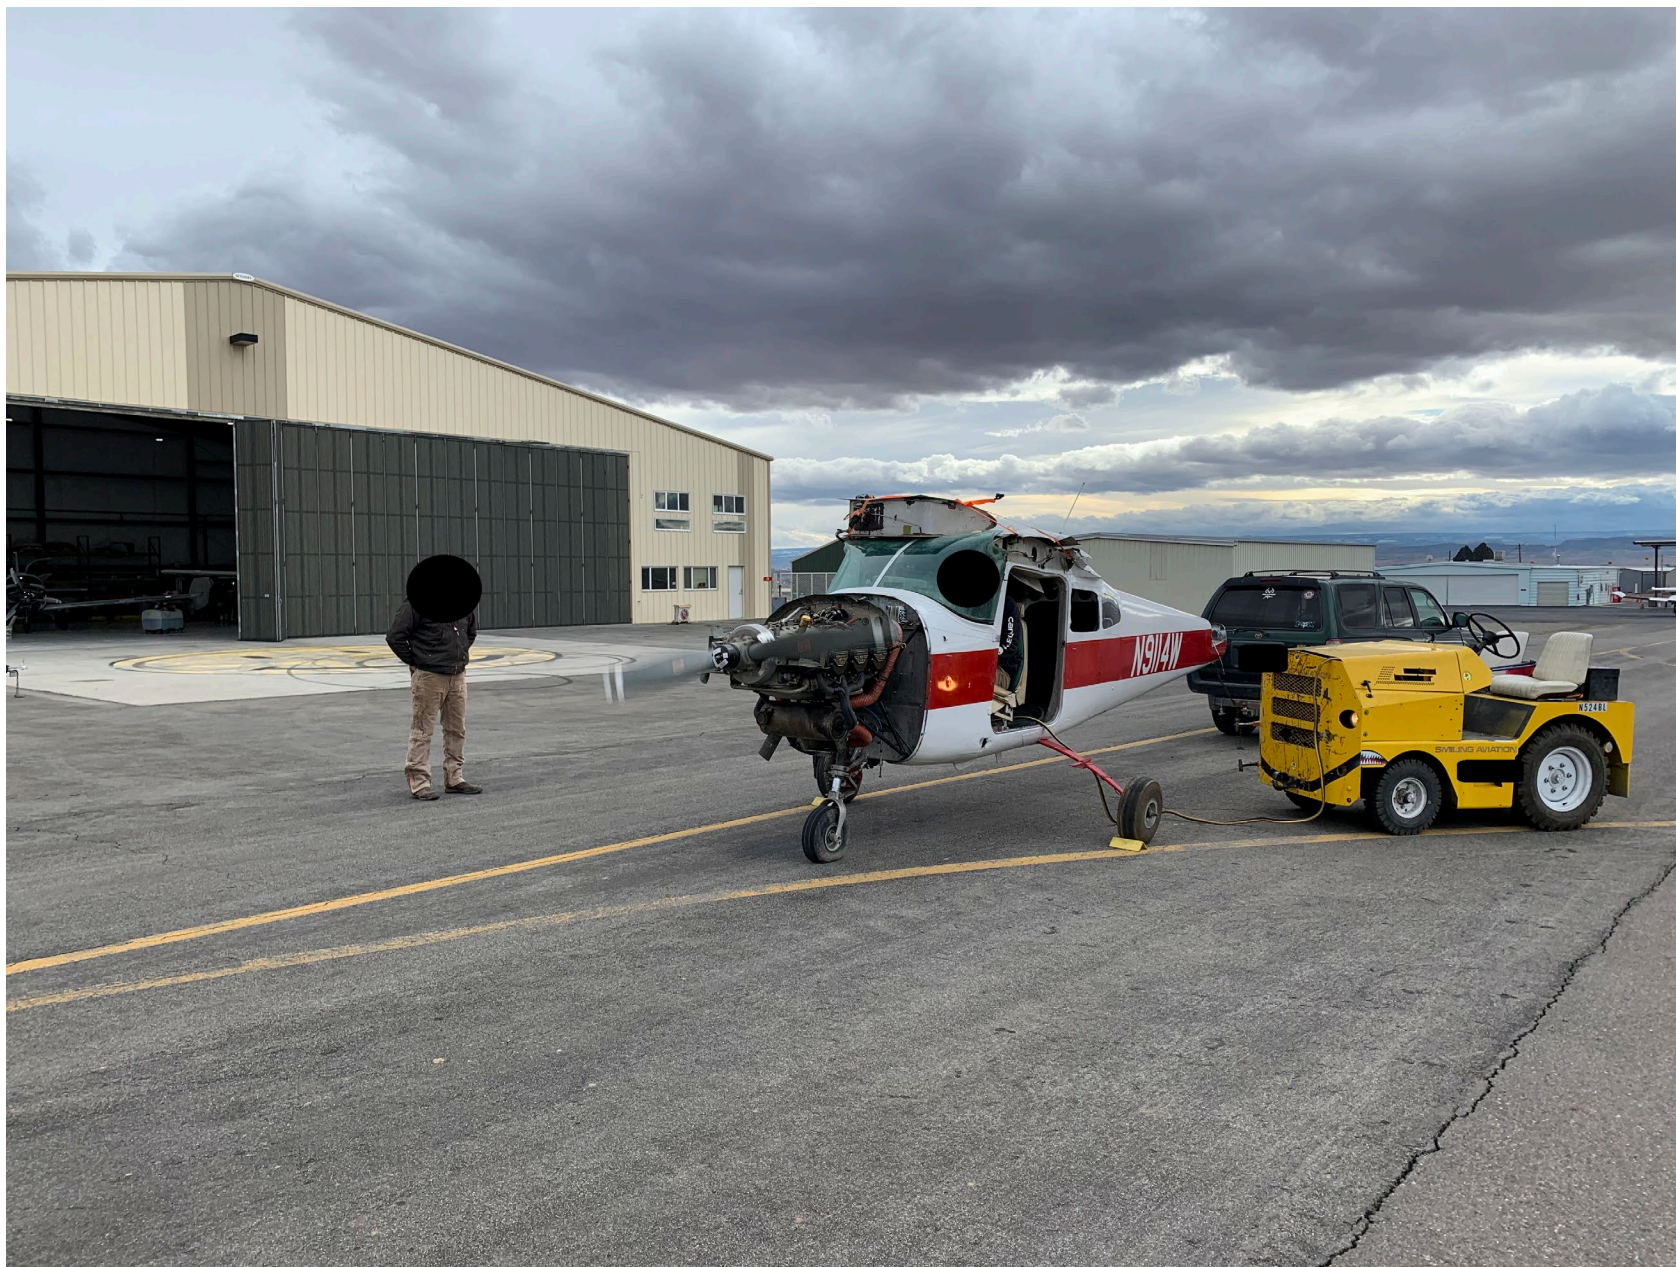
**Photo 12 – View of the engine operating during the test run.**
