# National Transportation Safety Board

CEN21LA418

## INVESTIGATION SUMMARY

Location: Magnolia, Texas  
Date: September 12, 2021  
Time: 1052 central daylight time  
Airplane: Piper PA-44-180, N740FT

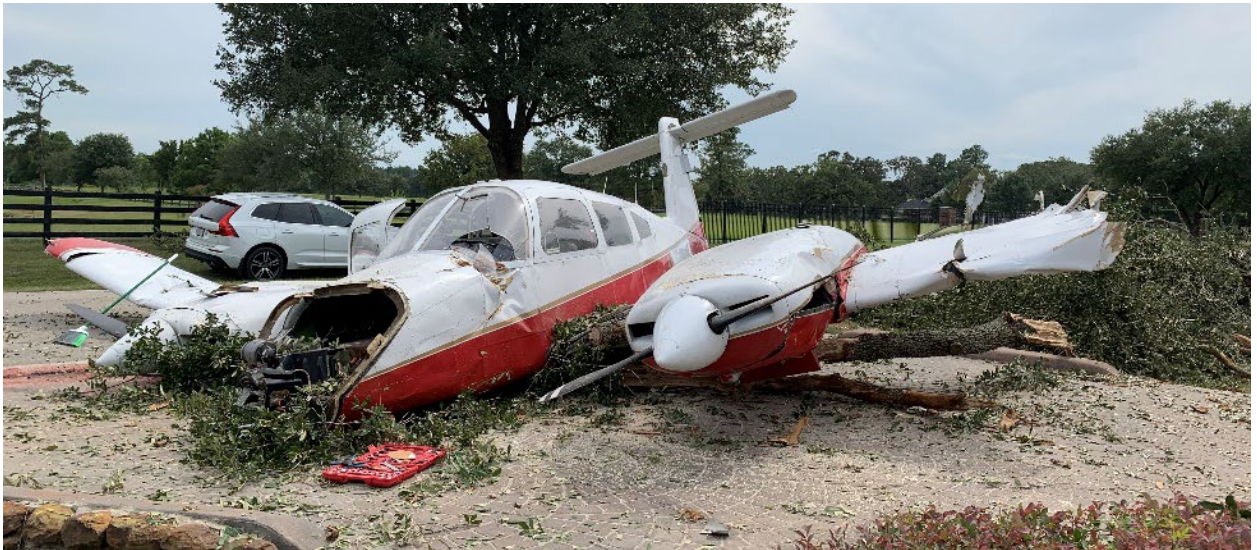
Figure 1. Front of the airplane at the accident site (Source: FAA)

The responding Federal Aviation Administration (FAA) inspector reported that the airplane sustained substantial damage to the fuselage, empennage, and both wings. The fuel tanks were not breached during the accident sequence and neither tank contained evidence of fuel.

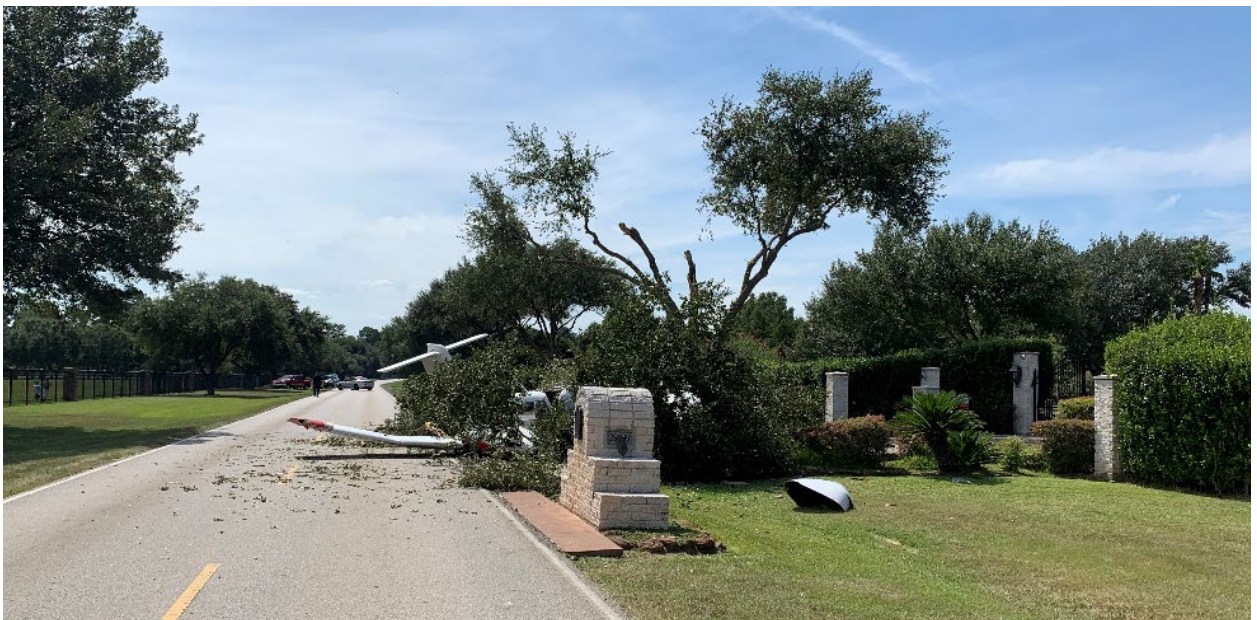
The airplane impacted trees in a residential area and came to rest on a driveway. See photos below.

Figure 2. Overall view of the accident site (Source: FAA)
