**ASW: GENERAL AVIATION ACCIDENT/INCIDENT INFORMATION**

**NTSB Investigator:** Craig Hatch
5. **Date, Time, and Location of Accident/Incident:**  
**Date:** September 12, 2021  
**Time:** 1030 local  
**Location:** [REDACTED], Magnolia, TX 030.17393 / -095.70600 (High Meadow Ranch subdivision)

6. **Make:** Piper
7. **Model:** PA-44-180
8. **Registration #:** N740FT
9. **Registered Owner:** Up and Up Aviation, LLC (Myron Hewlett)  
**Address:** [REDACTED]

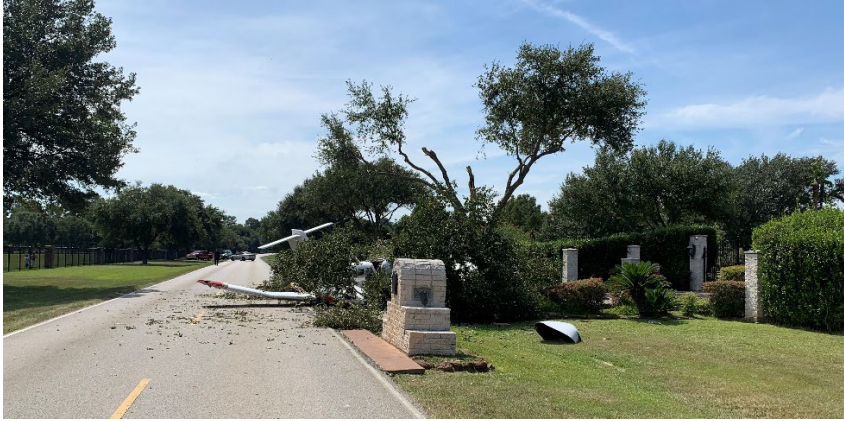
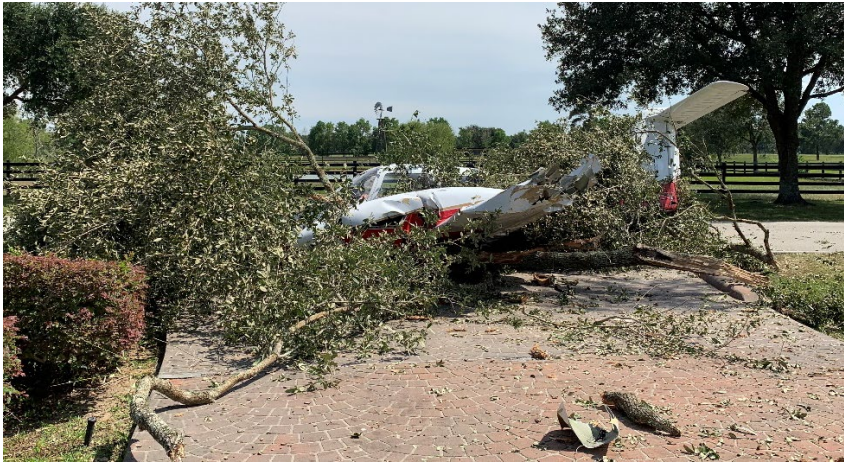
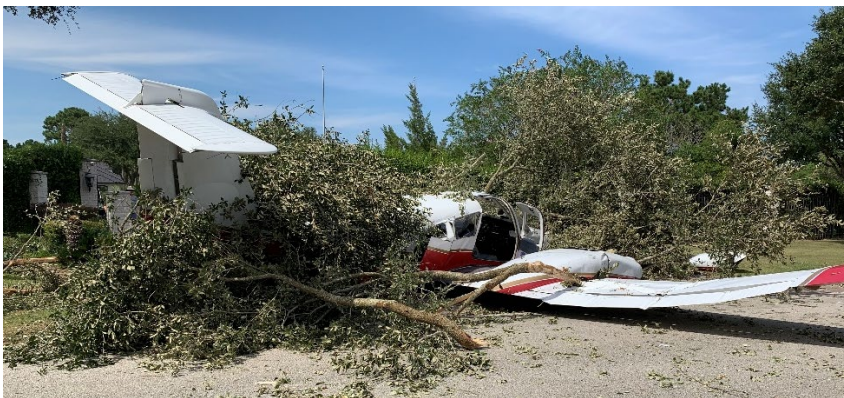
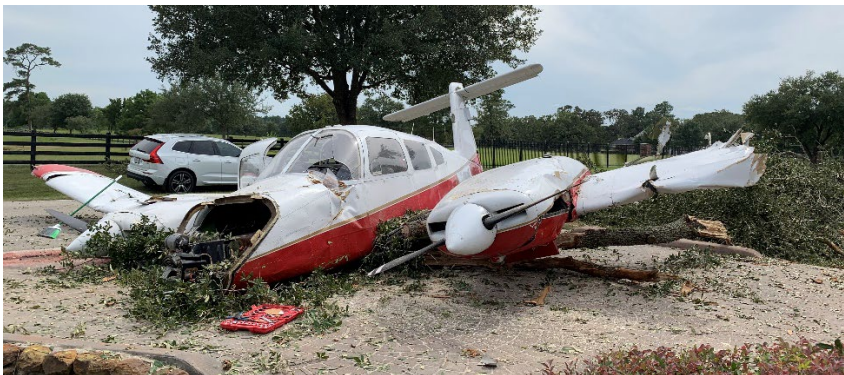
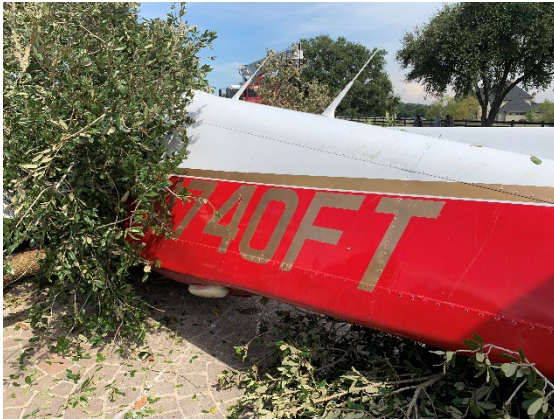
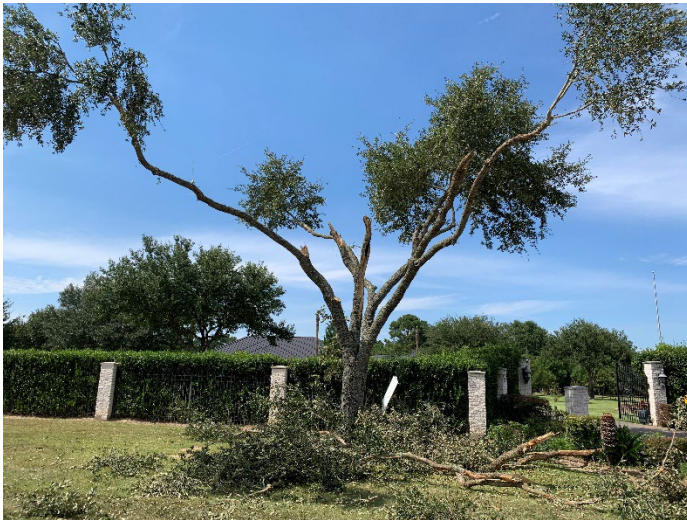
- f. Aircraft sustained significant damage and appears to be destroyed. Left main landing gear is partially extended. Right main landing gear and nose landing gear are not visible. Landing gear selector is in the "Up" position. The left fuel tank was inspected for integrity and the presence of fuel. The left fuel tank appears to be intact with no fuel inside the tank. The right fuel tank was inspected for integrity and the presence of fuel. The right fuel tank appears to be intact with no fuel inside the tank. The two propeller blades on the left engine are feathered with no visible damage. The two propeller blades on the right engine are feathered with no visible damage to one propeller blade and a bend at the tip of the other propeller blade. There is some oil leakage from the bottom of the right engine. No visible leakage of fluids from left engine. While on scene, owner painted over N-number with white paint. Authorization granted to remove aircraft.
