# NATIONAL TRANSPORTATION SAFETY BOARD

MATERIALS LABORATORY FACTUAL REPORT

Report No. 22-046

Place : East Sparta, Ohio  
Date : September 28, 2021  
Vehicle : Cessna T210N, N1925U  
NTSB No. : CEN21LA472  
Investigator : Andrew Todd Fox, ASI – CEN

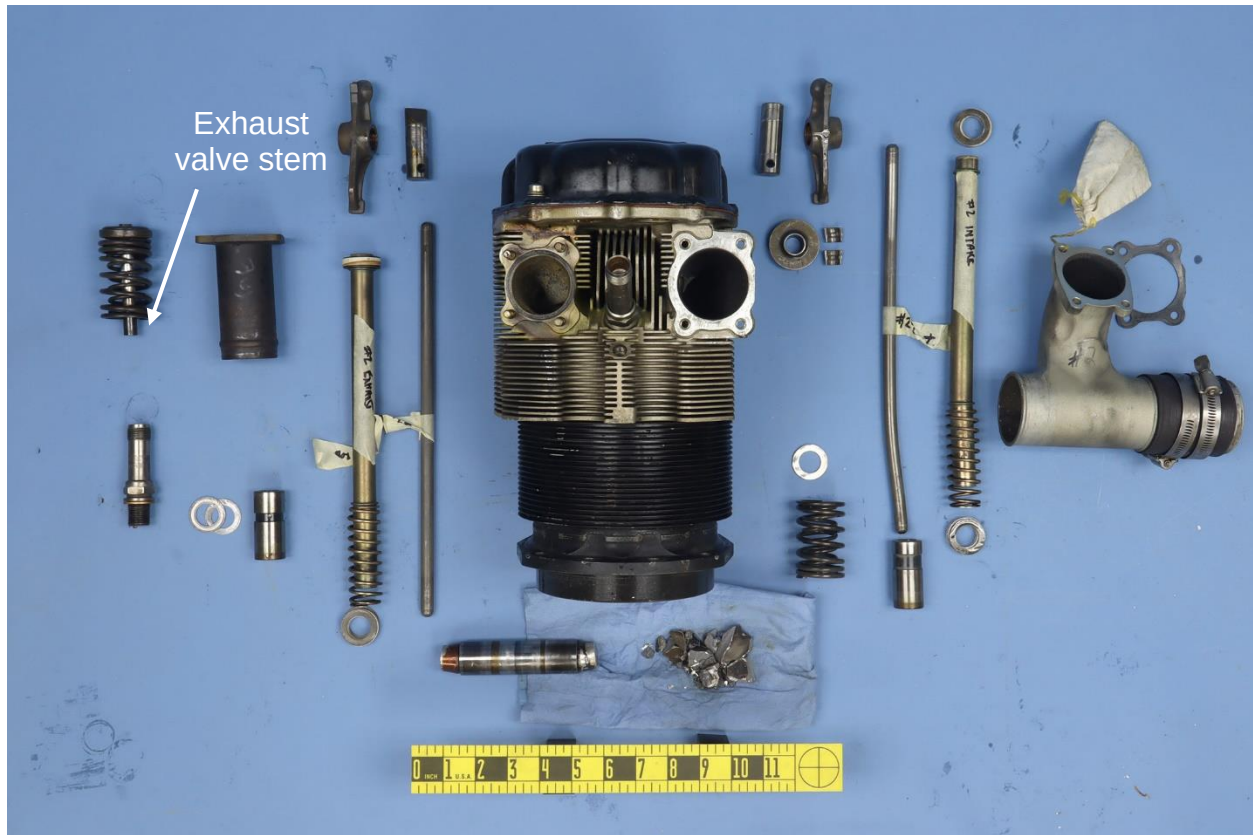
Components from and ancillary to a Continental Motors TSIO-520-R11B Number 2 cylinder assembly were submitted to the NTSB Materials Laboratory for examination as shown in figure 1. Components included the cylinder, intake and exhaust pushrod assemblies, lifters, rocker arm assemblies, valve and valve spring assemblies, manifold flange fittings, piston pieces, wrist pin, and spark plugs. The exhaust valve had fractured through the stem as indicated in the figure.

The cylinder's rocker box region, shown in figure 3, exhibited heat signatures (dark brown surfaces) around the exhaust valve guide and exhaust valve rocker arm shaft bosses. The intake valve stem was visibly bent, as was the intake valve pushrod, shown in figure 1.

**Figure 1:** Number 2 cylinder assembly and ancillary components, as received. Exhaust-related components are to the left of the cylinder and intake-related components are to the right of the cylinder.

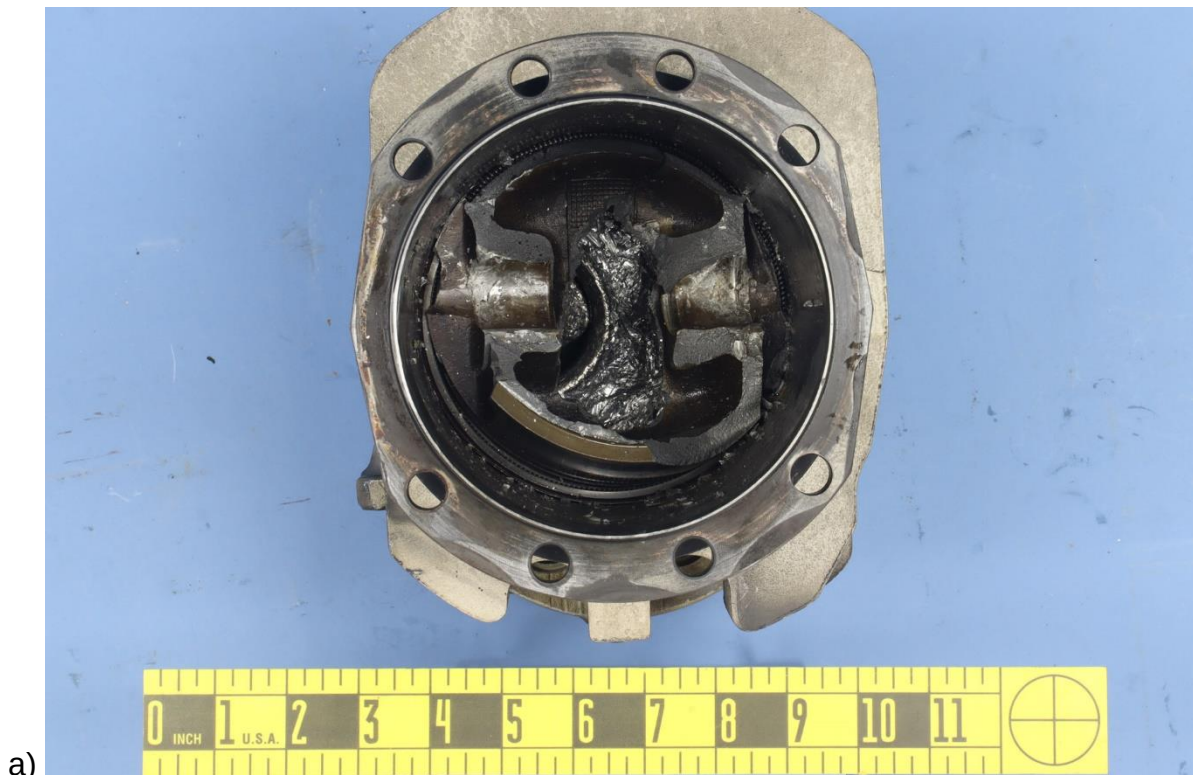
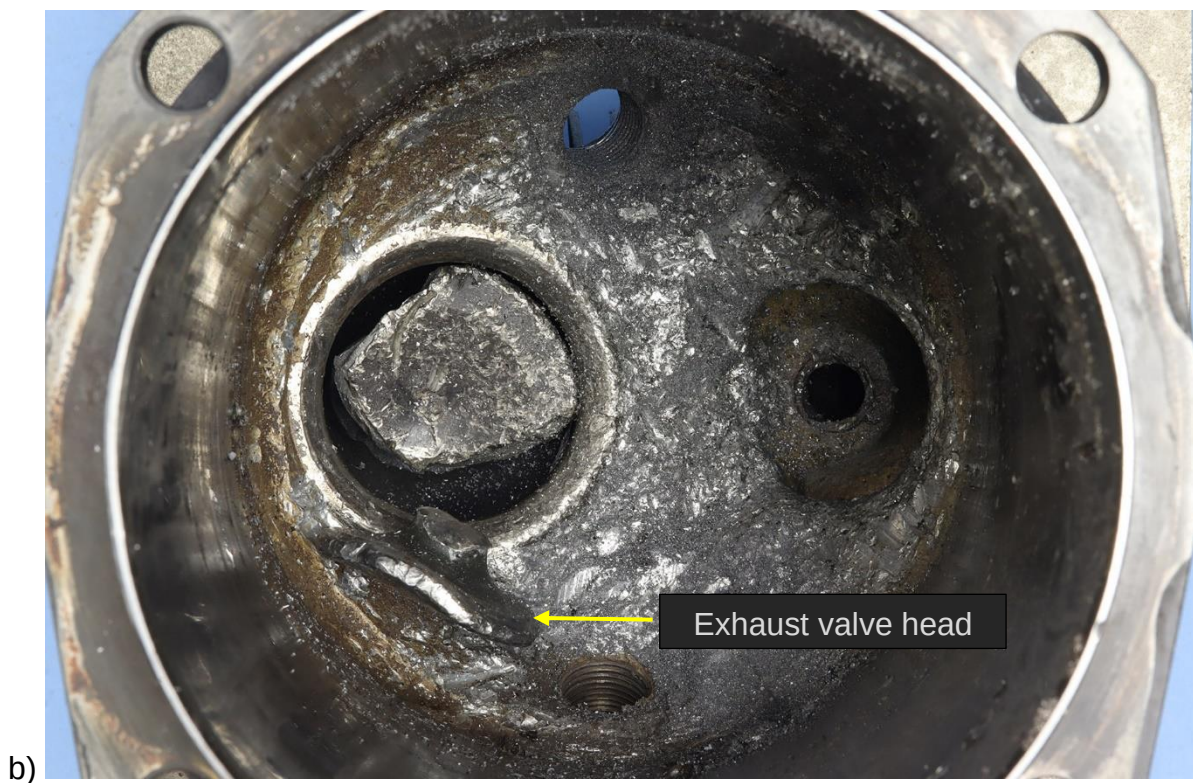
The piston was fractured into multiple pieces. The skirt had separated from the crown, leaving the crown portion lodged in the cylinder barrel with a hole in its center, as shown in figure 2a. The remnant piston piece was extract from the barrel revealing the inside surface of the cylinder head, as shown in figure 2b. The head of the exhaust valve was situated on edge, embedded in the cylinder head adjacent to the intake valve seat, as indicated in the figure. The intake valve's head was fractured in multiple locations and was pushed through the valve seat. The exhaust valve seat was missing and much of the cylinder head material around the exhaust outlet exhibited erosion and impact damage, leaving only a small remaining segment of the valve seat's counterbored recess in the cylinder head, as shown in figure 2c.

**Figure 2:** a) View of number 2 cylinder combustion chamber with seized piston fragment lodged in the barrel; b) image of the cylinder head after removal of the piston fragment revealing the exhaust valve, damage to the intake valve, and damage to the cylinder head; and

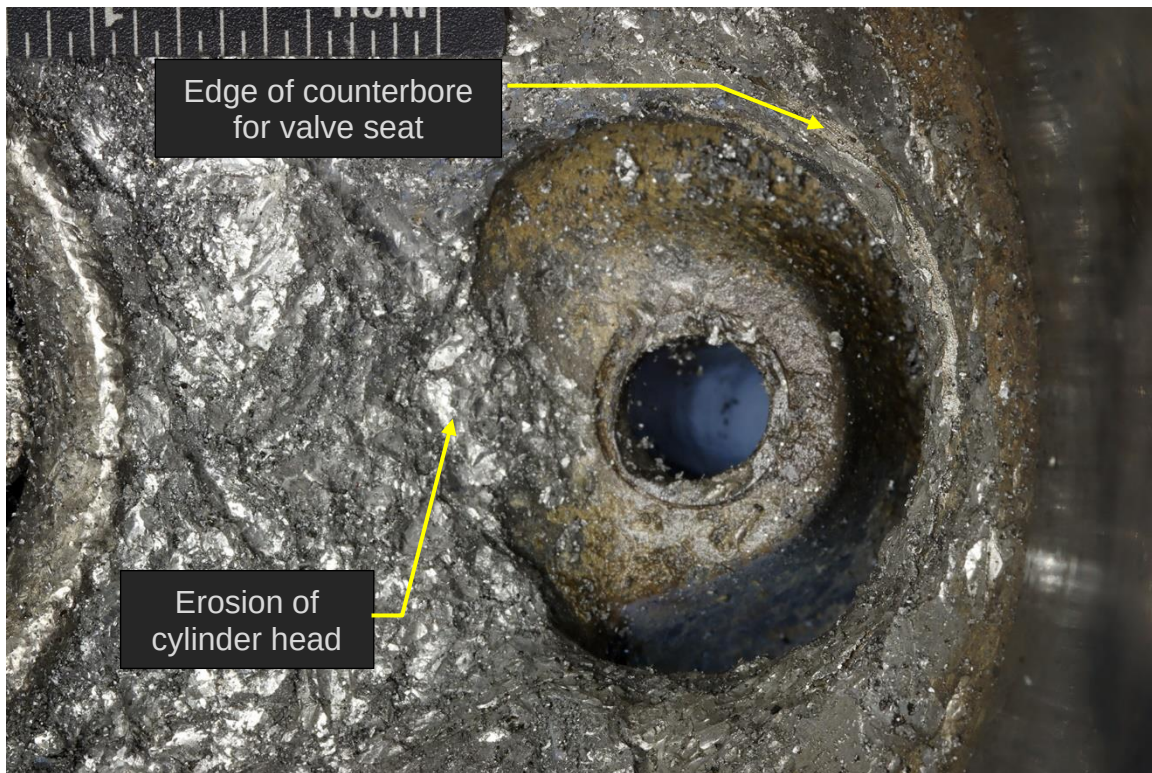
**Figure 2 (cont.):** c) Higher magnification image of the exhaust valve region highlighting the missing valve seat and eroded and damaged cylinder head material.

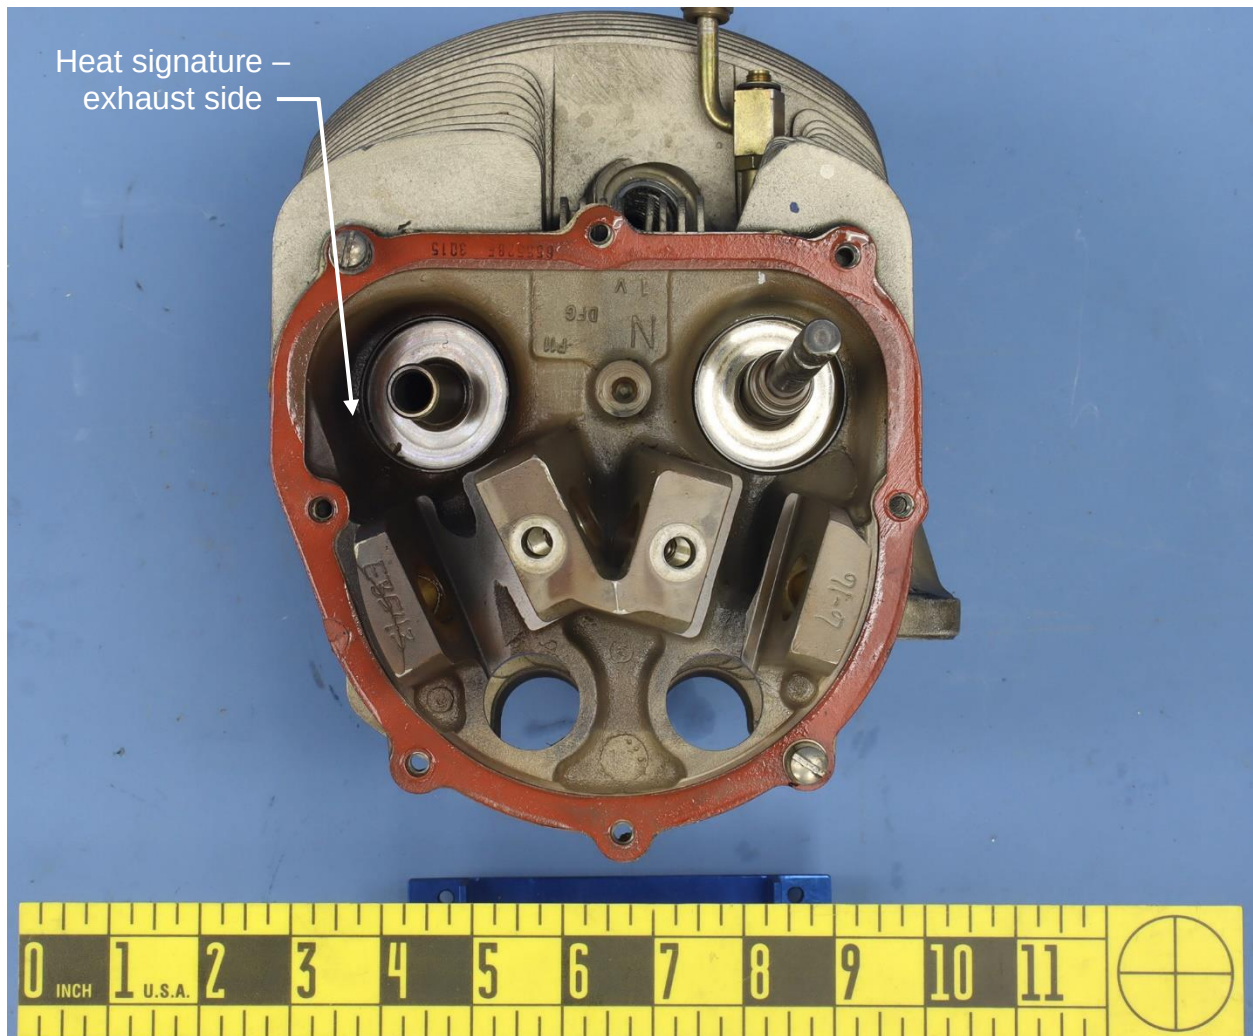
**Figure 3:** View of the number 2 cylinder rocker box region showing a heat signature around the exhaust valve guide and exhaust valve rocker shaft bosses.

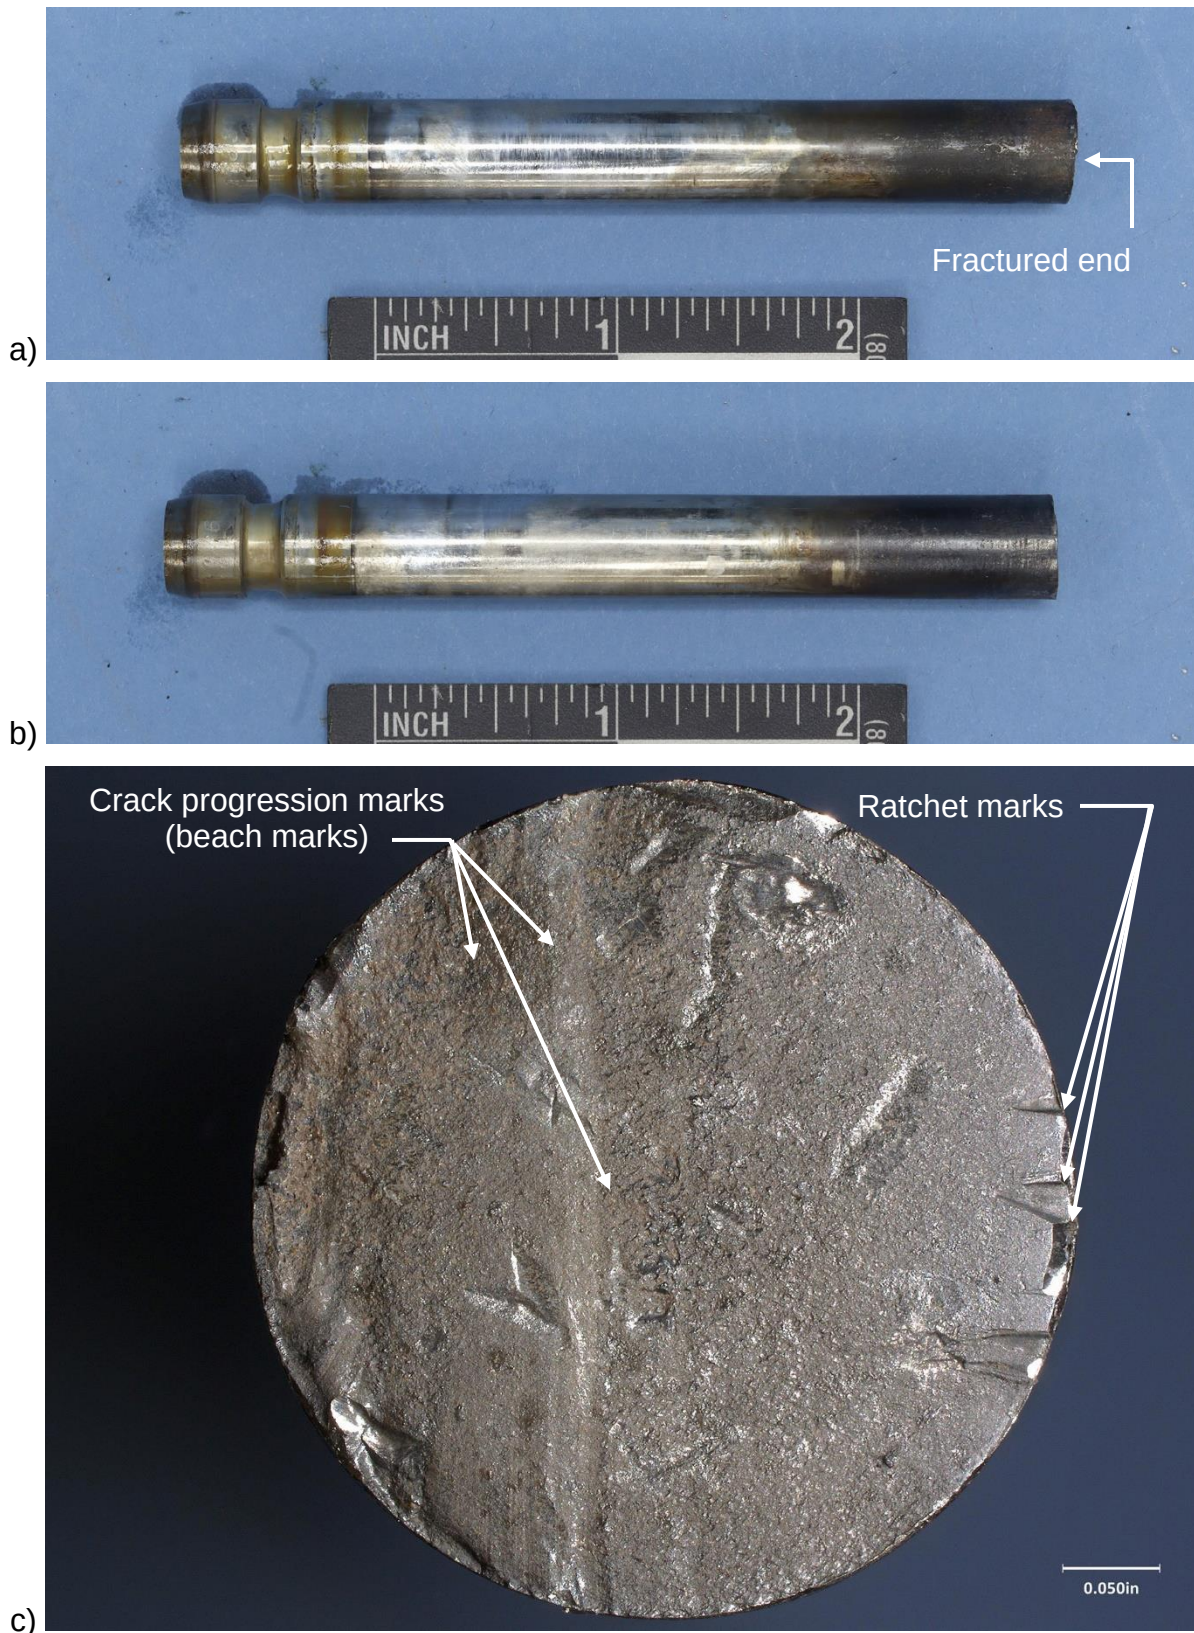
The exhaust valve stem and head pieces are shown in figures 4 and 5, respectively. The stem's surface, two views of which are shown in figures 4a and 4b, exhibited a typical appearance for an in-service exhaust valve, with a polished appearance mid-length and a black appearance from oxidation and/or deposits near the fractured end. The oxidized region of the stem was examined for any visually apparent material loss or pitting but none was found. The fracture surface on the stem piece, shown in figure 4c, exhibited a flat appearance, ratchet marks at one location along the edge, and crack progression marks on the fracture surface. The features were consistent with a fatigue fracture starting along the edge at the location of the ratchet marks. The origin was examined with the aid of a stereomicroscope and was found to have suffered post-separation impact damage. The end face of the stem's outboard tip, shown in figure 4d, was examined for any notable nonuniform wear patterns or pitting, but none was found. Two keys were present that formed a collar around the stem and located it within the upper spring retainer. Each key exhibited a deformed spot along the upper edge, the two spots being approximately 180° apart from one another but there were no other indications of deformation or wear of the keys. The tip of the rocker arm, shown in figure 4e, exhibited an asymmetric contact patch. The inboard side (biased towards the midline of the cylinder) exhibited a rubbed appearance while the outboard side (biased toward the outer cylinder wall) exhibited a matte appearance.

**Figure 4:** Images of the number 2 exhaust valve stem; a) one side of the stem; b) the other side of the stem; c) the stem fracture surface;

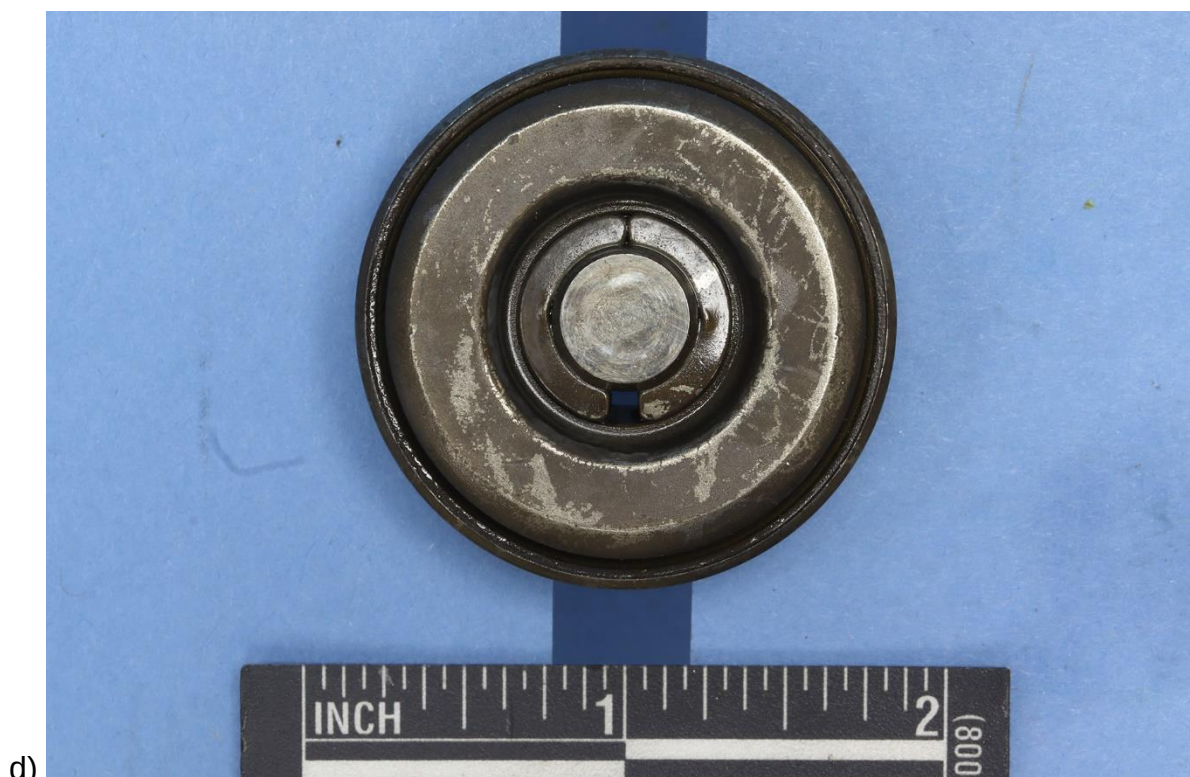
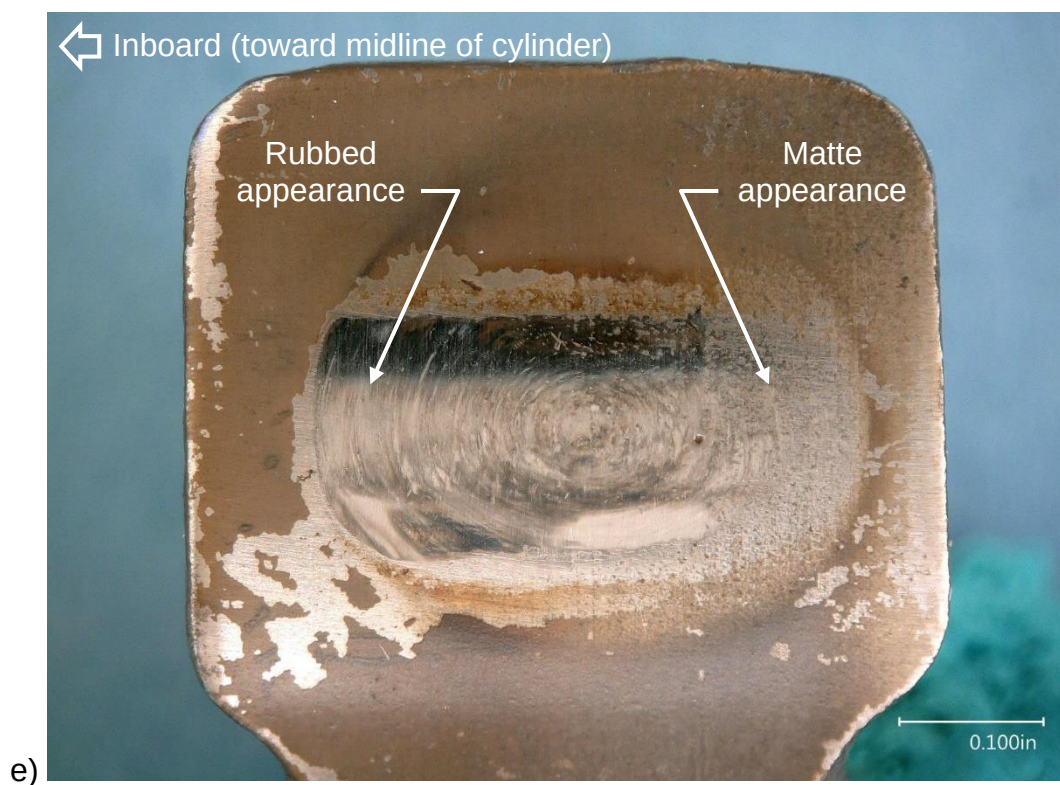
**Figure 4 (cont.):** d) image of the tip of the stem before removing the upper spring retainer and keys; and e) the tip of the rocker arm showing an asymmetrical contact patch.

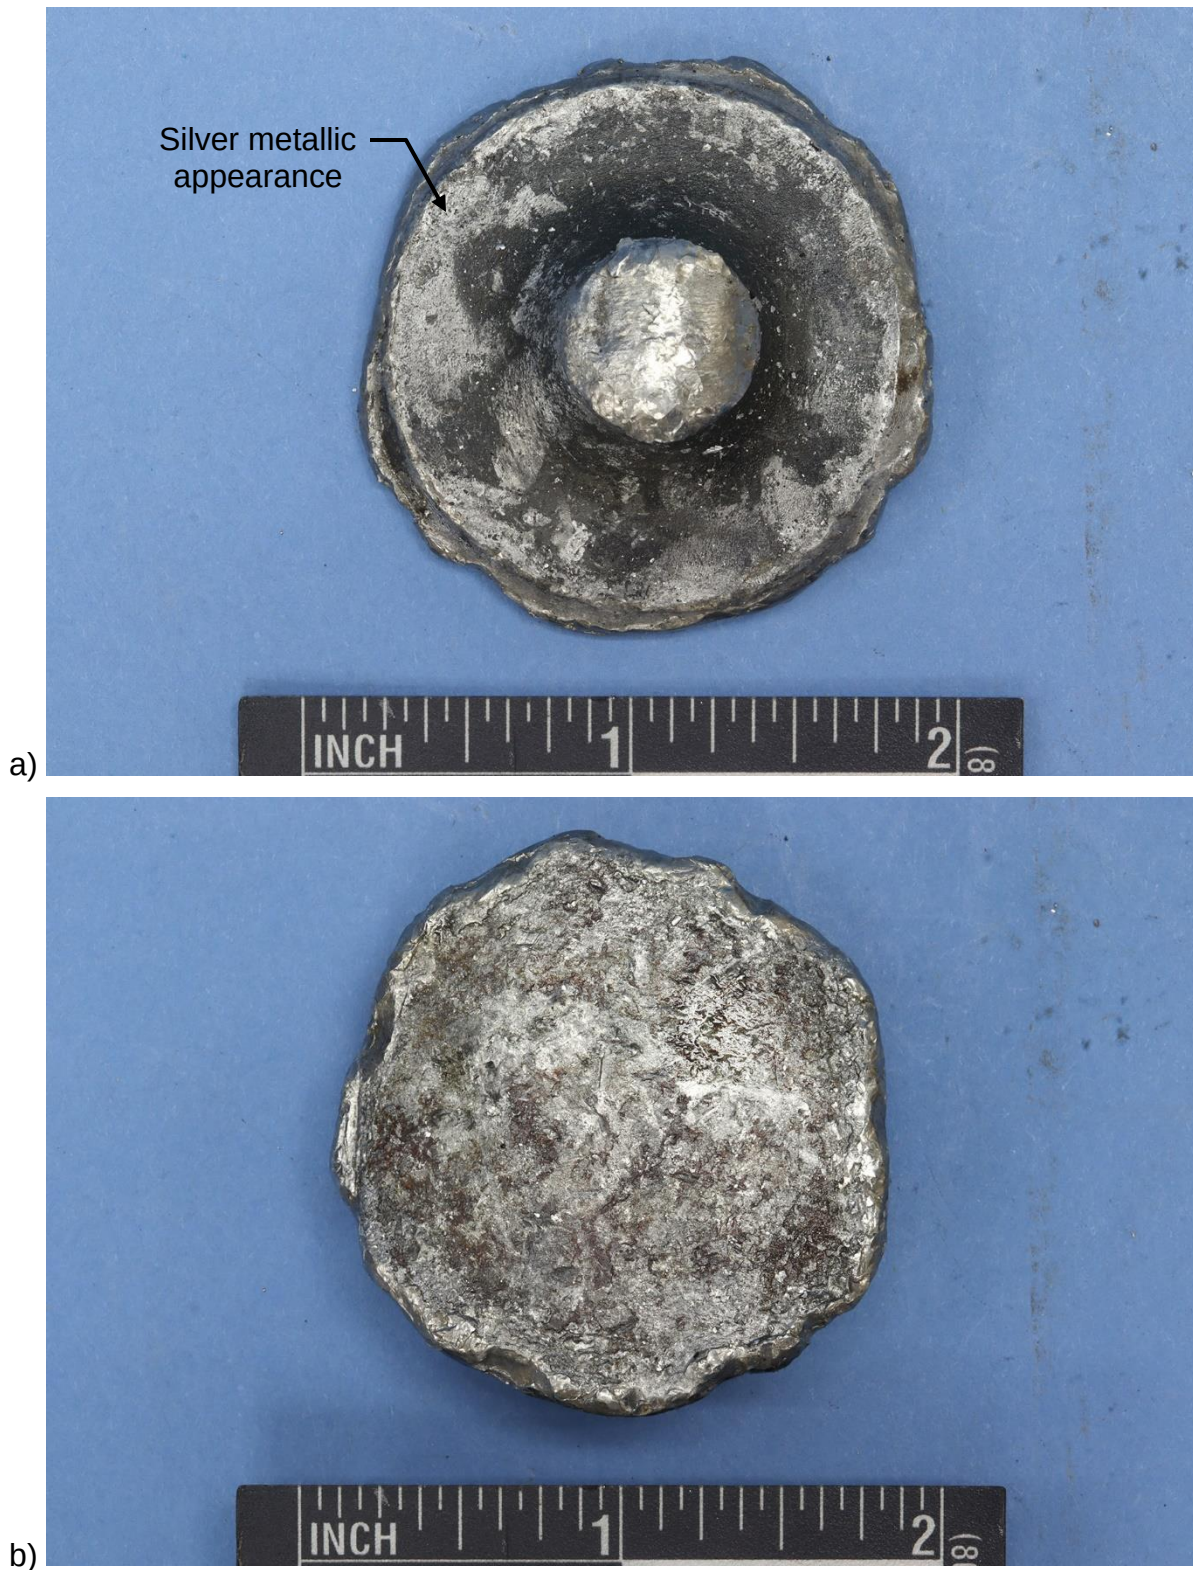
The valve head, shown in figures 5a and 5b, exhibited damage from multiple impacts. The fracture at the fillet to stem transition was smeared and featureless and the edge of the valve head was deformed and chipped. Portions of the valve head's fillet region (figure 5a) exhibited a silver metallic deposit. The composition of the deposit was examined using a scanning electron microscope (SEM) equipped with an energy-dispersive X-ray spectrometer (EDS). The spectrum, shown in figure 5c, exhibited primarily nickel (Ni), iron (Fe), chromium (Cr), and aluminum (Al).

**Figure 5:** a) Image of the valve head fillet region and smeared fracture at the fillet to stem transition; b) image of the combustion chamber-facing side of the head; and

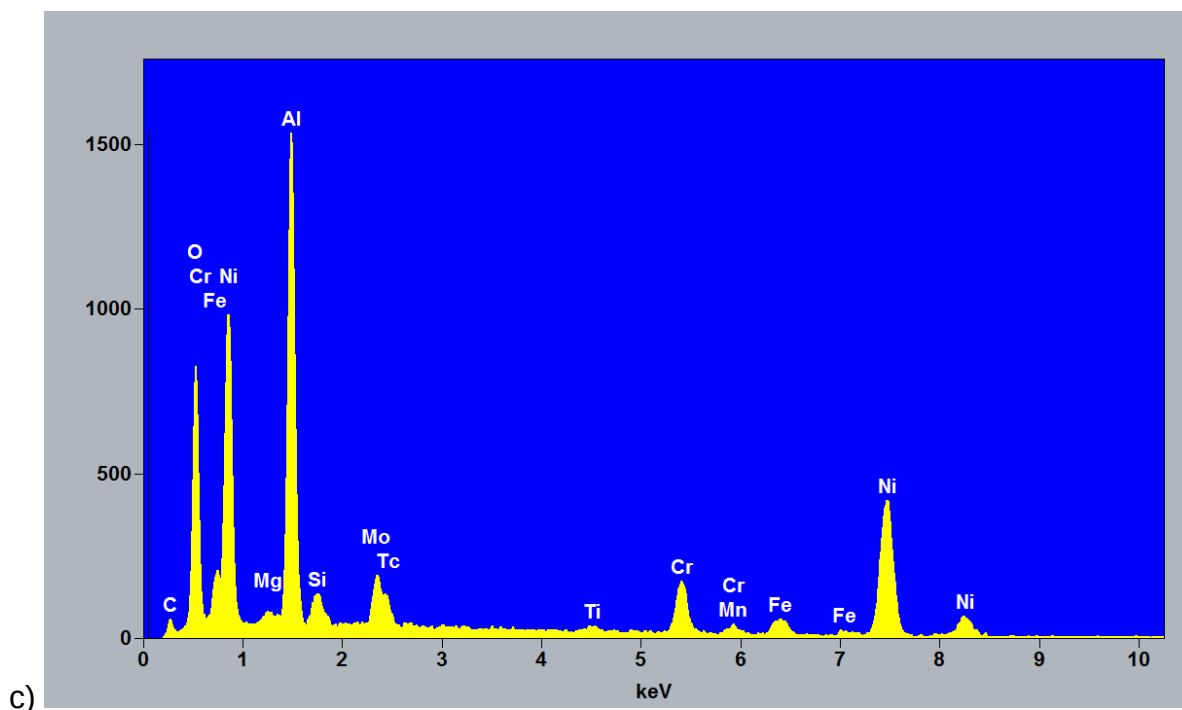
**Figure 5 (cont.):** c) EDS spectrum of a silver metallic deposit on the valve head exhibiting primarily nickel (Ni), iron (Fe), chromium (Cr), and aluminum (Al).

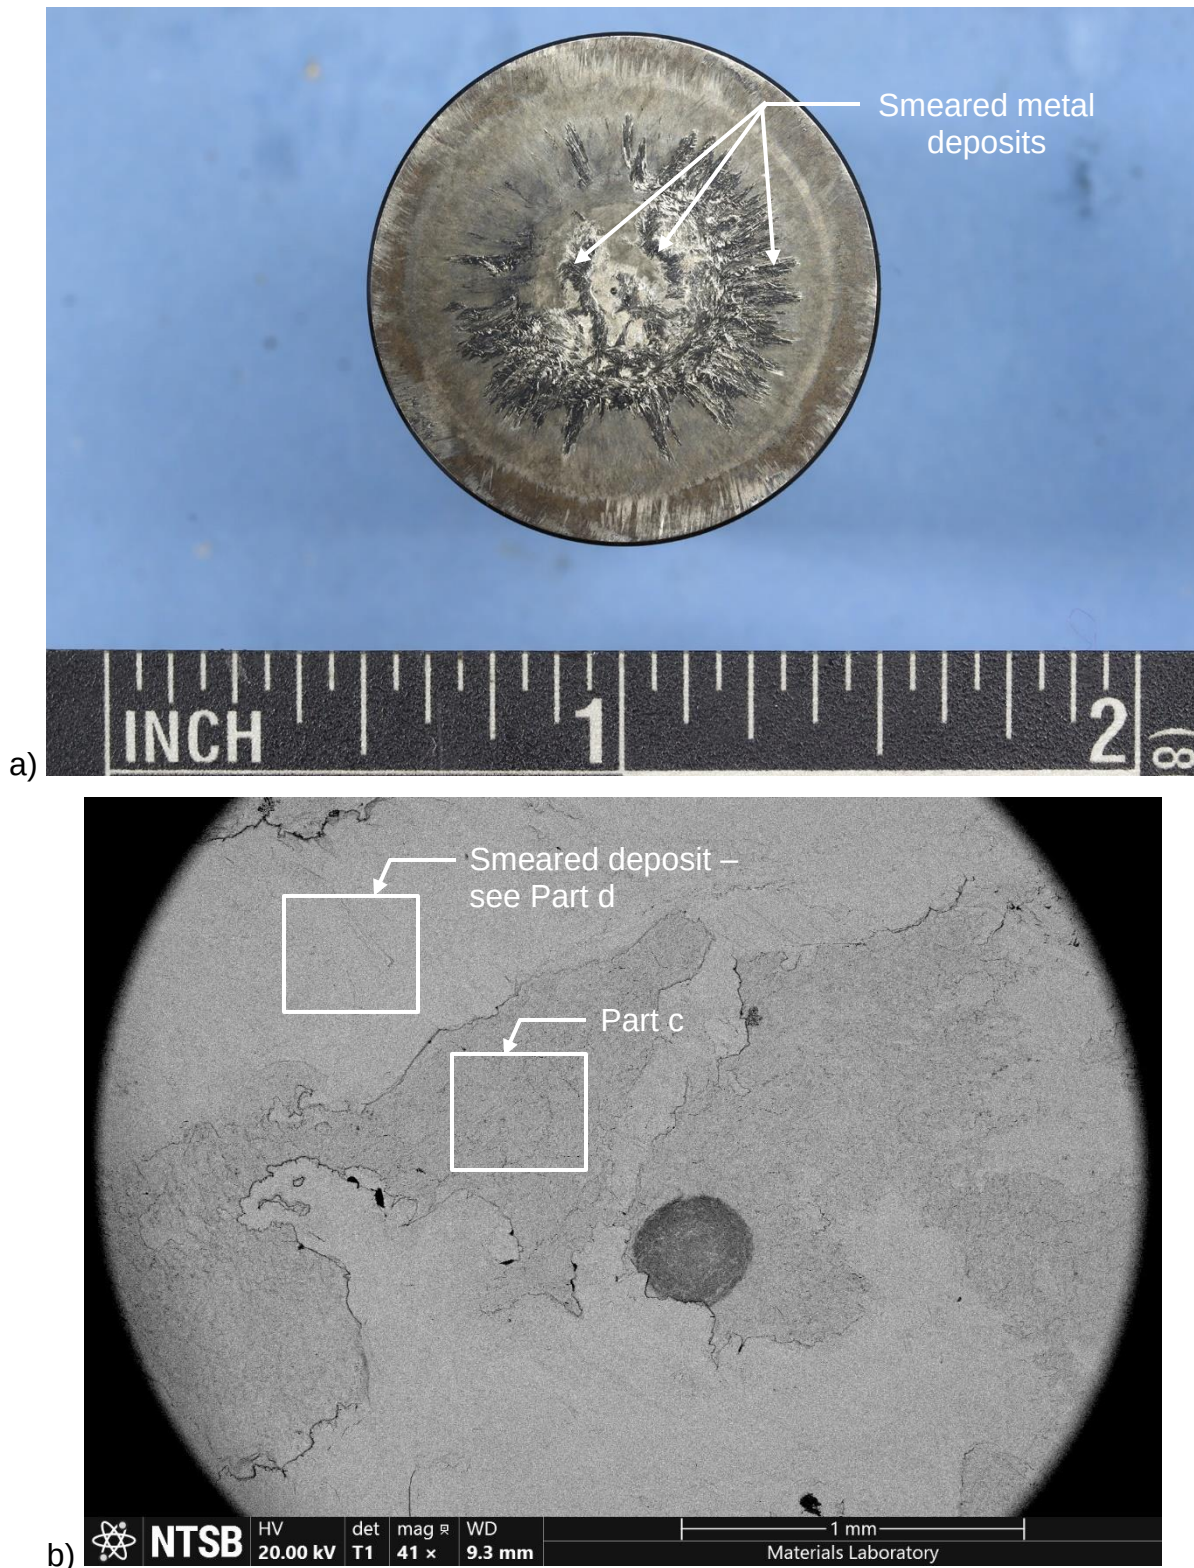
The lifter body for the number 2 exhaust valve exhibited smeared metal deposits on its cam-following end face, as shown in figure 6a. The composition of the deposits was examined in the SEM by EDS. An SEM image from the center of the lifter end face is shown in figure 6b. A region that was not covered by the smeared metal is indicated in the figure and the corresponding spectrum is shown in figure 6c. A region covered by the smeared metal is also indicated in the figure and is shown in figure 6d. Both spectra consisted primarily of Fe, but the end face of the lifter body (absent the smeared metal) also exhibited a silicon (Si) peak. The adjacent lifter body for the number 2 intake valve did not exhibit any similar smeared metal features on its end face, as shown in figure 7.

**Figure 6:** a) Image of the exhaust valve lifter body's cam-following end face exhibiting smeared metal deposits; b) SEM image of the end face highlighting two regions, one with smeared metal and one without, from which EDS spectra were taken.

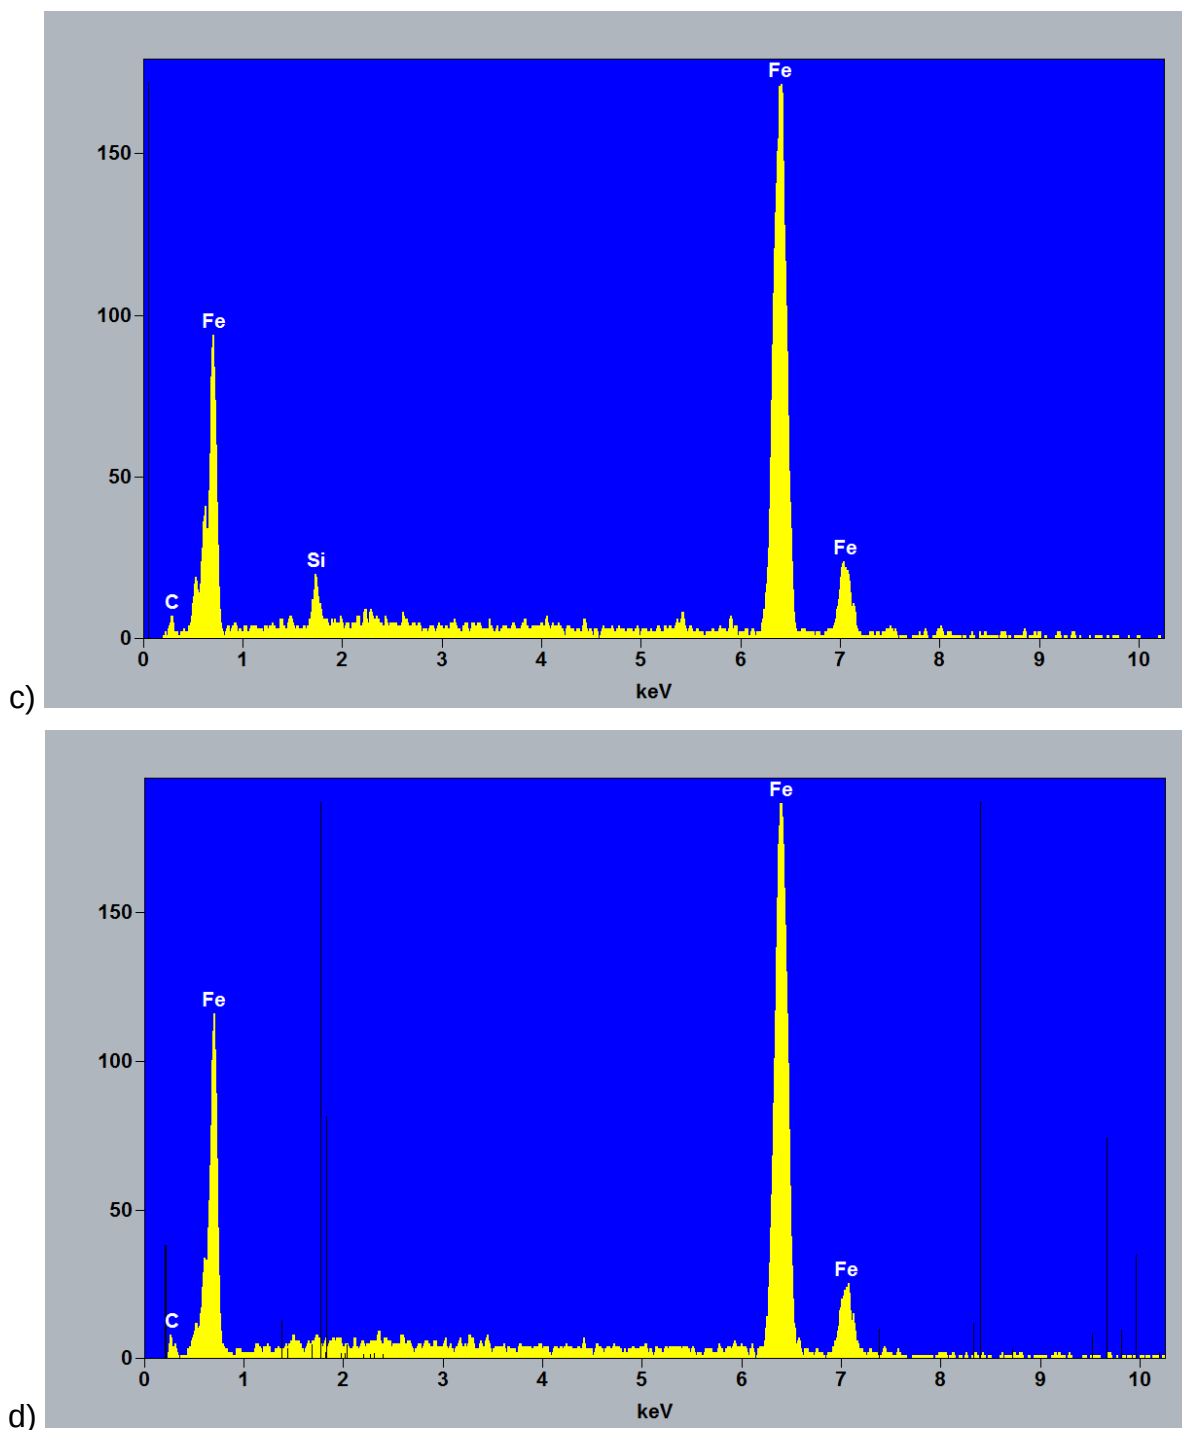
Figure 6 (cont.): c) EDS spectrum of the lifter body end face exhibiting primarily iron (Fe) and silicon (Si); and d) EDS spectrum of the smeared metal exhibiting primarily iron (Fe).

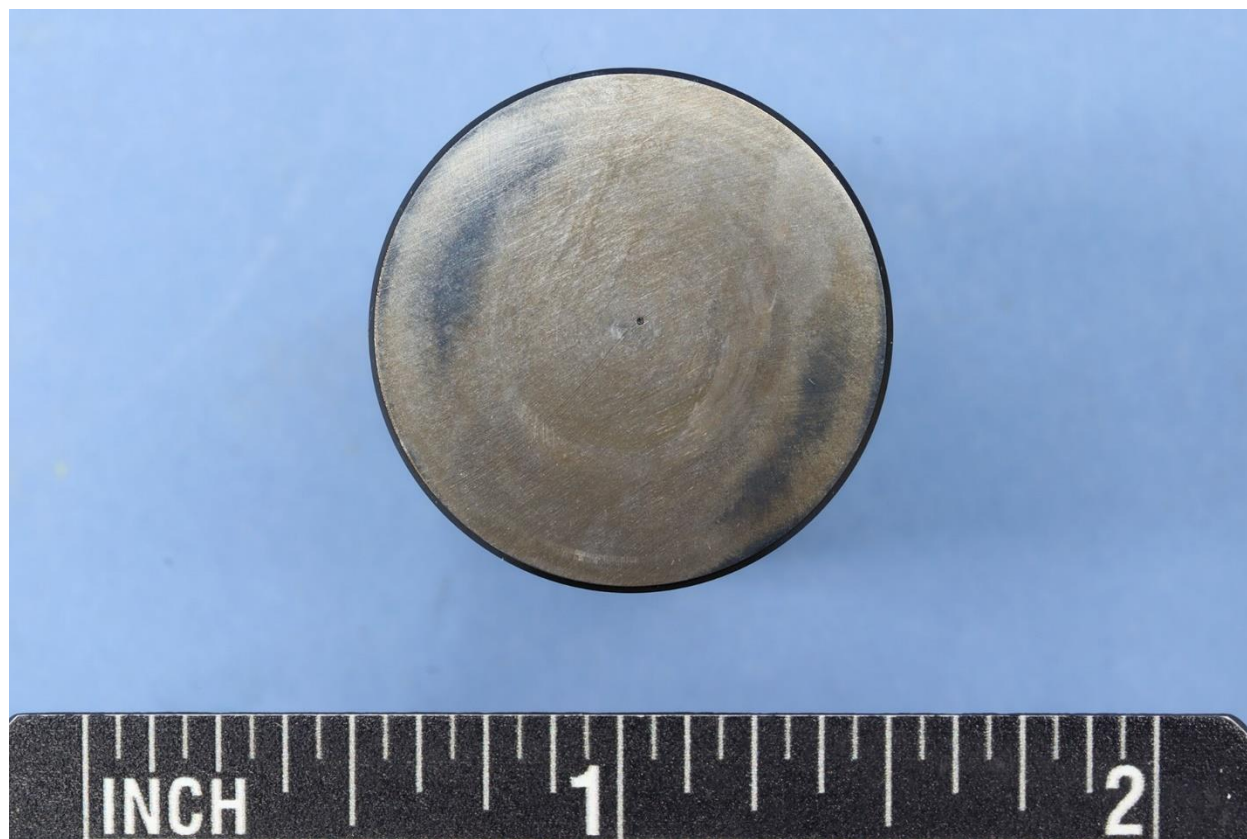
**Figure 7:** Image of the number 2 intake valve lifter body end face. There were no apparent smeared metal features.
