**SUMMARY OF ENGINE EXAMINATION**

-- CEN21LA473

Aircraft: Beechcraft 35, N5ML

**Engine** – Teledyne Continental Motors IO-520

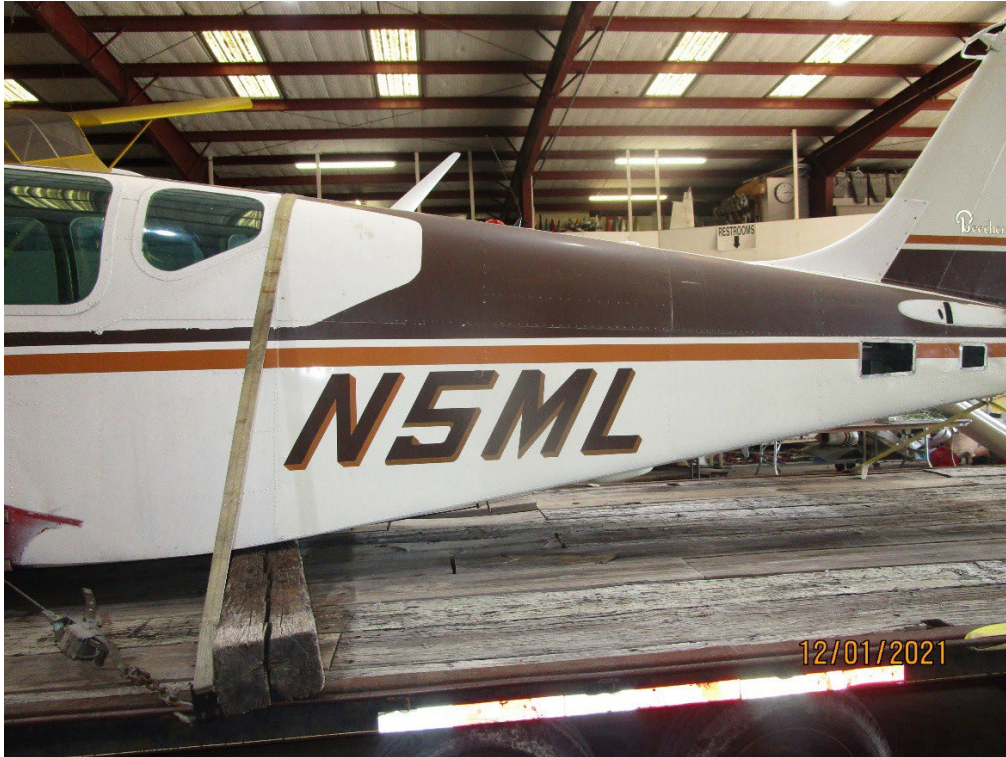
Figure 1: fuselage strapped down to trailer for engine run

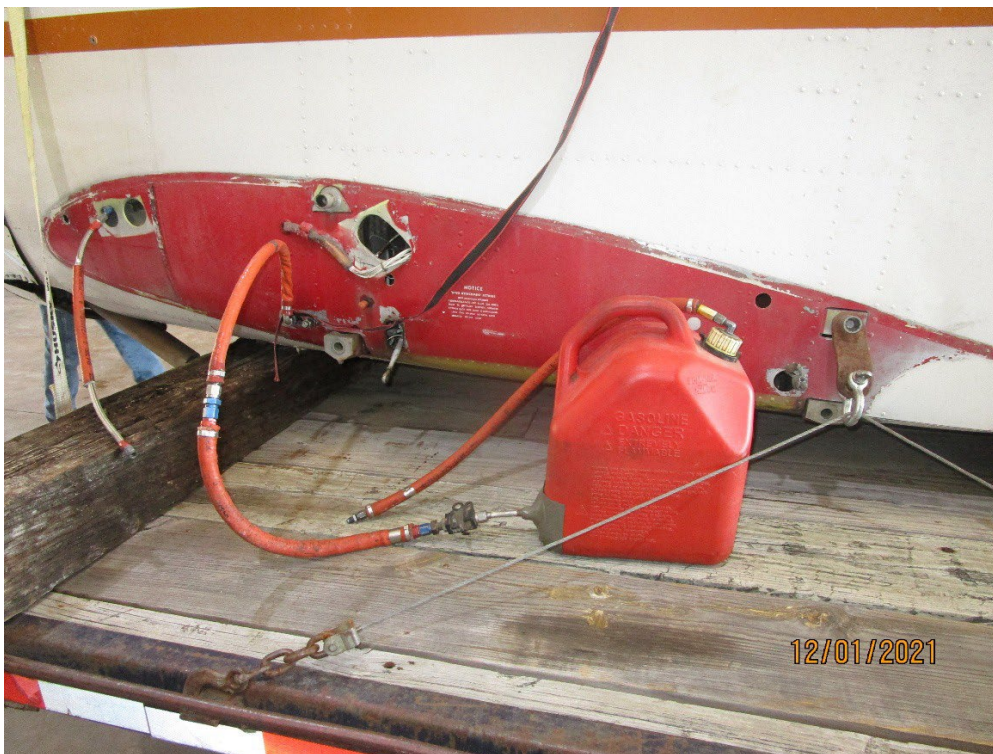
Figure 2: Fuel container – being plumbed into airplane's fuel system

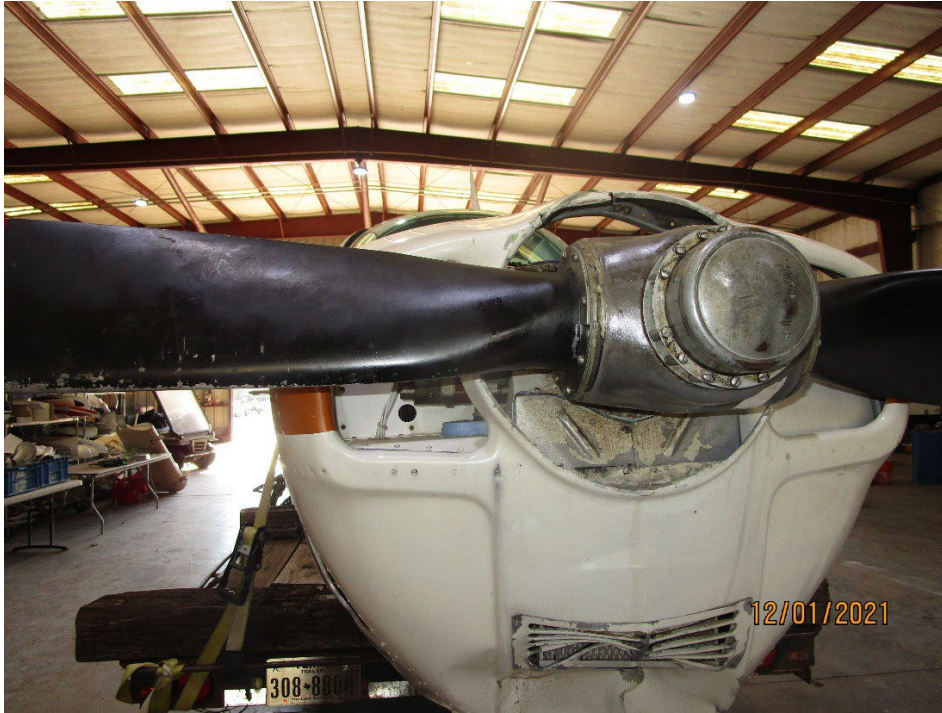
Figure 3: 2 bladed – constant-speed replacement propeller installed
