**NATIONAL TRANSPORTATION SAFETY BOARD**

**INVESTIGATION SUMMARY**

**CEN22FA011**

On October 11, 2021, at 0857 mountain daylight time, a Beech 58TC airplane, N6748V, was destroyed when it was involved in an accident near Mesa, Colorado. The pilot was fatally injured. The airplane was operated as a Title 14 *Code of Federal Regulations* Part 91 personal flight.

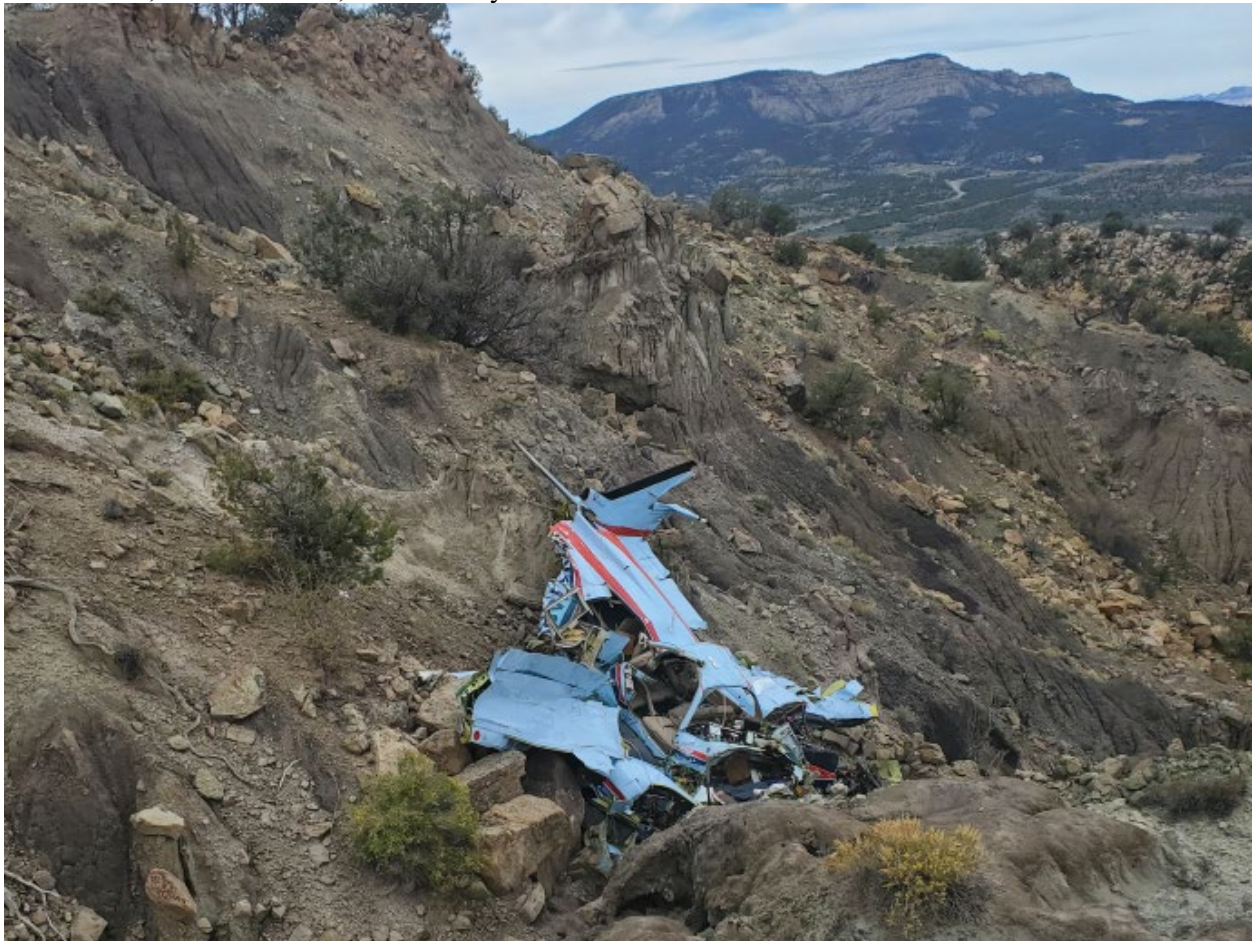
The accident site was located at 39.206489 x -108.123727 at an elevation of 5,750 feet. The geographic area consisted of rocky, and muddy terrain on a mountainside. The accident site was inaccessible due to poor weather conditions on 10/12-14. The NTSB and Textron reconvened on 10/19/21 for the on-site examination, documentation, and recovery. On-site observations detailed below.

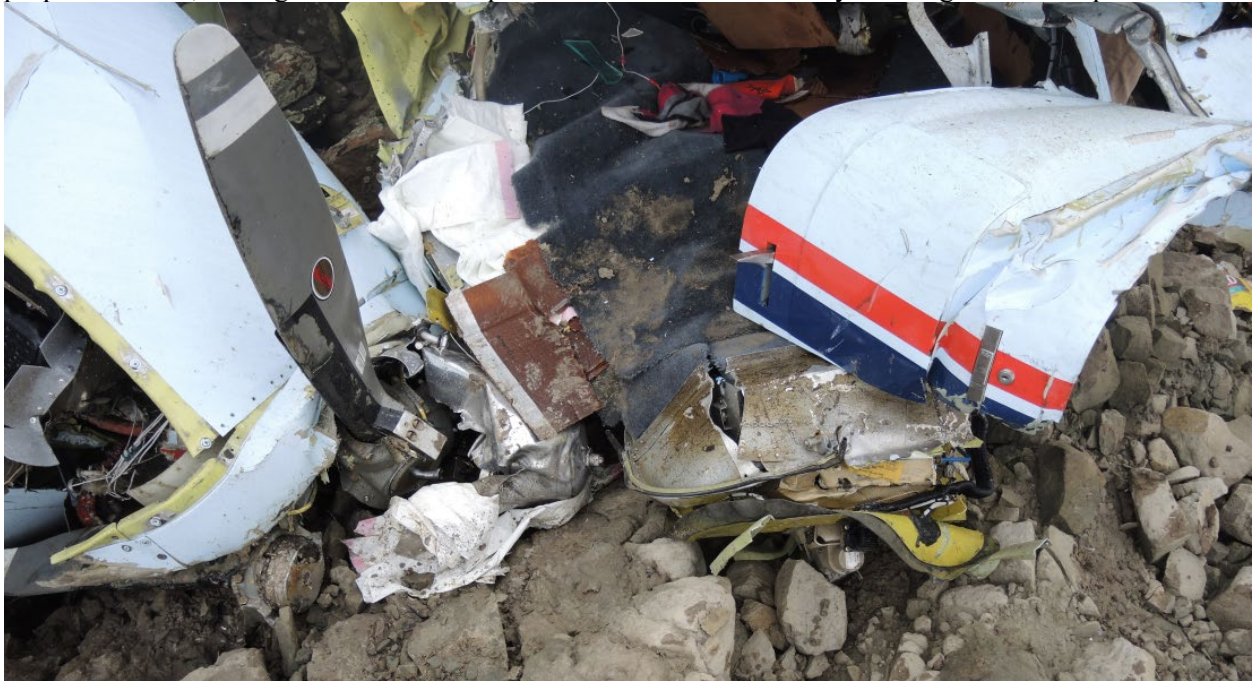
The right engine was still mostly attached to the nacelle via the engine mounts. The engine compartment, propeller blades, and right-side nose compartment were covered in a layer of engine oil. See photo below.

The engine sustained upward impact crushing damage sustained during the accident sequence. The oil sump was crushed upward and punctured by the oil dipstick tube. The oil sump was removed, no signs of debris or catastrophic engine failure were evident. The propeller hub remained attached to the crankshaft and one blade was impact separated from the hub. The other two blades remained attached to the hub.

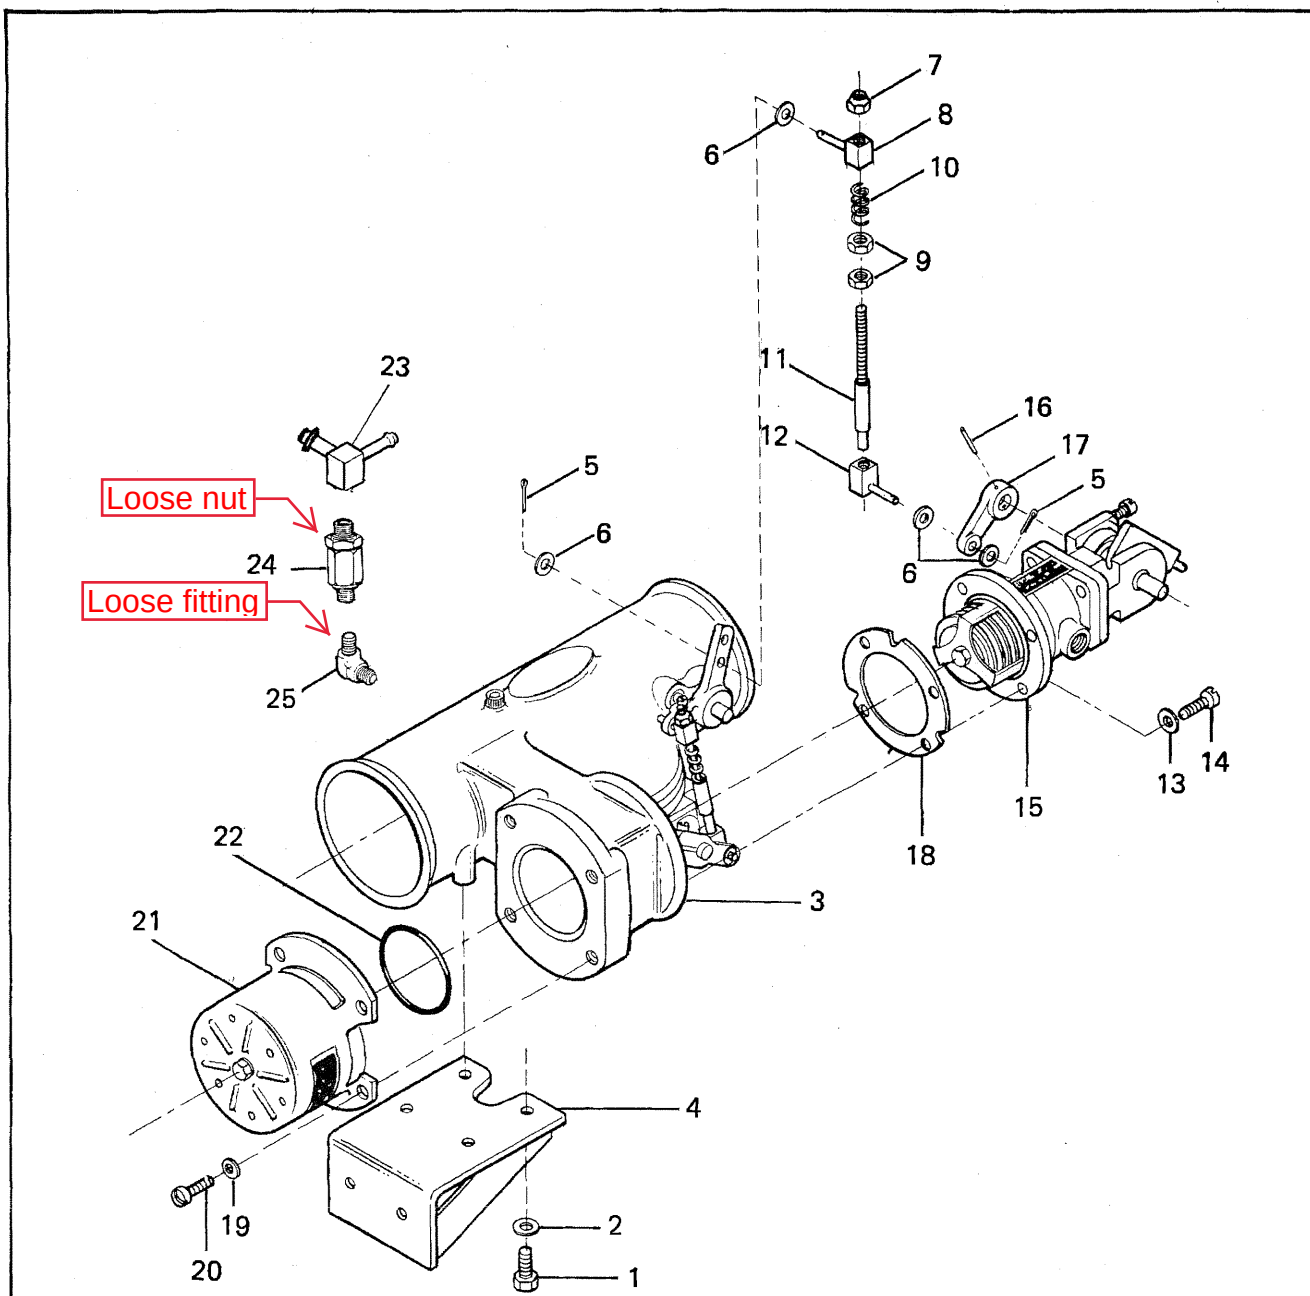
FIGURE 9-3 THROTTLE AND CONTROL ASSEMBLY

The turbo, fuel control, turbo controller, and associated plumbing was separated from their respective mounts but remained connected. Multiple oil and fuel lines were fracture separated at the fittings. The turbocharger wastegate valve was fractured from the valve control housing at the base. The wastegate control was removed from the turbo housing mount and examined. The turbo charger compressor housing was fractured, and impact separated from the turbo. The turbine rotor was in contact with the housing and seized. There was no evidence of rotational damage on the rotor assembly. The oil line from the turbocharger wastegate control valve outlet (p/n 635381-2) to the inlet side of the (VAPC) turbo pressure controller (p/n 640655-22) was loose at the wastegate outlet end. During the examination, the B-nut was rotated approximately  $\frac{3}{4}$  to 1 full rotation clockwise before the fitting tightened against the mating surface of the flared union fitting.

The fuel rail assembly was in place and attached, but the connections were easily turned clockwise with a wrench at all 6 fuel injector locations. The fuel injectors were removed from the cylinder heads and observed to be free from obstructions. When removing the fuel injectors, it was noted that only two to three threads were engaged. The No. 2 fuel injector was dislodged from the cylinder head. The thread material from the cylinder head remained in the injector threads. The fuel injectors were removed and examined. Fuel injectors 1,2,3,5, and 6 were free of obstructions. The No. 4 injector was partially obstructed. The material obstructing the injector was removed using a piece of 0.02" safety wire. The material was soft in composition and black in color. The fuel flow divider valve was removed and examined. Black rubber material from the flow divider diaphragm was present in the pressure chamber of the flow divider. The flow divider did not have a fuel filter screen installed. The fuel pump was removed from the accessory housing. The pump drive was intact, and the pump rotated freely. Fuel flow transducer was free and clear, and air was blown through without obstruction.
