## **NATIONAL TRANSPORTATION SAFETY BOARD**

### **ON SCENE OBSERVATIONS**

**CEN22FA016**

Location: Stroud, OK  
Date: October 18, 2021  
Aircraft: AutoGyro Cavalon, Registration N419LB  
NTSB IIC: Samantha Link

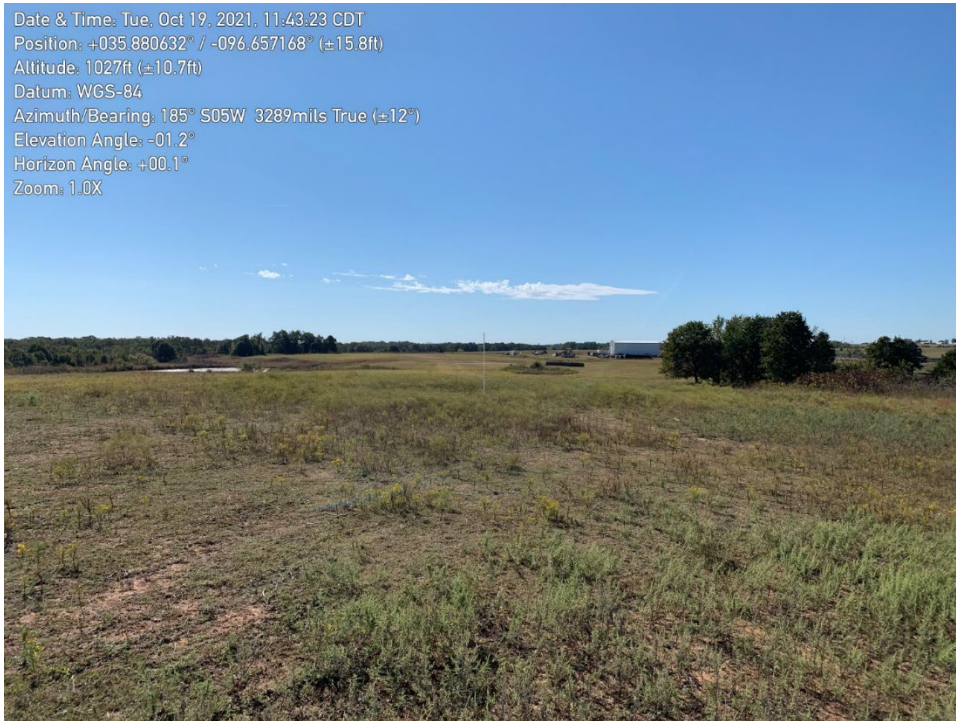
Figure 1: The Takeoff Field (View from the barbed wire fence looking toward the beginning of the field)

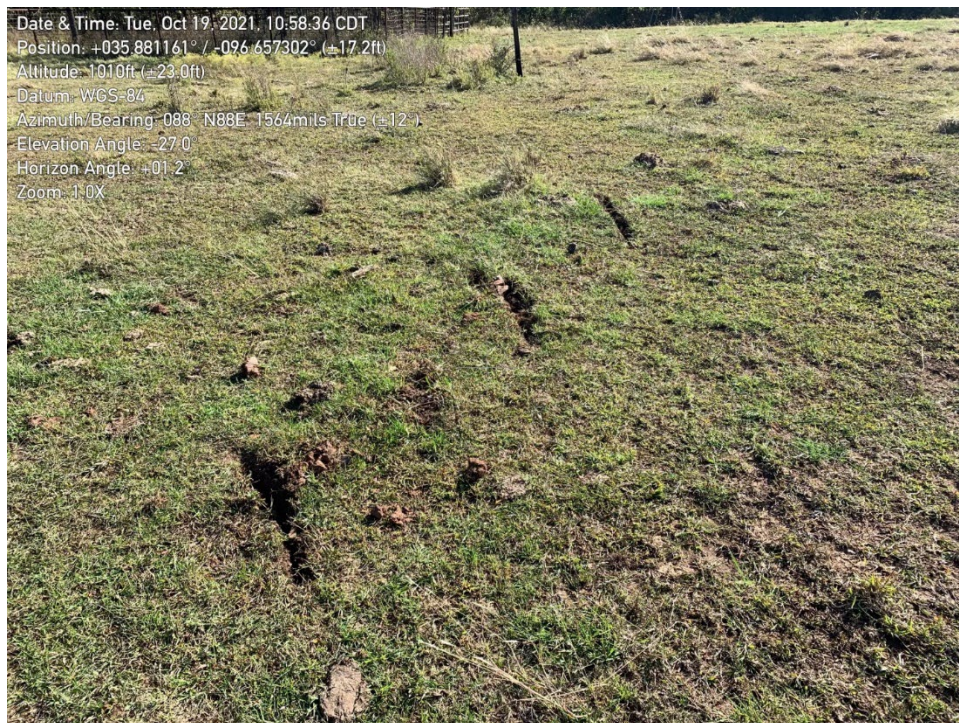
The first identified point of impact was a barbed wire fence. Followed by striations in the dirt from the rotor blades about 100 feet later. The gyroplane came to rest about 25 feet beyond that; it was upright and parallel to the fence line.

Figure 2: Striations in the Dirt

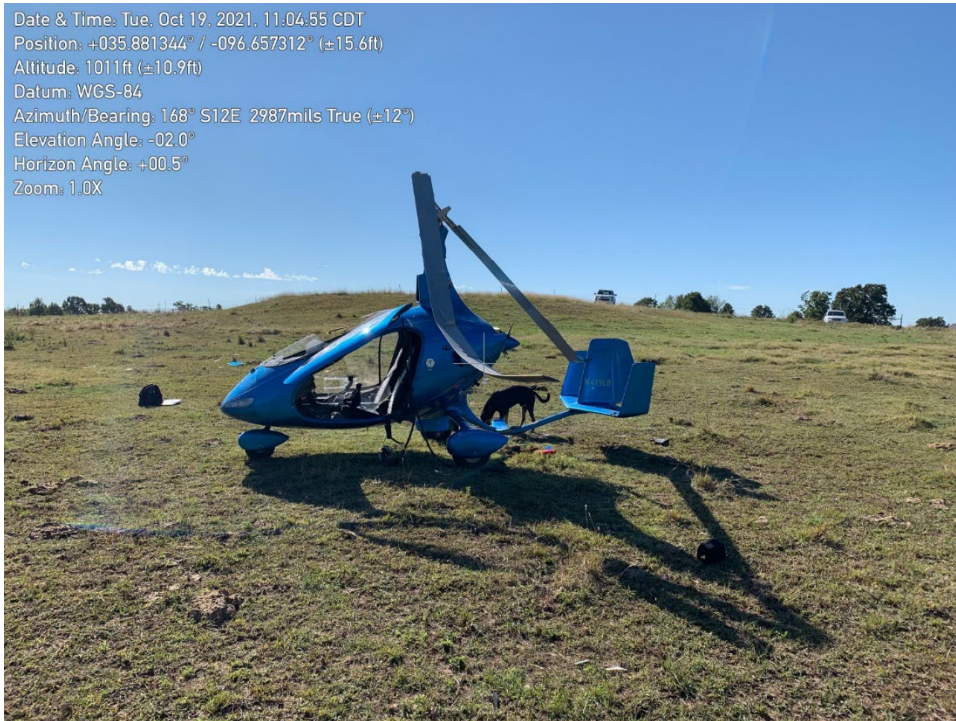
Figure 3: Left side of Gyroplane

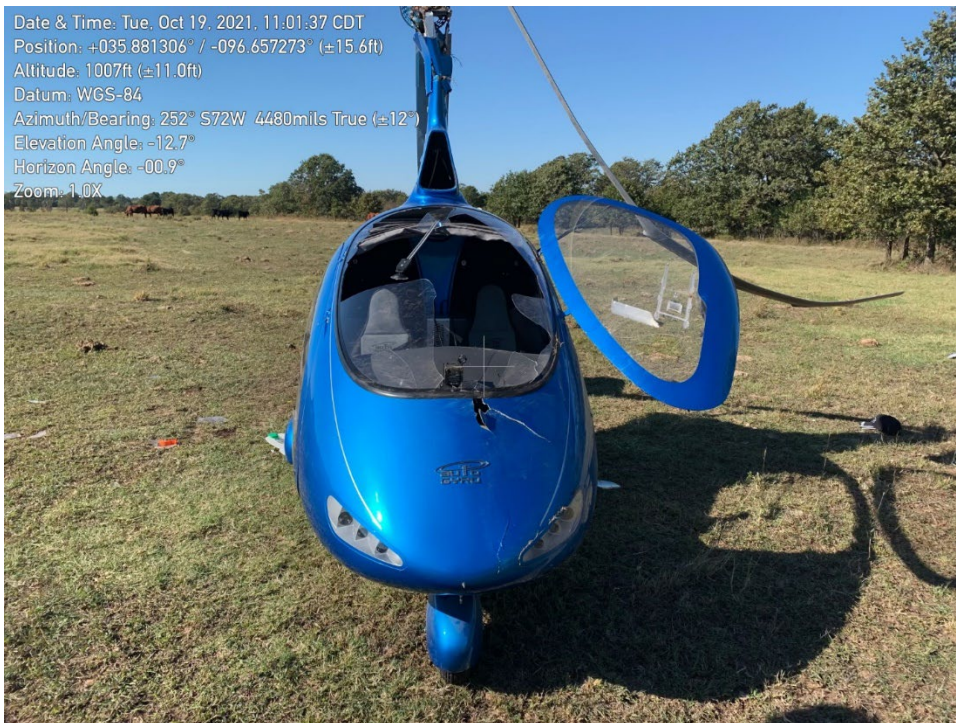
Figure 4: Front of Gyroplane

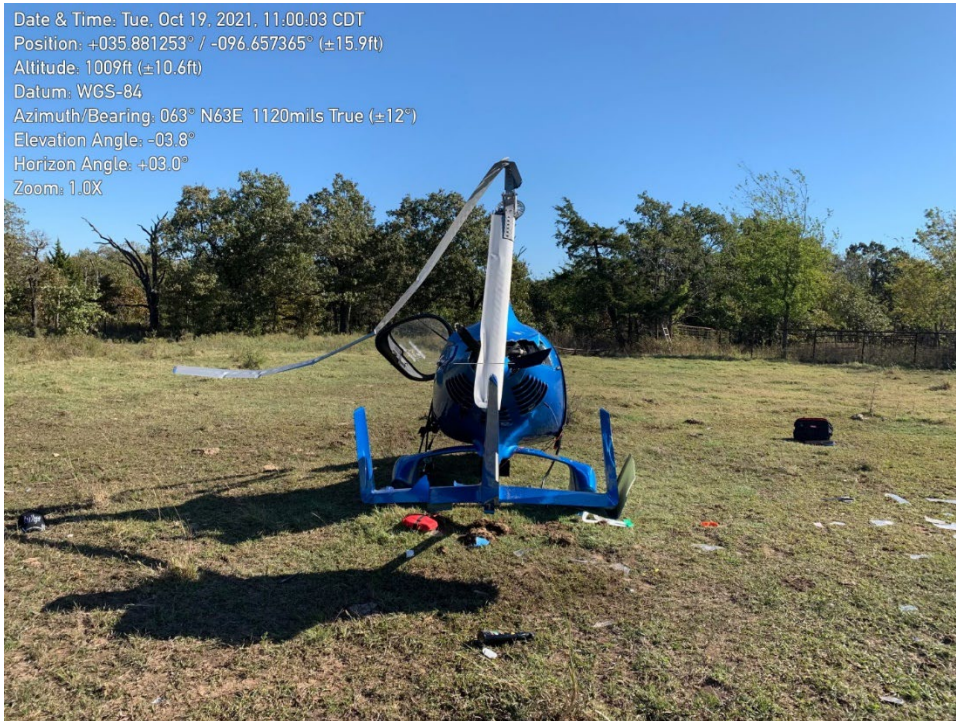
Figure 5: Aft side of Gyroplane

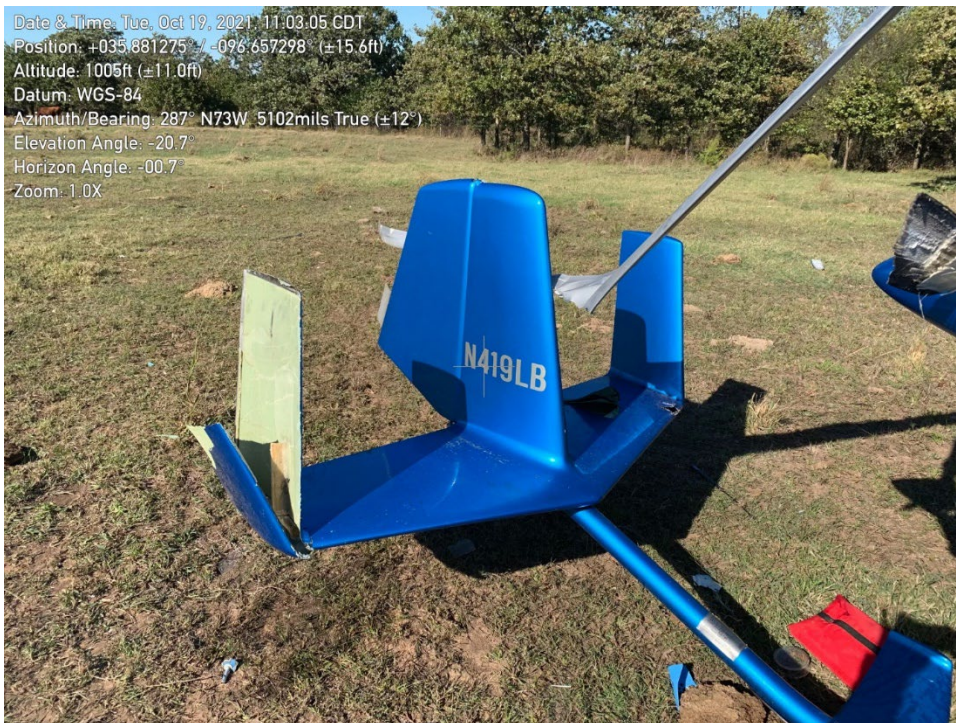
Figure 6: Vertical Stabilizer

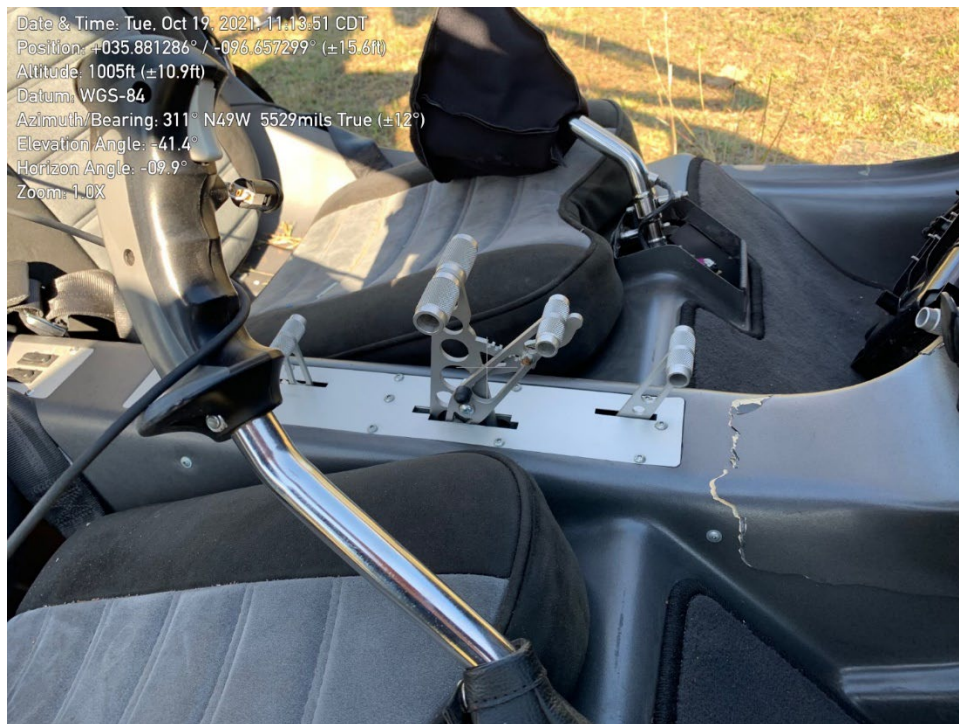
Figure 7: Cockpit Controls

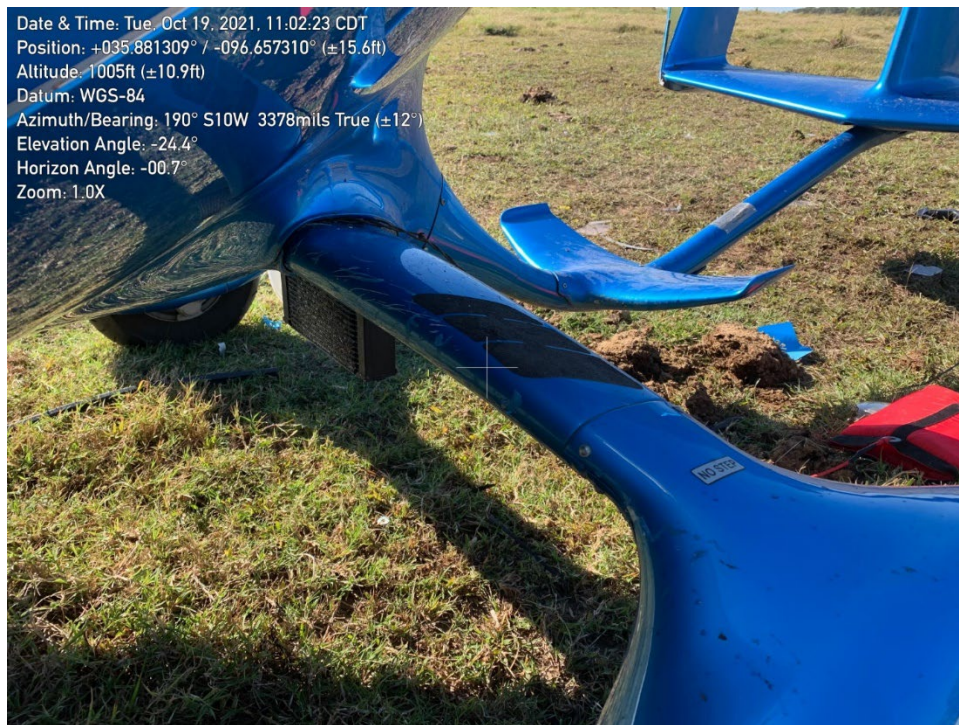
Figure 8: Left Landing Gear Strut

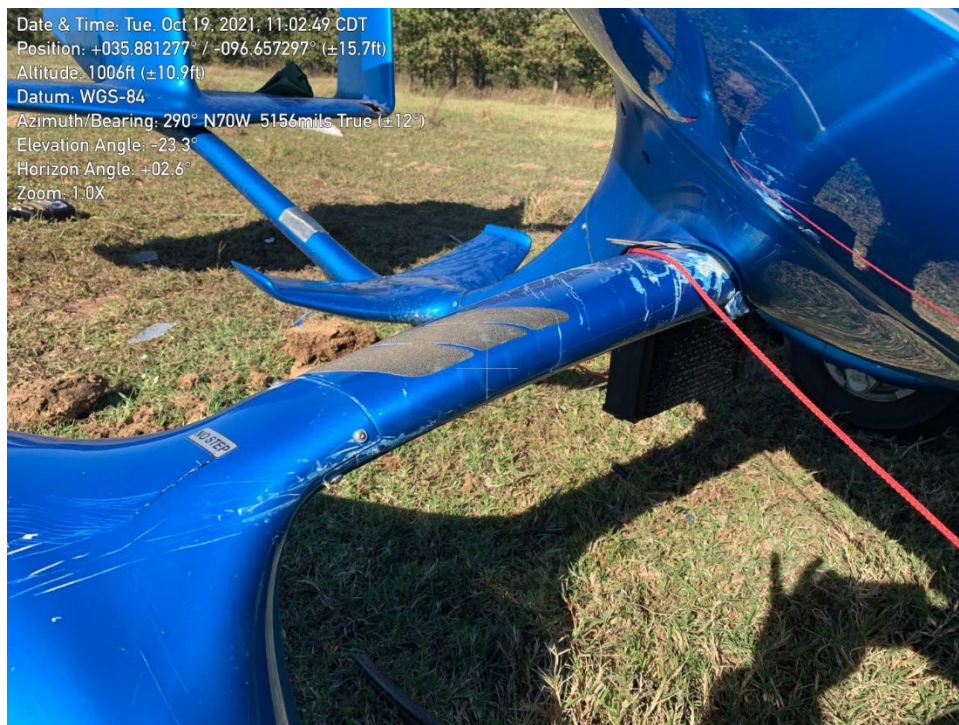
Figure 9: Right Landing Gear Strut

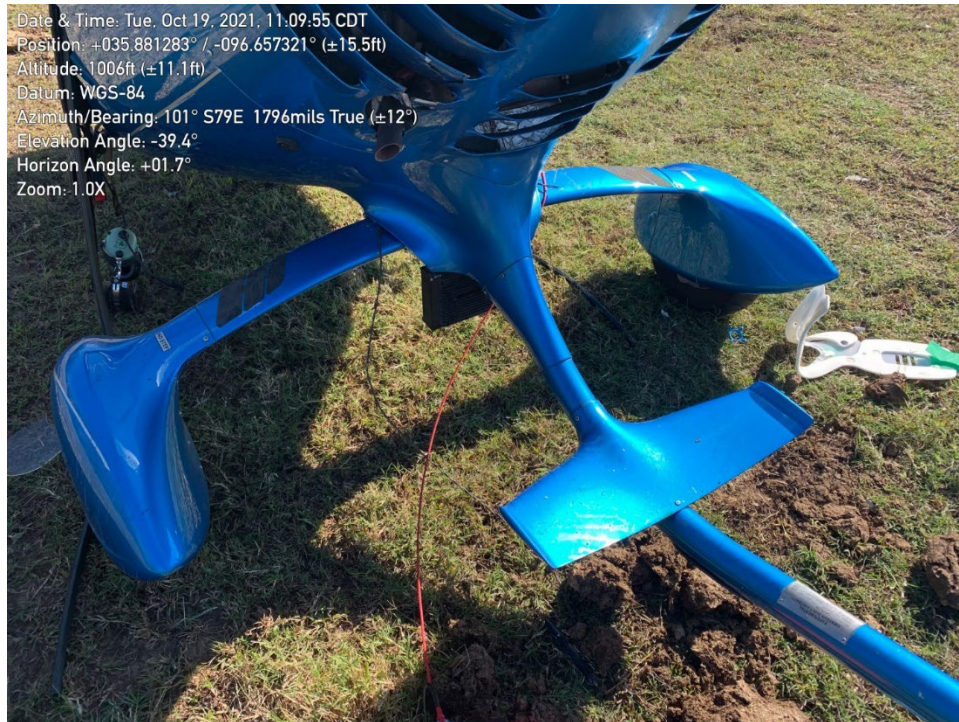
**Figure 10: Fragment of Barbed Wire Fencing**

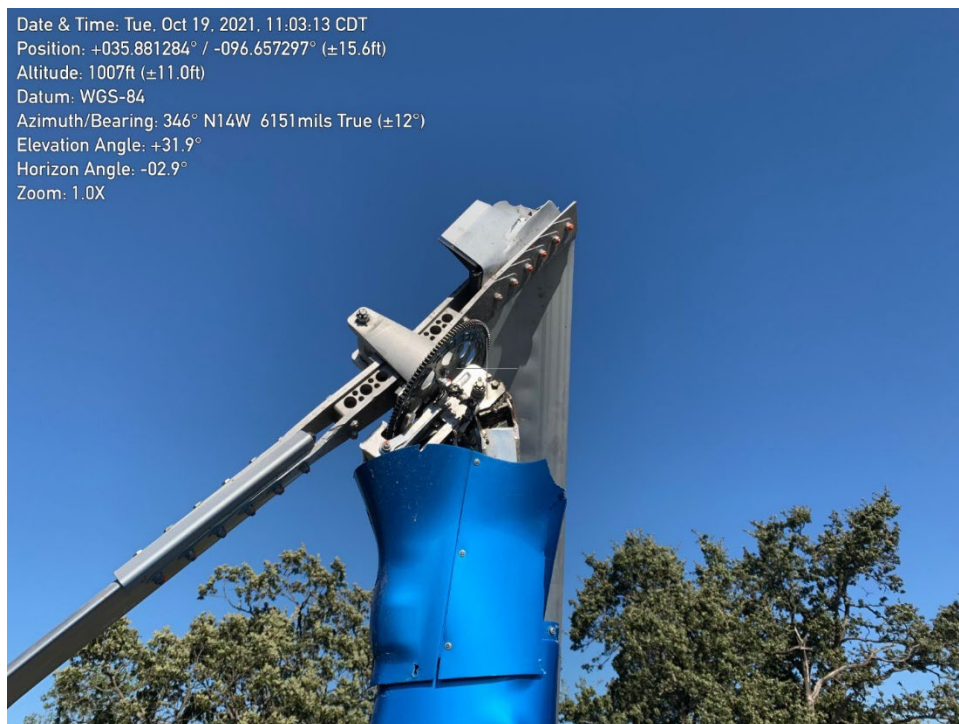
**Figure 11: Rotor Head Assembly**

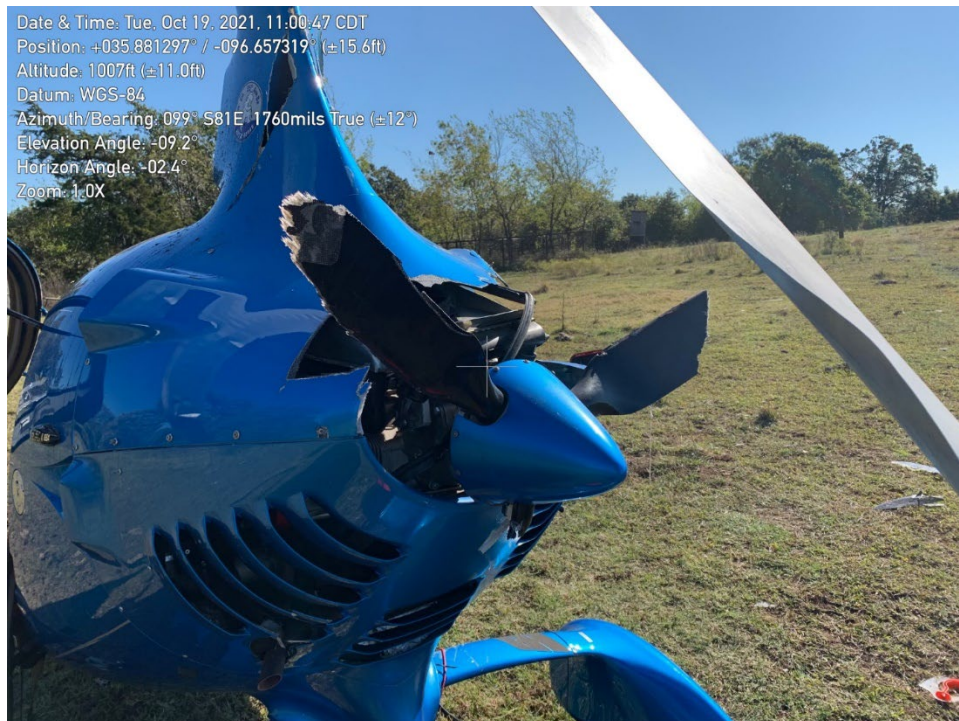
- The three propeller blades remained attached at the propeller hub.
  - One blade was fractured at the root.
  - The second and third blades were fractured about midspan.
  - The propeller blades fragments were scattered throughout the debris field.
- Engine controls remained intact from the cockpit to the engine controls. They operated normally when manipulated by hand.
- The avionics master was turned on and the gauge indicated fuel was present in the fuel tank.

Figure 12: Propeller Assembly

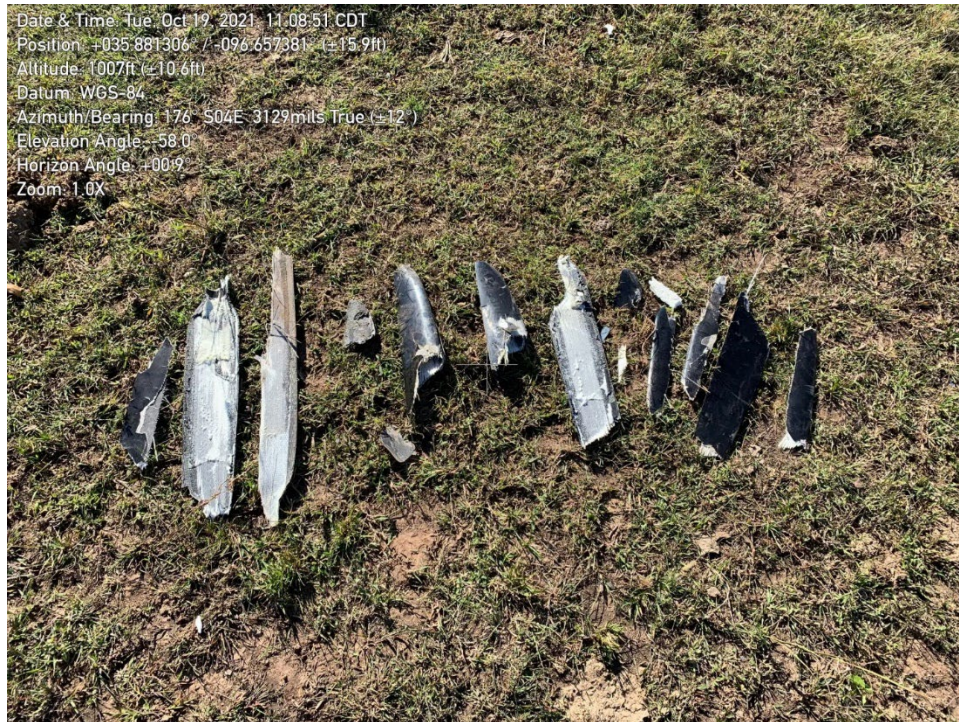
**Figure 13: Propeller Blade Fragments**

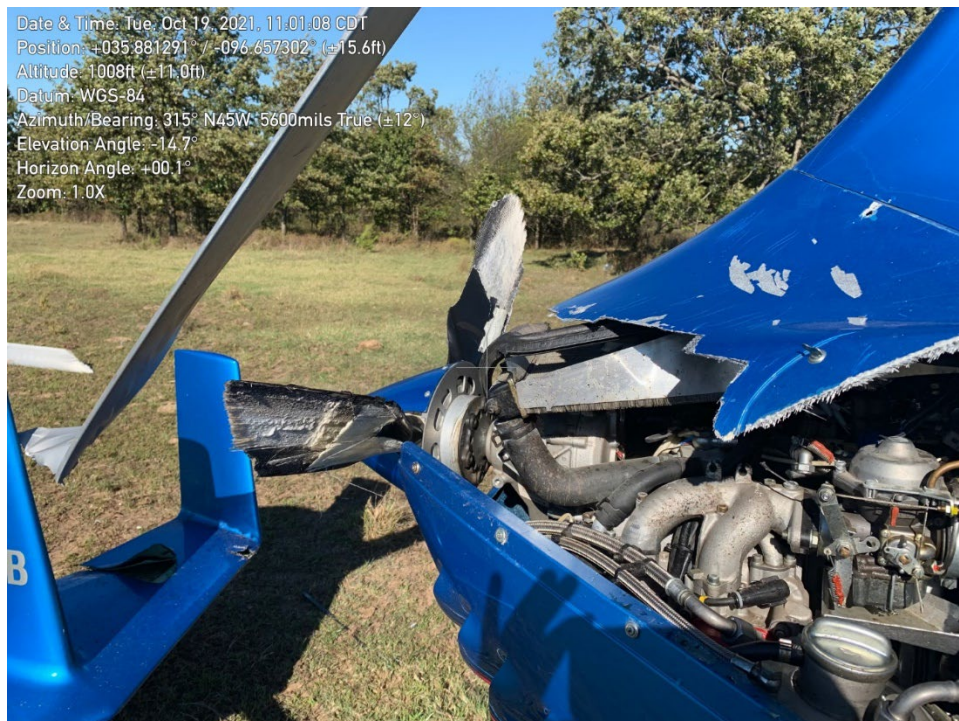
**Figure 14: Engine Overview and Propeller Assembly**
