# National Transportation Safety Board

CEN22FA019

## **WRECKAGE EXAMINATION SUMMARY**

Location: Marengo, Wisconsin  
Date: October 23, 2021  
Time: 1440 central daylight time (1940 UTC)  
Airplane: American Champion Aircraft model 8KCAB, Registration No. N843AC

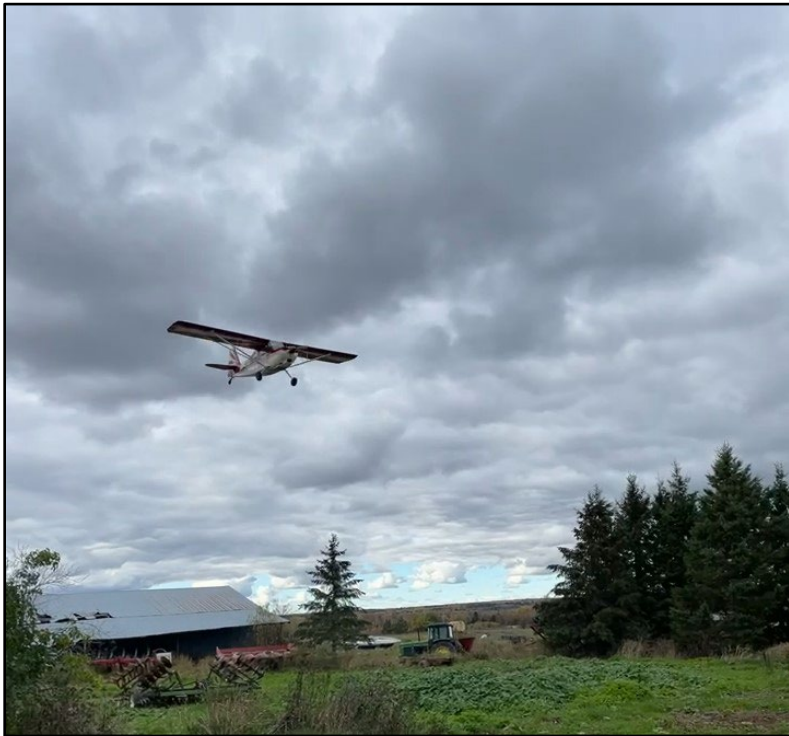
**Figure 1.** Airplane flying low over the ground (still image extracted from a video that was recorded by a witness)

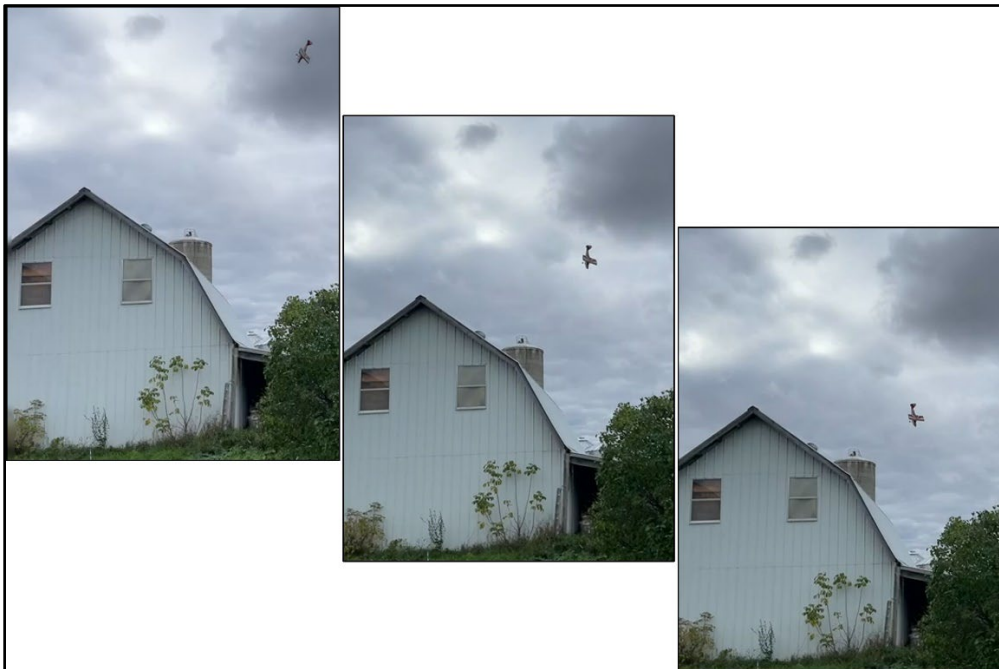
The pilot's sister-in-law used her mobile phone to capture several "live" photos of the airplane while it maneuvered near her house during the final minutes of the flight. These "live" photos consisted of several frames of video with sound to create a short movie clip. One of these movie clips showed the airplane as it flew over a residential yard at a low altitude, as shown in figure 1. Another movie clip showed the airplane in a steep nose down descent in the moments before the accident, depicted in figure 2. A review of the sound spectrum extracted from the movie clip that captured the final

descent determined the fundamental propeller blade passage was about 80 Hz, which corresponded to 2,400 rpm for the 2-blade propeller installed on the airplane.

**Figure 2.** Airplane descending during final low altitude maneuver (still images extracted from a video that was recorded by a witness)

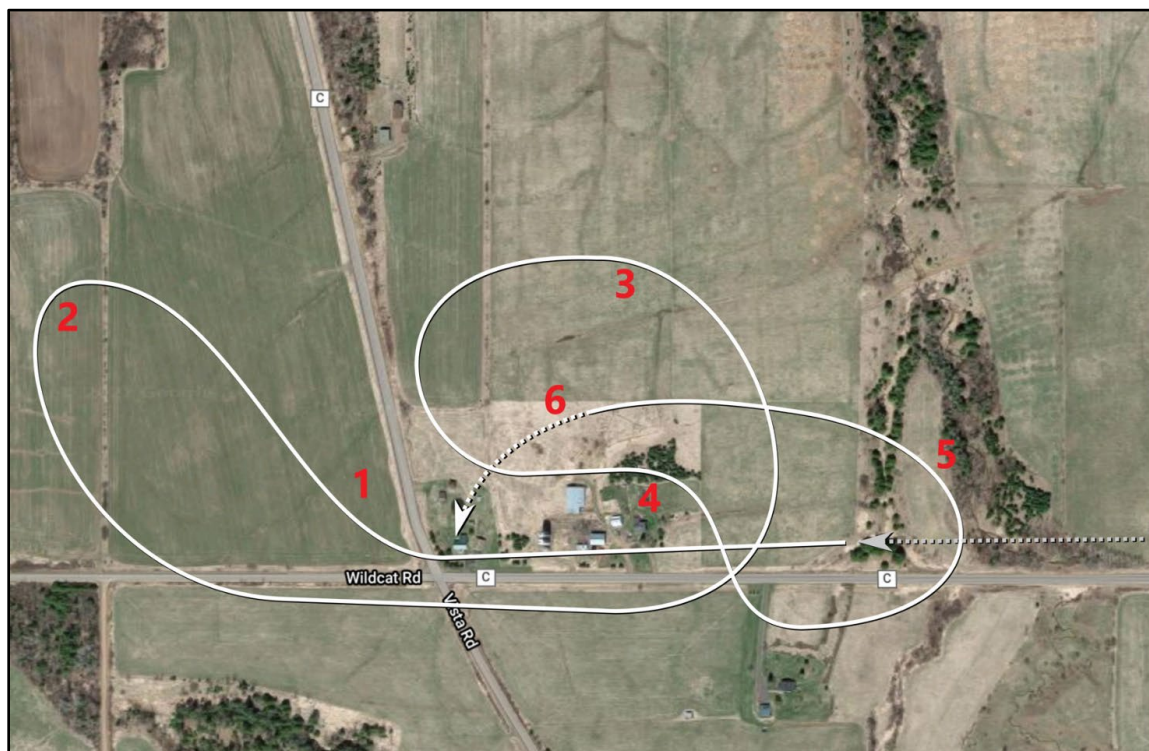
The airplane’s general ground track in the vicinity of the accident location was constructed based on recovered video footage and is depicted in figure 3. The airplane’s bank angle with respect to the visible horizon was estimated for several turns, with each turn chronologically numbered 1-6 and annotated in figure 3. Additionally, the airplane’s maximum bank angle during each turn is listed in table 1.

**Figure 3.** The airplane’s estimated ground track in the minutes before the accident, with red numbers indicating where the bank angles were measured during each turn

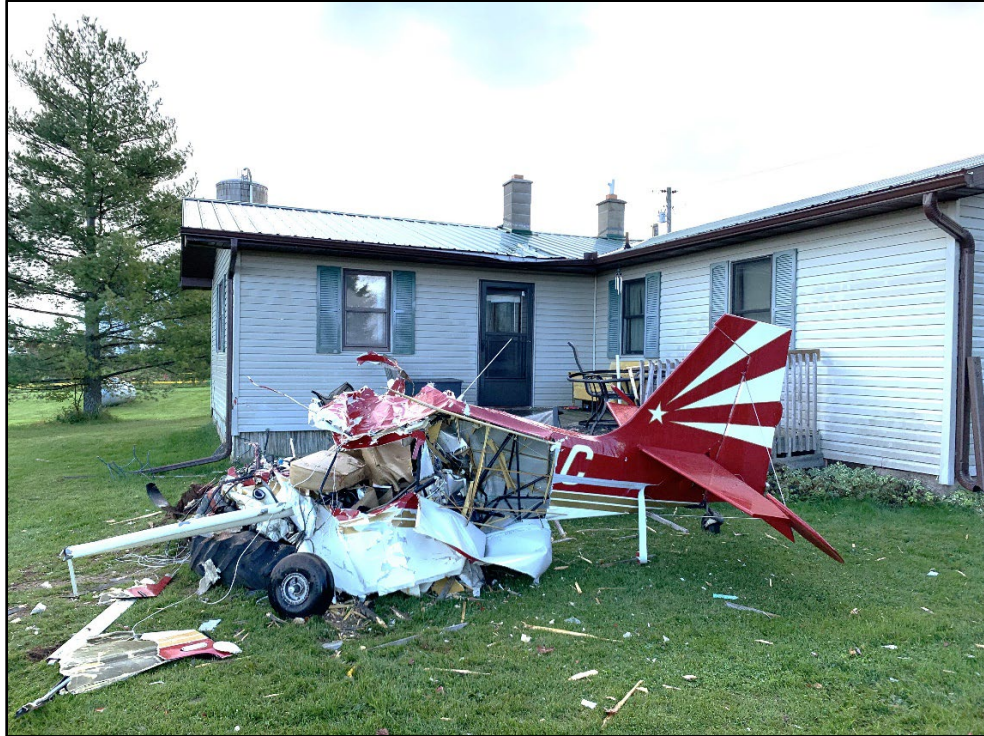
An onsite examination determined the airplane's right wing leading edge impacted the roof of a house before the fuselage impacted the ground in a nose down pitch attitude, as shown in figure 4. The main wreckage came to rest in the backyard of the house on a north heading. The main wreckage location was 46.406685° north latitude, 90.898016° west longitude, at 877 ft msl. The main wreckage consisted of the fuselage, empennage, engine, and propeller. Both wings separated from the upper fuselage during impact and were found about 20 ft north of the main wreckage, as shown in figure 5.

**Figure 4.** Main wreckage at the accident site

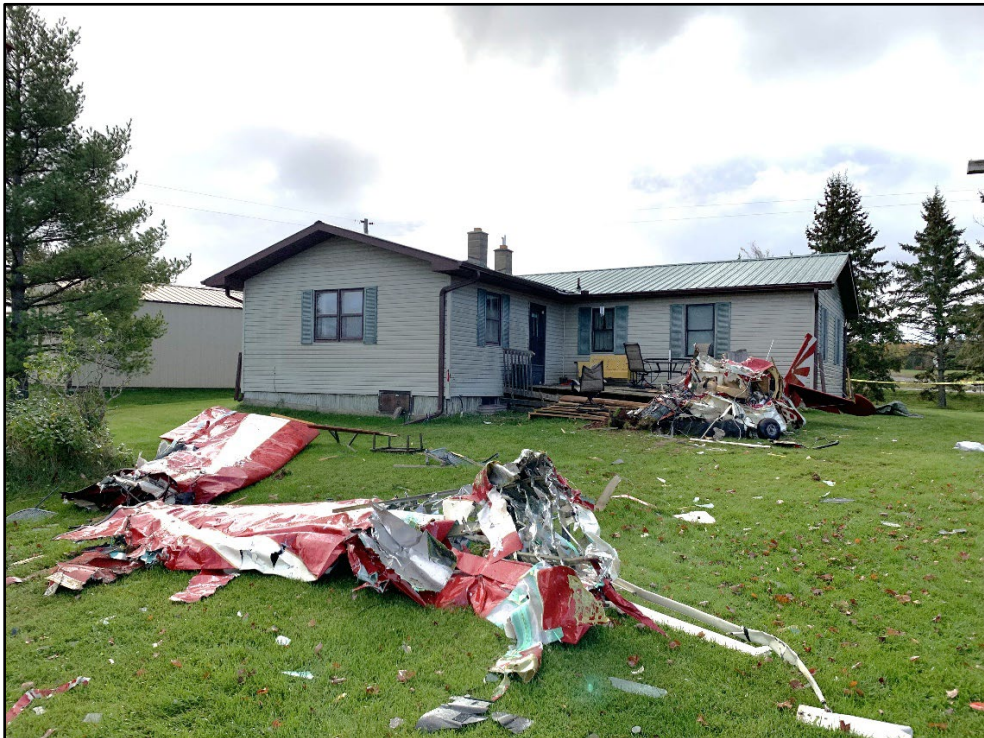
**Figure 5.** Wings as found at the accident site

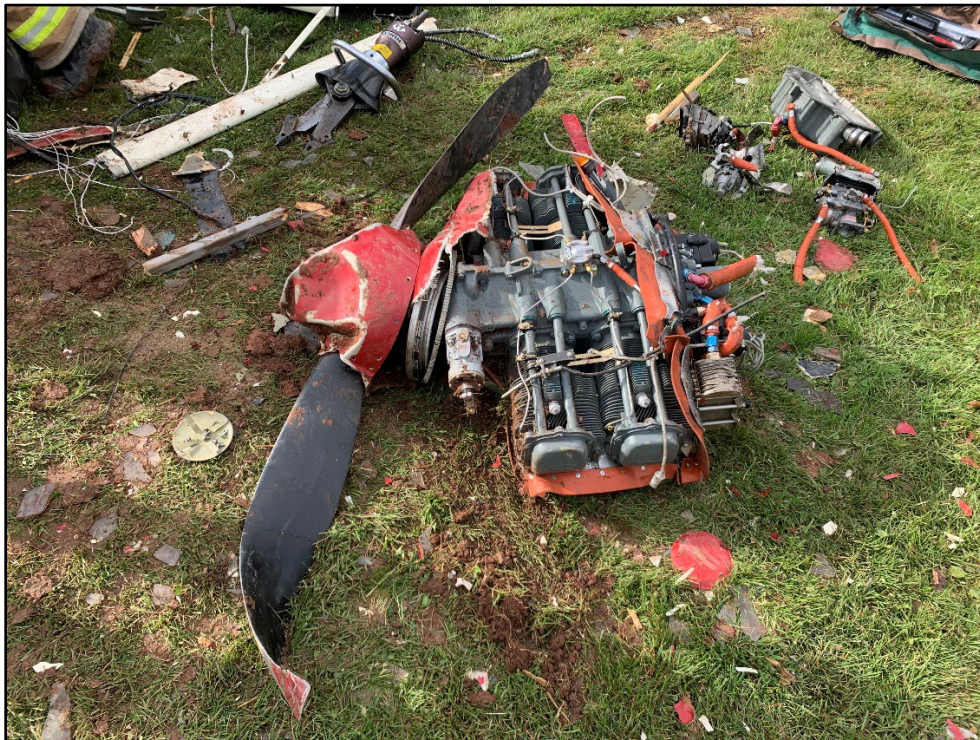
The engine remained attached to the fuselage mounts and did not exhibit any crankcase or cylinder fractures. The upper sparkplugs exhibited features consistent with normal engine operation. Internal engine and valve train continuity were confirmed as the engine crankshaft was rotated through the propeller governor drive gear. Compression and suction were noted on all four cylinders in conjunction with crankshaft rotation. Both magnetos provided spark at each post when rotated by hand. Fuel was observed in the electric fuel pump, engine-driven fuel pump, fuel servo, and the fuel line to the fuel manifold valve.

The engine examination revealed no evidence of a preimpact mechanical malfunction or failure that would have precluded normal operation.

**Figure 6.** Engine with propeller

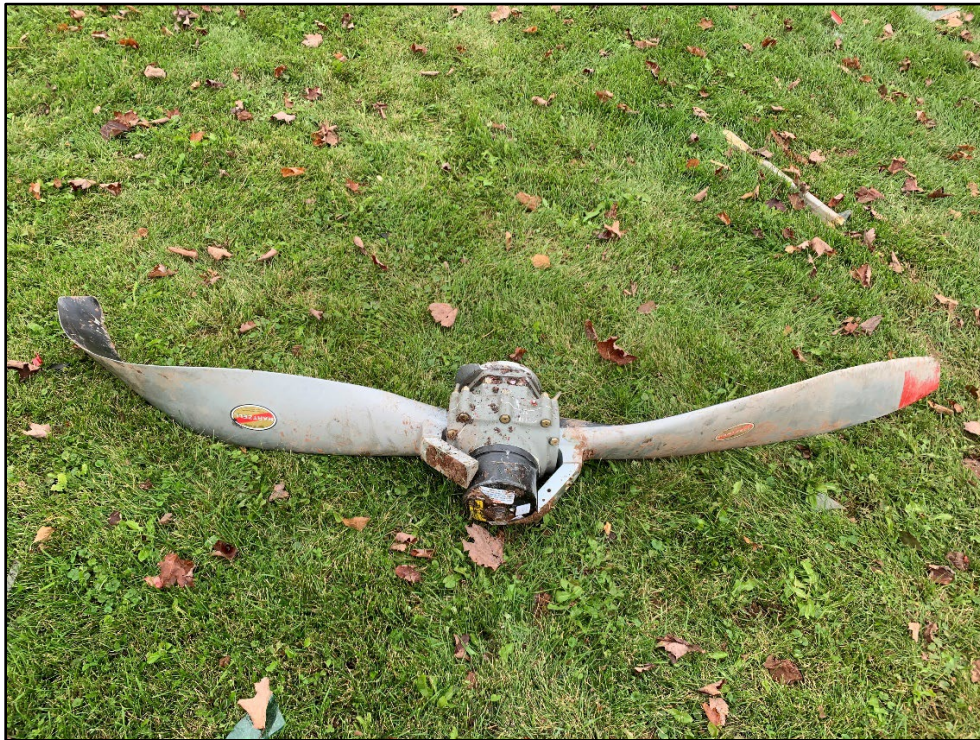
The propeller remained partially attached to the engine crankshaft, as shown in figure 6. One propeller blade exhibited compound bending; opposite rotation, aft, and twisted toward low pitch. The other propeller blade mostly exhibited aft bending. Both propeller blades exhibited chordwise/rotational scoring and leading-edge gouging.

The propeller examination revealed no evidence of a preimpact mechanical malfunction or failure that would have precluded normal operation.

**Figure 7.** Propeller

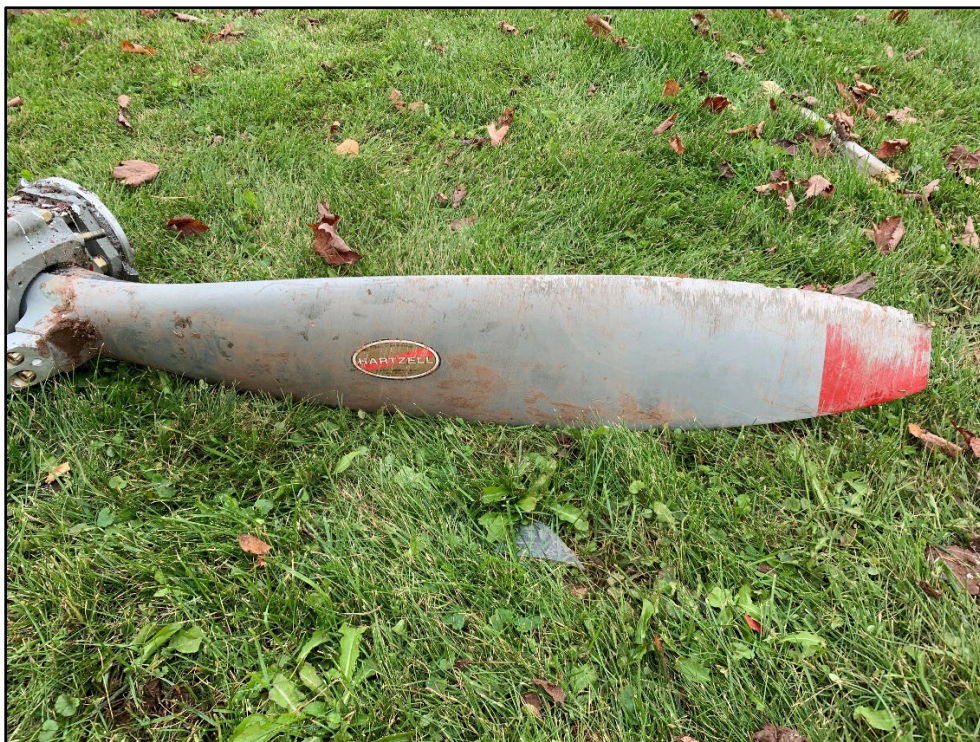
**Figure 8.** Propeller Blade
