**GROUP CHAIRMAN'S FACTUAL REPORT OF  
INVESTIGATION**

**CEN22FA019**

### Specialist's Factual Report

Location: Marengo, Wisconsin  
Date: October 23, 2021  
Aircraft: American Champion Aircraft 8KCAB  
Registration: N843AC  
Operator: Private  
NTSB Number: CEN22FA019

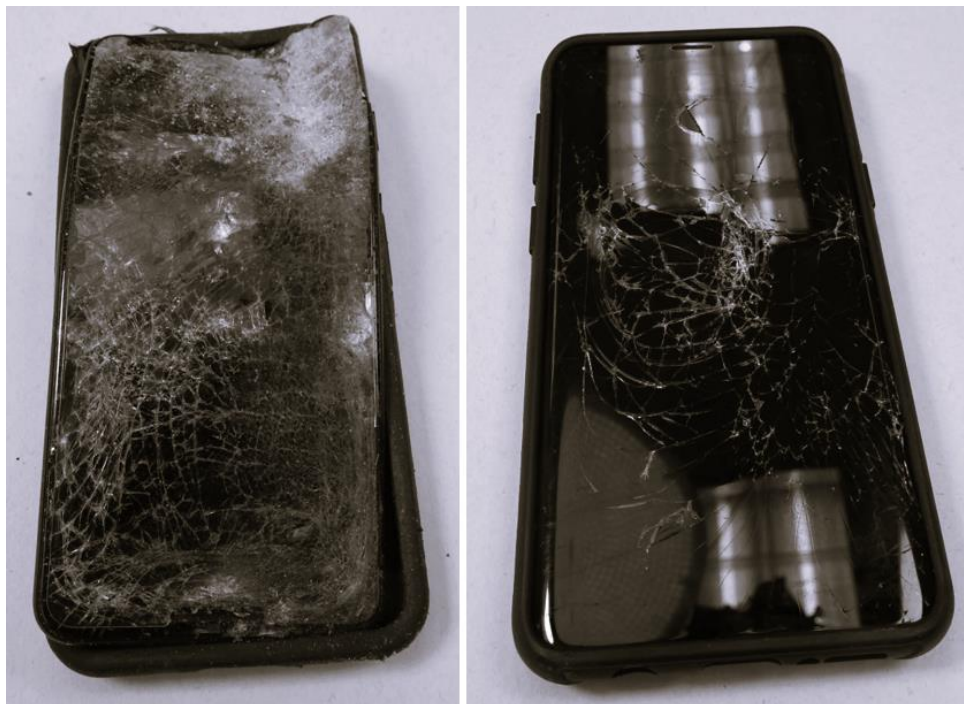
Upon arrival at the NTSB Vehicle Recorder Division, both PED devices showed signs of impact damage. Figure 1 shows the pilot's PED on the left and the passenger's PED on the right. The motherboard of the pilot's PED was removed, and the damage presented on the motherboard showed that it would require a chip-level data recovery procedure. However, the lab was notified that the passcode of the PED was unknown, thus no further data recovery procedure for pilot's PED was attempted. The passenger's PED powered up normally and was operable despite the scattered screen. The PED was unlocked with a passcode provided by family members, and the data were extracted using laboratory tools.

**Figure 1: Pilot's PED (left) and passenger's PED (right) upon arrival at the laboratory.**

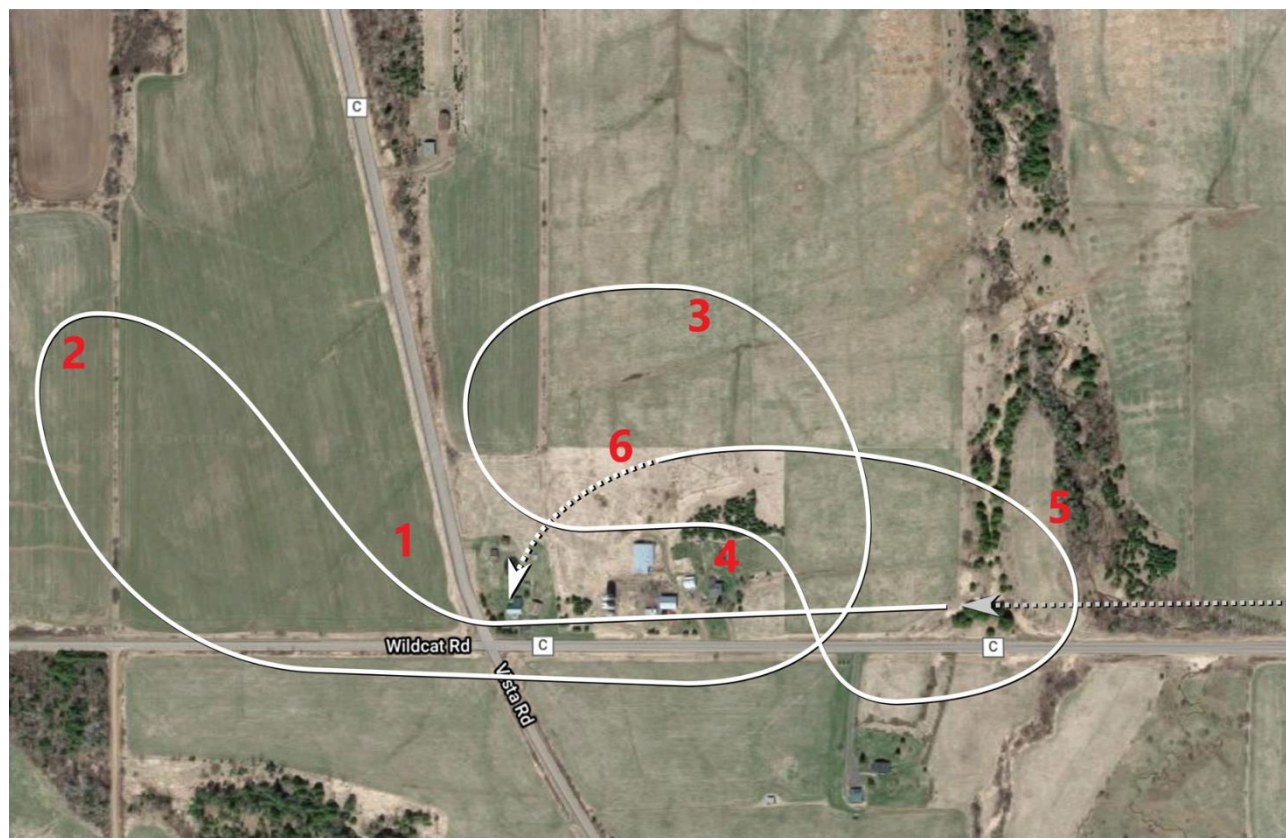
**Figure 2: Estimated flight path with turn numbers in the vicinity of the accident location. Note that the flight path is not drawn to scale and the aircraft may have crossed geographic landmarks not depicted in the figure. Also note that the latest available aerial imagery was from 1985 and may not accurately depict structures in the vicinity of the accident site.**

Figure 2 has numbers listed on the flightpath. These numbers chronologically list the number of turns the accident aircraft made during the onboard recording. Table 1 lists the turn number and the estimated bank angle of each turn. The bank angle was estimated by using a protractor which measured the aircraft bank with respect to the horizon. A positive angle indicates as right bank while a negative angle indicates as left bank. The maximum bank angle of each turn is represented in the table.

**Table 1: Estimated bank angle at each turn.**

| Turn # | Estimated Bank Angle |
| 1 | at least 55 degrees |
| 2 | at least -70 degrees |
| 3 | at least -80 degrees |
| 4 | unknown due to camera angle |
| 5 | about -45 degrees |
| 6 | accident maneuver, camera lost horizon.<br>at least -80 degrees |

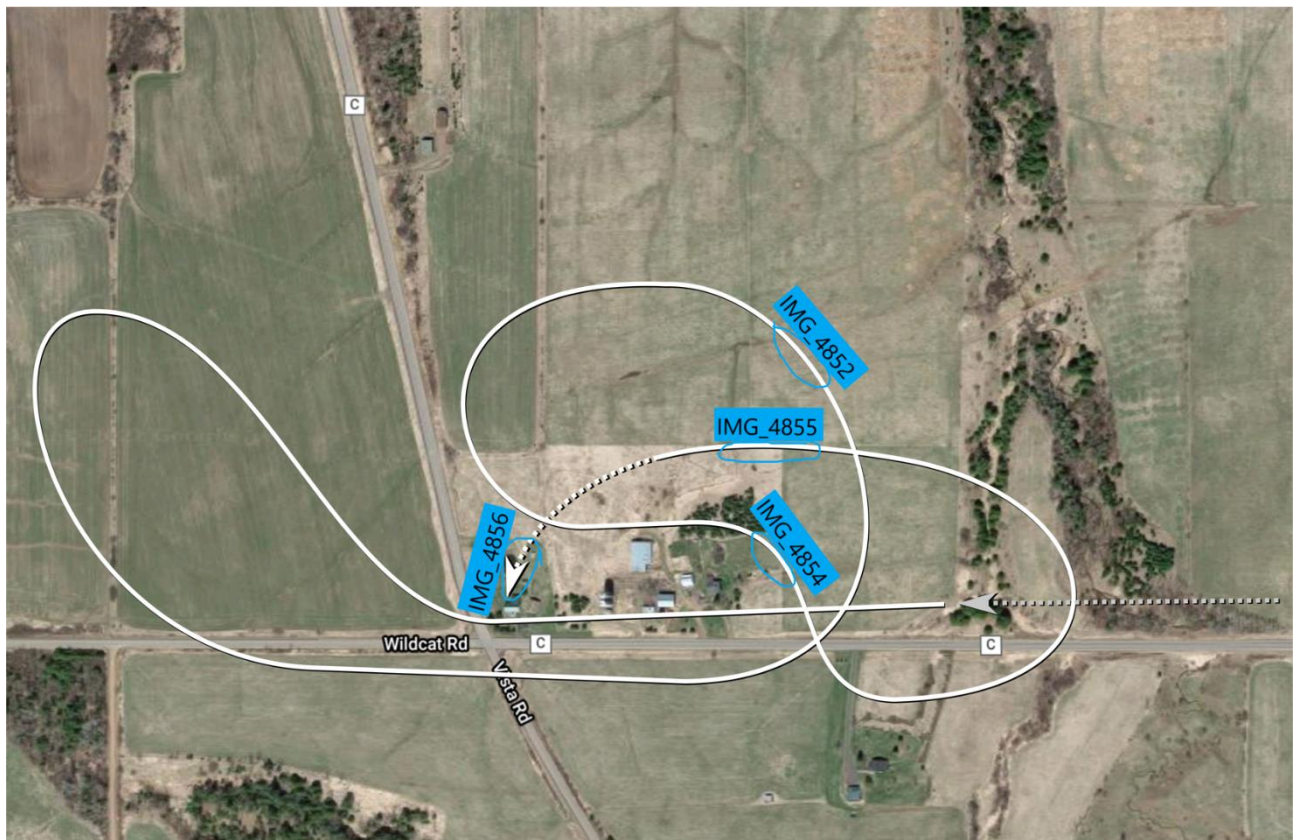
Several live photos<sup>1</sup> taken by a ground observer were sent to the NTSB, capturing the accident aircraft maneuvers in the vicinity of the accident location. Figure 3 contains estimations of the accident aircraft's locations when the ground live photos were taken by the ground witness. The image file numbers are listed on the depictions of the aircraft's flightpath in the vicinity of the estimated accident aircraft's locations. The live photos are appended below in this report as their filename, rather than a figure number. Additionally, short movie files created from the live photos are appended to this report as attachments 1-4. The attachments are listed based on their corresponding filename. The person in the live photos have been redacted.

**Figure 3: Estimated accident aircraft locations when the live photos were taken. Note that the flight path is not drawn to scale and the aircraft may have crossed geographic landmarks not depicted in the figure. Also note that the latest available aerial imagery was from 1985 and may not accurately depict structures in the vicinity of the accident site.**
