**NATIONAL TRANSPORTATIONS SAFETY BOARD**  
**Office of Aviation Safety**  
**Washington, DC 20594**

**SUMMARY OF EXAMINATION**

-- CEN22FA021 --

Location: Lena, Wisconsin  
Date: October 27, 2021  
Time: 1817 central daylight time  
Aircraft: Beech B36TC (s/n EA-402), N75RM

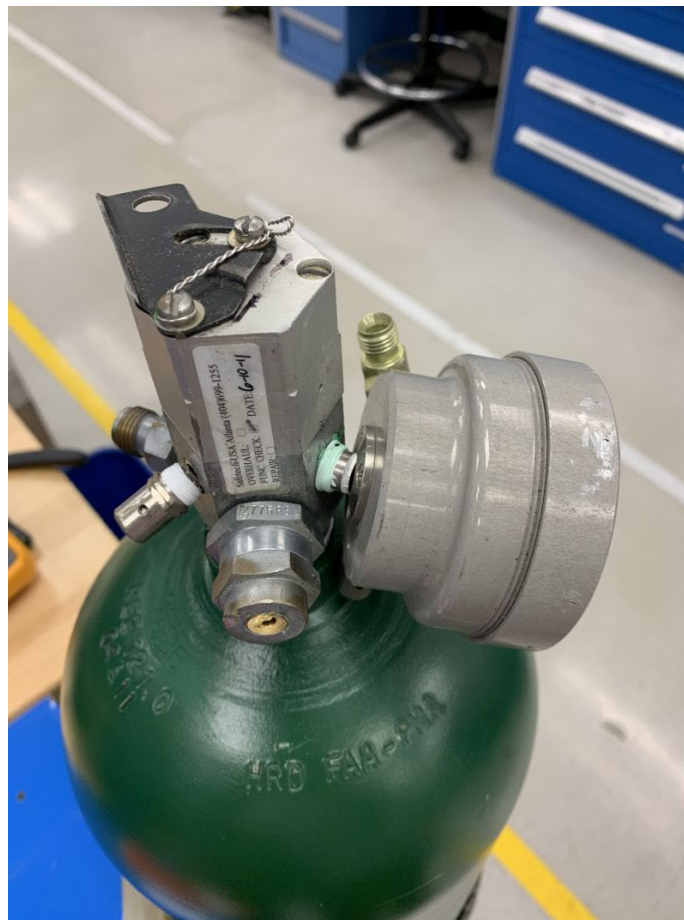
*Figure 1 – Cylinder Assembly (As Received for Testing)*

The oxygen cylinder with the valve, cylinder regulator, and altitude compensating regulator were received for examination in the as-shipped condition.<sup>1</sup> The valve/cylinder regulator assembly was securely attached to the cylinder. It was disassembled from the cylinder to facilitate further examination. Visual examination of the cylinder revealed no deformation or evidence of emergent/unrepaired cracking. Areas appeared to have been touched up with paint. No other anomalies were observed.

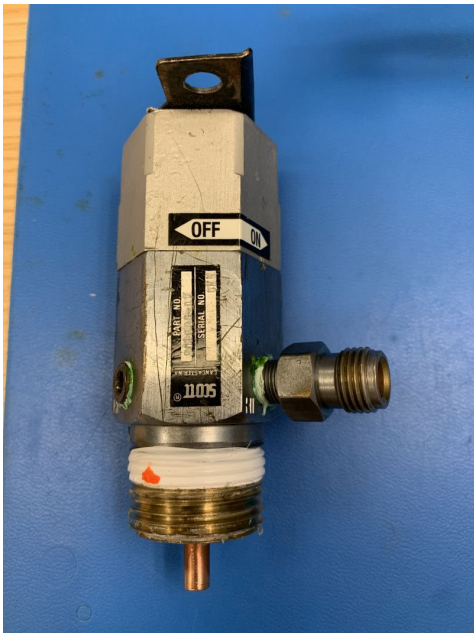
*Figure 2 – Cylinder Valve/Regulator Assy  
(As Removed from Cylinder)*

The cylinder valve and regulator housing appeared intact. The cylinder valve rotated freely.<sup>2</sup> Several fittings were fractured and partially separated. The low-pressure relief valve threaded attachment fitting was fractured. The relief valve appeared otherwise intact. The high-pressure relief line attachment fitting was fractured.<sup>3</sup> The high-pressure relief valve assembly appeared otherwise undamaged. The valve assembly was removed, and the burst disc was intact. The altitude compensating regulator was partially separated at the threaded attachment fitting. It was disassembled from the cylinder valve housing to facilitate further examination. The tank fill port fitting was secure and the valve intact. Fitting threads exhibited PTFE tape consistent with current assembly procedures. The fittings also exhibited an unknown green compound not in use by the manufacturer.

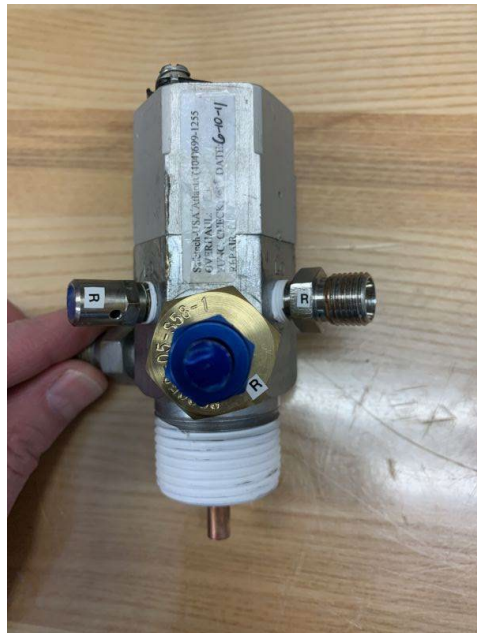
*Figure 3 – Cylinder Valve/Regulator Assy  
(As Prepared for Testing)*

The low-pressure relief valve was removed and replaced with an exemplar valve for testing. The high-pressure port common to the high-pressure relief valve was capped for testing. The assembly was placed into the testing apparatus with supply pressure provided at the valve inlet as specified by the test procedure. Pressure and airflow were measured at the low-pressure outlet common to the altitude compensating regulator inlet port. The cylinder valve was positioned as observed during the on-scene examination. Testing revealed that the cylinder regulator outlet pressures were within the specified range at each data point.<sup>4</sup> The cylinder valve functioned properly with downstream pressure reduced to zero within 30 seconds of moving the valve to the OFF position as required.

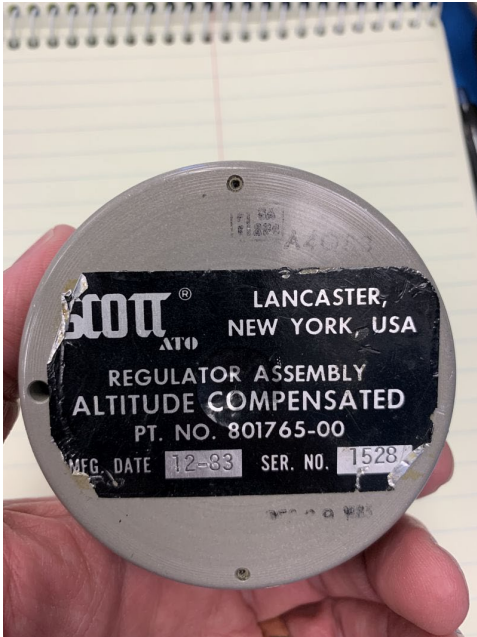
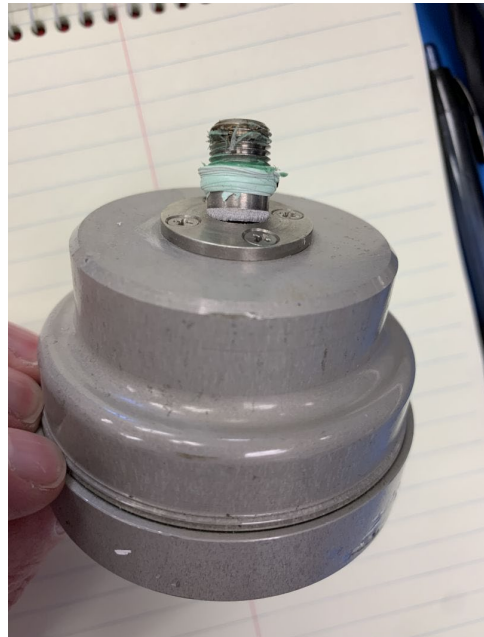
**Figure 5 – Altitude Compensating Regulator**  
*(As Removed from Valve Assy)*

The altitude compensating regulator housing appeared intact. However, the threaded inlet fitting and the low-pressure relief valve were damaged consistent with impact forces. Fitting threads exhibited PTFE tape consistent with current assembly procedures.

However, the fittings also exhibited an unknown green compound not in use by the manufacturer. The fittings were replaced to facilitate testing.

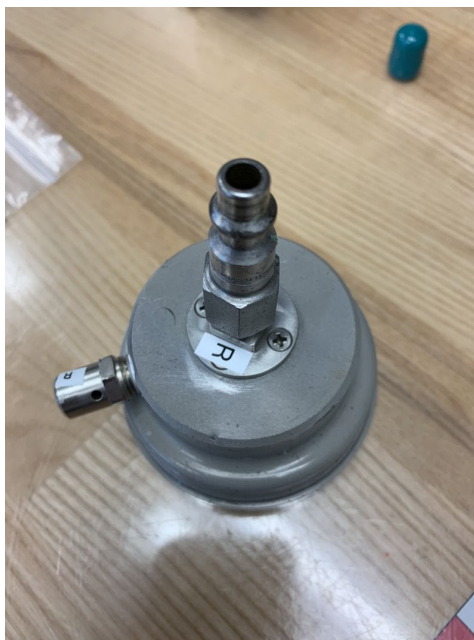
**Figure 7 – Altitude Compensating Regulator**  
*(As Prepared for Testing)*

The regulator was placed in the testing apparatus with supply pressure provided to the regulator inlet as specified by the test procedure. Ambient pressures corresponding to the discrete testing set points corresponding to altitudes of 1,000 ft to 35,000 ft. were applied to the regulator. At the specified flow rate, the outlet pressure at the 1,000 ft. and 8,000 ft. set points were within the specified test range. At 12,500 ft., the outlet pressure was about 2.5% below the specification. At 20,000 ft., the outlet pressure was within 0.14% of the specification. At 35,000 ft., the outlet pressure was within 1.2% of the specification.<sup>5</sup>
