# National Transportation Safety Board

CEN22FA021

## **MATERIALS LABORATORY**

Factual Report 22-077

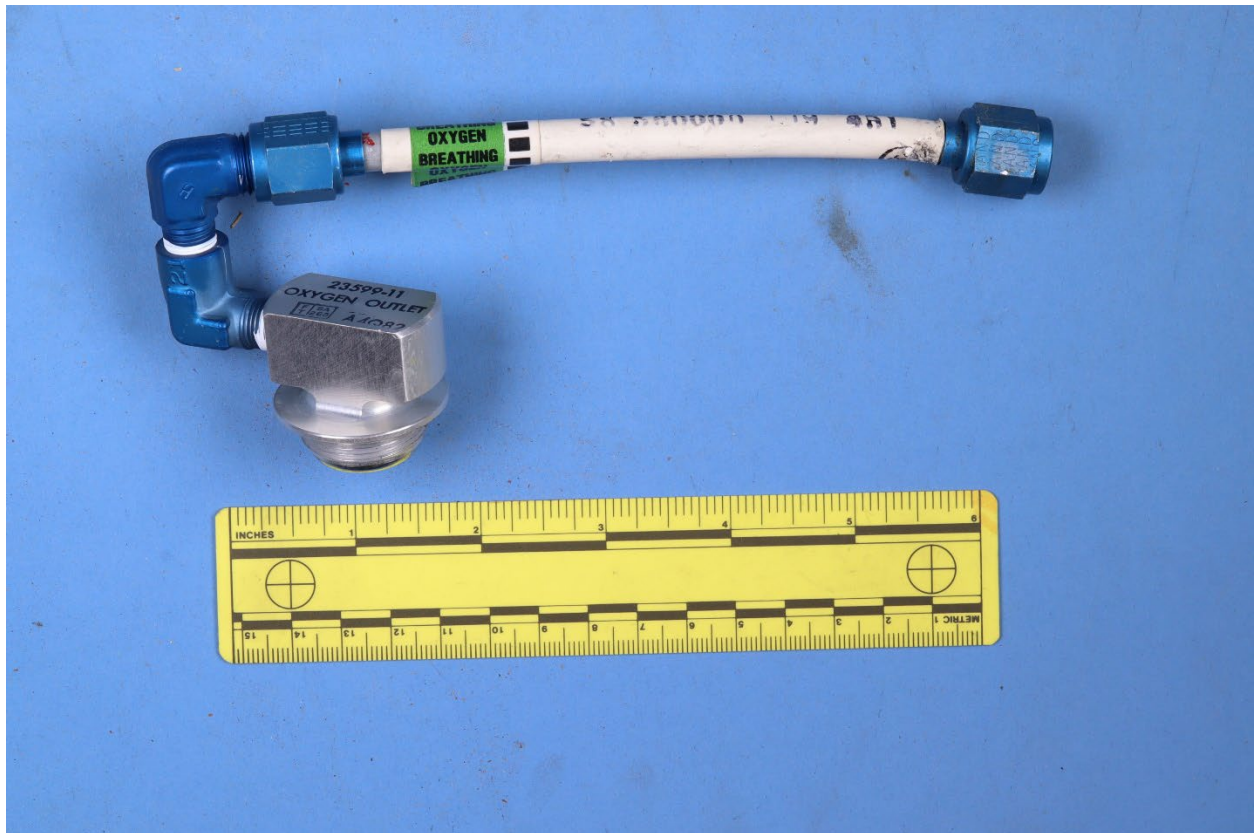
Pilot side oxygen fitting assembly (Figure 1)

**Figure 1.** Pilot side oxygen fitting assembly as received.

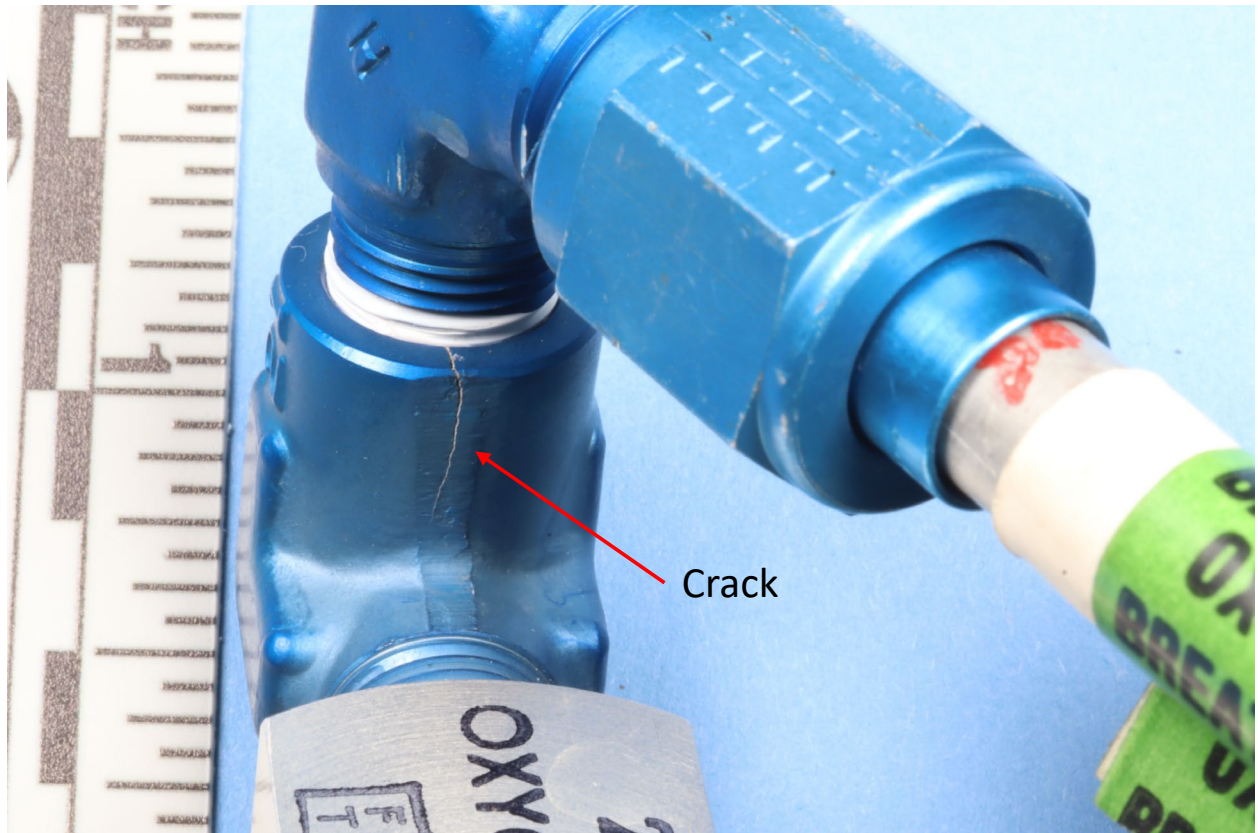
The pilot side oxygen fitting in question was a ninety-degree elbow fitting with an NPT male thread on one end and an NPT female thread on the other. The portion of the fitting with the NPT female thread exhibited a crack extending from the open end of the fitting towards the center (Figure 2).

**Figure 2.** Cracked ninety-degree elbow fitting.

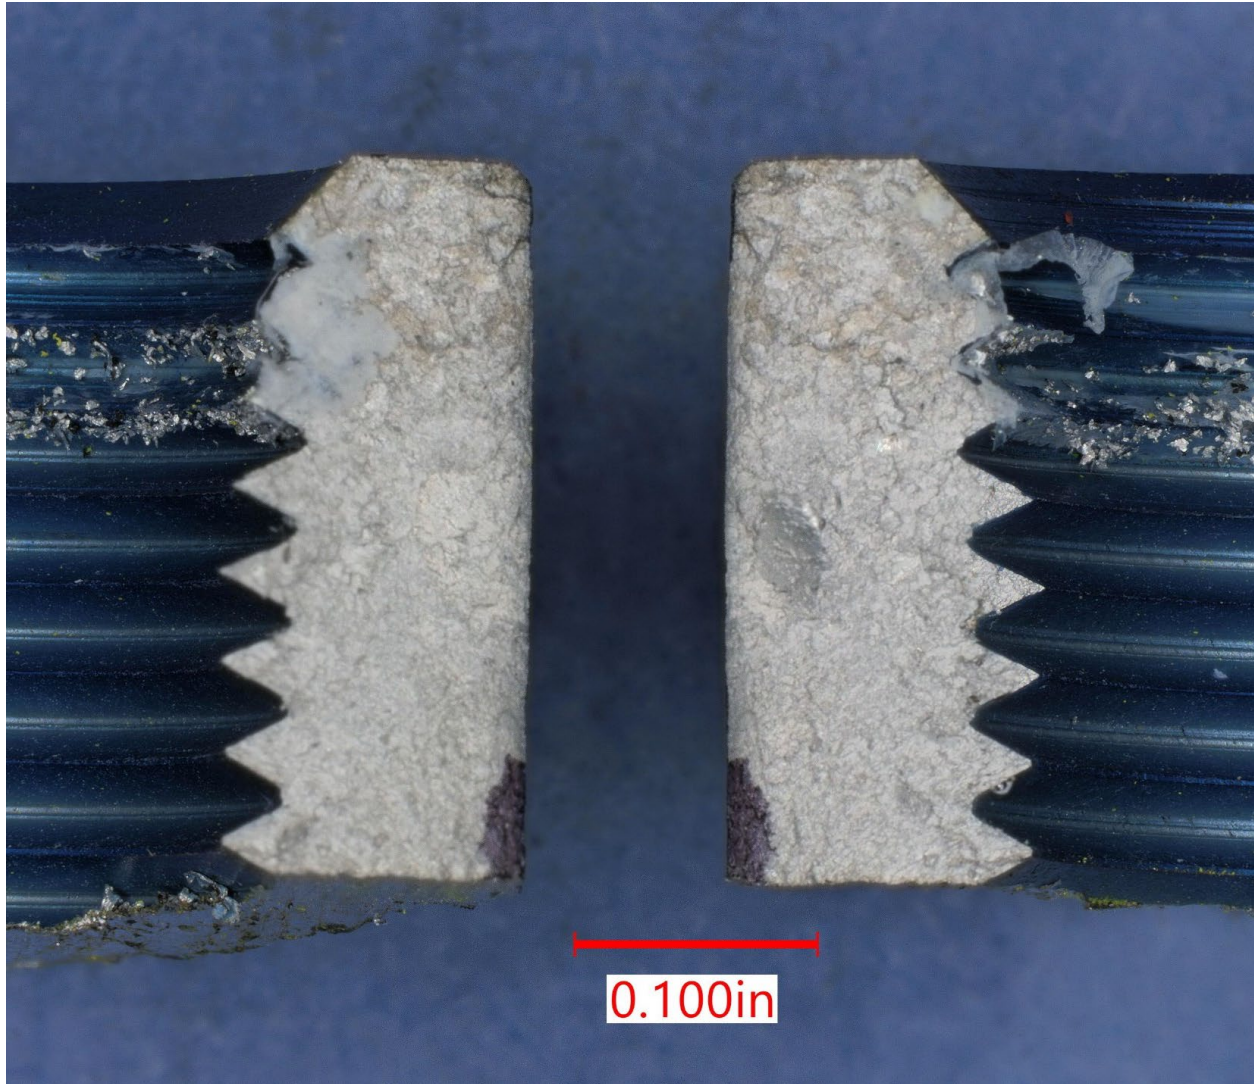
The female threaded end of the fitting was sectioned where the crack terminated and separated from the rest of the elbow fitting. The crack was then opened for examination (Figure 3). The fracture faces exhibited a duller appearance for the first couple threads into the crack after which the appearance was brighter. One side of the fracture surface exhibited an area with Teflon thread sealant embedded onto the surface (Figure 4). The area exhibiting the embedded Teflon thread sealant began at approximately the first thread and extended down to the third thread. The area exhibiting the embedded Teflon thread sealant did not extend the full width of the crack.

**Figure 3.** Crack opened for to reveal both halves of the fracture surface.

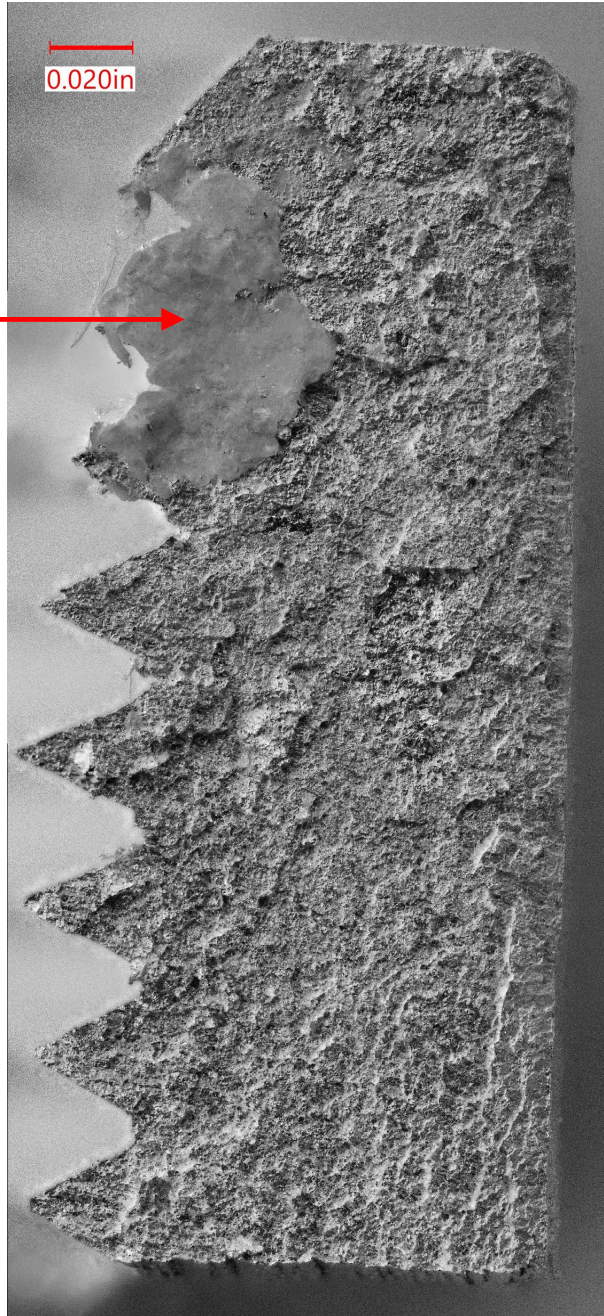
Teflon tape  
residue

**Figure 4.** Fracture surface with embedded Teflon thread sealant.

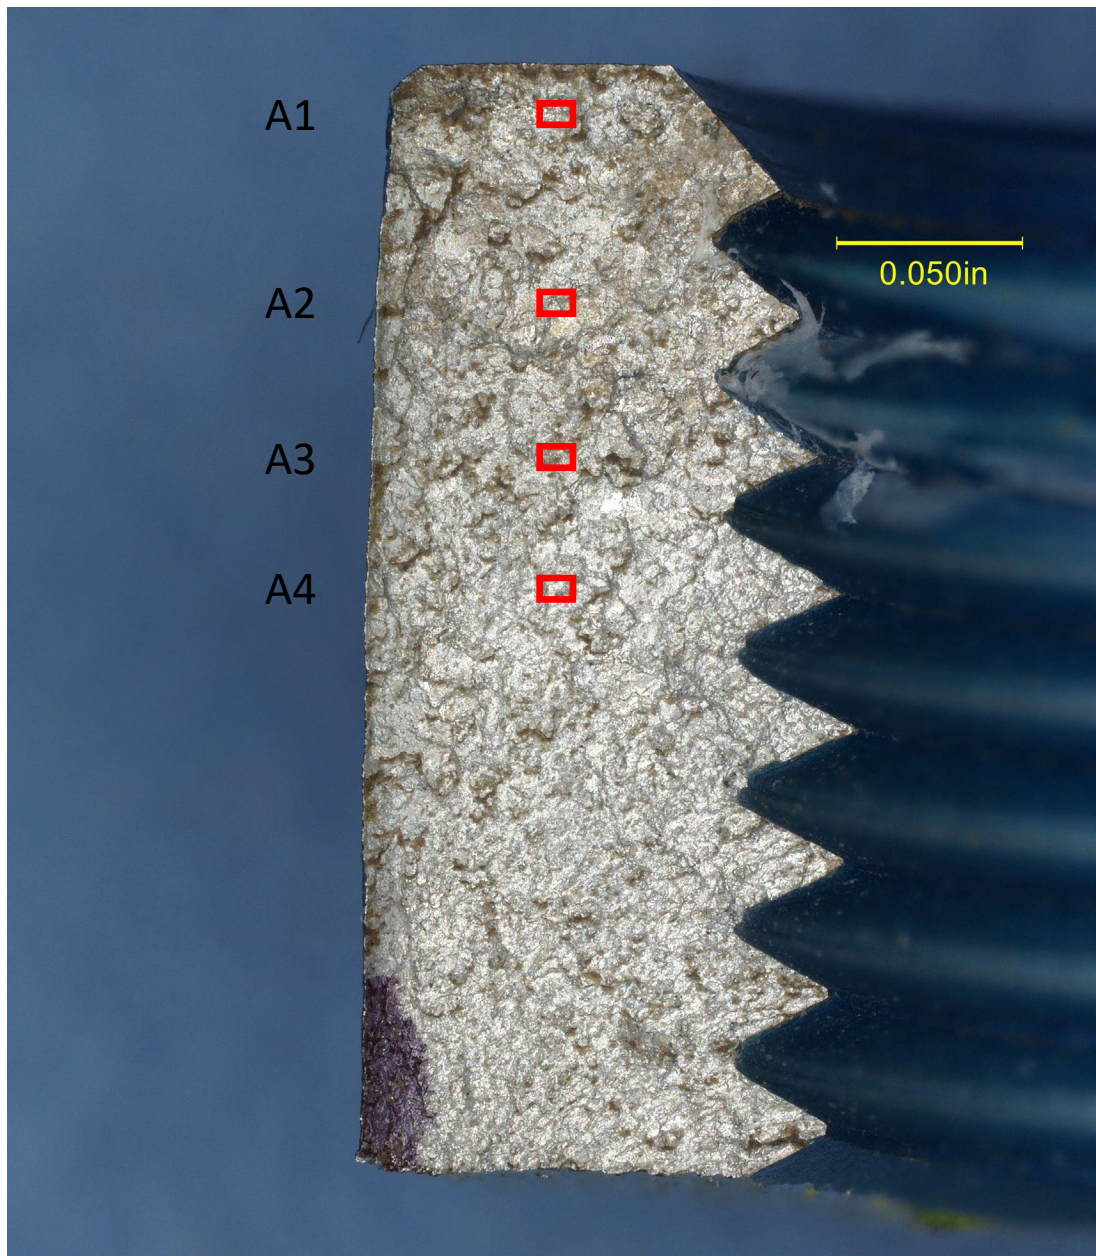
**Figure 5.** Fracture surface indicating approximate areas of SEM examination.

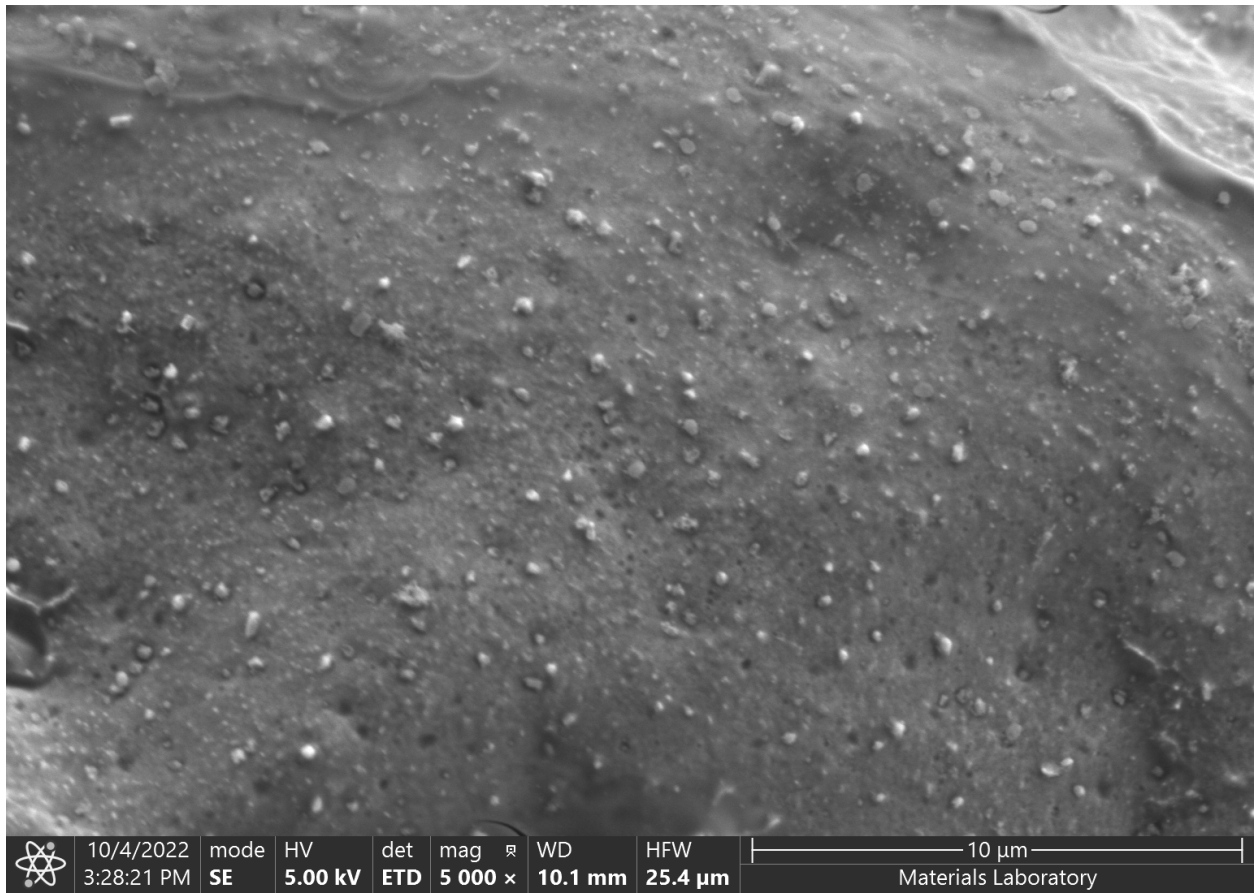
The fracture surface half that did not contain the embedded Teflon thread sealant was examined using a scanning electron microscope (SEM). Figure 5 depicts the approximate areas (labeled A1 through A4) where photomicrographs were taken. In area A1 (Figure 6) the fracture surface was smooth and featureless without the presence of fracture features, such as ductile dimples. The featureless fracture surface in area A1 is consistent with a casting defect in that area. Area A2 (Figure 7) exhibited

**Figure 6.** Secondary electron SEM photomicrograph of area A1 (See Figure 5). No fracture features were observed.

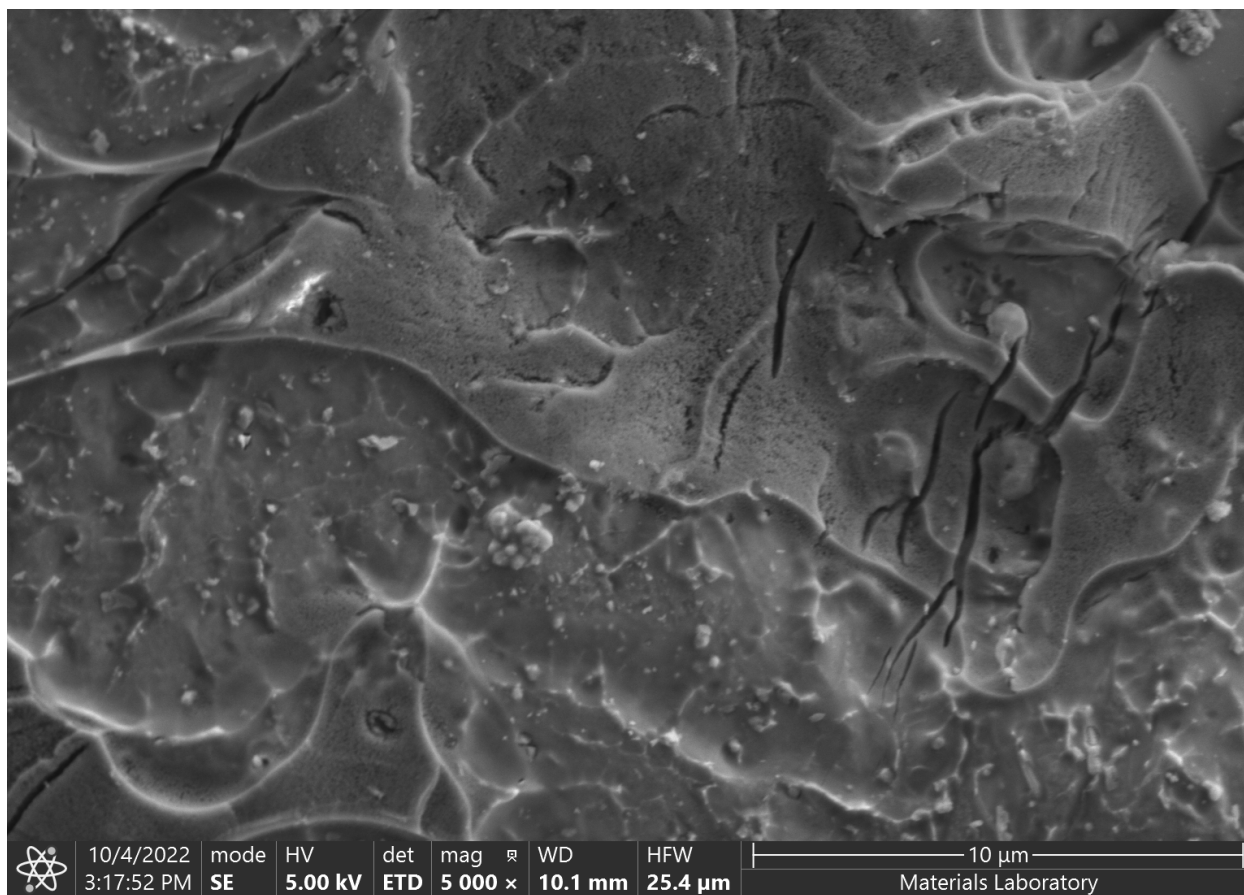
similar characteristics to area A1 but with more features. Area A3 (Figure 8) exhibited ductile dimples consistent with an overstress fracture. Area A4 (Figure 9) also exhibited ductile dimples consistent with an overstress fracture.

**Figure 7.** Secondary electron SEM photomicrograph of area A2 (See Figure 5). The fracture face is largely featureless with some ridges present.

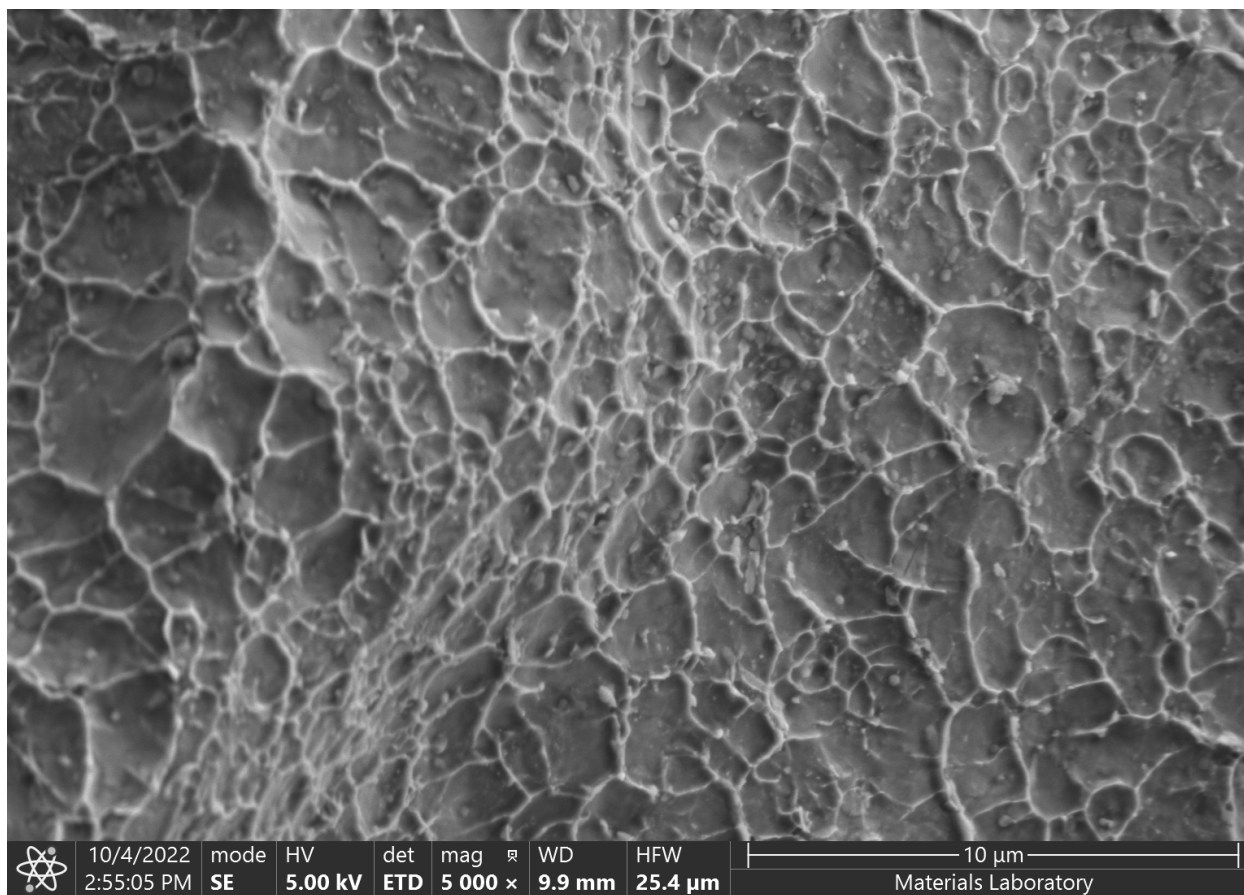
**Figure 8.** Secondary electron SEM photomicrographs of area A3 (See Figure 5). Dimple rupture features indicative of microvoid coalescence fracture are present across the field of view. Such features indicate ductile overstress fracture.

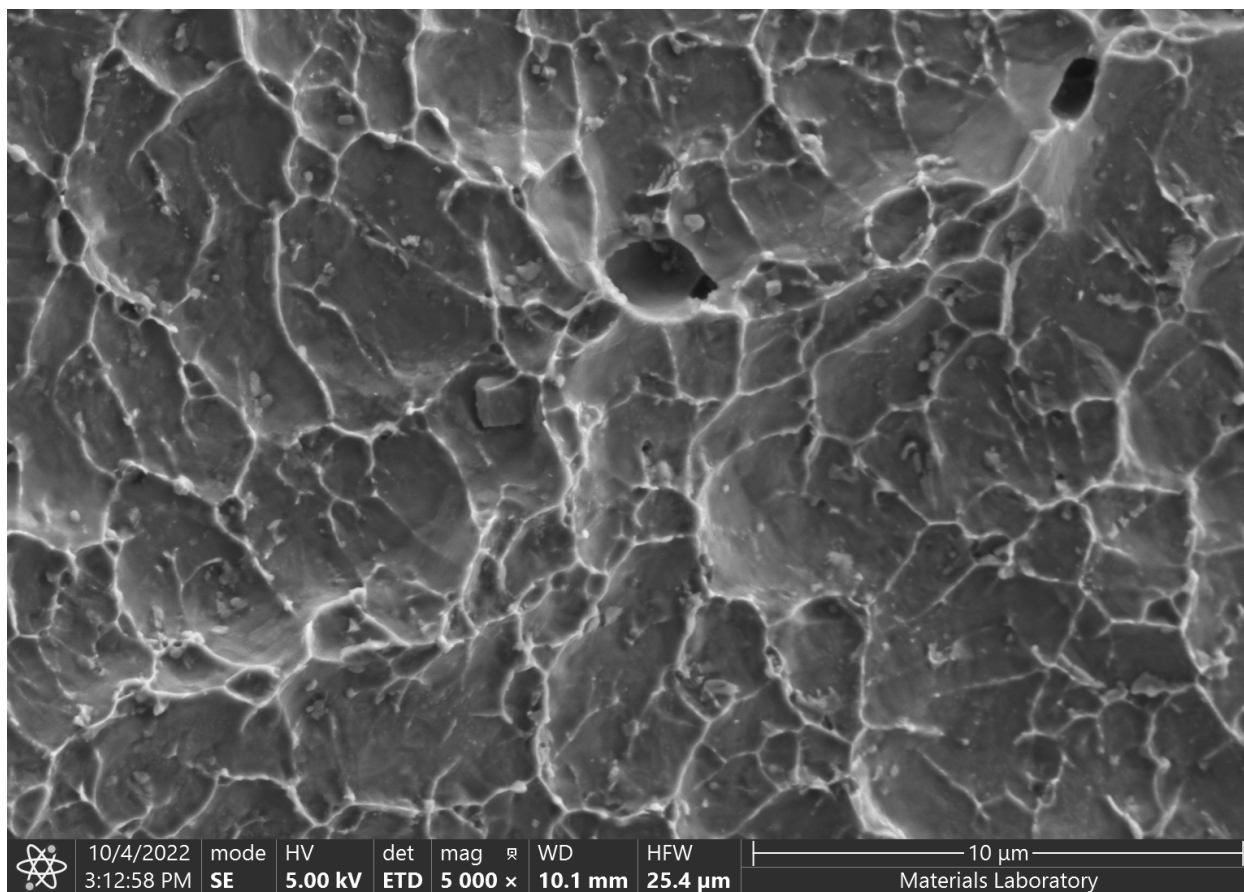
**Figure 9.** Secondary electron SEM photomicrographs of area A4 (See Figure 5). Dimple rupture features indicative of microvoid coalescence fracture are present across the field of view. Such features indicate ductile overstress fracture.

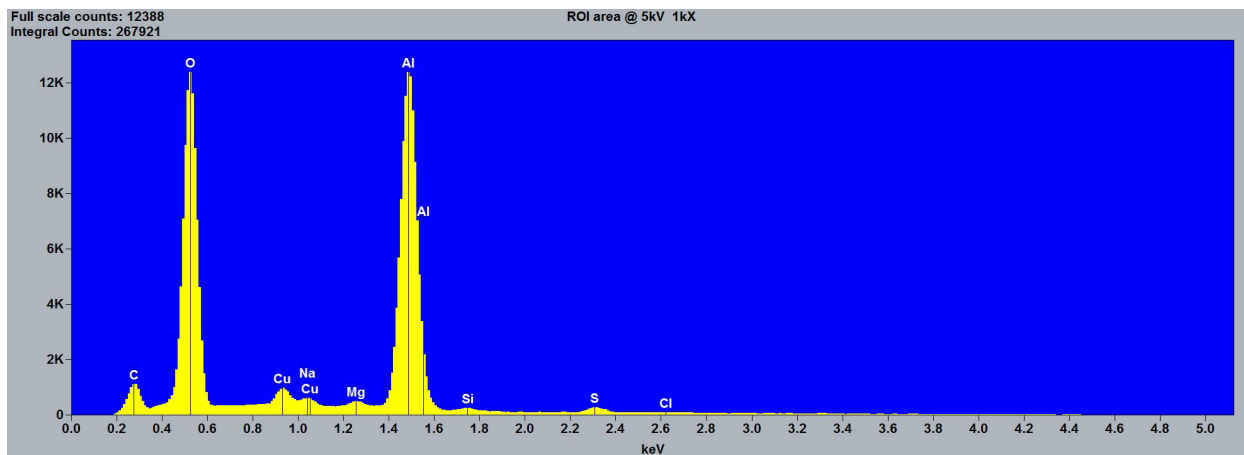
Energy dispersive spectroscopy (EDS) was performed on areas A1 and A4. The spectrum for area A1 revealed a major oxygen peak, consistent with the presence of aluminum oxide. The spectrum for area A4, with a trace oxygen peak, is typical for a fractured aluminum alloy.

**Figure 10.** EDS spectrum from area A1.

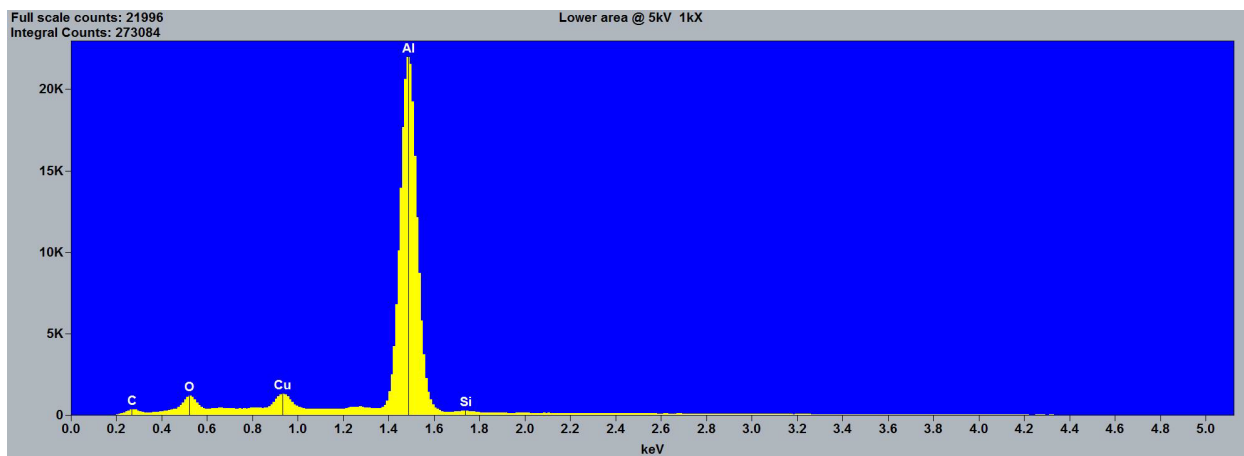
**Figure 11.** EDS spectrum from area A4.
