# National Transportation Safety Board

CEN22FA029

## **AIRCRAFT EXAMINATION NOTES**

Location: Harrison, Michigan  
Date: November 5, 2021  
Time: 0930EDT  
1330 UTC  
Airplane: Van's RV-6, N16TG

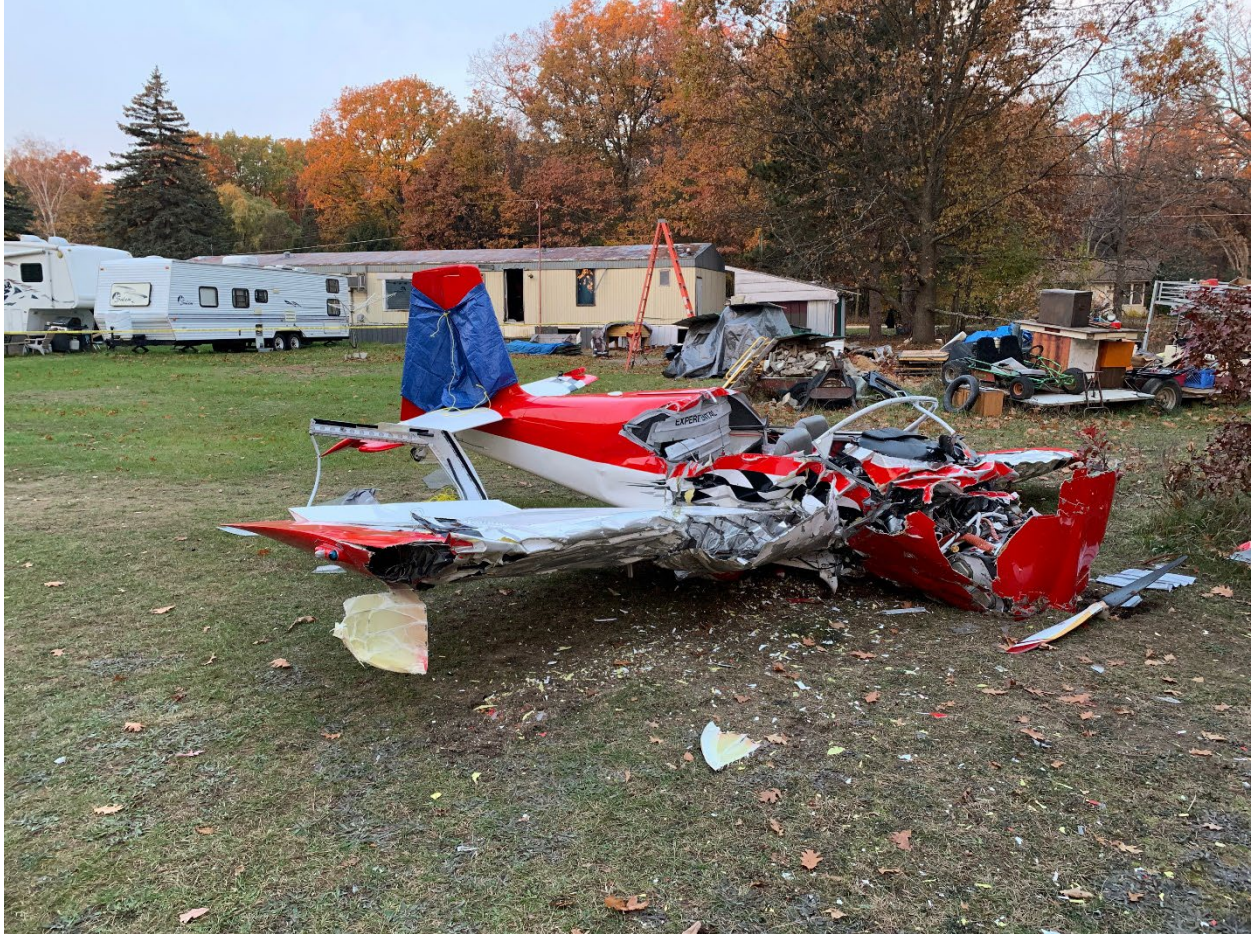
The airplane impacted the back yard of a residence. The terrain was level and impact signatures indicated that the airplane struck the ground about 45 degrees nose low. The initial impact point was located directly beneath the airplane.

Figure 1 Overall view of accident site (NTSB Photo)

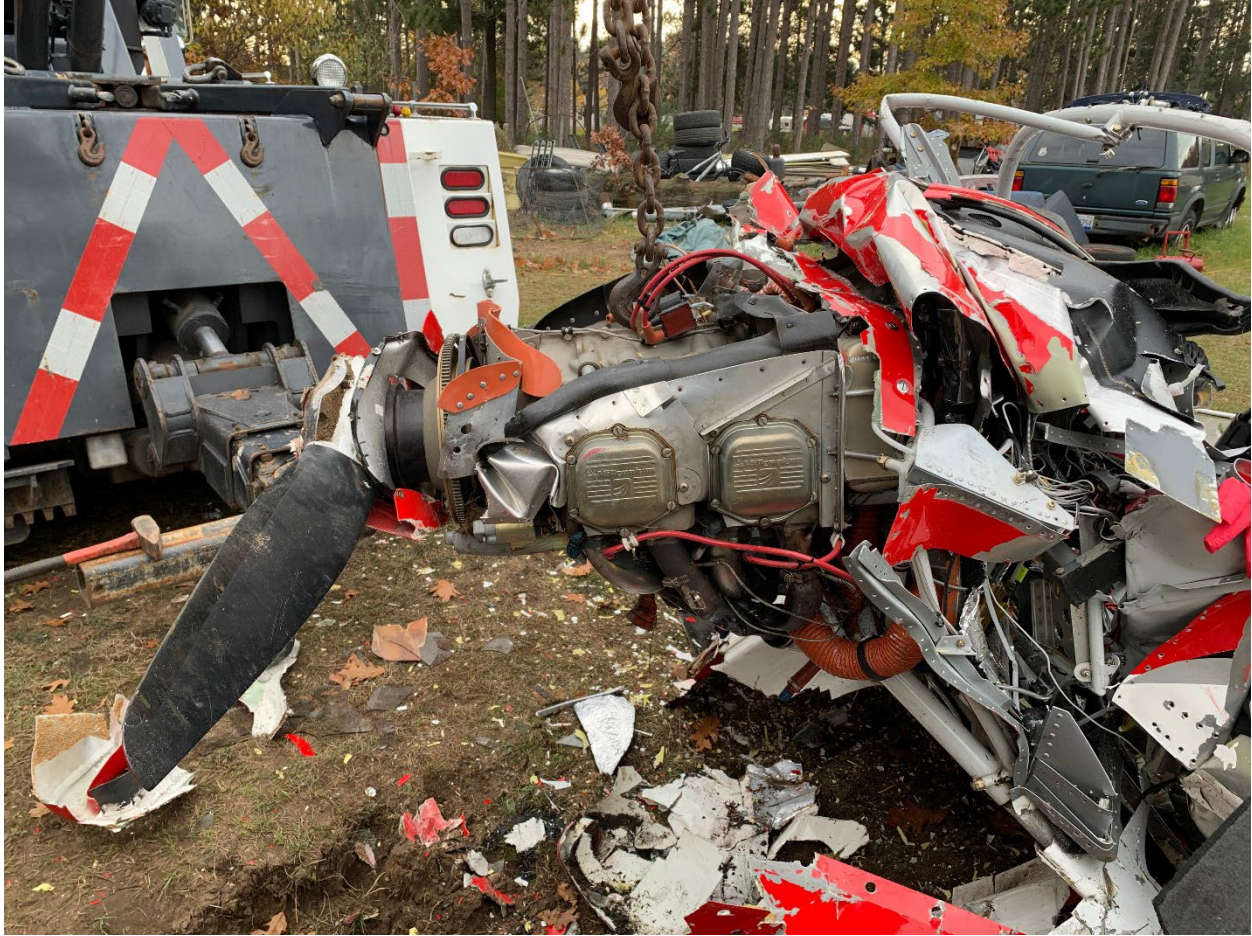
The front of the airplane was suspended using a tow truck to gain access to the engine and allow rotation. The engine crankshaft could be rotated using the propeller. The top set of spark plugs was removed. The spark plugs were automotive type spark plugs and exhibited normal coloration. The engine was rotated, and suction and compression could be felt through the open spark plug holes on all cylinders.

Figure 2 Engine during examination (NTSB Photo)

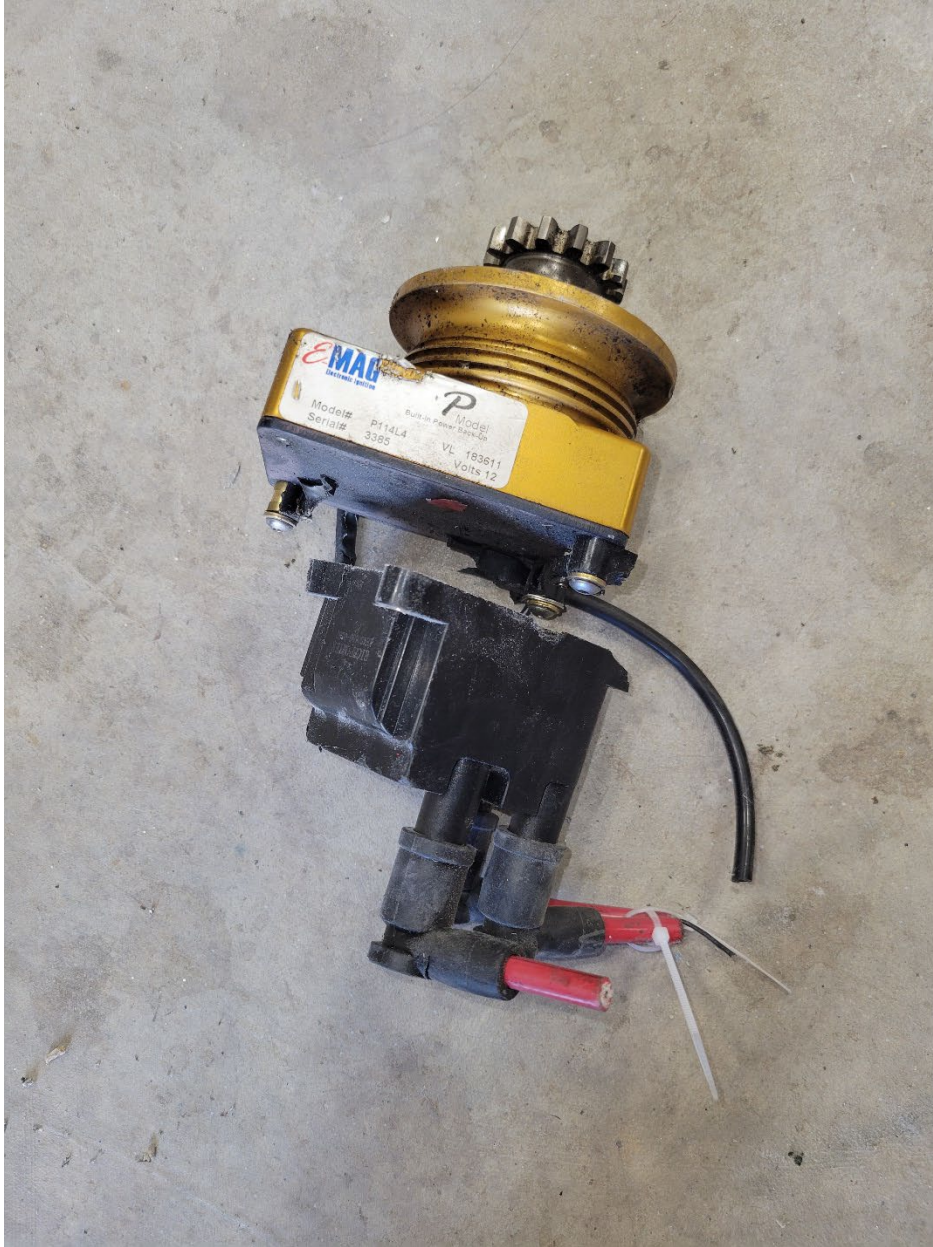
The second ignition system was a E-Mag model P114L4, Serial number 3385. This was an electronic ignition system that replaced an original magneto. The system utilized ship electrical power for starting and low (idle) power running. According to the manufacturer, after about 800 rpm, the internal alternator within the E-mag would produce enough output to run the engine and switching from ship electrical power to the internal alternator was automatic. The E-mag from the accident airplane was damaged during the accident and the mounting ears of the coil pack were broken. One ignition lead tower and connector were broken for cylinders 3-4. The ignition lead towers for cylinders 1-2 were intact. The cable from the coil to the main part of the unit was intact and the wires were damaged but unbroken. The main harness

connector was broken. The unit was tested by installing test wires into the main harness connector for ground and 12V connections. The tach and P-lead connections were left disconnected. The ignition leads for the 1 and 2 cylinders were stripped back exposing the inner radio suppression core and the core of each lead placed in close proximity to each other to simulate the spark plug gaps. Power was applied and the LED on the back of the unit flashed a series of different colors and then went dark. According to the manufacturer this indicated that the unit performed its internal self-check and the observed flashing and then remaining dark was normal since the p-lead was not connected. The input gear was rotated, and a series of sparks was generated at the ignition leads. The manufacturer was questioned about the spark produced and it was explained that at low rpm, the system creates a series of 5 sparks in very rapid succession to aid in low rpm ignition and that at higher rpms it reverted to a single spark. This description was consistent with the observed spark during hand rotation. To test the operation of the internal alternator, an electric drill was used to spin the input shaft of the E-mag with power applied to the 12v and ground terminals. Spark was established and with the drill still operating at full rpm (drill rated for 950 rpm), the 12V power was disconnected and the unit continued to produce sparks from the cylinder 1-2 ignition leads. This indicated that the internal alternator was functioning.

Figure 3. E-Mag ignition system removed from the accident airplane. (NTSB Photo)

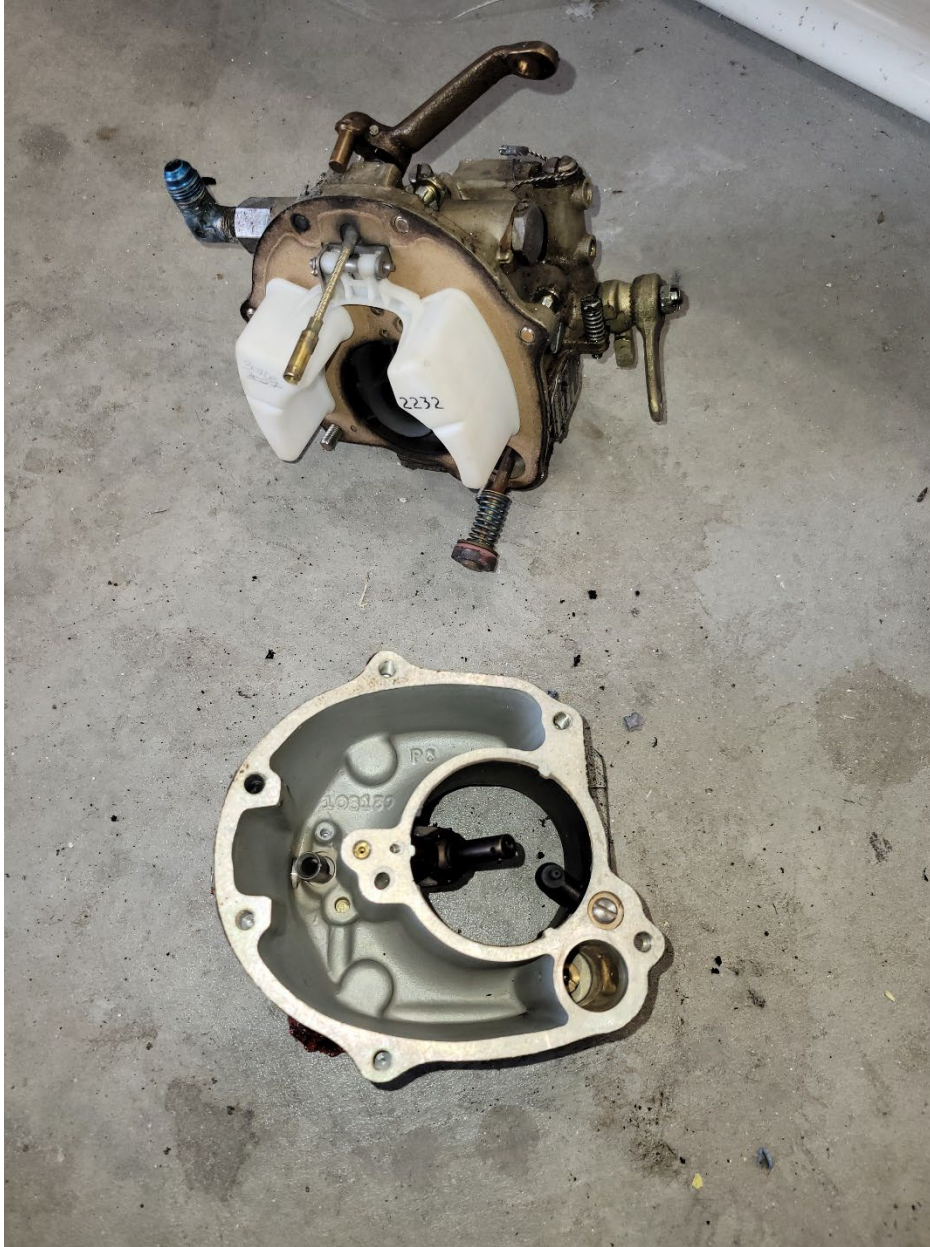
The engine carburetor had one mounting ear broken off during impact. The carburetor controls were still attached with no defects noted. The carburetor bowl was removed and examination of the carburetor and internal components didn't reveal any defects.

Figure 4. Disassembled carburetor (NTSB Photo)
