# National Transportation Safety Board

CEN22FA053

## **HYDRAULIC SERVO EXAMINATION**

Specialist's Factual Report

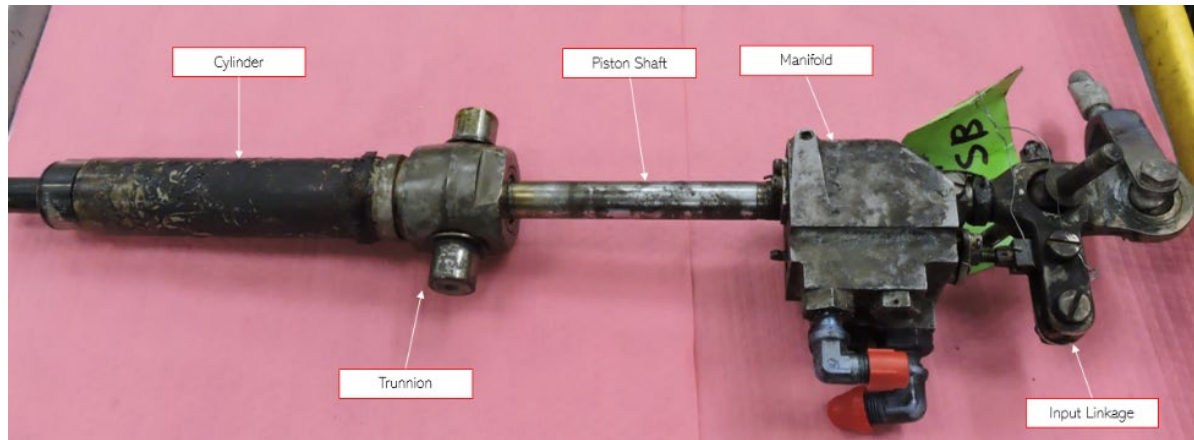
The servo was manufactured by Hydraulic Research & Mfg Co., part number (PN) 4100067015-XX (dash number was illegible), and serial number (SN) 2023 (Figure 2). The servo was covered in dark soot and had a light oil coating over the cylinder. All castellated nuts were cotter keyed. The primary spherical bearing was assessed to be very loose. The control rod that mates with the clevis shank was fractured at the top of the clevis shank. The input linkage moved manually within the normal range of movement (typical), was connected, and moved the spool. The trunnion lugs didn't appear to have heavy wear. The cylinder was measured as extended 4.4 inches from the cylinder face to manifold face. The servo was manually extended to full extension of 5.5 inch. No fluid drained during this action.

Figure 2. Right servo actuator as received.

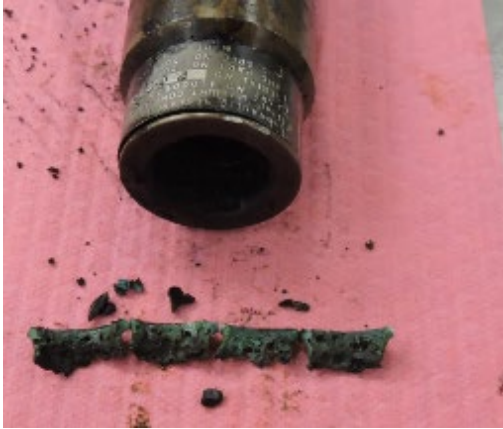
In the right actuator, there were indications of seal distortions and seal gaps in seals 1 and 2. Seals 3, 4, 5, and 6 appeared to have minimal anomalies.

The cylinder end gland scraper and seals were in good condition. The piston rod was in good condition with no scoring. The fluid ports were open and clear. The cylinder end gland (seal 1, Figure 3) exhibited heat damage, and the o-ring behind the Teflon was carbonized. Seal 2's blue Teflon sheathing was removed intact (Figure 4); the o-ring material behind it was carbonized.

Figure 3. Cylinder gland scraper seal (seal 1) stretched out, and carbonized o-ring fragments.

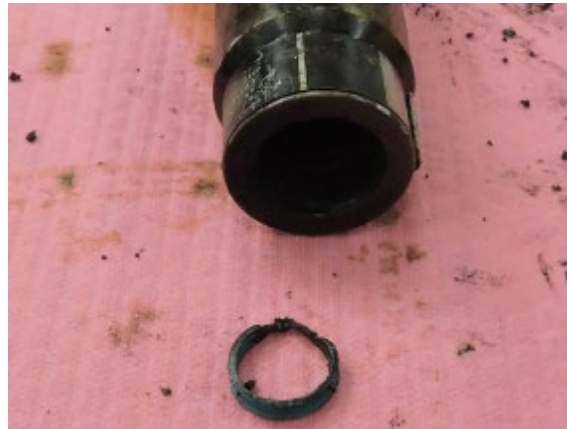
Figure 4. Cylinder gland primary seal (seal 2).

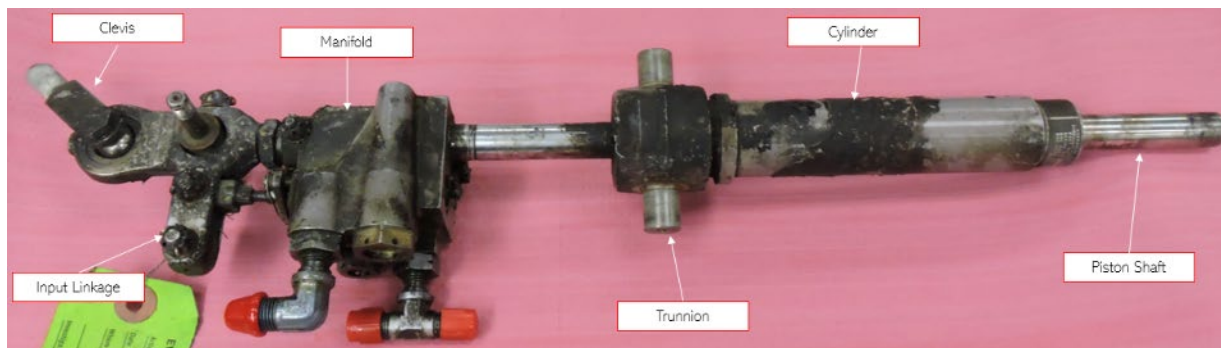
The servo was manufactured by Hydraulic Research & Mfg Co., PN 41000670-003, and SN 4233 (Figure 5). The servo was covered in a light amount of soot and a light layer of oil coating on the manifold. All castellated nuts were cotter keyed and safety wires were intact. The primary spherical bearing was assessed to be very loose. The control rod that mates with the clevis shank was fractured at the top of the clevis shank. The input linkage moved manually within the normal range of movement (typical), was connected, and moved the spool. The trunnion lugs didn't appear to have heavy wear. The cylinder was measured in the as-received extended position of 2.8 inches from the cylinder face to manifold face.

Figure 5. Middle servo as received.

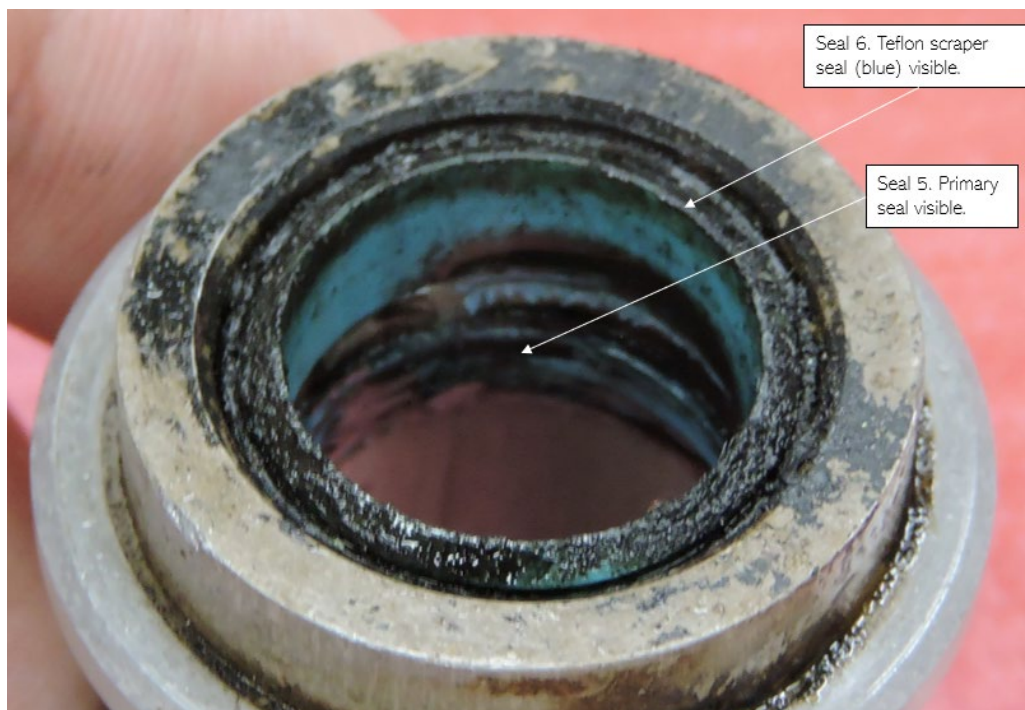
The trunnion was unscrewed from the power cylinder and the cylinder end gland was slid from the piston shaft. The piston shaft had interior oil/fluid present; black flakes/particles were observed in the oil. The black particles were non-substantive (not hard or granular). The end gland static o-ring (seal 4) appeared to have more wear than normally found. A brown surface coating was surrounding the piston head area. The coating was easily removed using a cloth or cotton swab. The primary seal (seal 5, Figures 6 and 7) was removed intact, both the outer Teflon and inner o-ring had pliable characteristics. The scraper seal (seal 6, Figures 6 and 8) was removed. It's o-ring was hard and broke during the removal. The cylinder end gland interior primary seal (seal 2) had visible damage to the blue Teflon. The scraper seal was removed (seal 1). The Teflon portion was removed whole and pliable; the o-ring portion was slightly stiff and broke while being removed. The Teflon portion primary seal (seal 2) was removed whole and was pliable. The backing o-ring was removed whole and was pliable. All seals were slightly damaged during removal.

Figure 6. End gland seals.

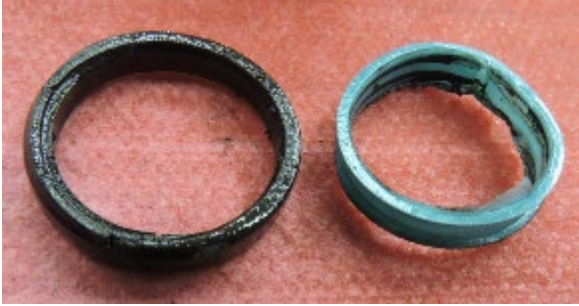
Figure 7. Seal 5, primary seal removed from the end gland.

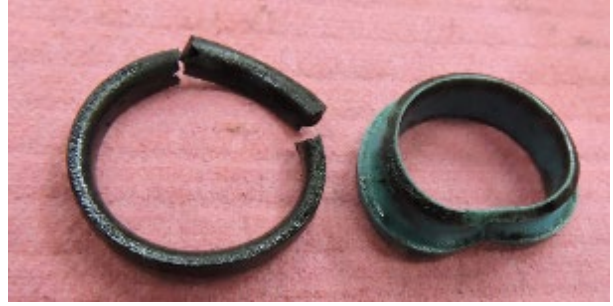
In the middle actuator, the seals appeared to have minimal anomalies except for seal 6 which had indications of voids throughout the seal.

Figure 8. Seal 6, scraper seal removed from the end gland.

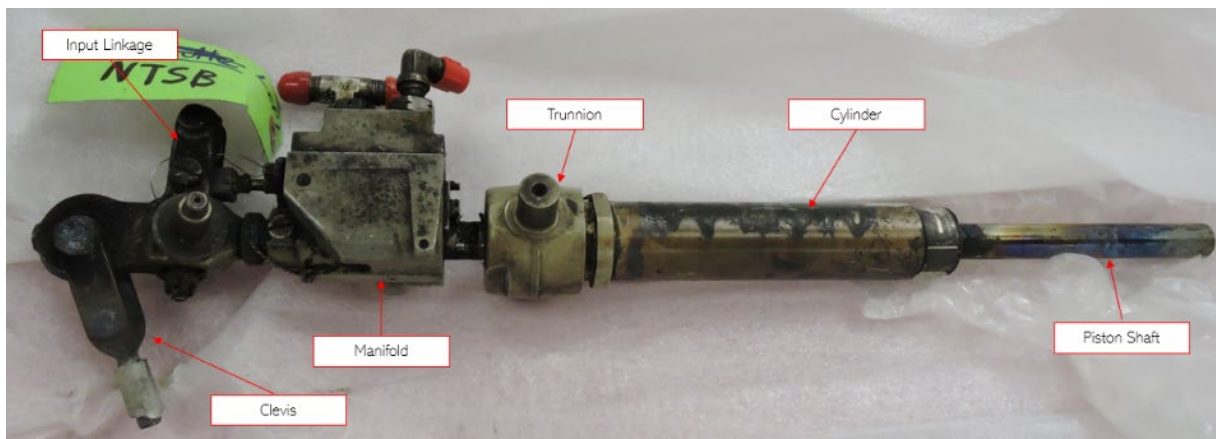
The servo was manufactured by Hydraulic Research & Mfg Co., PN 41000670-003, and SN 1789 (Figure 9). The servo was covered in a heavy amount of soot on the manifold and rod end linkage, with bluing of the metal on the end of the cylinder side piston shaft. All castellated nuts were cotter keyed and safety wires intact. Teflon o-ring material extruded out of the return port fitting. There was an extruded seal on the cylinder end gland. The primary spherical bearing was assessed to be very loose. The control rod that mates with the clevis shank was fractured at the top of the clevis shank. The input linkage moved manually within the normal range of movement (typical), was connected, and moved the spool. There was a heavy buildup of carbon like material around the cylinder end gland. The trunnion lugs didn't appear to have heavy wear. The cylinder was measured in the as-received extended position of 0.7 inches from the cylinder face to manifold face.

Figure 9. Left servo actuator as received.

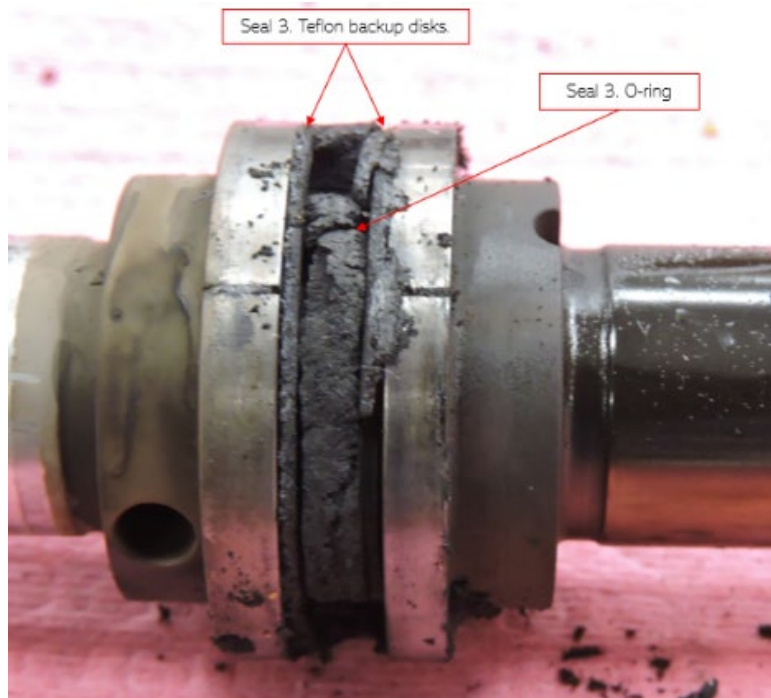
The trunnion was unscrewed from the cylinder, and the cylinder end gland was slid off the piston shaft. The piston shaft was then slid out of the cylinder. Black powder like debris dropped out of the cylinder once the piston was removed. The piston head seal and Teflon backup disks were present; the o-ring elastomer was brittle and broke apart into chunks (Figure 10). Seal 4 was in the same condition as seal 3. Brownish discoloration was observed on the piston rod on either side of the piston head.

Figure 10. Piston and piston seal (seal 3).

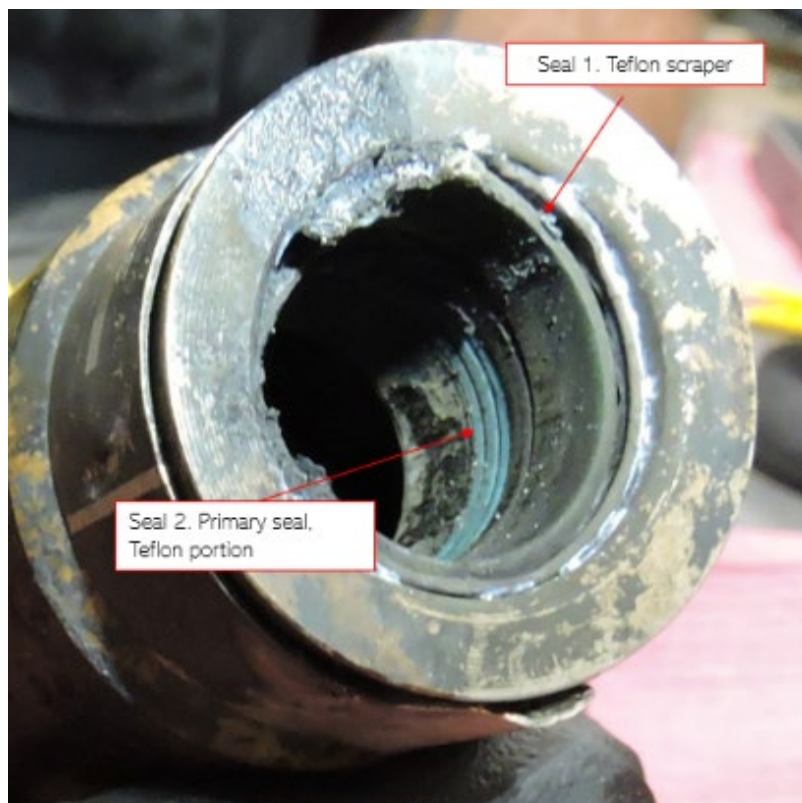
The cylinder end gland seals (seals 1 and 2, Figure 11), scraper and primary, were both present. Both seals exhibited a section that had been extruded (pushed out) of position in the same location (Figure 11, 12, 13). Seal 1 was removed; the Teflon scraper was mostly intact with a section of outward deformation and separation. The inner o-ring was brittle and carbonized. The primary seal's (seal 2) Teflon was mostly intact except for a section missing and separation; the primary o-ring was carbonized and brittle. A 5-millimeter bare metal witness mark was created while removing the cylinder from the end gland. The end gland exterior had a similar mark that was created on the interior of the cylinder where the end gland mated with the cylinder. The end gland was pressed from the piston rod. The scraper (seal 6, Figures 14 and 16) and primary (seal 5, Figures 14 and 15) were in place. A Teflon section of both seals had been deformed in the same location. The seal 6 Teflon scraper was removed intact; the o-ring behind it had been carbonized. The primary seal (seal 5, Figure 15) Teflon was removed with damage observed in one area; the backing o-ring had been carbonized.

Figure 11. Cylinder end gland

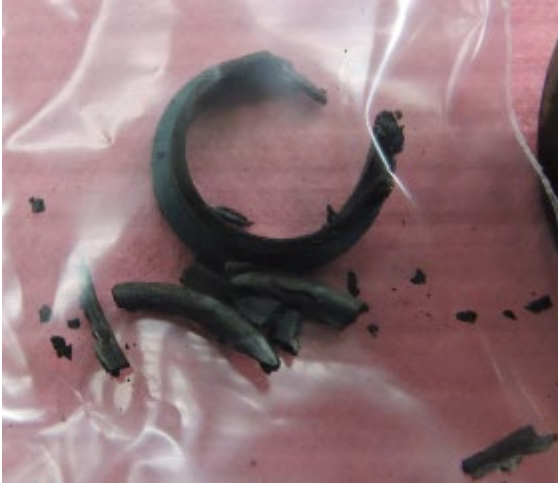
Figure 12. Seal 1, Teflon scraper seal and o-ring fragments.

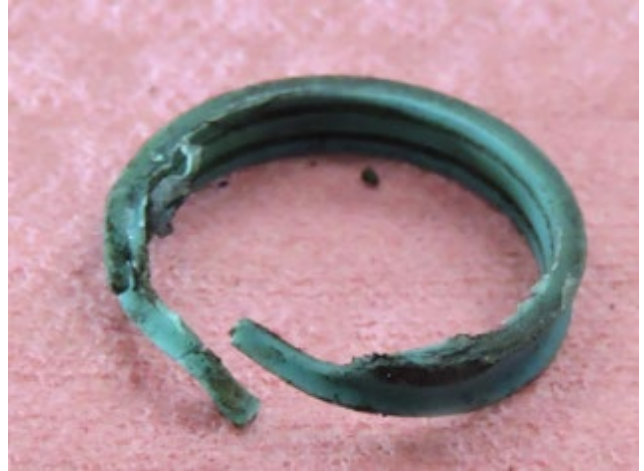
Figure 13. Seal 2, primary seal, Teflon portion.

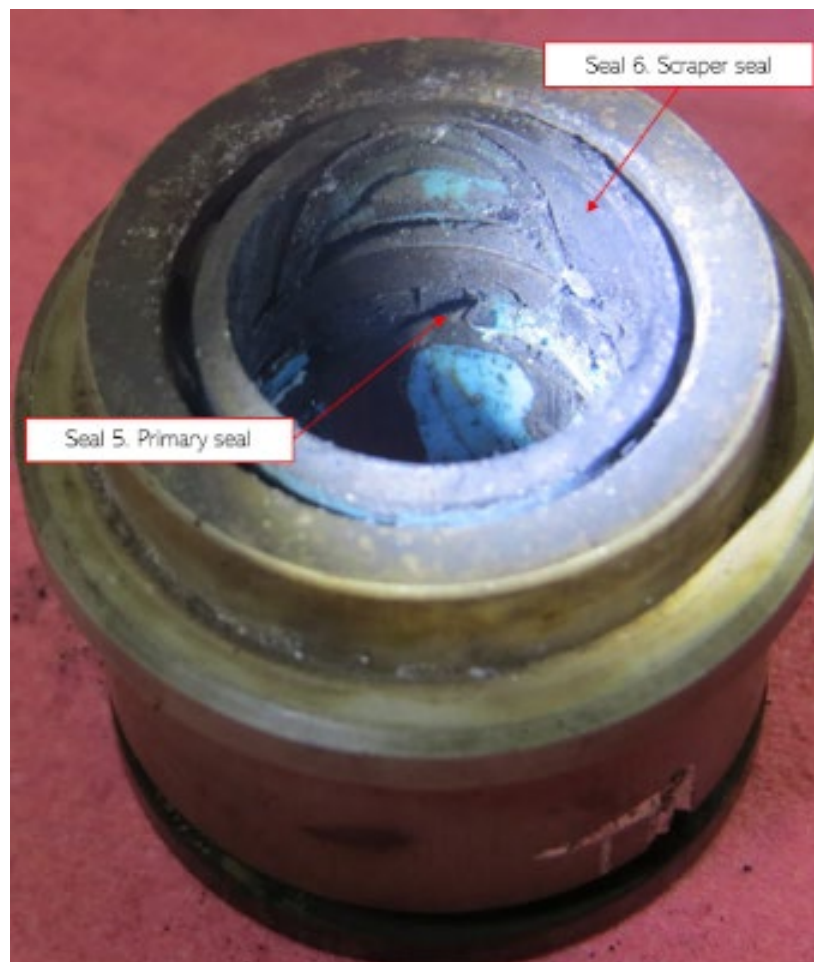
Figure 14. End gland seals (seals 5 & 6).

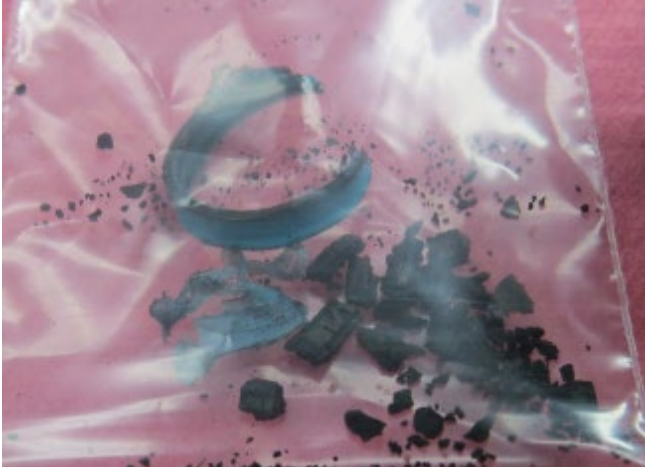
Figure 15. Primary seal, seal 5. Teflon seal and carbonized o-ring fragments.

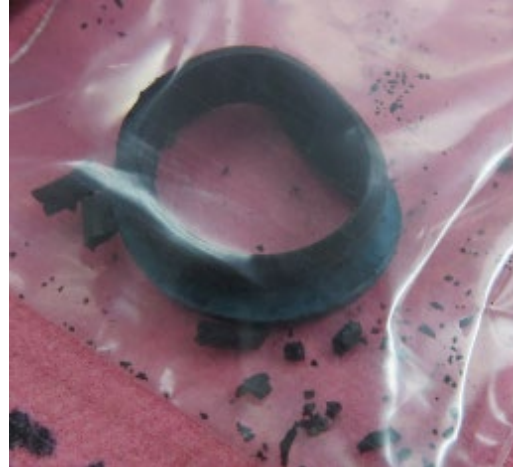
Figure 16. Scraper seal, seal 6. Teflon scraper and pieces of carbonized o-ring.
