## Summary of Aircraft Examination

### NATIONAL TRANSPORTATION SAFETY BOARD Office of Aviation Safety Washington, DC 20594

#### SUMMARY OF METEOROLOGICAL INFORMATION

-- CEN22FA064 --

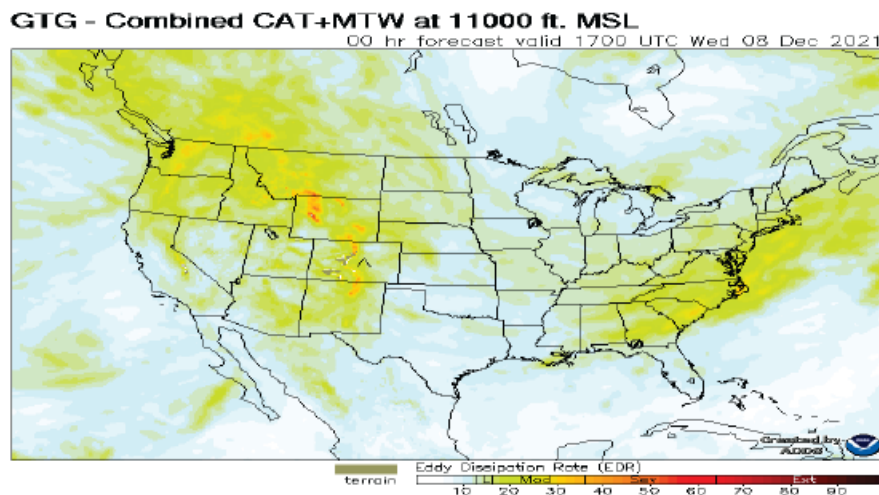
Graphic Turbulence Guidance (GTG) - the NWS supplemental product provided an eddy dissipation rates between 20 to 45 over southern Colorado in the vicinity of the accident site consistent with moderate-to-severe turbulence (See Figure 1.).

Figure 1. Graphic Turbulence Guidance for 11,000 ft for a light category aircraft. Moderate to severe turbulence due to mountain wave indicated over the area.
