### NATIONAL TRANSPORTATION SAFETY BOARD Office of Aviation Safety Washington, DC 20594

#### SUMMARY OF AIRCRAFT EXAMINATION

-- CEN22FA064 --

On December 8, 2021, about 1013 mountain standard time, a Cranford Vans RV-4 airplane, N456MC, sustained substantial damage when it was involved in an accident near Walsenburg, Colorado. The pilot sustained fatal injuries. The airplane was operated as a Title 14 *Code of Federal Regulations* Part 91 personal flight.

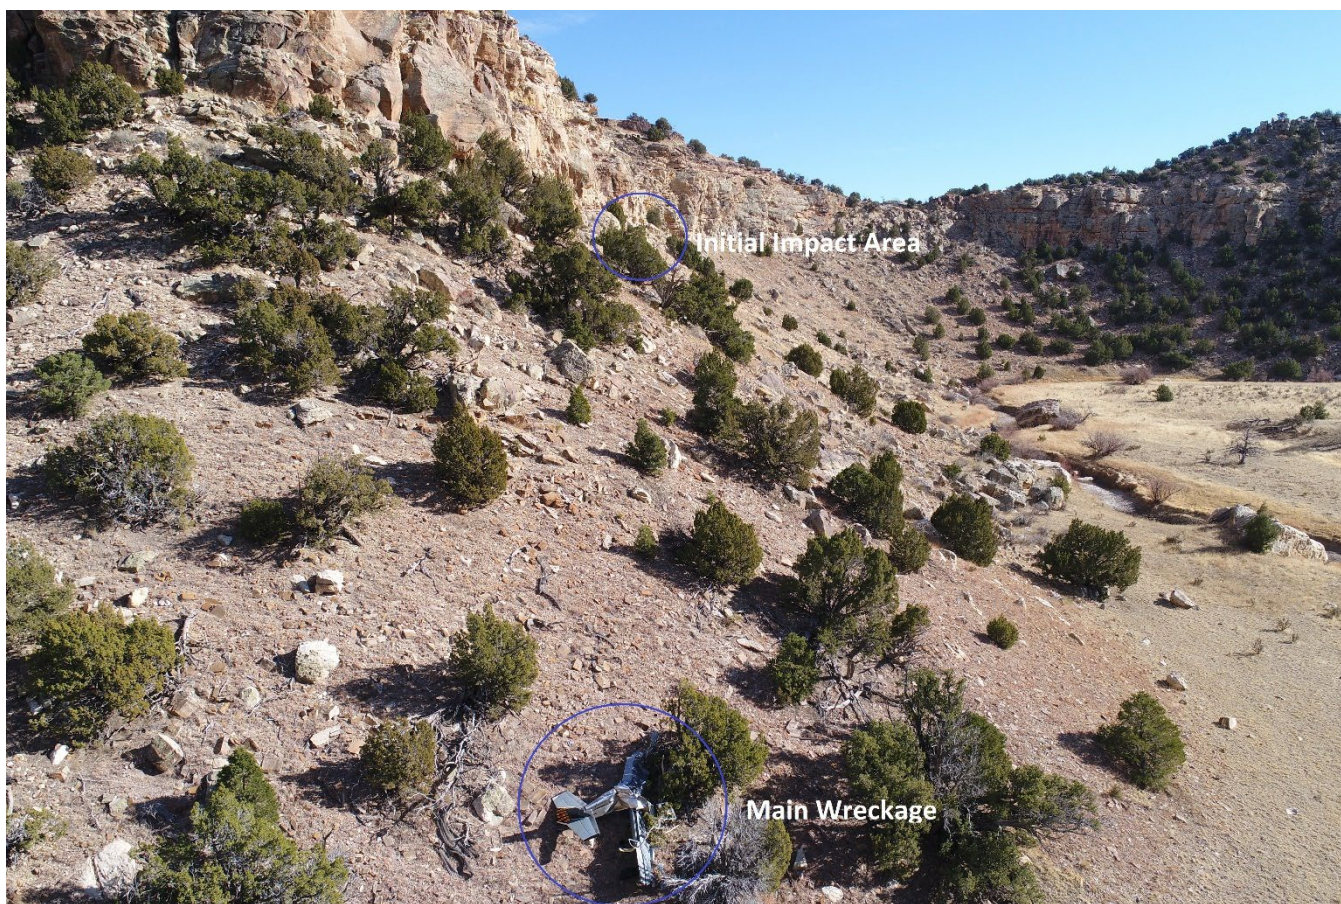
Figure 1. Accident Site

The accident site was located in canyon that contained rocky and scrub-type tree covered terrain. Postaccident examination of the accident site revealed airplane debris consistent with the left wing and wing tip were at the initial impact area. The airplane's forward fuselage impacted rocky terrain, and the airplane fragmented into multiple sections. The engine, fractured composite propeller blades, and the main landing gear were separated and came to rest between the initial impact and main wreckage. The main wreckage consisted of the cockpit/cabin, empennage, and inboard sections of the left and right wings (see Figures 1. and 2.).

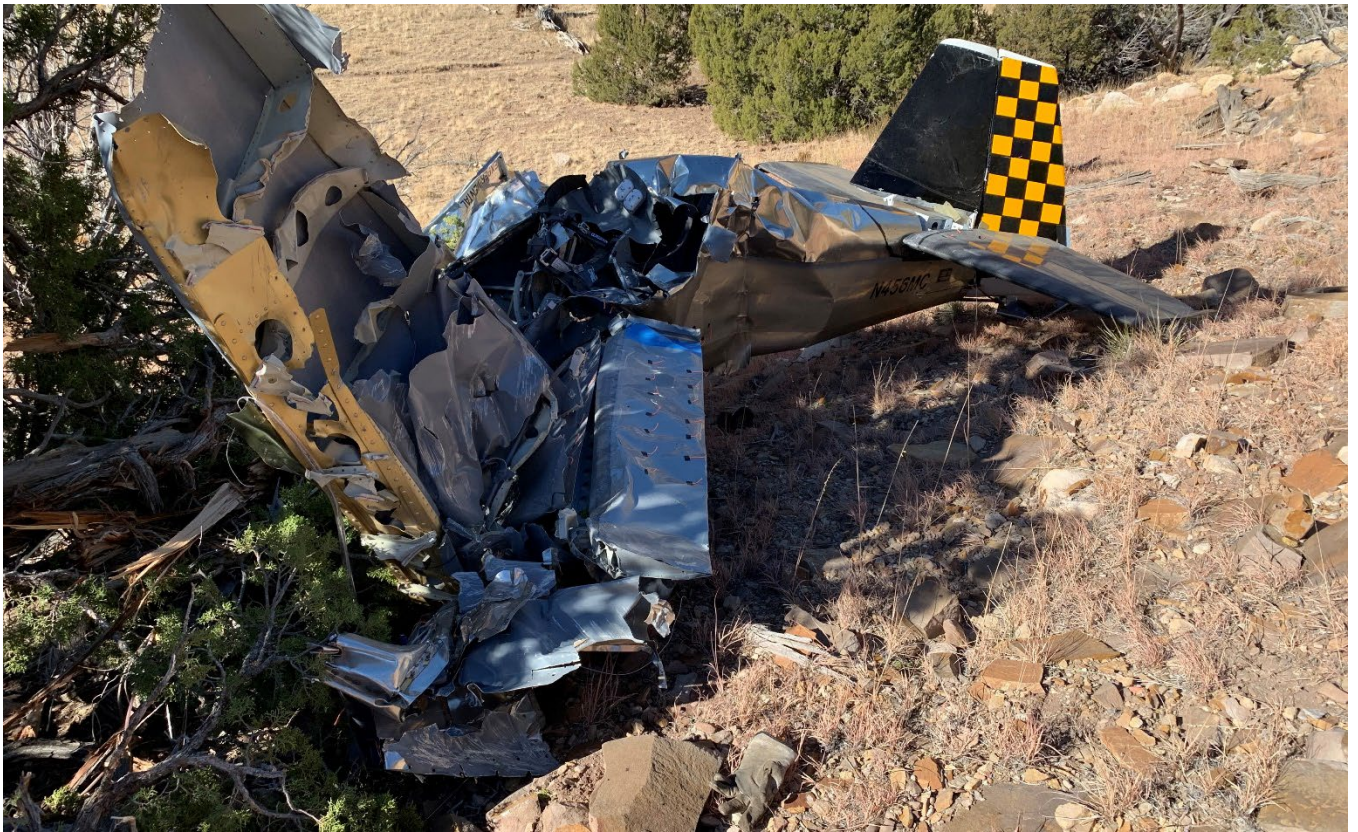
Figure 2. Main Wreckage

The outboard left wing was fragmented and separated structure was noted between the initial impact and main wreckage. The left aileron was separated and located near the initial impact and left wing tip. The outboard right wing was bent and distorted; the right wing remained partially attached to the fuselage. The vertical stabilizer and rudder remained partially attached to the fuselage.

The forward fuselage was crushed aft and sustained impact damage. The forward seat structure was crushed aft and fragmented. The canopy was fractured into multiple sections, and a majority of the canopy came to rest adjacent to the main wreckage.
