**NATIONAL TRANSPORTATION SAFETY BOARD**

**ON SCENE OBSERVATIONS**

**CEN22FA067**

Location: Houston, TX  
Date: December 8, 2021  
Aircraft: Piper PA28-140, Registration N3865K, Serial #28-23754  
NTSB IIC: Samantha Link

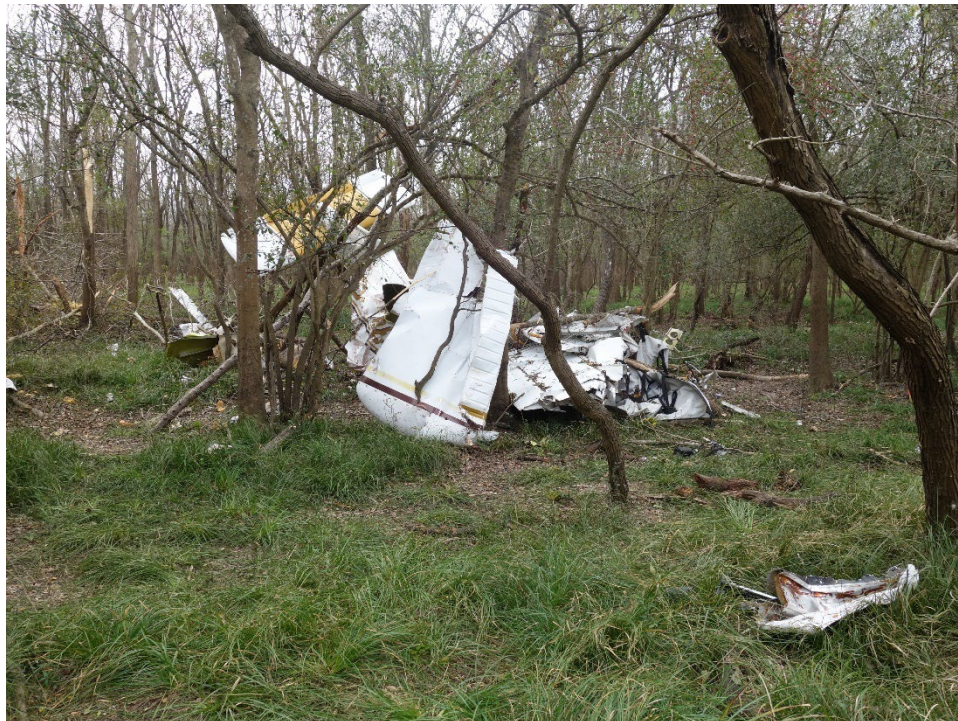
Figure 1: Last Piece of Debris looking toward Beginning of Debris Path

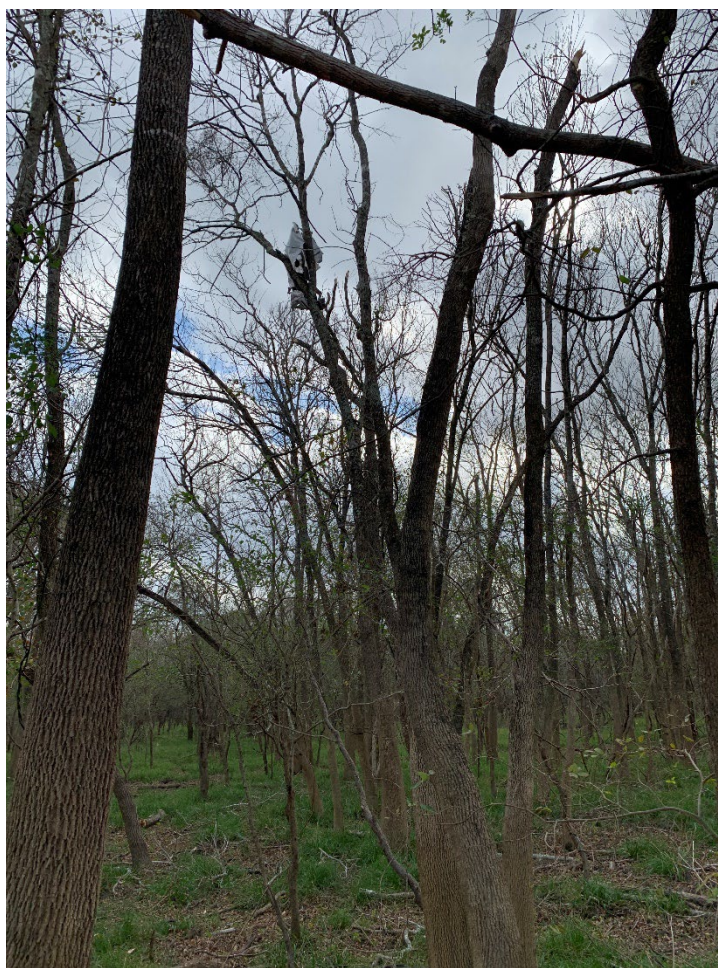
The airplane impacted a wooded area about 2.5 miles south of the airport. The debris path was about 50 feet long on a heading of 320 degrees. The first identified point of impact were two topped trees. Followed by the first piece of debris about 10 feet later, which was a fragment of outboard right wing. It remained wrapped around, and high, in a tree. Continuing along the debris path were a series of topped trees. Each one was topped slightly closer to the ground. Scattered on the ground around these trees were various fragments the right wing, the main landing gears, and the vertical stabilizer with rudder attached. Next was a large impact crater in the soft dirt. It was about 2.5 feet deep by 5 feet long. Inside of the crater was the propeller assembly, the starter ring gear, spark plug fragment, and other fragments of engine. Portions of

**Figure 2: First Topped Trees and Outboard Right Wing Fragment**

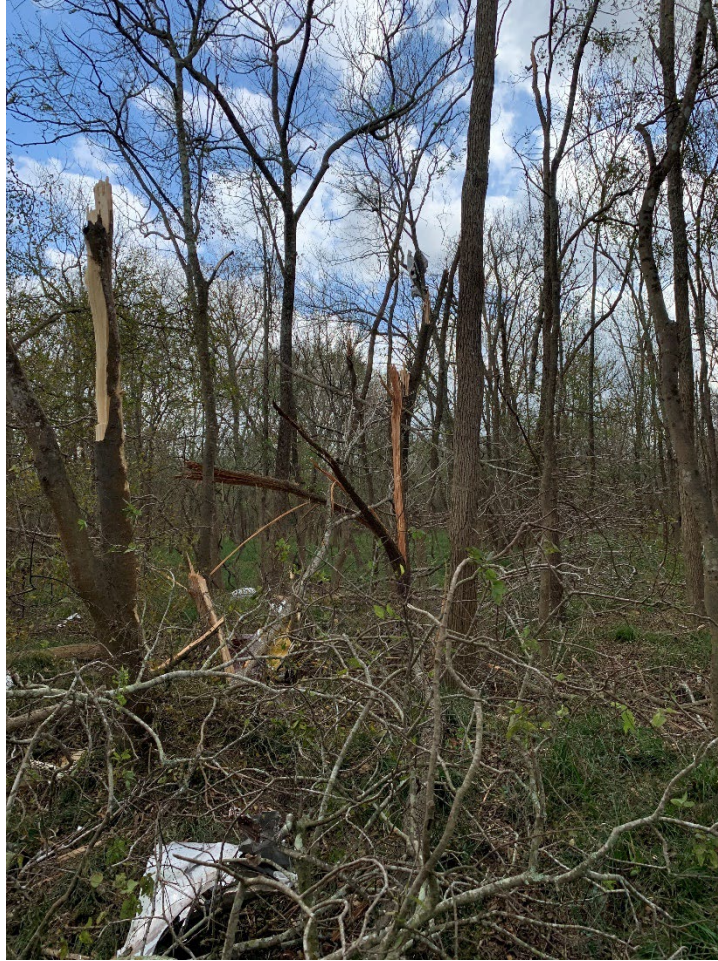
**Figure 3: From Impact Crater showing Series of Topped Trees**

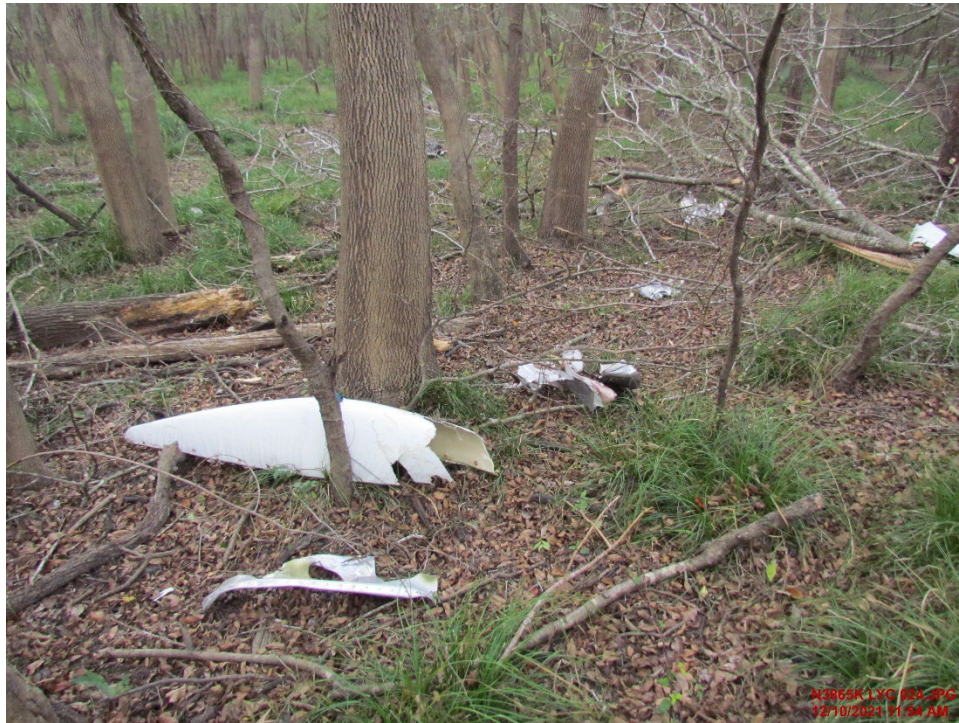
**Figure 4: Fragments of Right Wing Scattered Below Topped Trees**

- The right wing was fractured into several pieces.
  - The outboard right wing came to rest wrapped around and high up in a tree.
  - The wingtip with green navigation light was fracture separated and found early in the debris path.

- A narrow portion of right wing and aileron was found about mid debris path. It exhibited a leading-edge tree strike, and it was heavily accorded.
  - The inboard portion of the wing was fracture separated from the fuselage.

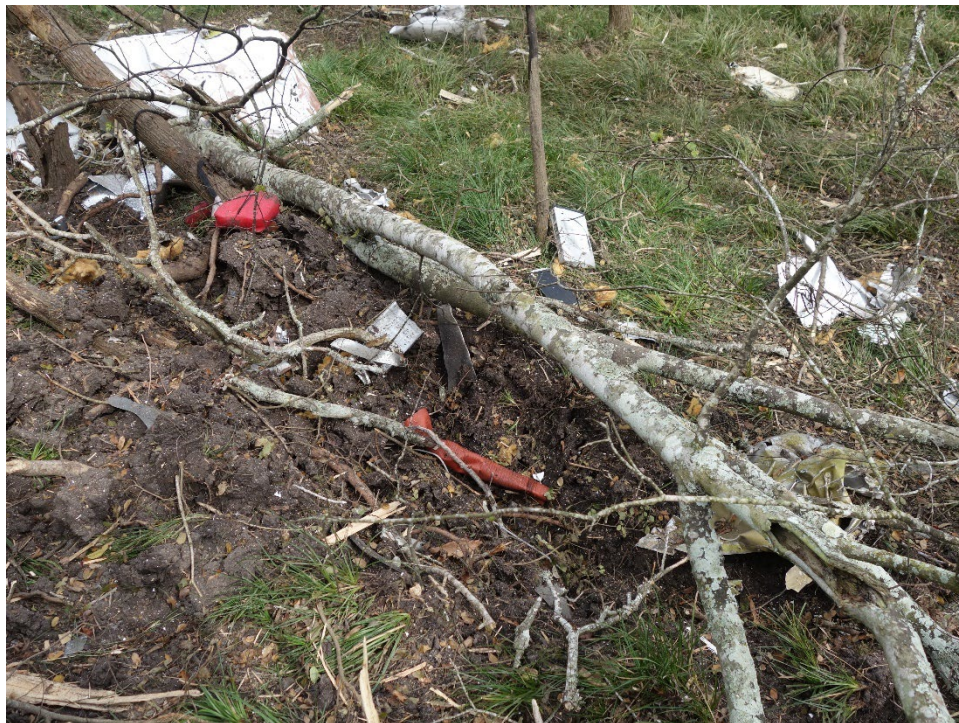
**Figure 5: Impact Crater**

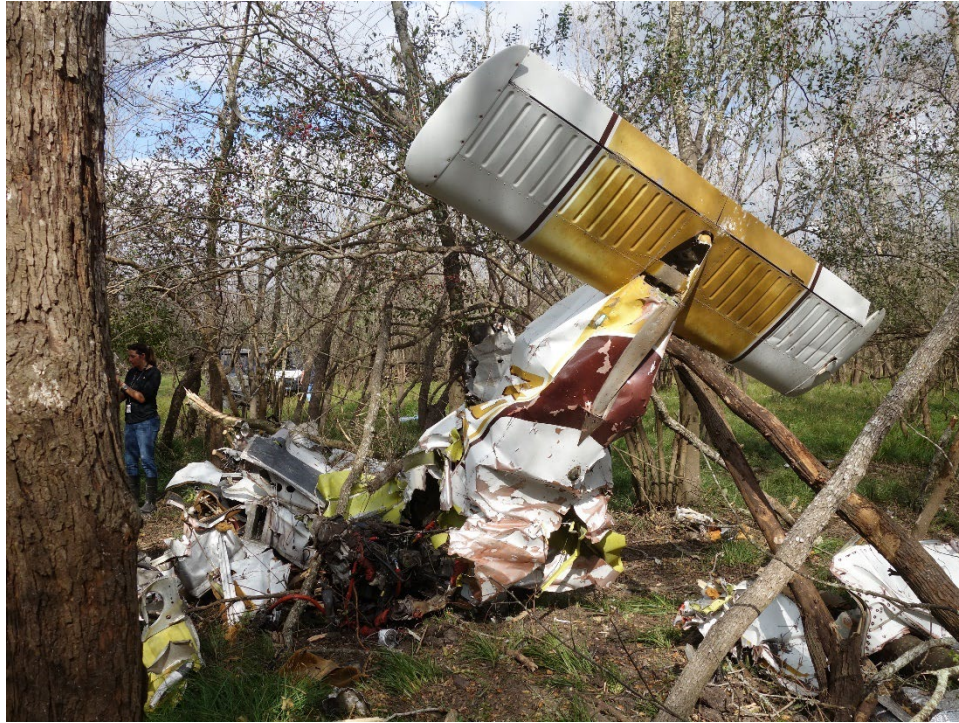
The main wreckage came to rest just beyond the impact crater. It contained the major components of the airplane: the engine, cabin, inboard wings, aft fuselage, and empennage. The airplane came to rest nose low with the tail extending on an angle upward. The airplane appeared to be somewhat upside down, but still overall vertical. The engine was completely separated from the airplane and came to rest near the empennage. The firewall, instrument panel, and cabin area were heavily damaged.

Figure 6: From beginning of Impact Crater looking toward Main wreckage.

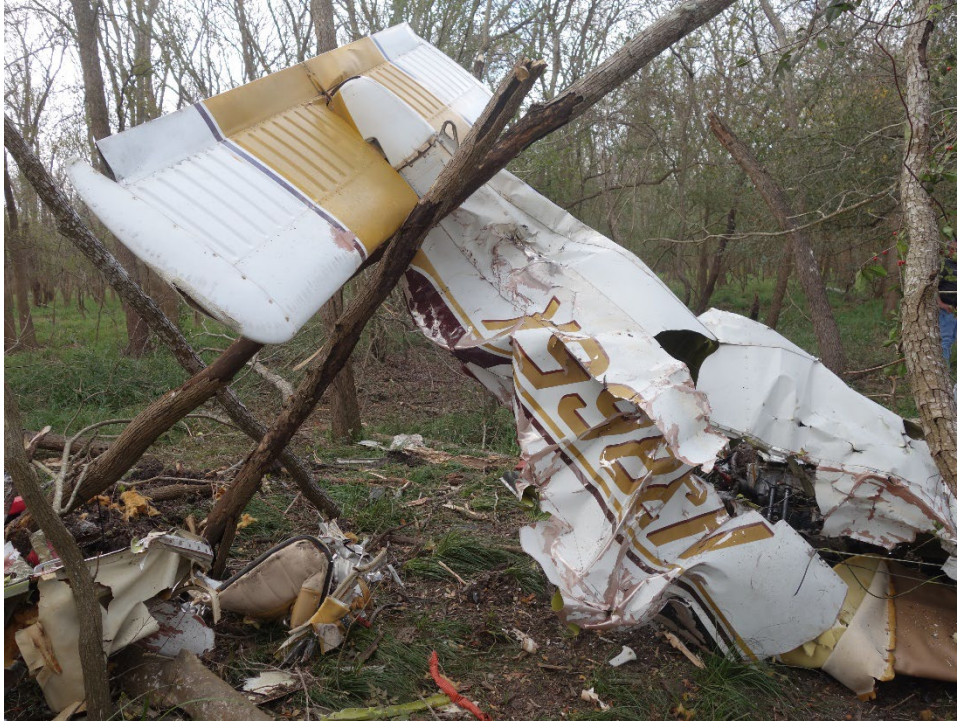
- The aft fuselage and empennage were extended upward on an angle.
  - The aft fuselage exhibited extensive downward accordion crushing.
    - A large impact dent, consistent with tree impact, was noted on the right side of the aft fuselage just in front of the empennage.

- Its counterweight remained attached.
    - It moved freely when manipulated by hand.
    - The trim tab remained attached.
      - The trim jackscrew was measured and was consistent with a partial nose up trim setting.

Figure 7: Aft Fuselage and Stabilator

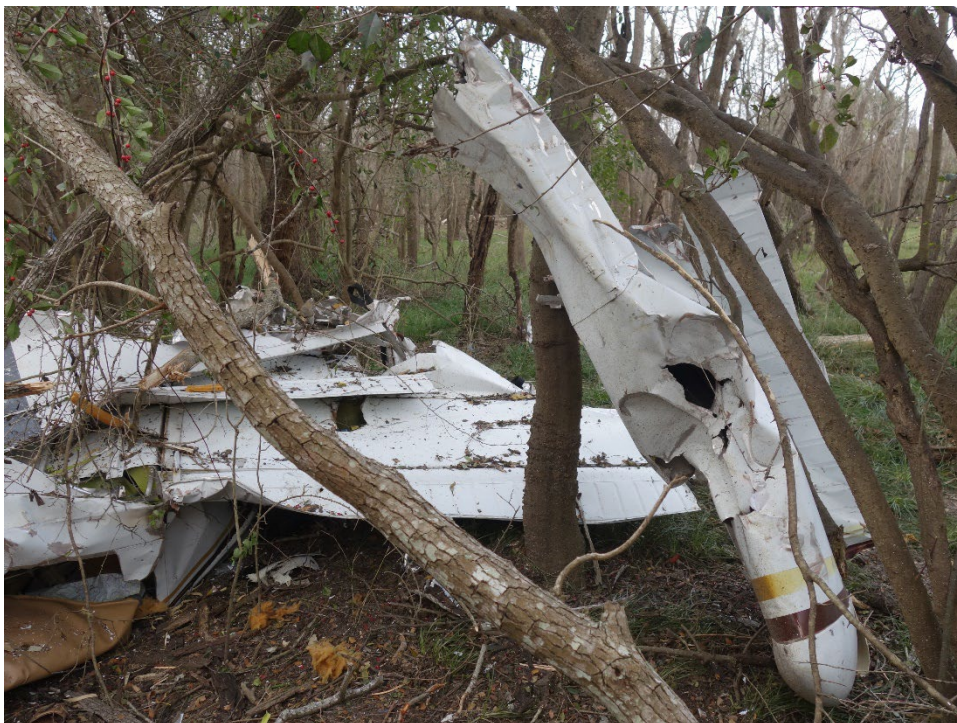
- The inboard portion of the left wing remained attached to the wing spar. It was fracture separated about midspan.
  - The fuel cap remained secured; however, the fuel tank was breached, and no fuel was noted.

- The flap remained secured to the inboard portion of the wing.

Figure 8: Left Wing

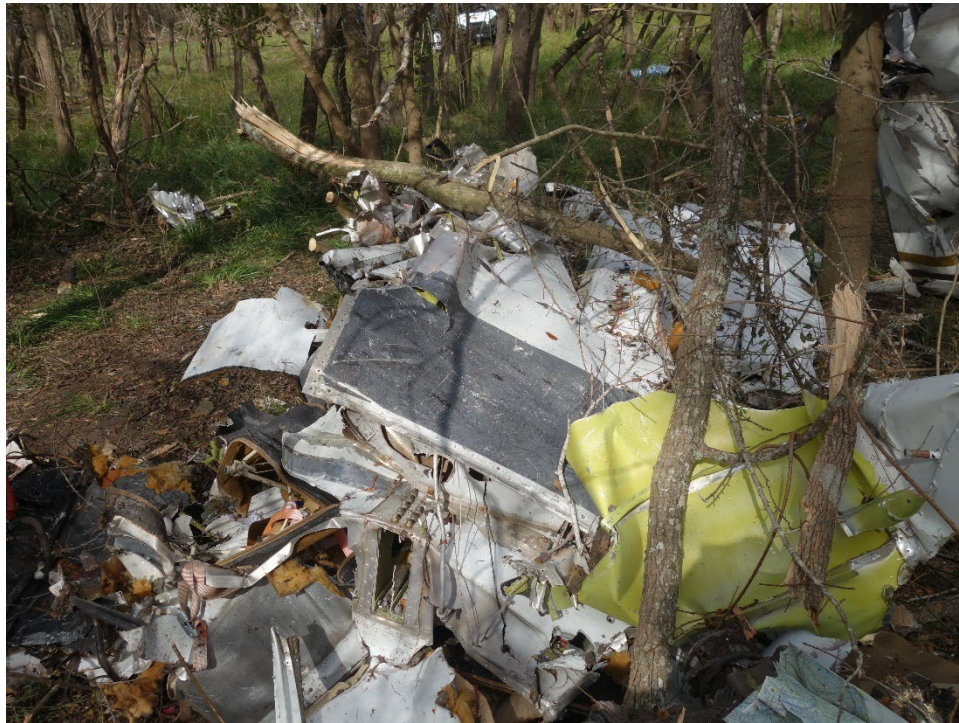
- The fuel cap remained secured in place.
    - The fuel tank was breached, and no fuel was present.
    - The flap remained attached.
- Fuel selector was removed.

Figure 9: Inboard Right Wing

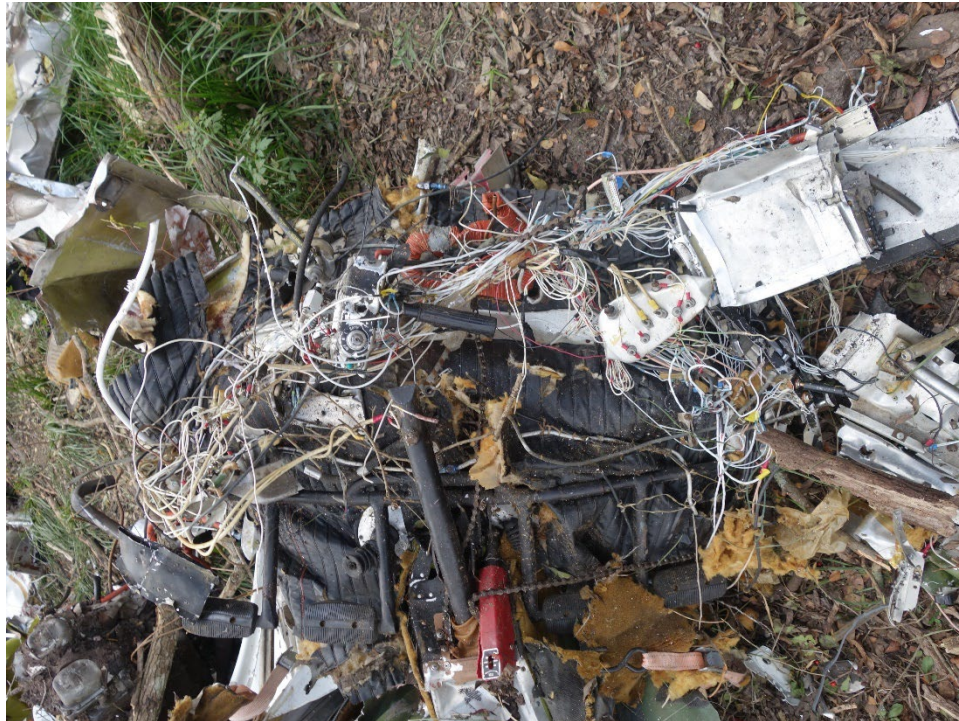
- The flight controls were heavily fragmented; however, control continuity was established throughout.
  - They remained connected at their respective attachment points, but the cables were fractured consistent with overload.

Figure 10: Cockpit Flight Controls

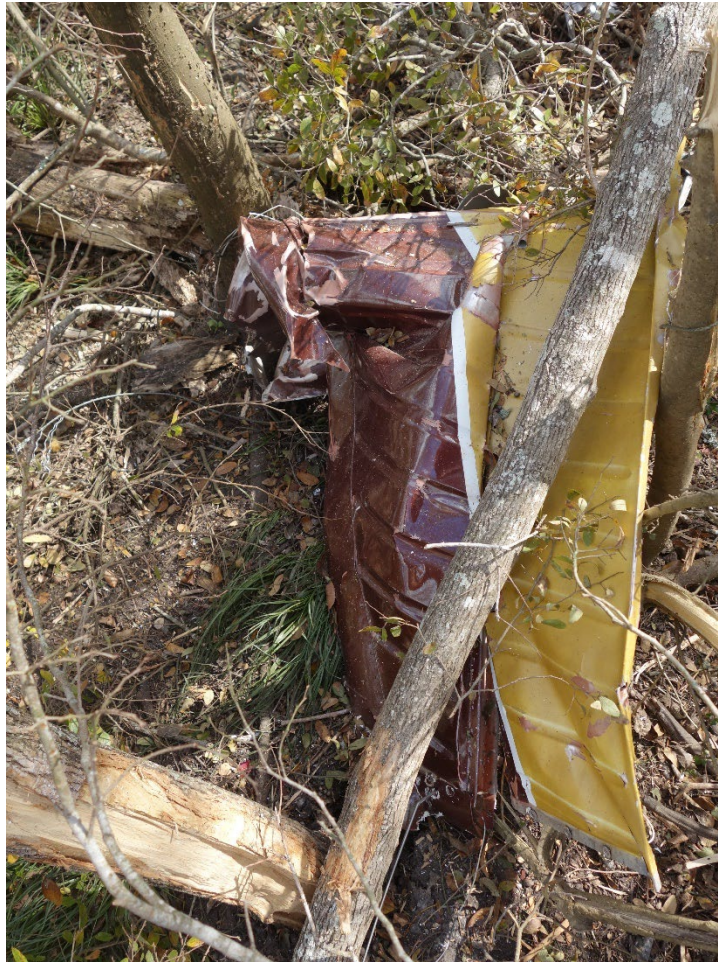
- The vertical stabilizer and rudder were fracture separated.
    - They were found about mid debris field.
  - The stabilator remained attached to the aft fuselage.

**Figure 11: Vertical Stabilizer and Rudder**

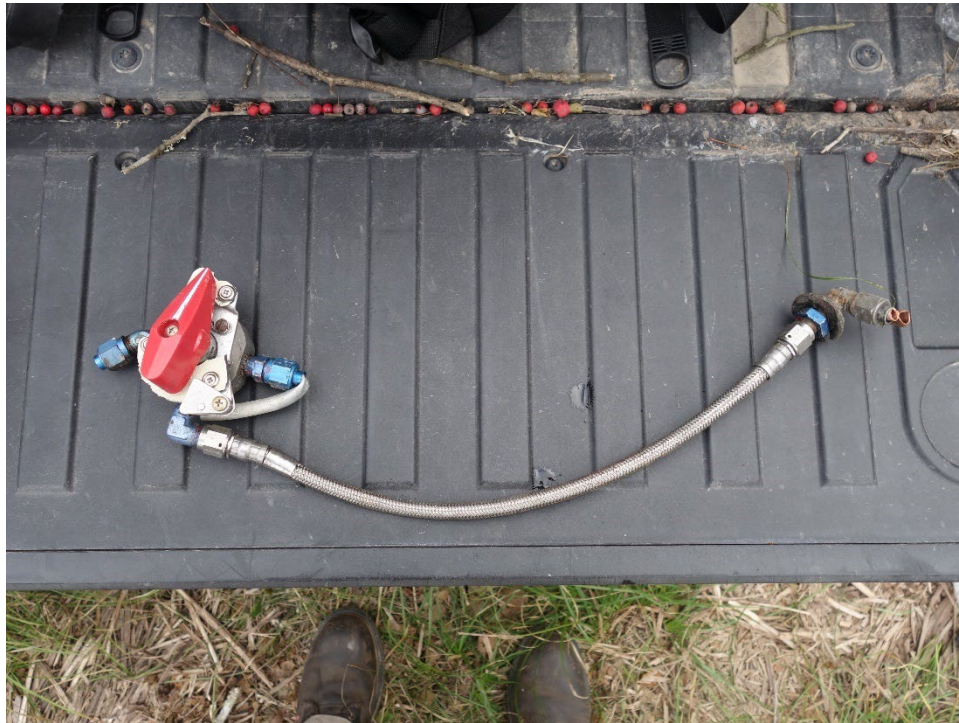
- It was in the left position.
  - Air was blown through it, and no blockages were noted.
  - The selector was manipulated; it had distinct detents.
- The fuel system was heavily fragmented, and no fuel was noted in the system. The smell of fuel was not noted at the accident site.

Figure 12: Fuel Selector Valve

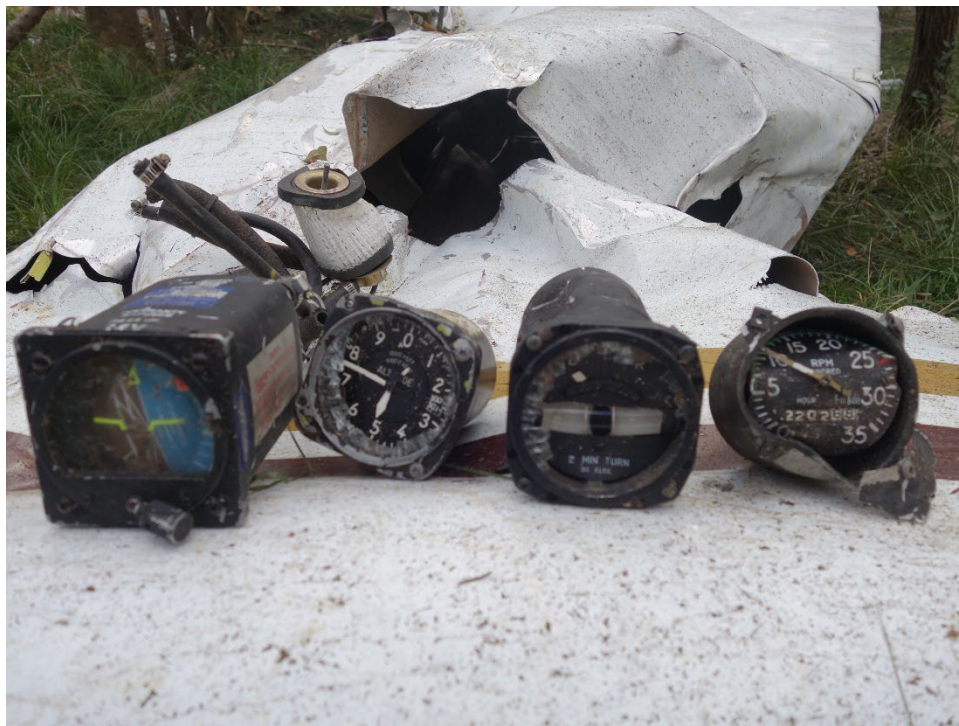
- The cabin area was destroyed.
  - The instrument panel was fragmented. The instruments were separated from their mounting pads and distributed throughout the debris path.

- The directional gyro was destroyed and only the faceplate was located.
    - The attitude indicator was disassembled, and no scoring was noted within the internal gyro.

Figure 13: Recovered Instruments

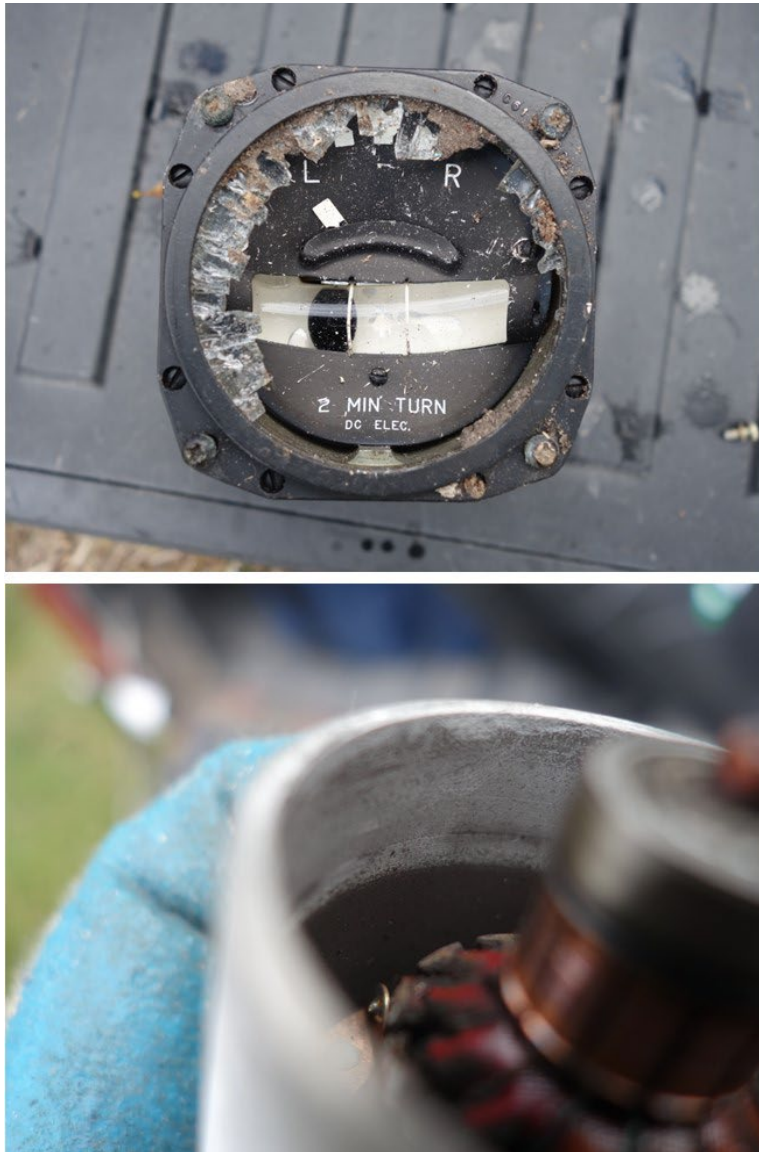
- The turn coordinator was disassembled.
      - A small score mark was noted within the internal gyro.
  - The front two seats were fracture separated and easily removed from the cabin area.

Figure 14: Turn Coordinator

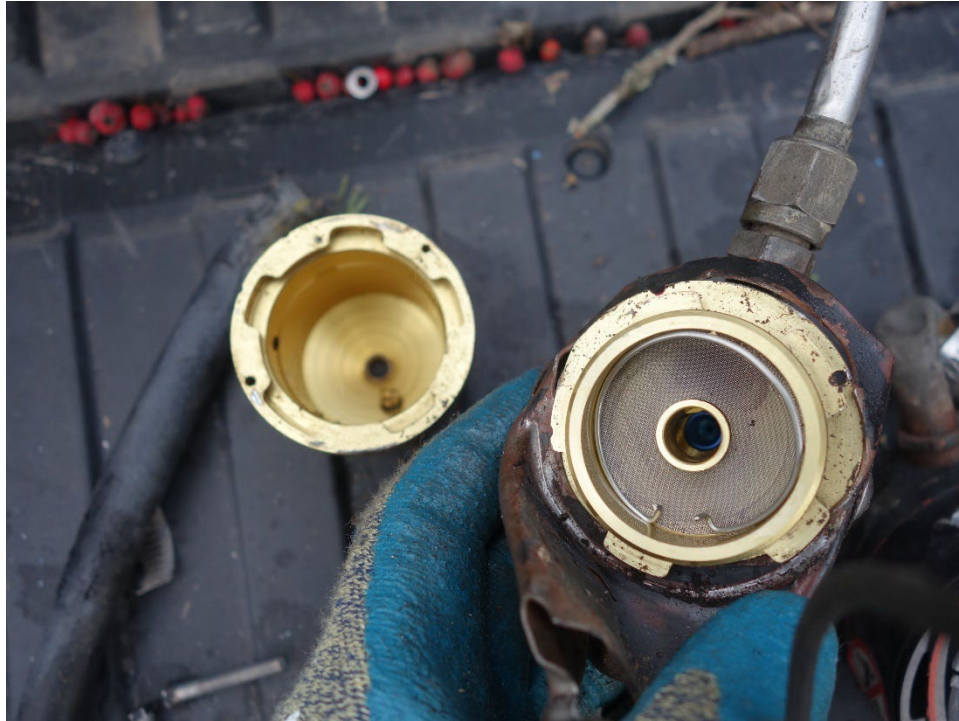
- The sump drain was fracture separated from the bowl. The fuel strainer was disassembled:
    - No fuel was noted in the bowl.
    - No debris was noted in the screen.

Figure 15: Fuel Strainer

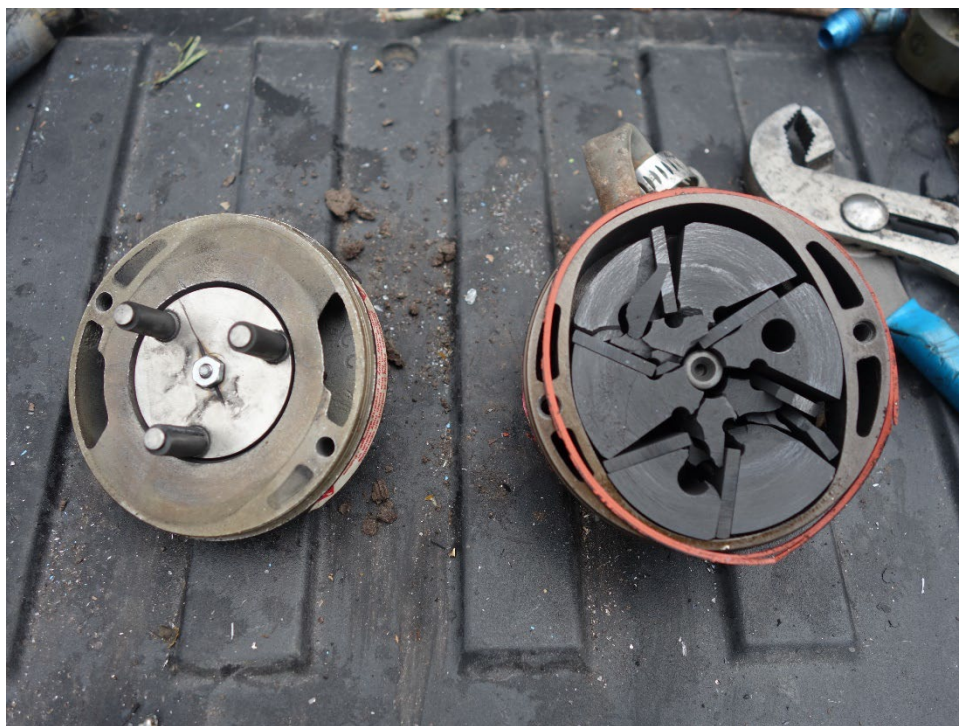
- The vacuum pump was located and disassembled.
  - The internal veins and components were fractured.
- The fuel strainer was fracture separated from the firewall and found near the engine.

Figure 16: Vacuum Pump

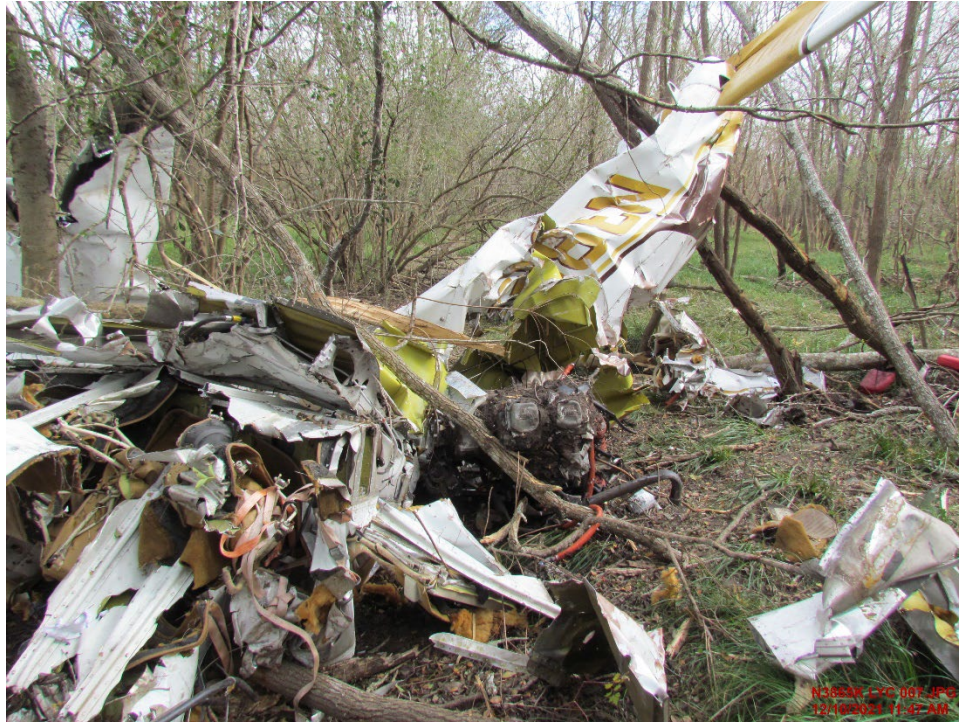
- The engine was found fracture separated from the airframe.
  - It came to rest mostly upright near the aft fuselage and empennage.
- There were no obvious visual signs of catastrophic mechanical anomalies.

Figure 17: Where Engine Came to Rest

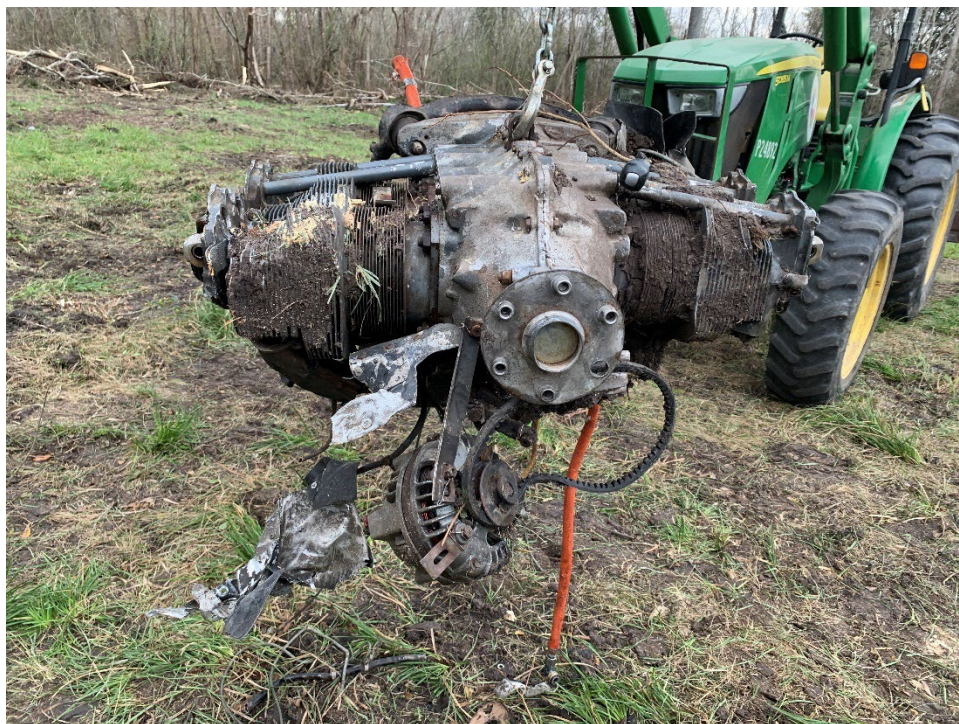
- The propeller assembly was fracture separated from the propeller flange.
  - The propeller flange was bent.
  - The starter ring gear was fracture separated; it was found in the impact crater.

Figure 18: Front of Engine

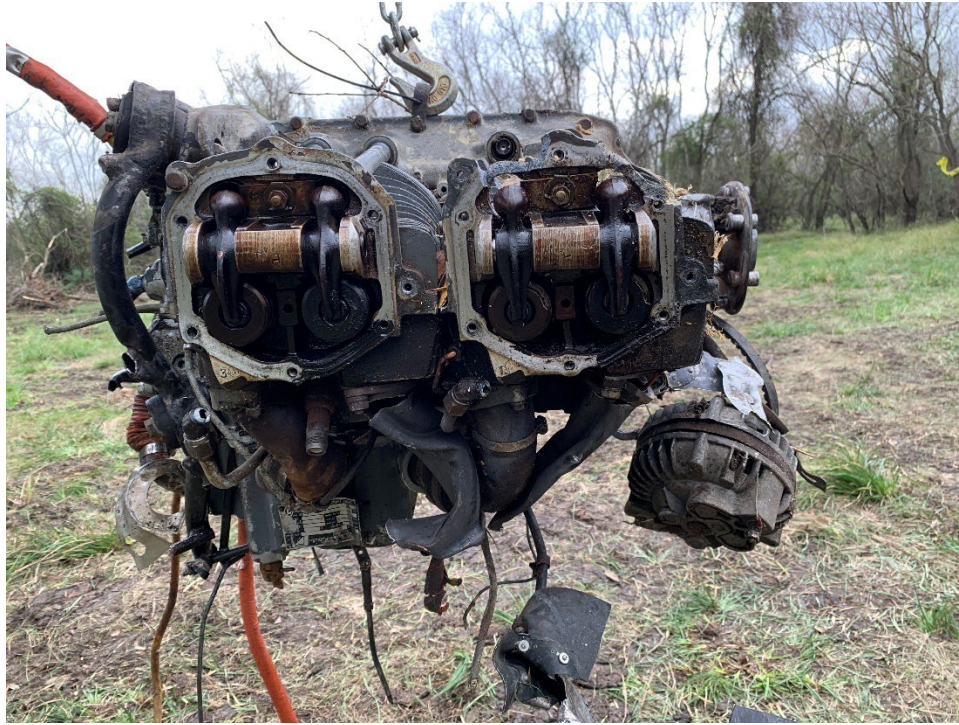
Figure 19: Right Side of Engine

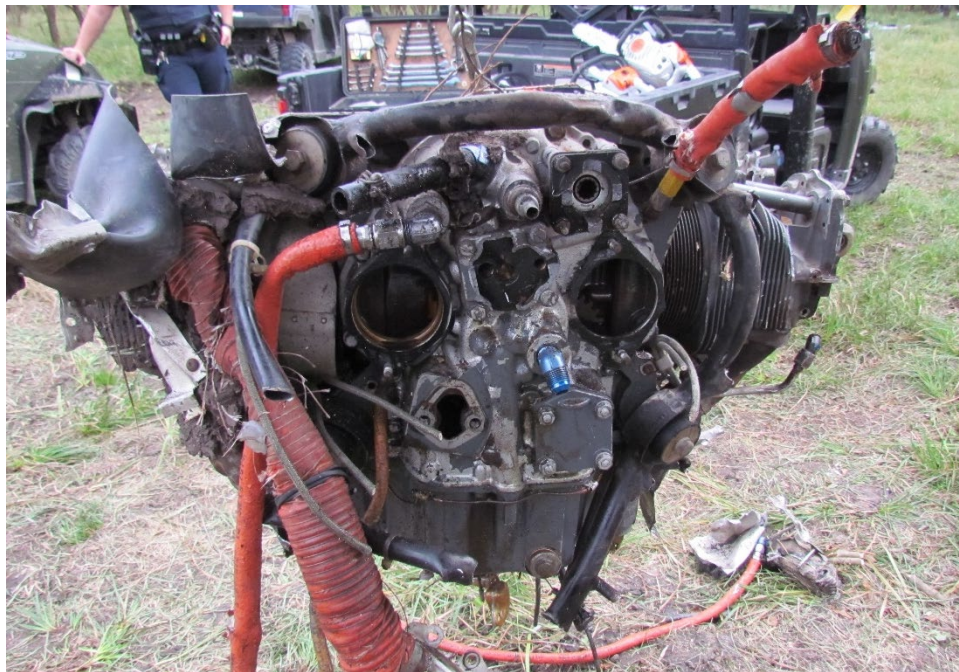
- The accessory gears rotated accordingly and did not exhibit damage.
- All cylinders were borescoped. The piston heads, cylinder walls, valves, and lower spark plugs were all consistent with normal operations.

Figure 20: Accessory Section

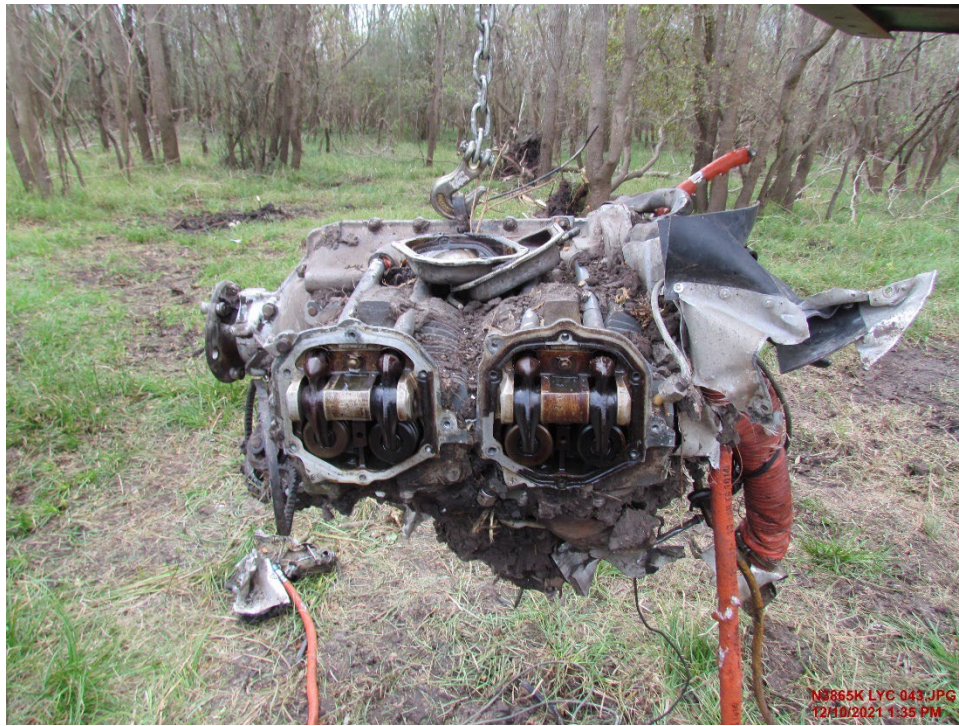
Figure 21: Left side of Engine

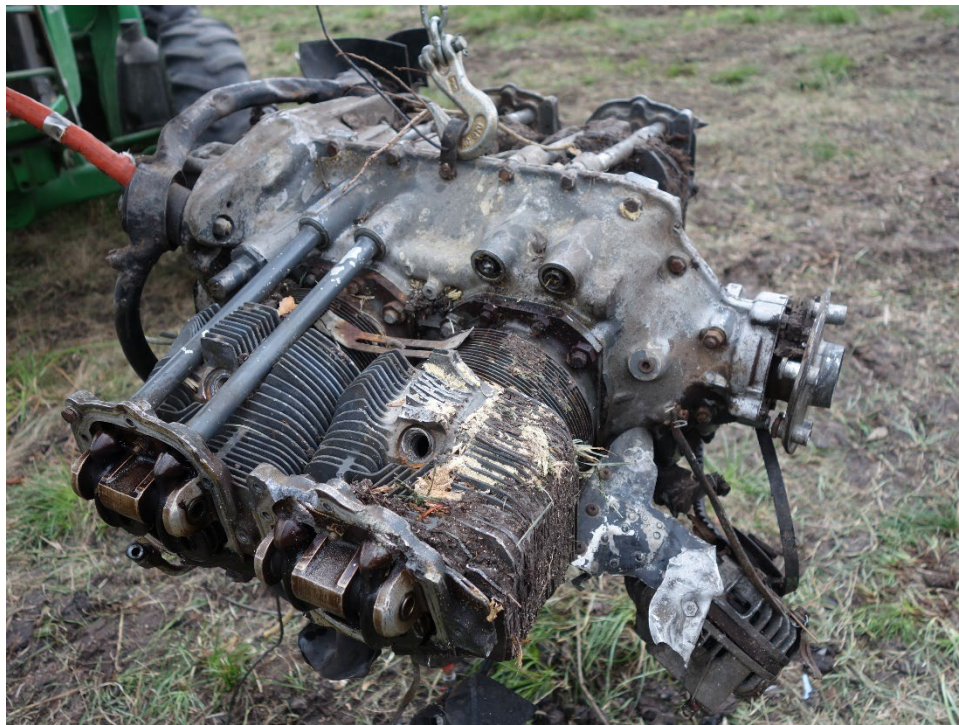
- The #1 cylinder exhibited impact damage.
  - The upper spark plug, and push rods were fracture separated and found within the impact crater.
  - The cylinder head was cracked.

Figure 22: Damage to Number 1 Cylinder

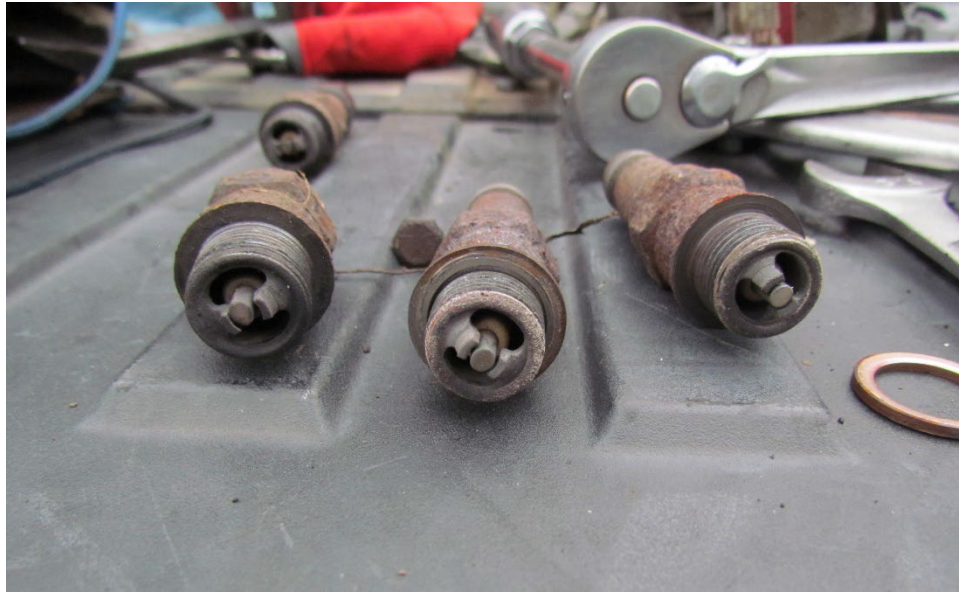
- The left magneto was removed.
    - The ignition harness was cut before the damaged areas and spark was obtained on all leads.
- The spark plugs exhibited rust on the tops of them. Several were fractured.

- The upper spark plugs were removed, except of the #1 cylinder (which was fracture separated).
  - The spark plugs were consistent with normal operations.

Figure 23: Upper Spark Plugs

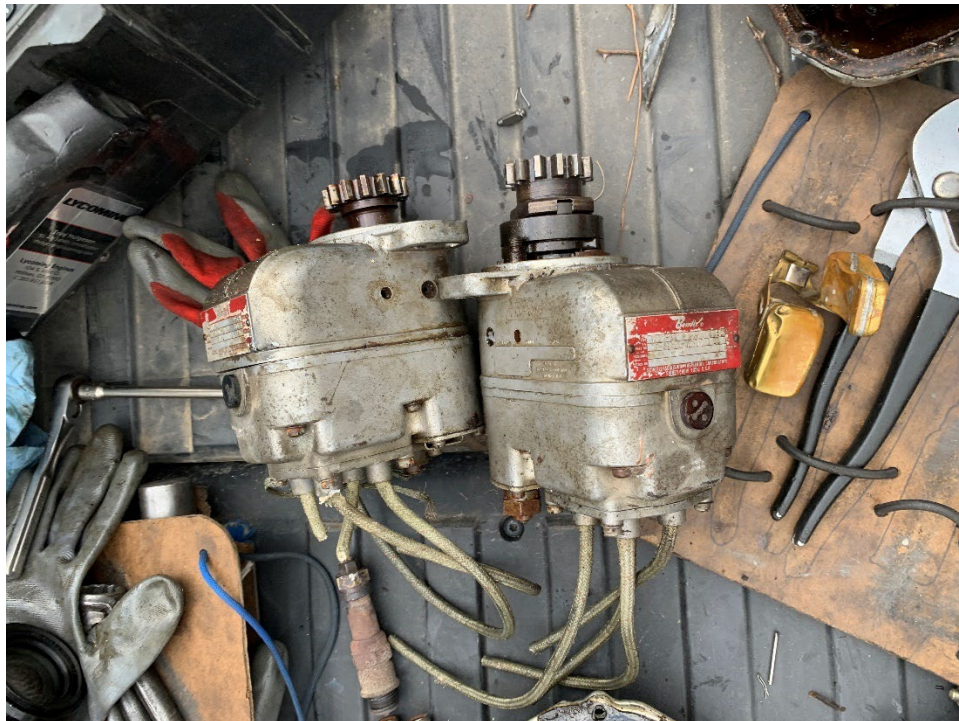
- The magnetos remained secured to their mounting pads. The ignition harness was present and exhibited damage consistent with impact.
  - The right magneto was cracked at the seam consistent with impact. It was unable to be rotated.

Figure 24: Magnetos

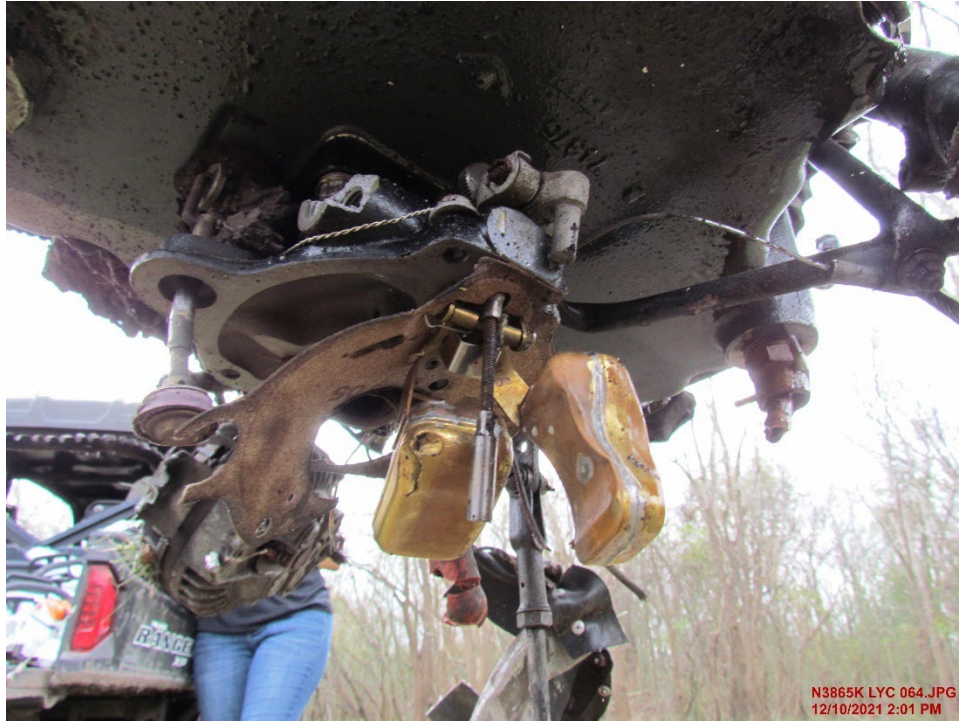
- The carburetor bowl was fracture separated from the engine. The metal floats remained attached, and both exhibited impact damage.
  - The floats were removed, and no fuel was noted inside of them.

- One float exhibited distinct crush damage.
  - The second float exhibited a couple small spots of crush damage.
    - One side of the float appeared to be “sucked” inward.

Figure 25: Remaining Portions of Carburetor

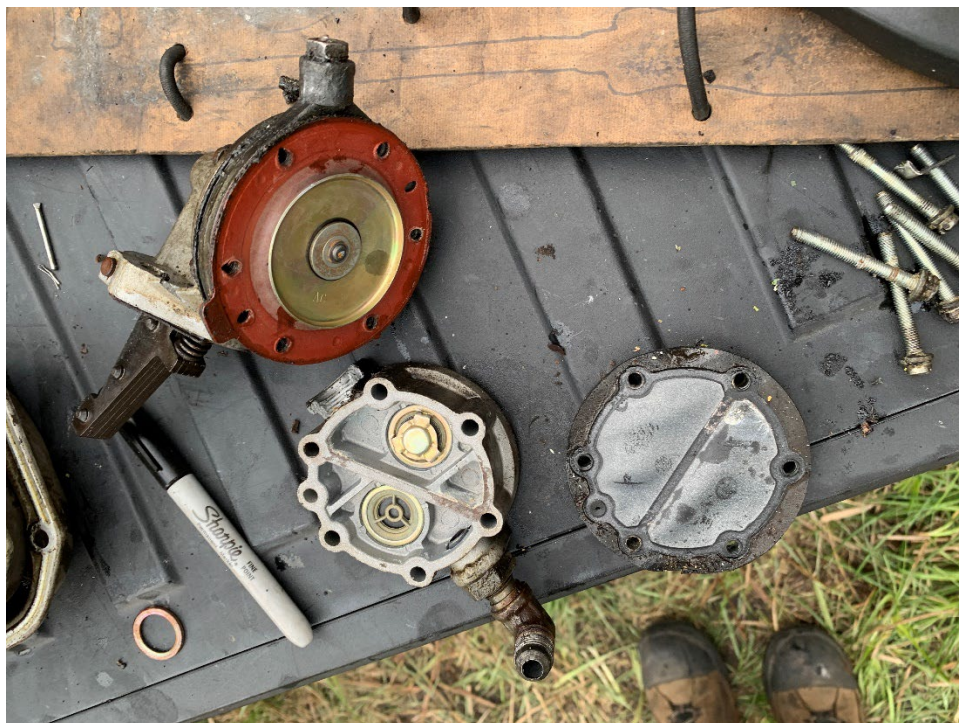
- The engine driven fuel pump was removed and disassembled.
  - During disassembly, a small amount of fuel exited the pump. The fuel smelled consistent with 100LL Avgas.

- The internal diaphragms, and valves were consistent with normal operations.
- The oil suction screen was removed and clear of debris.

Figure 26: Fuel Pump

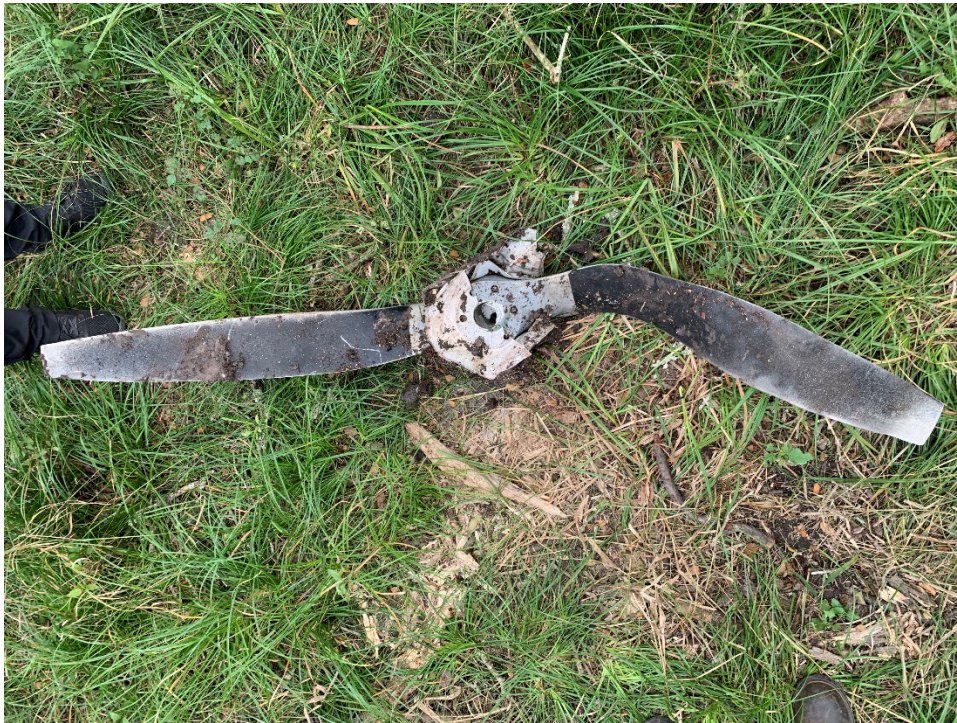
- The propeller assembly was found mostly buried in the impact crater.
  - Only about 1/3 of one blade extended above the dirt.
- The spinner was crushed aft past the propeller hub. It exhibited dirt packed ripples throughout.
- Both propeller blades remained attached to the hub, and both were bent in a large aft arc.
  - One blade was twisted and exhibited some waves towards the tip of the blade. However, still had an overall aft arc.
  - The second blade was flatter, but still had an overall aft arc.
- A tree, which was about 5 inches in diameter, appeared to have a very straight, about 45-degree cut, consistent with a propeller strike. This tree fragment was observed early in the debris field.

Figure 27: Face Side of Propeller Blades

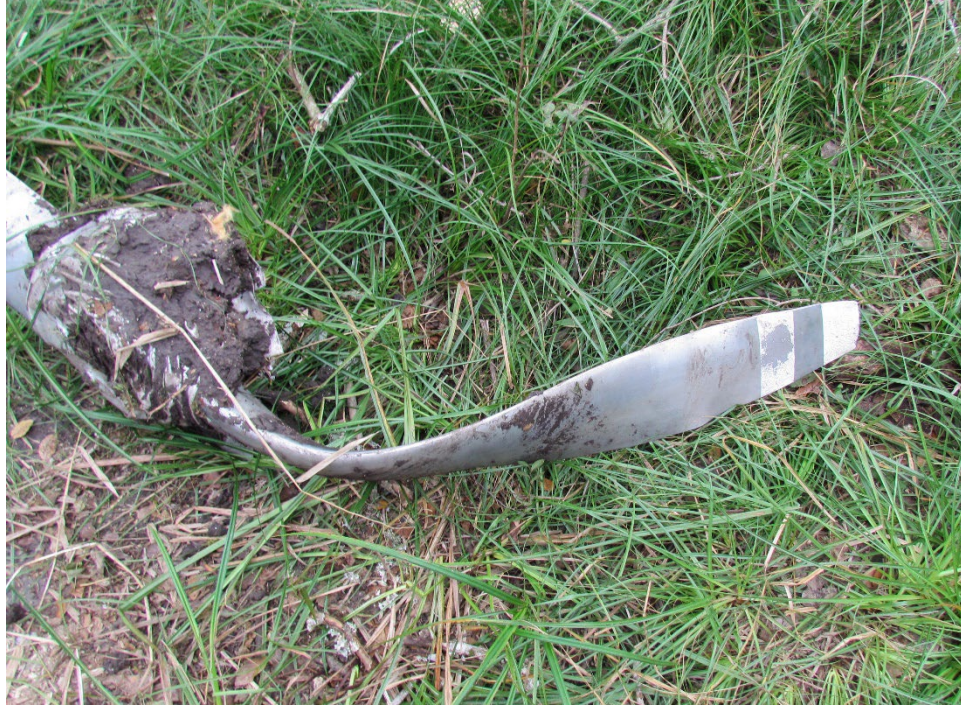
**Figure 28: Front of a Propeller Blade**

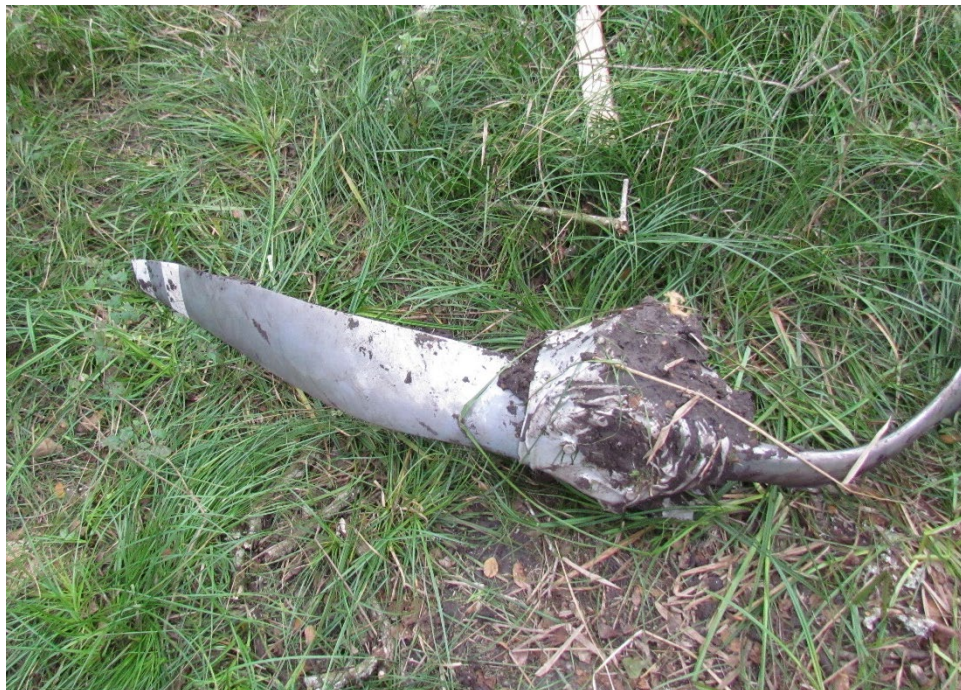
**Figure 29: Front of the other Propeller Blade**

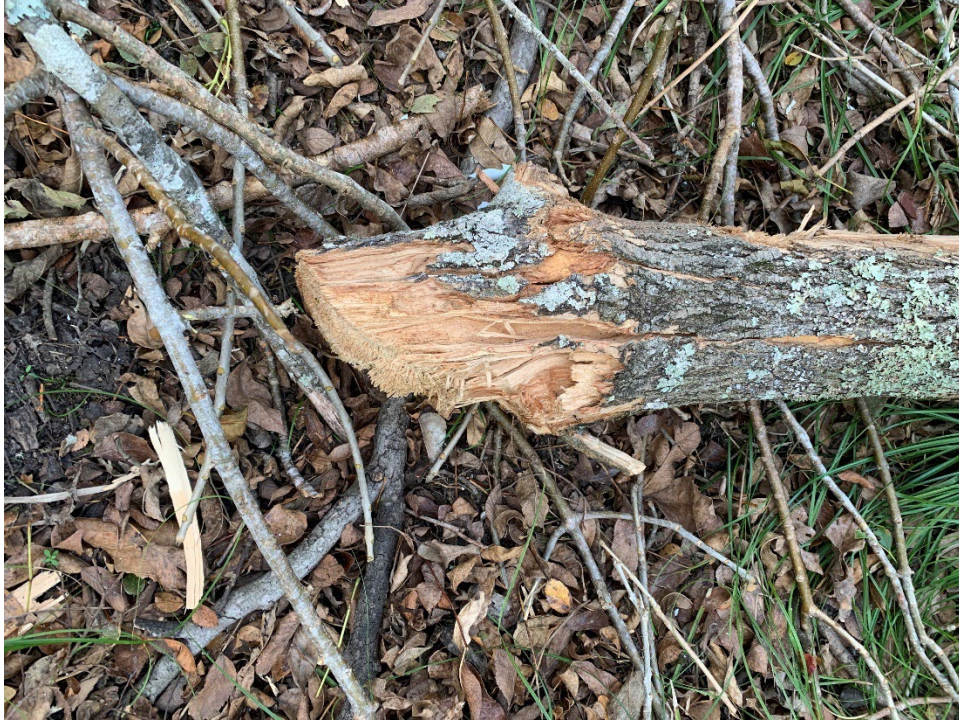
**Figure 30: Cleaning Cut Tree consistent with Propeller Impact**
