**CEN23FA080**

**INVESTIGATION PHOTOGRAPHS**

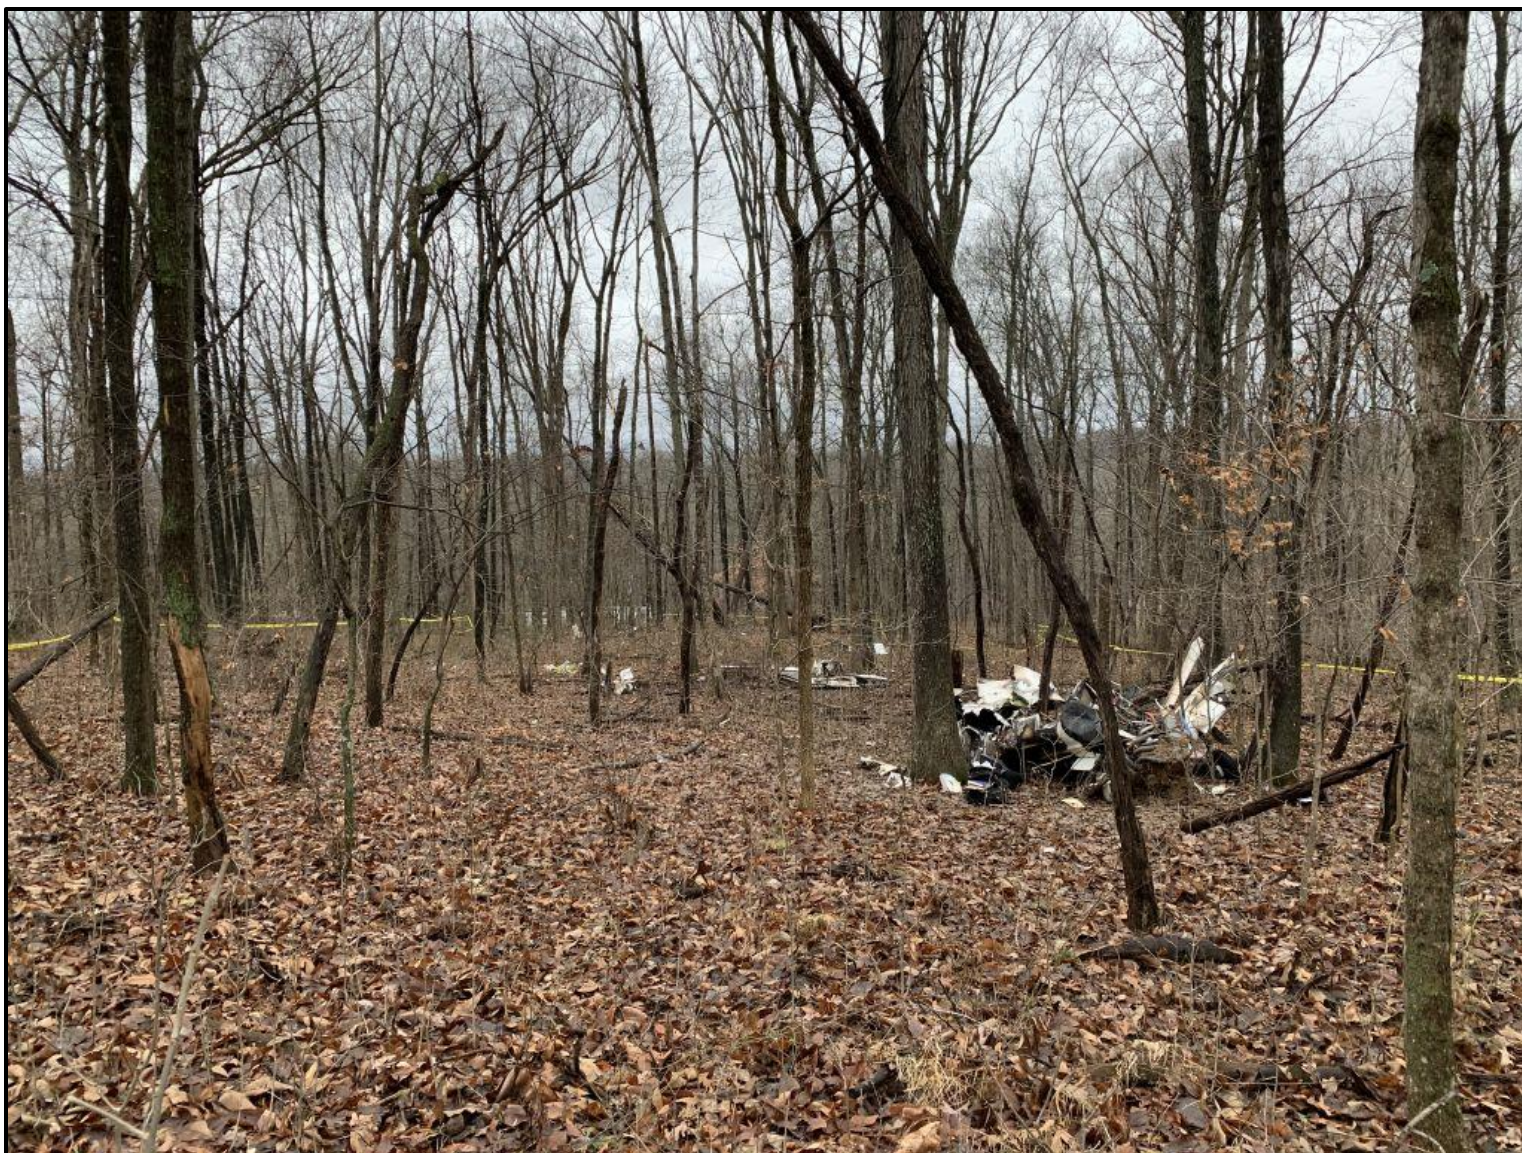
**Photograph 1 - Accident Site**

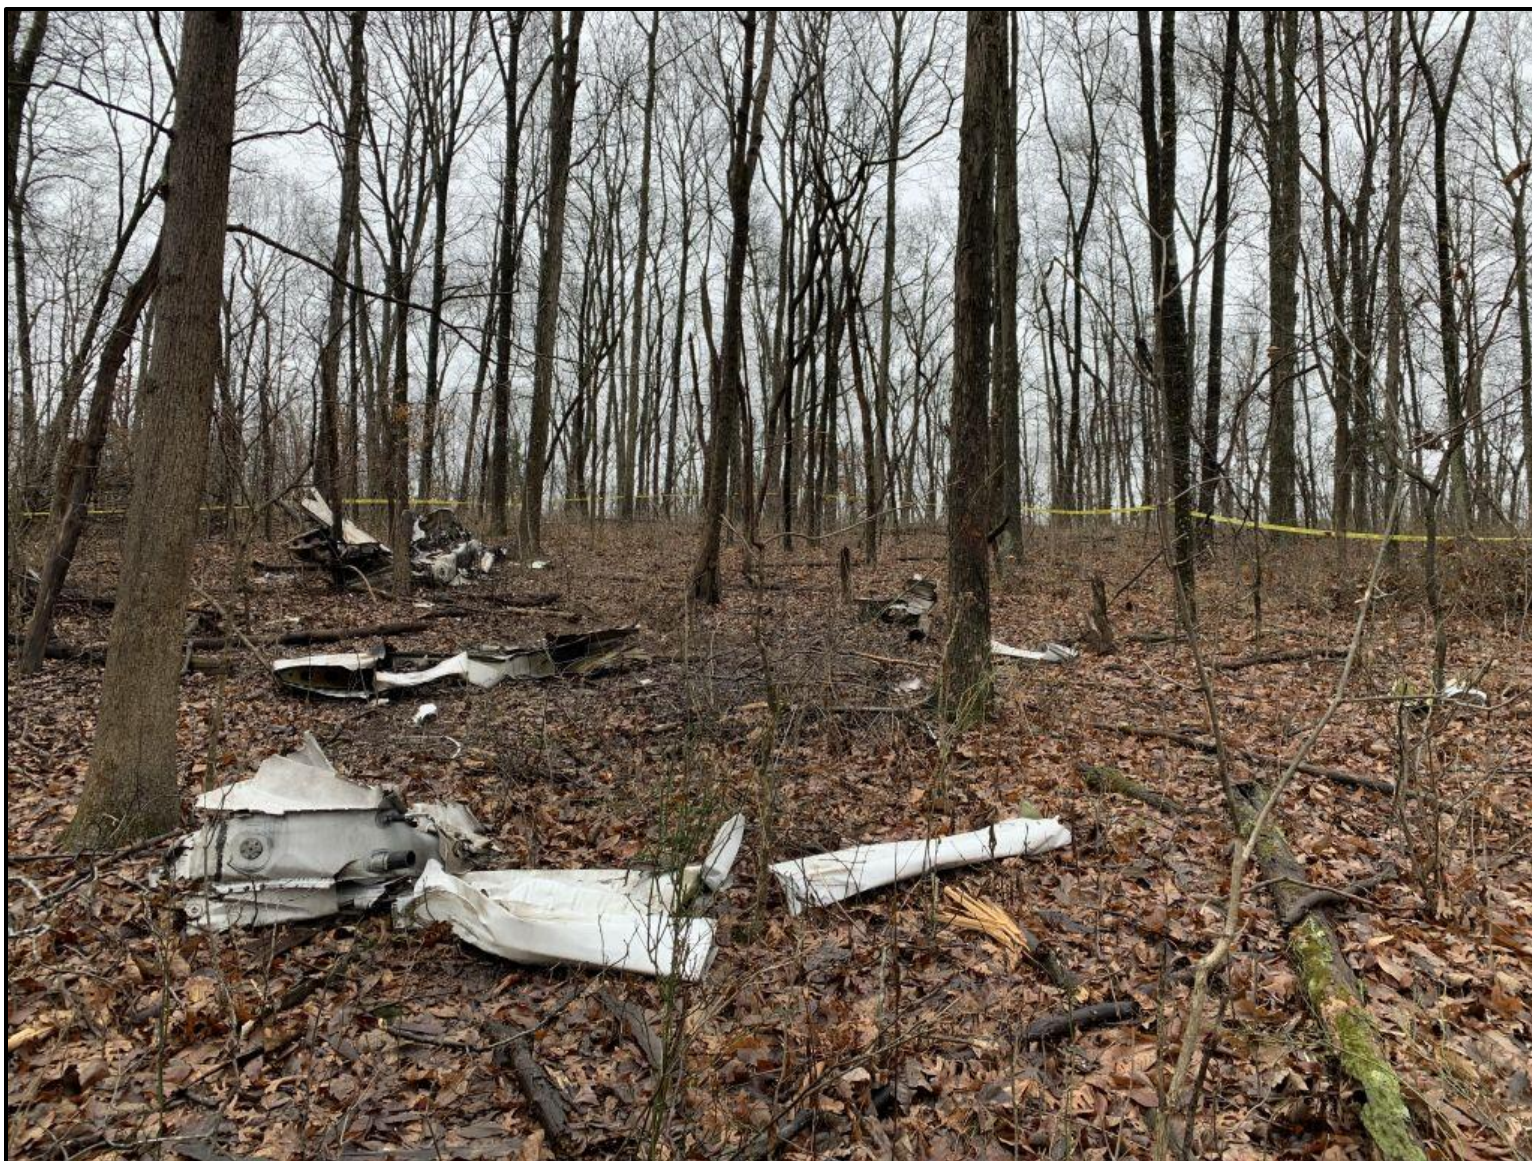
**Photograph 2 - Accident Site**

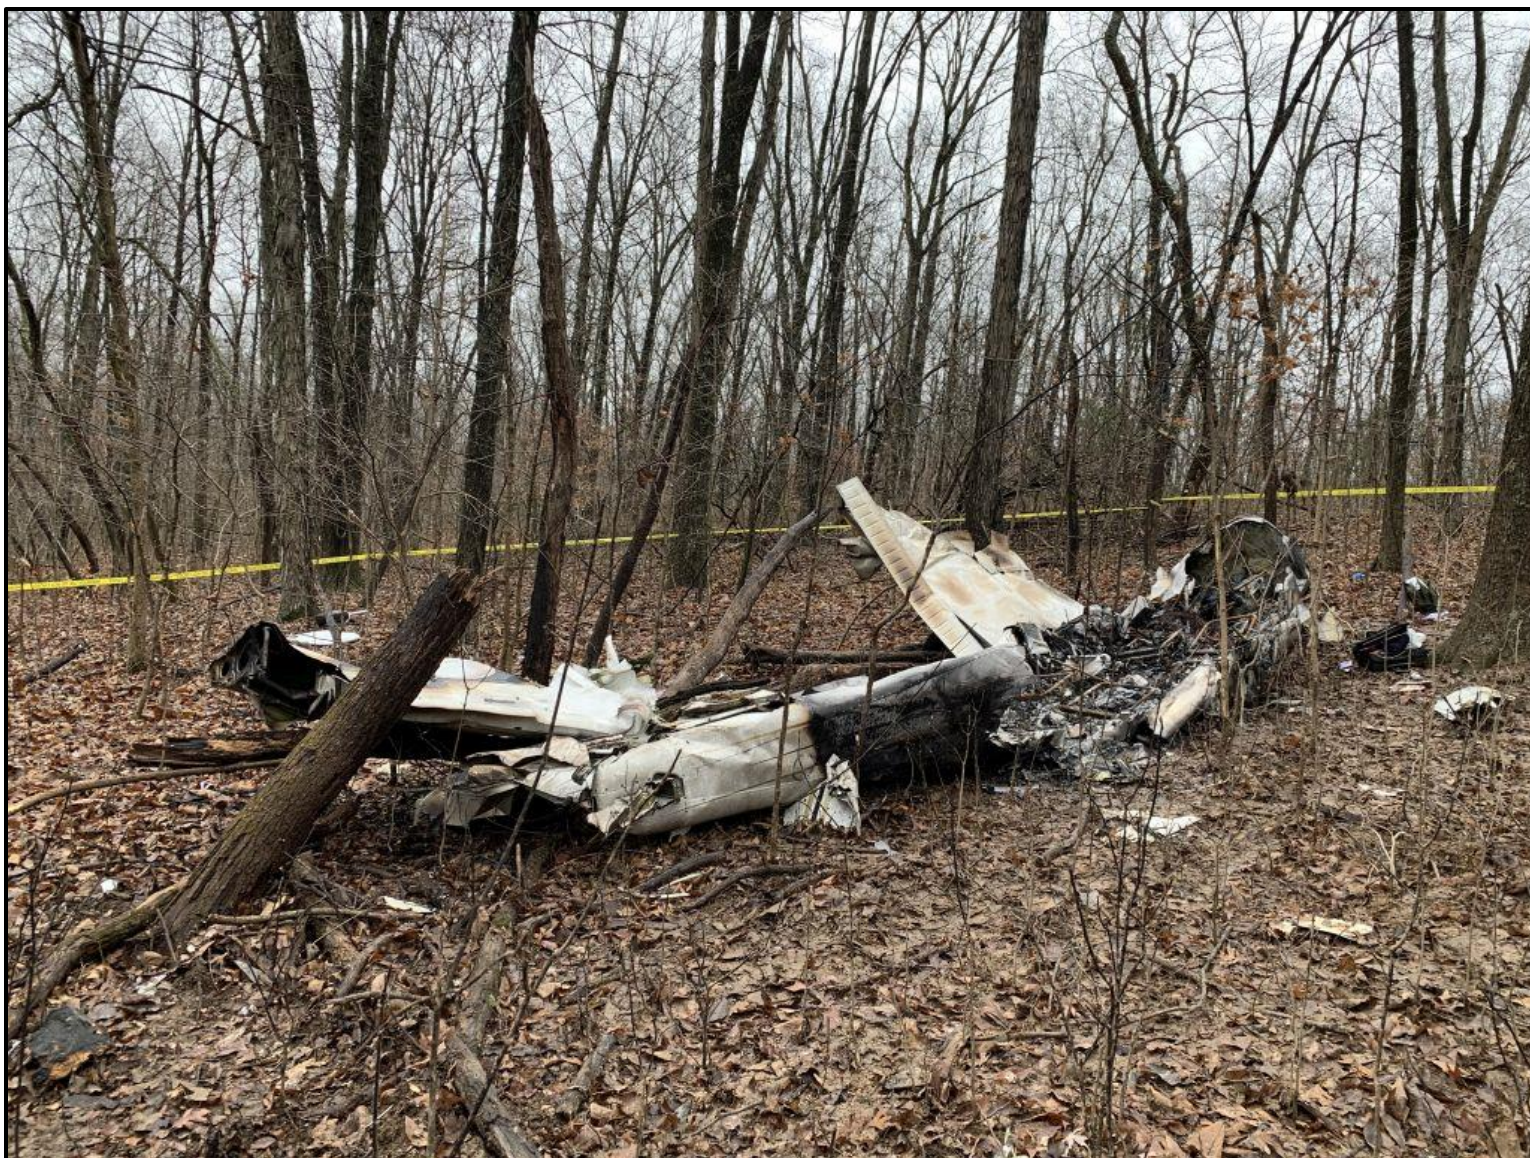
**Photograph 3 - Main Wreckage**

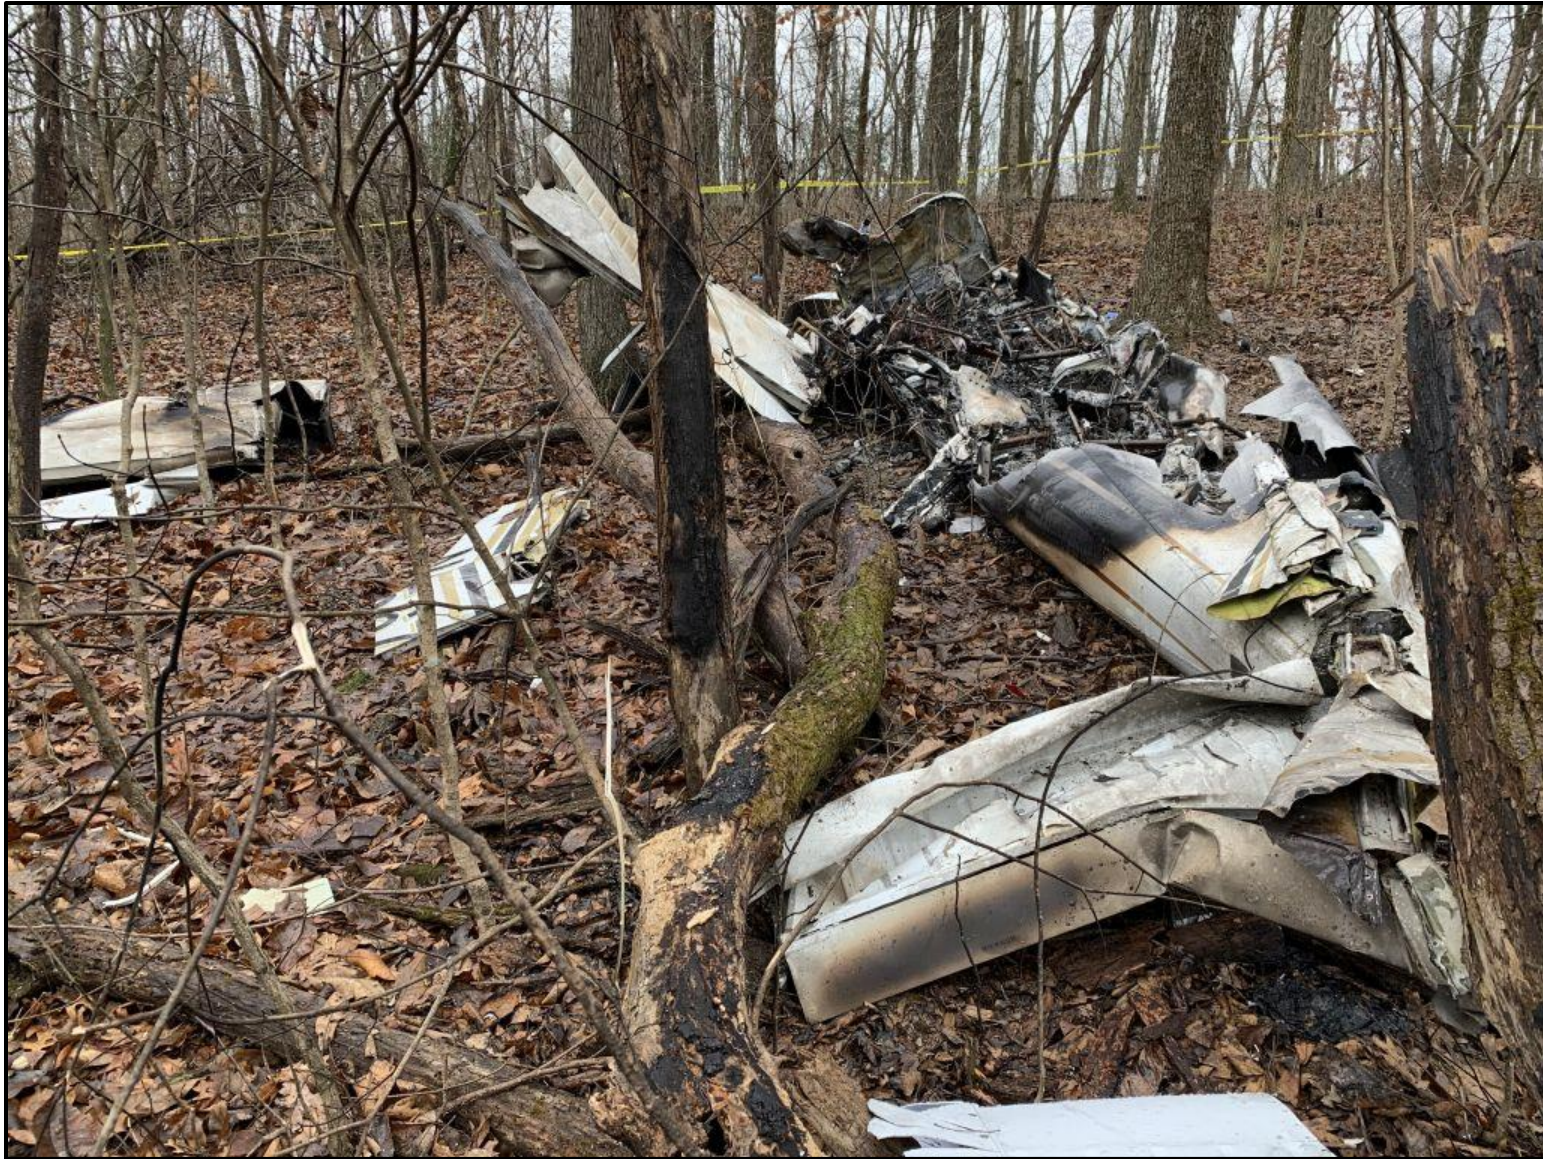
**Photograph 4 - Main Wreckage**

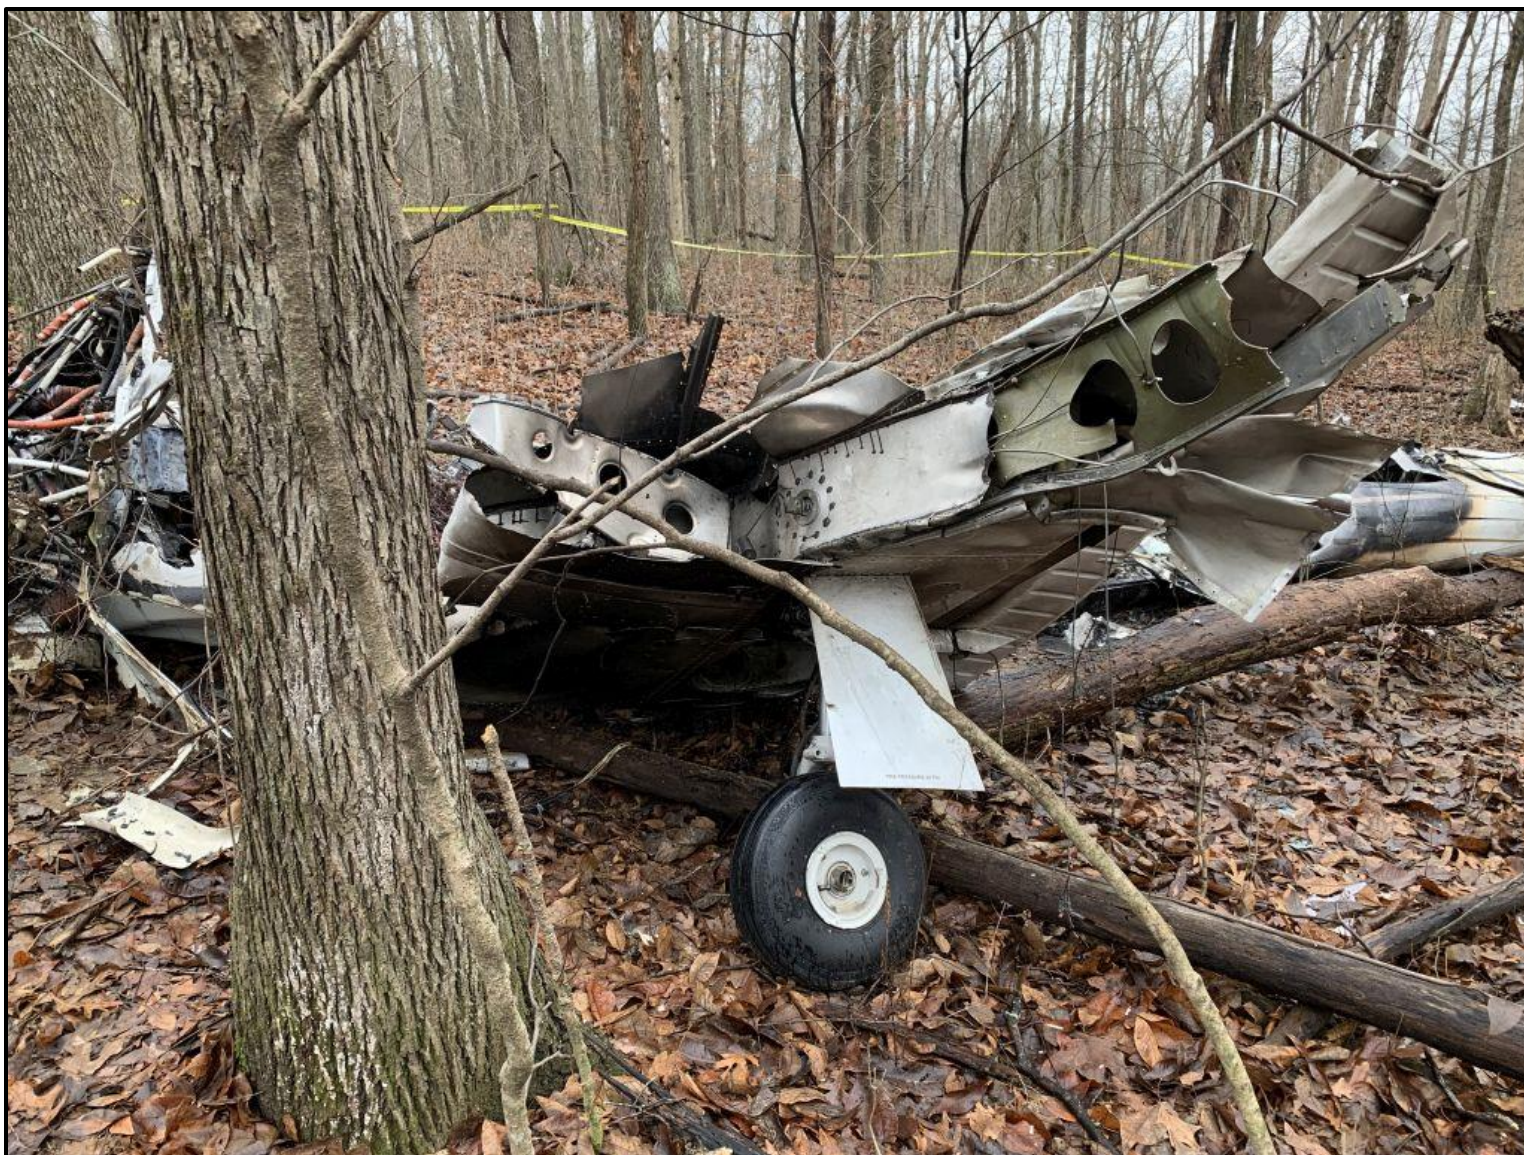
**Photograph 5 - Left Wing**

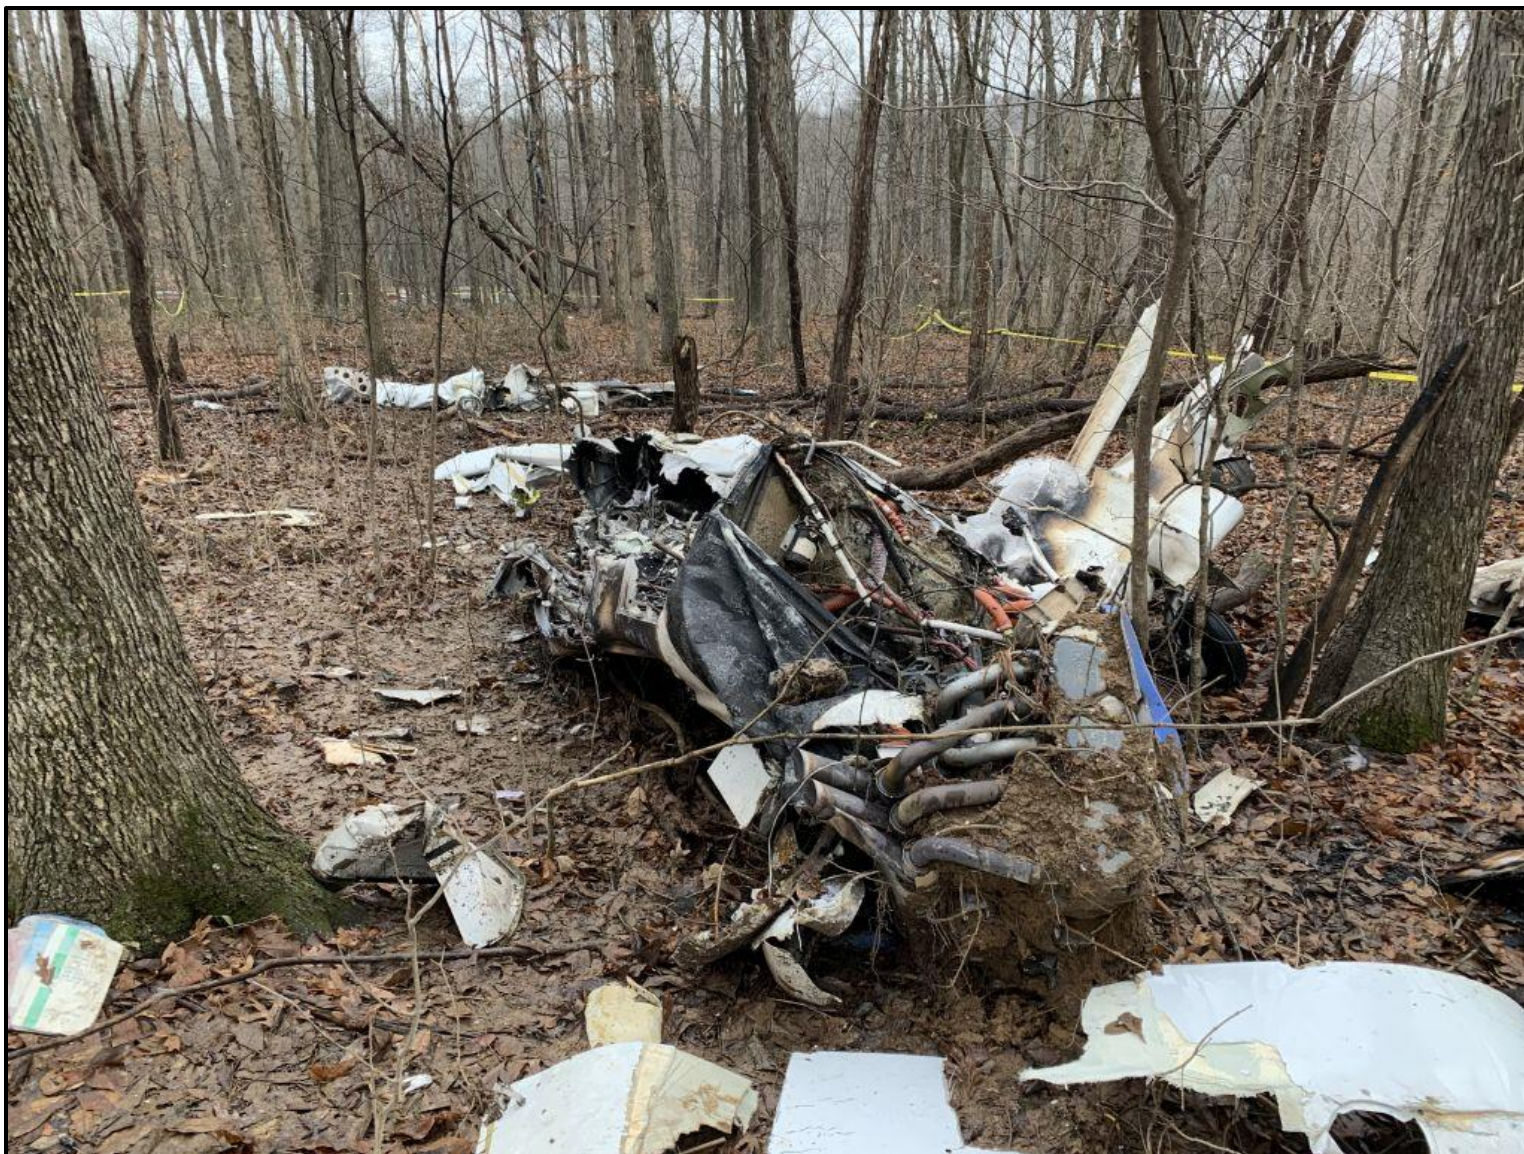
**Photograph 6 - Main Wreckage**

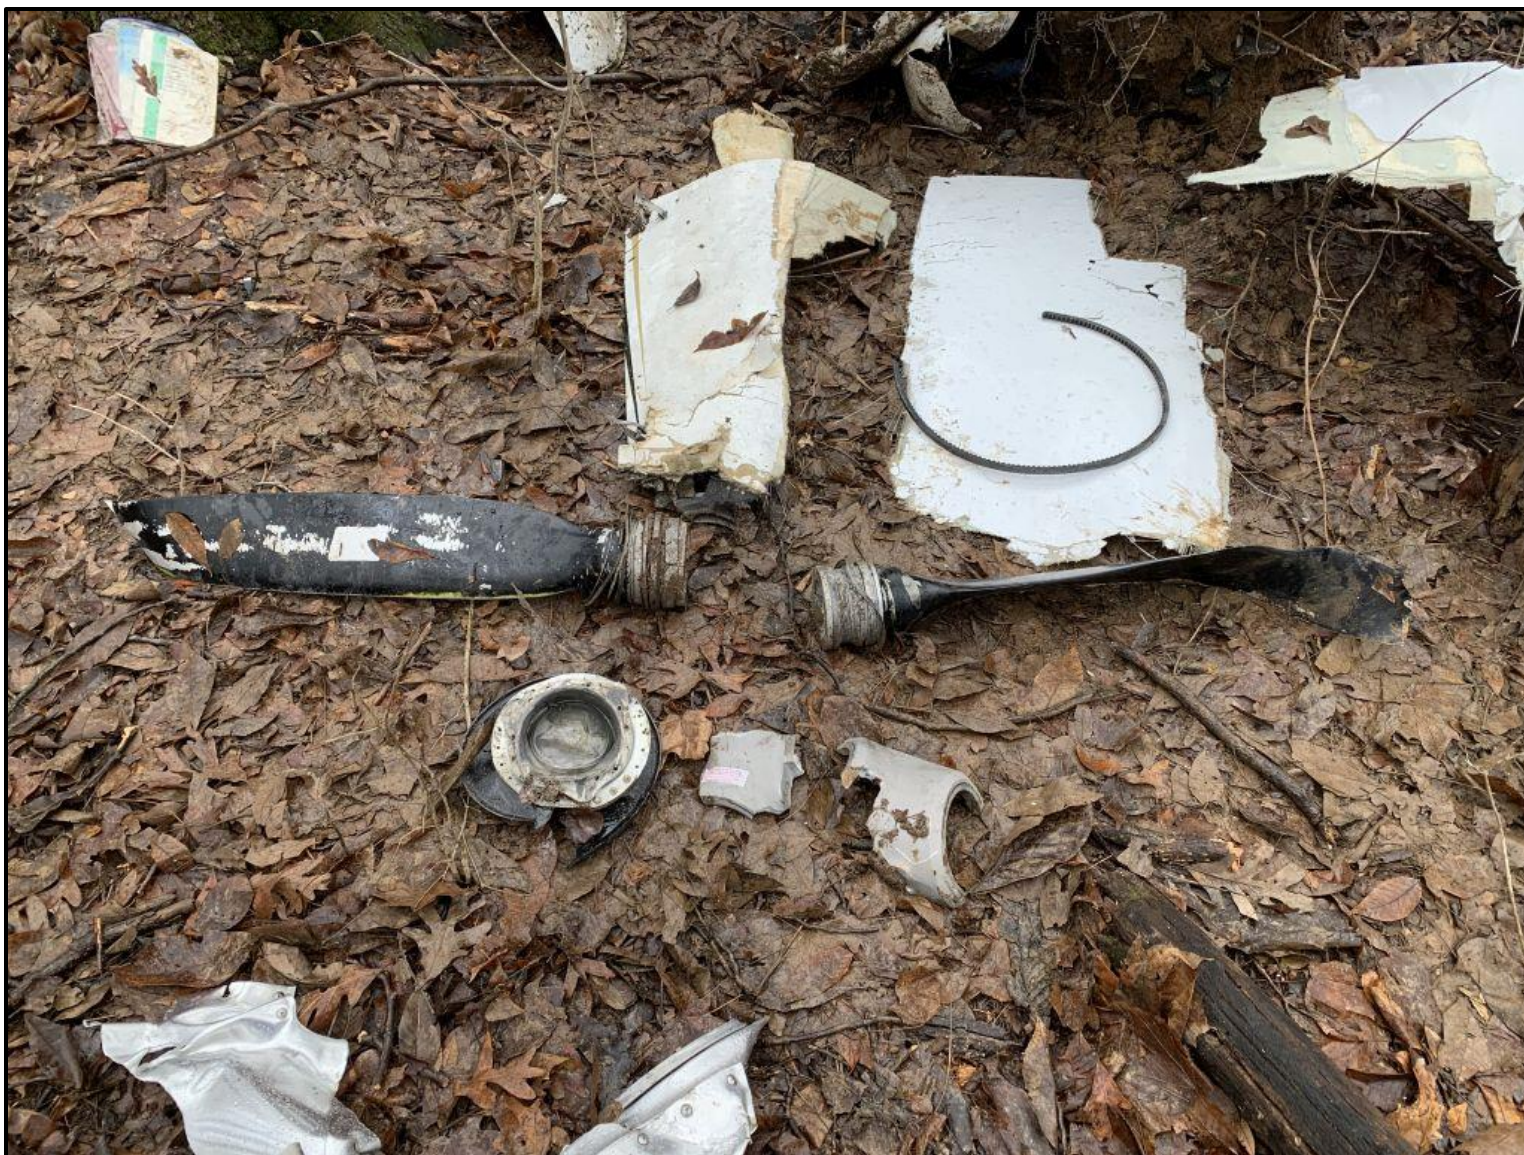
**Photograph 7 - Propeller Blades / Hub Fragments**

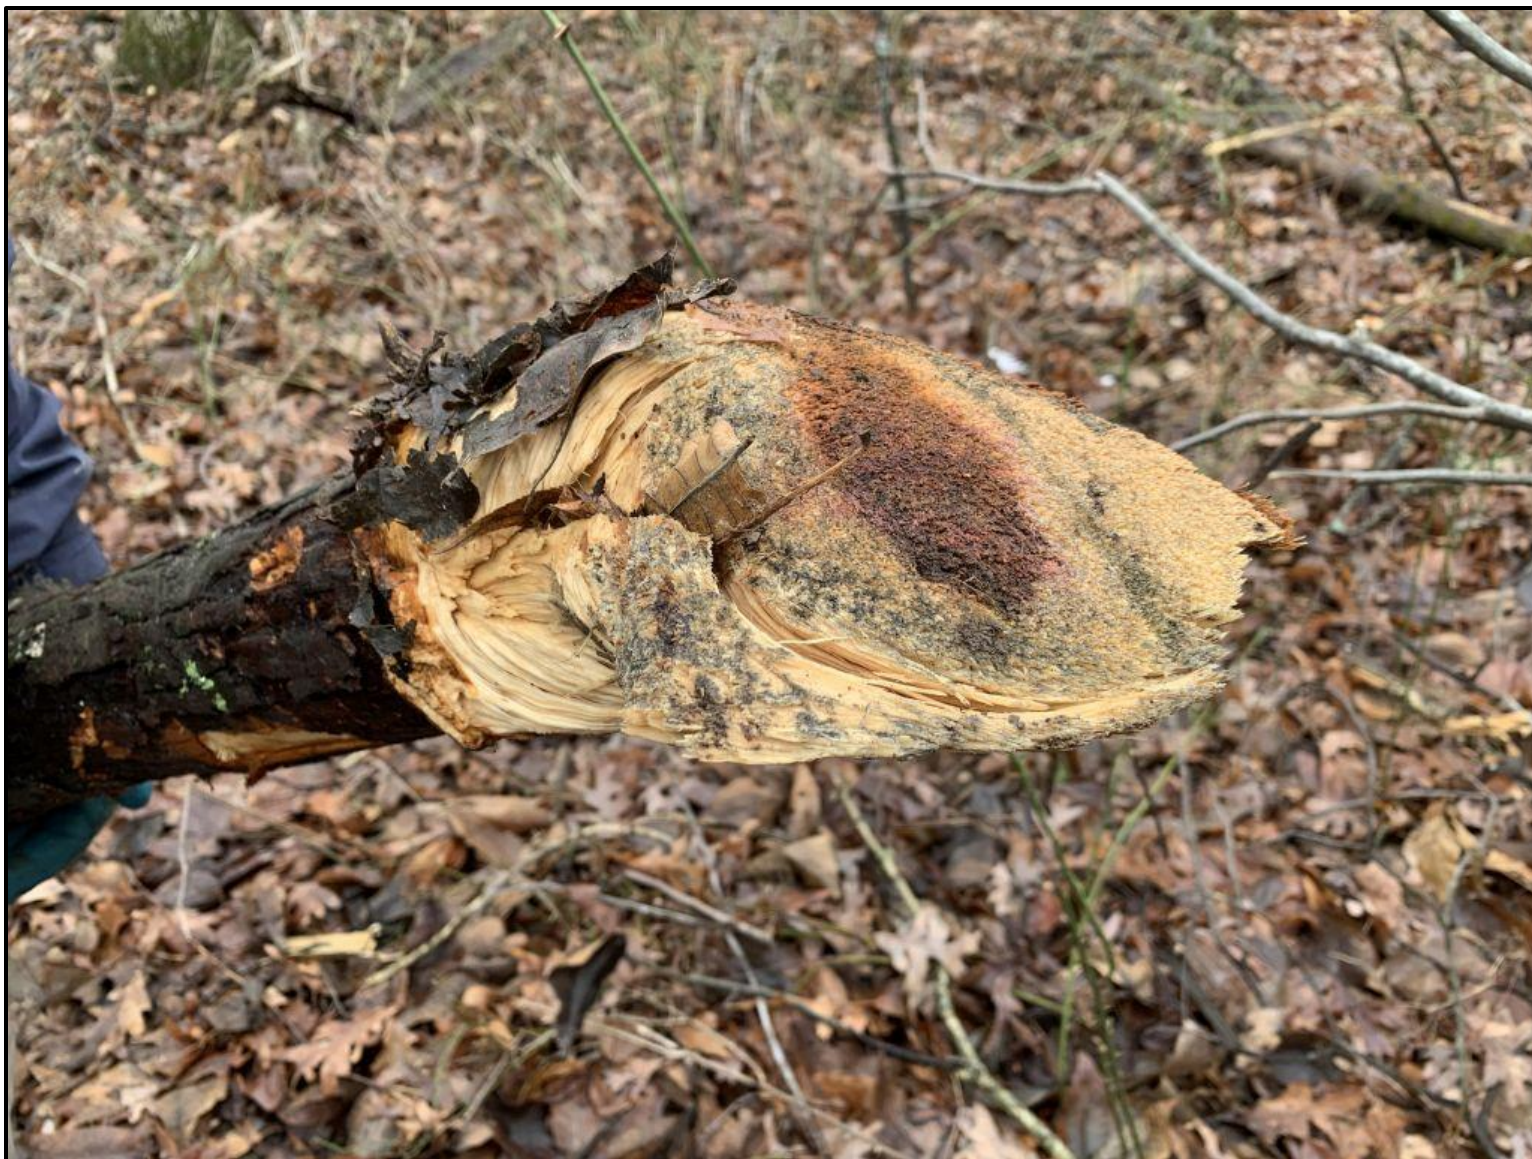
**Photograph 8 - Tree Limb at Accident Site**

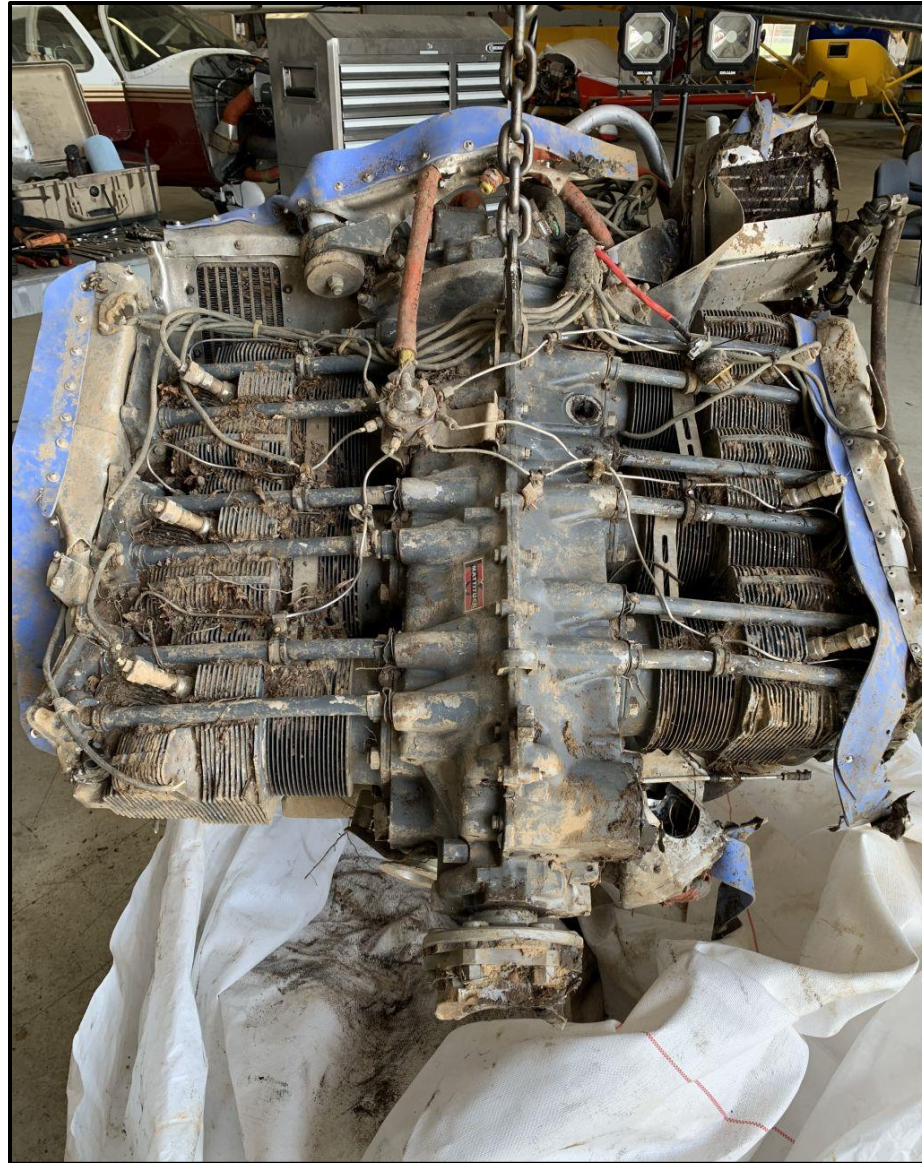
**Photograph 9 - Engine**

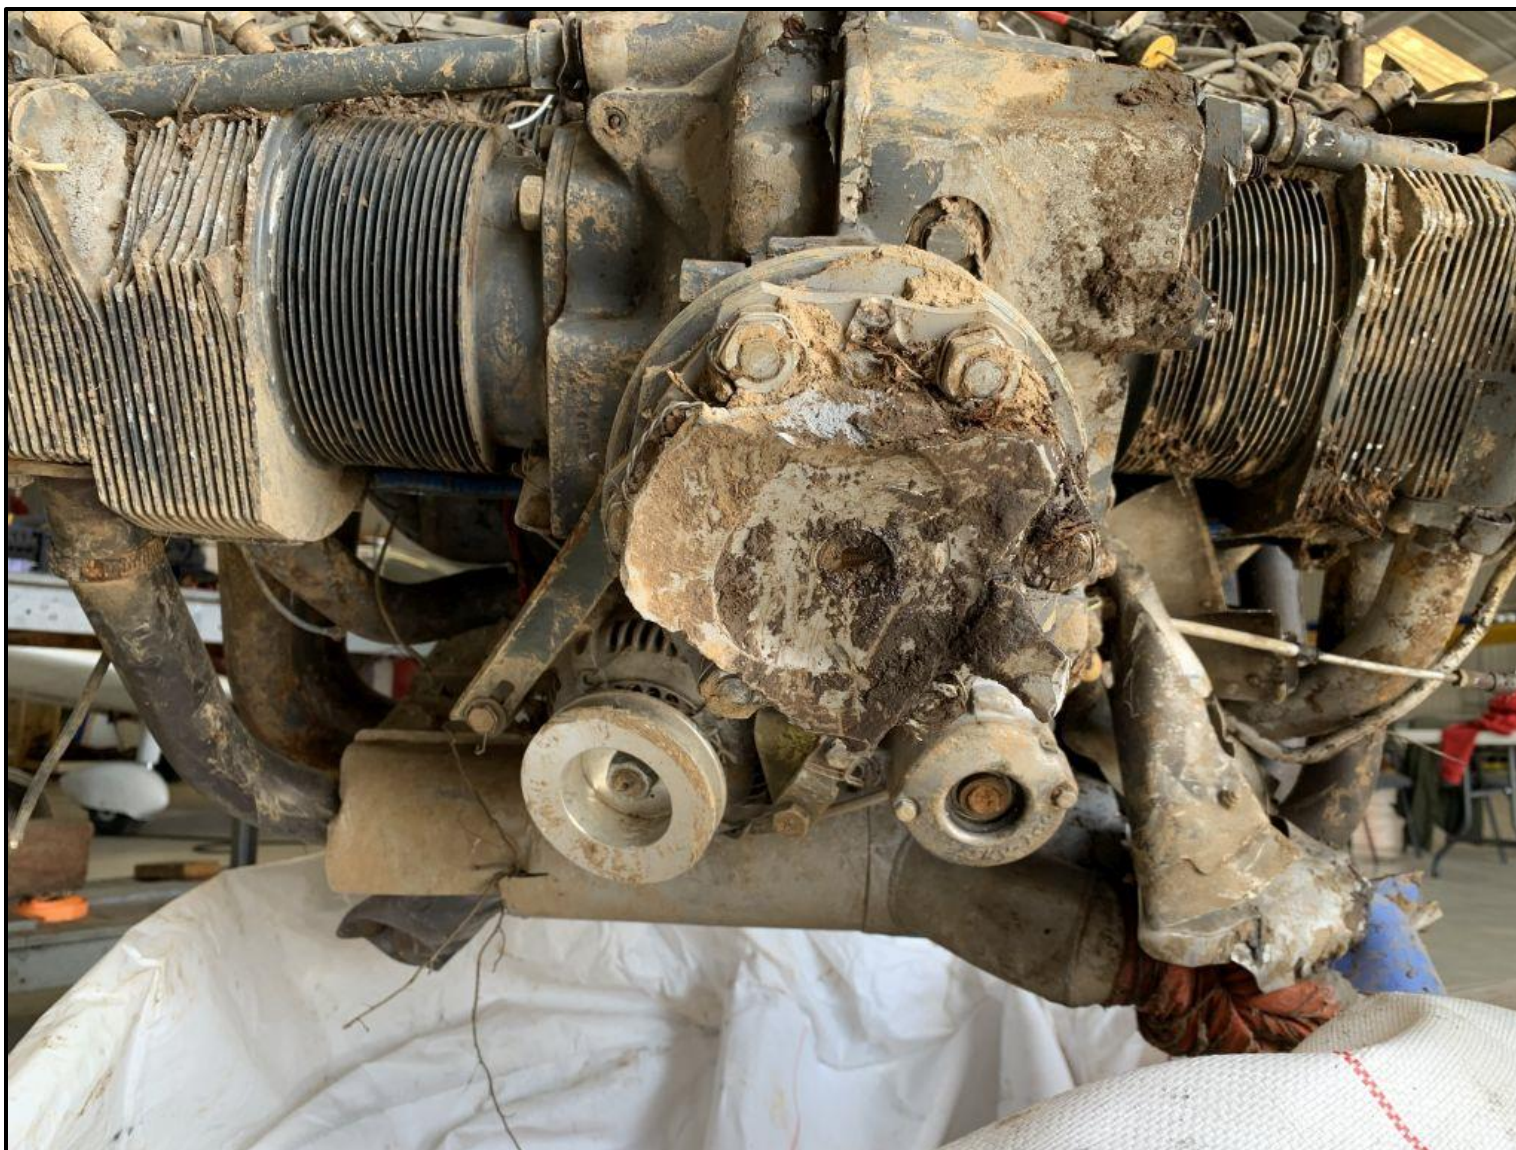
**Photograph 10 - Engine / Propeller Flange**
