# National Transportation Safety Board

CEN22FA081

## **WRECKAGE EXAMINATION SUMMARY**

Location: Fulshear, Texas  
Date: December 21, 2021  
Time: 0926 central standard time (1526 UTC)  
Airplane: Cessna 208B, Registration No. N1116N

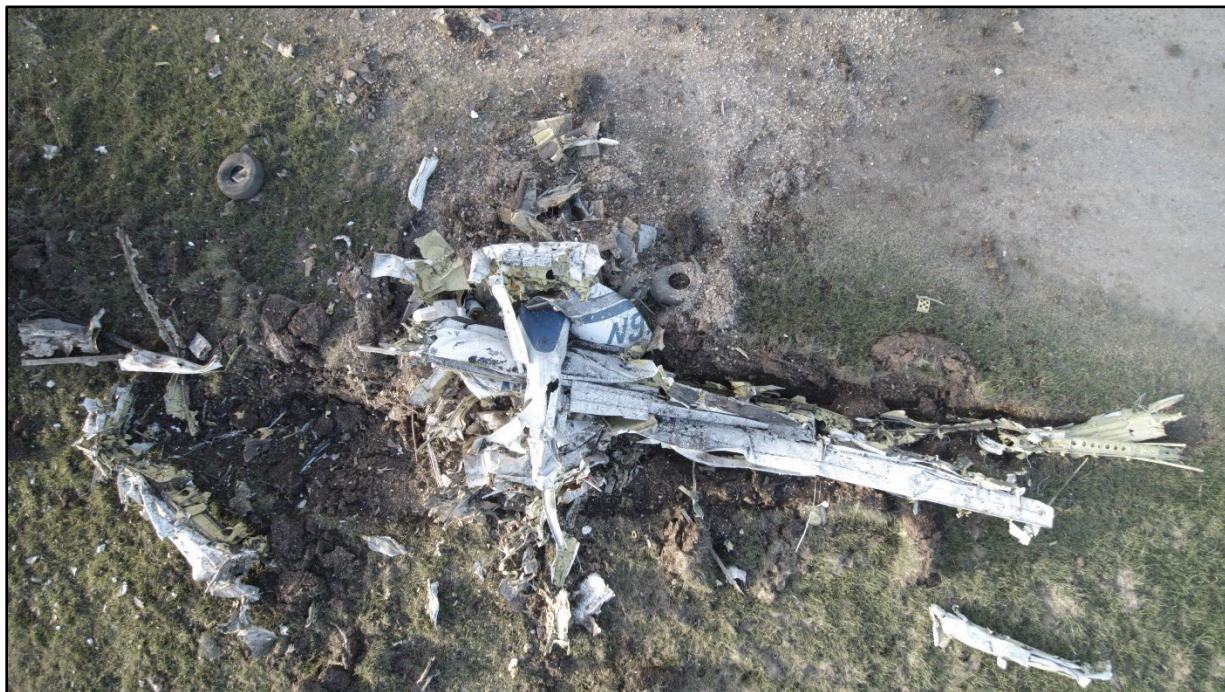
The Cessna airplane impacted terrain at high vertical speed in a steep nose down and inverted attitude, as shown in figure 1. The airplane impacted terrain on a 332° magnetic heading. Most of the fuselage structure was highly fragmented during impact. The larger identifiable fragments exhibited extensive compression damage due to impact with terrain.

**Figure 1.** Cessna 208B main wreckage (Fort Bend County Medical Examiner Office photo)

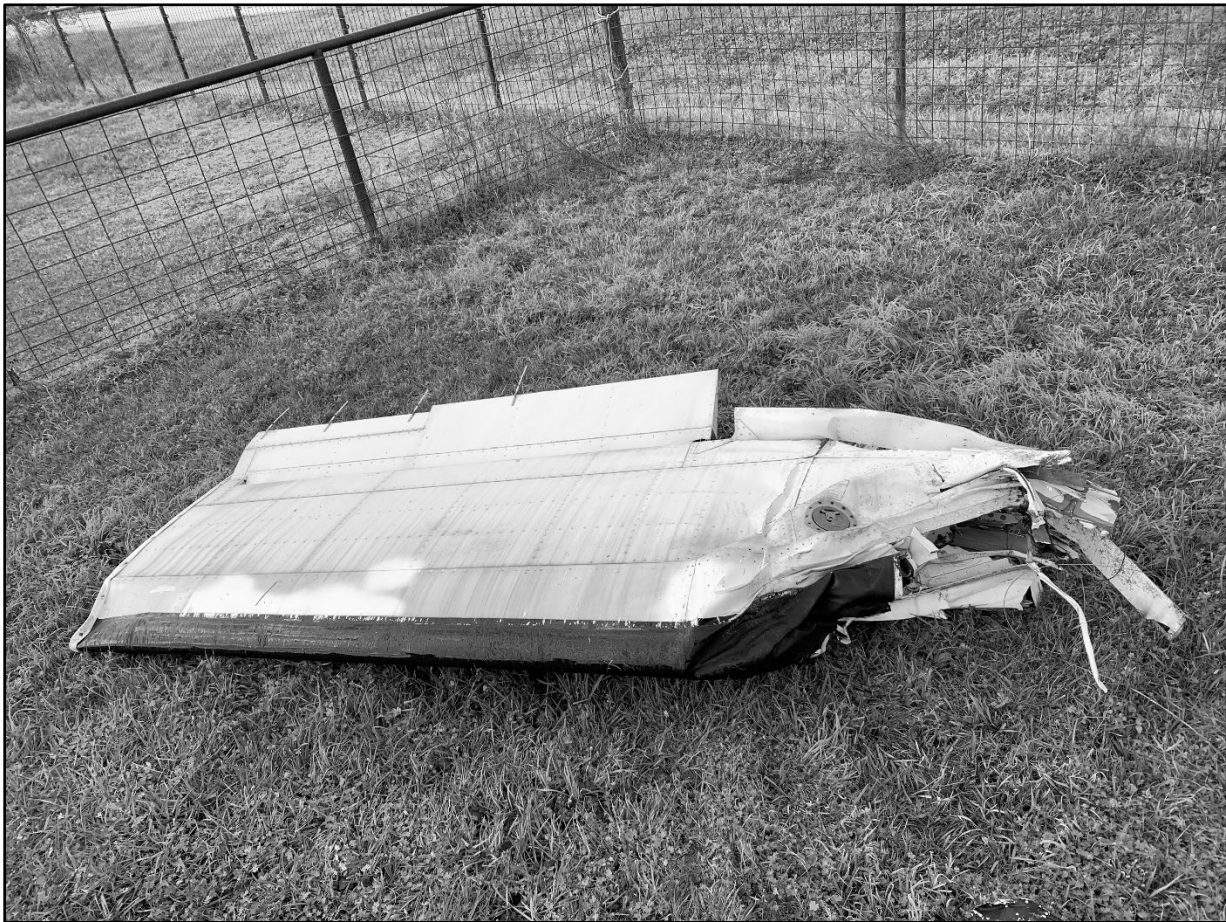
The outboard 10 ft of the right wing, outboard of the lift strut attach point at right wing station (RWS) 170, separated following the impact with the powered paraglider, as shown in figure 2. The separated section of the right wing was located 0.6 mile east (95°) of the main wreckage site. The outboard half of the flap separated with the wing and was found 0.25 nm south of the separated wing section. The right aileron and spoiler remained attached to the separated section of the right wing.

There was a semicircular impact impression in the leading edge of the right wing outboard section. The center of the impression began at RWS 170 and extended outward to RWS 200. Fabric material, resembling the material observed in FAA photographs of the powered paraglider operator's jacket, were embedded in the right wing structure common to the impression area. Additionally, there was biological matter observed in the vicinity of the fabric material inside the wing structure. The inboard portion of the impact impression was distorted aft during ground impact. The impression depth extended chordwise aft from the wing leading edge aft about 36 inches to the aft wing spar.

**Figure 2.** Outboard section of Cessna 208B right wing

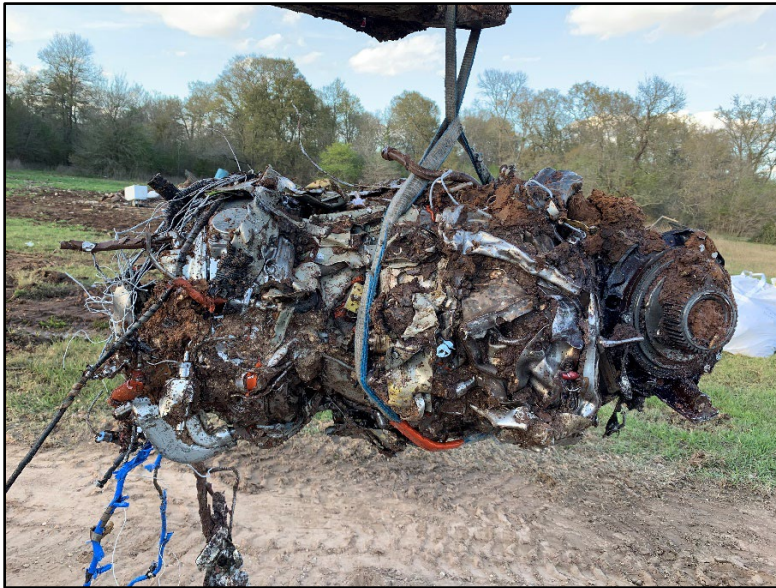
The Cessna's engine and propeller were embedded about 10 ft below the soil surface. The engine was extracted from the impact crater and is shown in figure 3. All three propeller blades were found separated from the hub, as shown in figure 4. Blade 1 was bent aft midspan and exhibited leading edge gouges and chordwise scoring. Blade 2 exhibited S-shaped bending, leading edge gouging, and chordwise scoring. Blade 2 was fractured in two pieces about 18" outboard of the hub. Blade 3 was fractured into multiple pieces, which included the inboard 2 ft of the blade and a 6-inch-long section of blade. The recovered fragments exhibited chordwise scoring and S-shaped bending.

**Figure 3.** Engine after it was extracted from impact crater

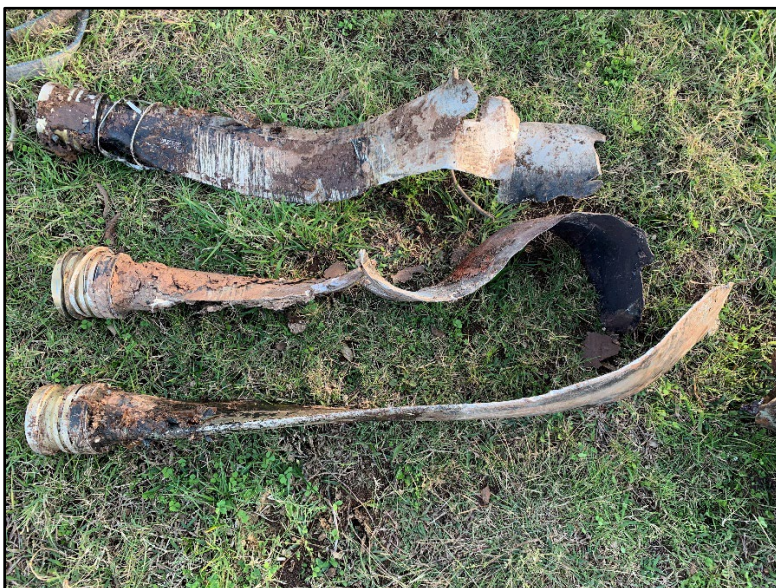
**Figure 4.** Propeller Blades

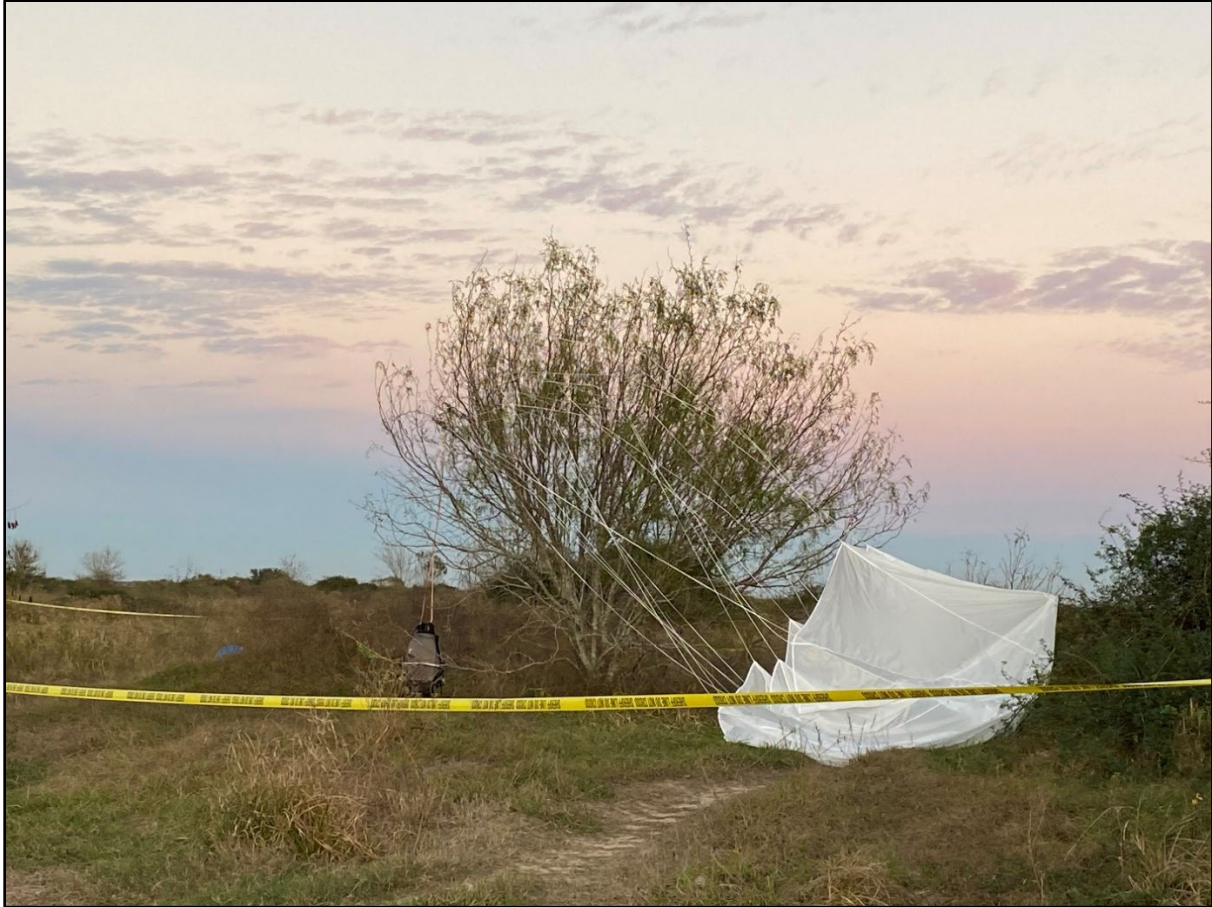
The paraglider wing, harness, and emergency parachute were located about 3.9 miles south (170° true) from the Cessna main wreckage, as shown in figures 5-7. The static and control lines remained intact and attached to the harness and wing. The harness exhibited tearing and impact damage. The wing remained intact with only slight tearing present on the bottom surface, as shown in figure 8 and figure 9. The emergency parachute was found deployed, intact, with no tearing or damage. The recovered components of the powered paraglider are shown in figure 10.

**Figure 5.** Paraglider harness and emergency parachute (FAA photo)

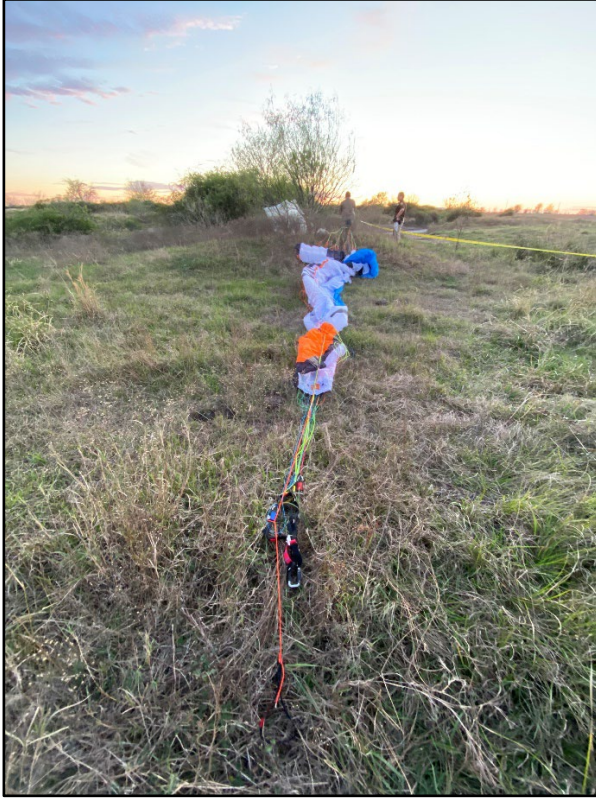
**Figure 6.** Paraglider wing (FAA photo)

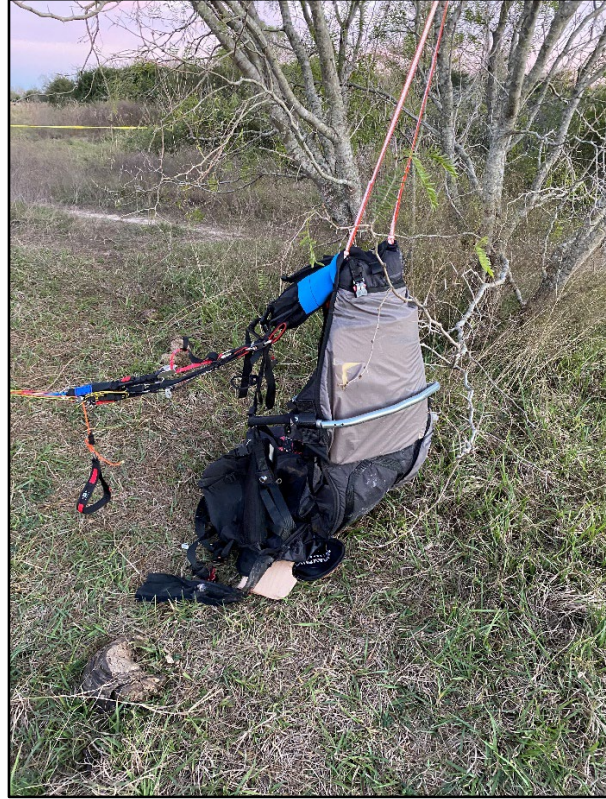
**Figure 7.** Paraglider harness (FAA photo)

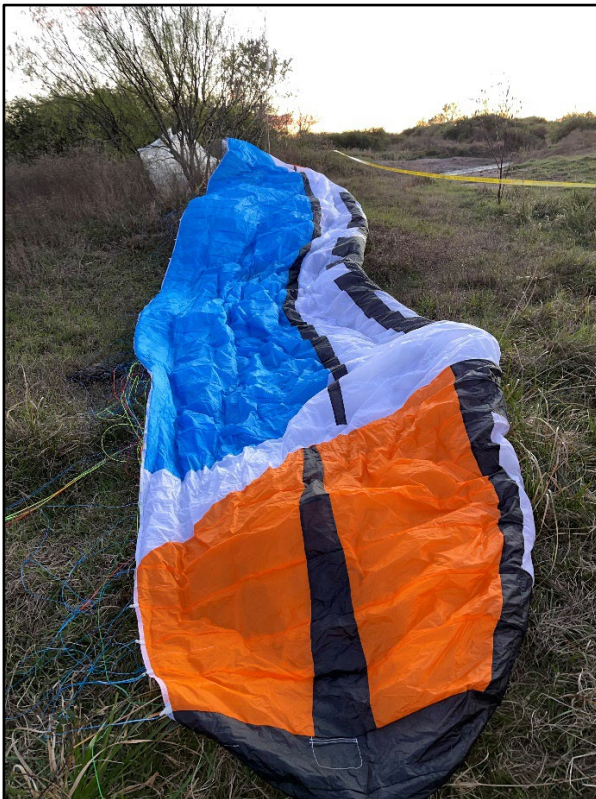
**Figure 8.** Wing top (FAA photo)

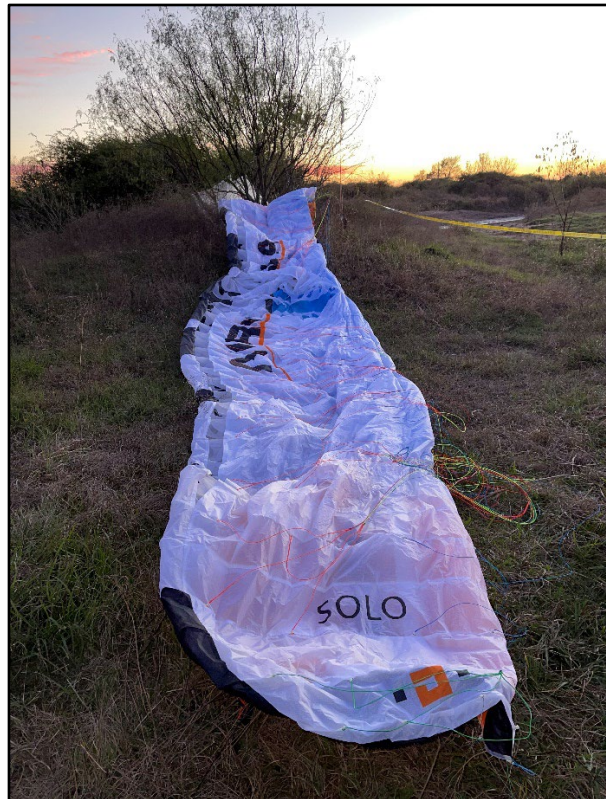
**Figure 9.** Wing bottom (FAA photo)

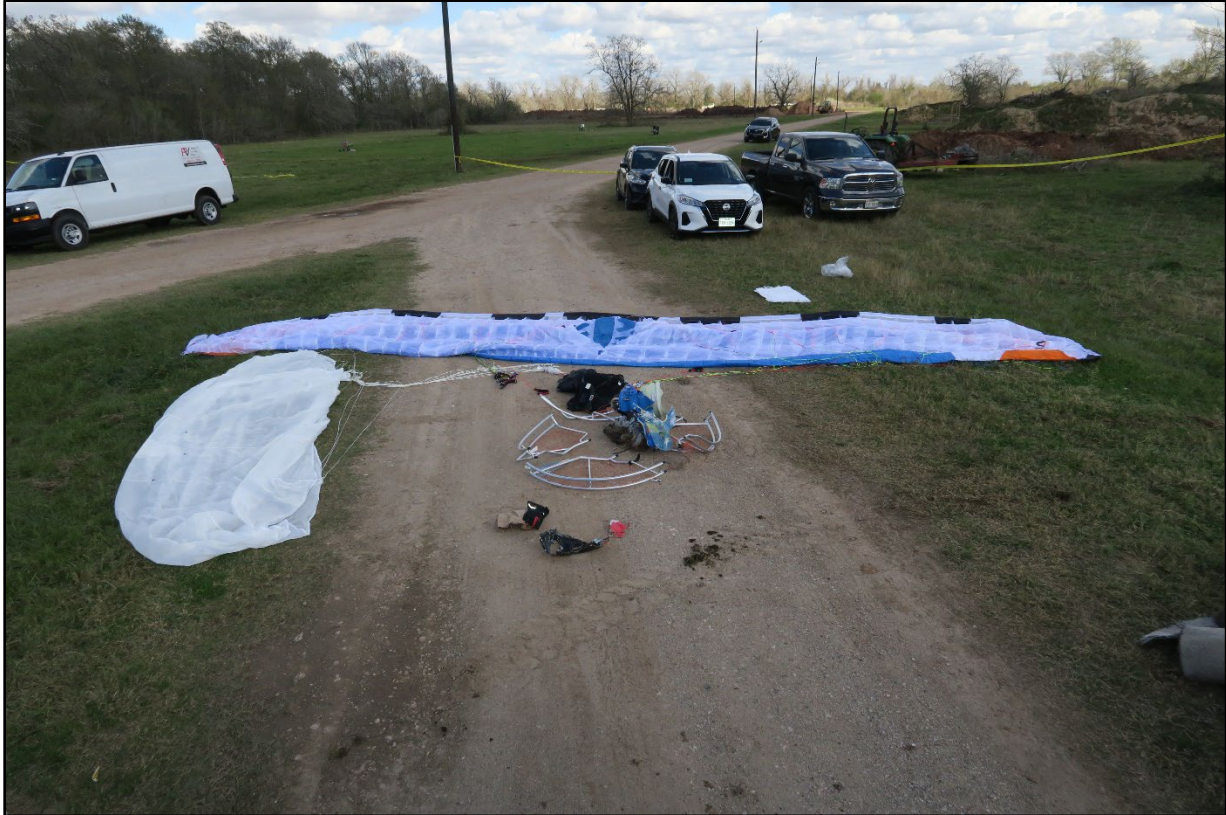
**Figure 10.** Powered paraglider layout after recovery (Textron Aviation photo)
