# National Transportation Safety Board

CEN22FA081

## **ONBOARD IMAGE RECORDER**

Location: Fulshear, TX  
Date: December 21, 2021  
Time: 09:26 central standard time (CST)  
15:26 coordinated universal time (UTC)  
Airplane: Cessna 208, N1116N  
Vehicle: Dudek Paragliders Solo 21 (A2), Unregistered

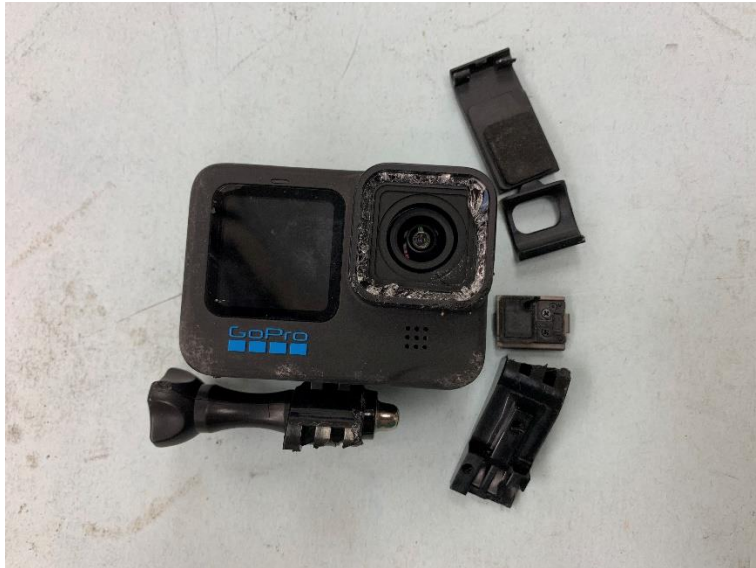
The device was damaged in the event. The device's arrival condition is shown in Figure 1. A microSD card was found in the appropriate mounting location in the camera. The microSD card was attempted to be read via a PC and a forensic write blocker. The microSD card failed to mount using this method, and a variety of other similar methods using different adapters, different PCs and different software.

**Figure 1.** The GoPro HERO 10 Black as received.

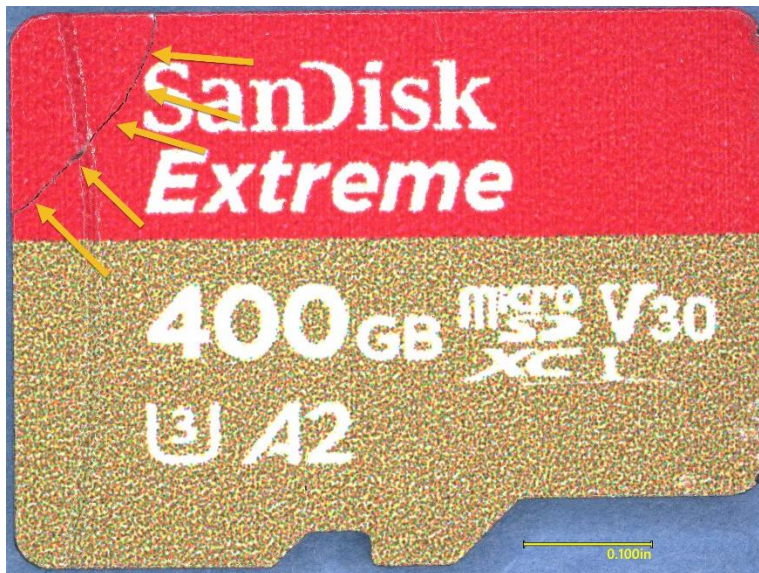
The microSD card was then examined using a digital stereomicroscope. The front of the card is pictured in Figure 2. A crack is noted with yellow arrows on the front of the card. The rear of the card is pictured in Figure 3. The rear of the card has two areas in which a crack appeared; these areas are noted with yellow arrows. Figure 4 is a 100x magnification image of one of the cracked areas on the rear of the card. Figure 5 is an X-ray image of a cracked area of the device. Note that X-rays are typically ineffective at imaging damaged silicone. This X-ray image shows potential damage to the device's internal bond wires.

**Figure 2.** A stereo microscope image of the front of the microSD card. The yellow arrows note a cracked area.

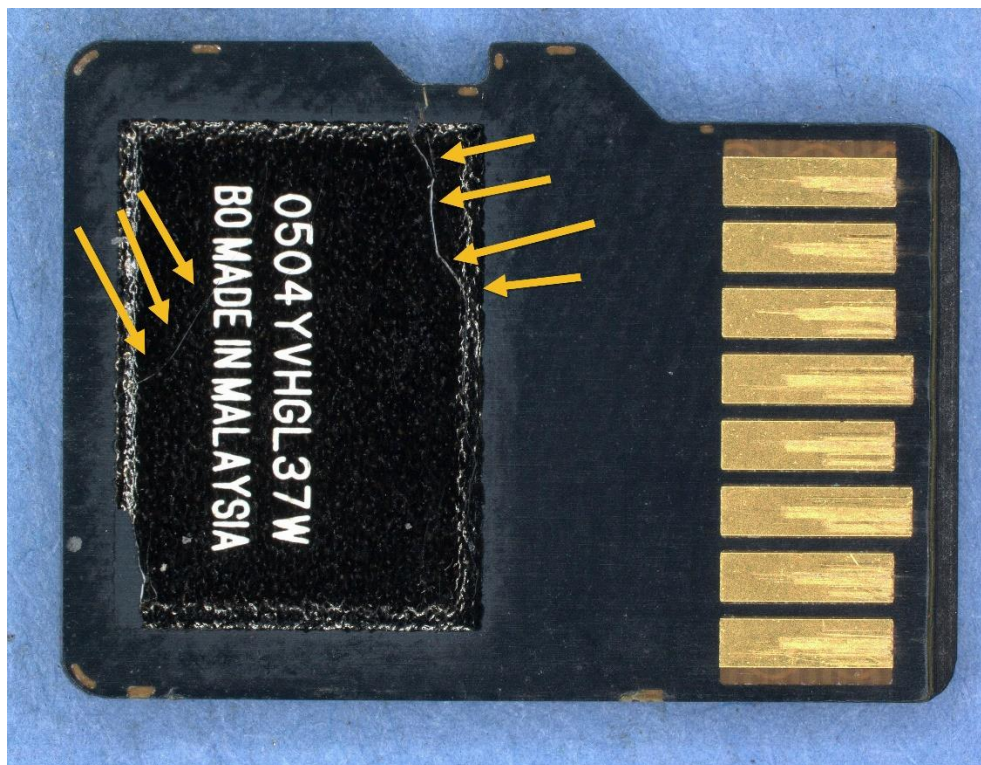
**Figure 3.** A stereo microscope image of the rear of the microSD card. The yellow arrows note two cracked areas.

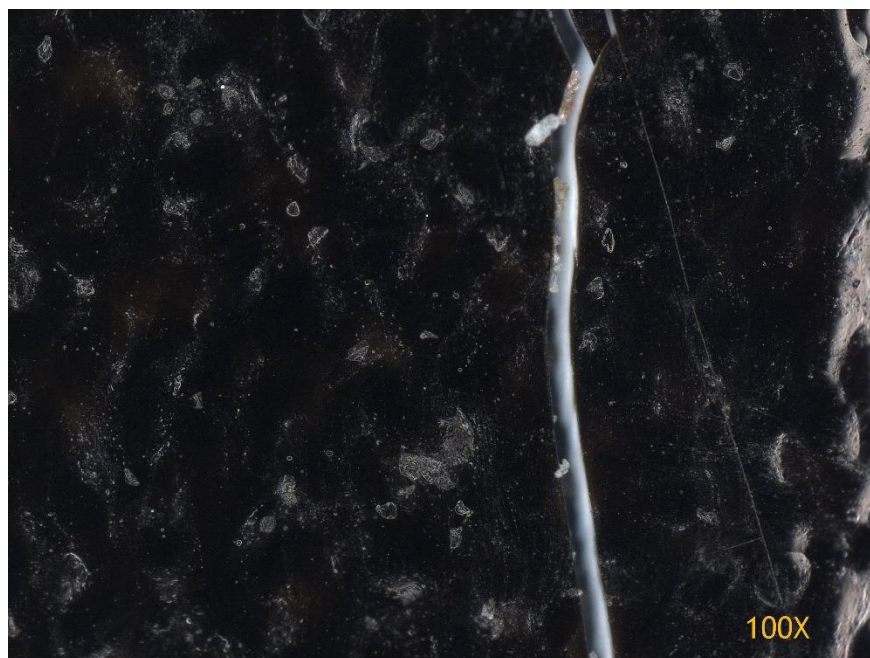
**Figure 4.** Close detail of one cracked area on the rear of the microSD card.

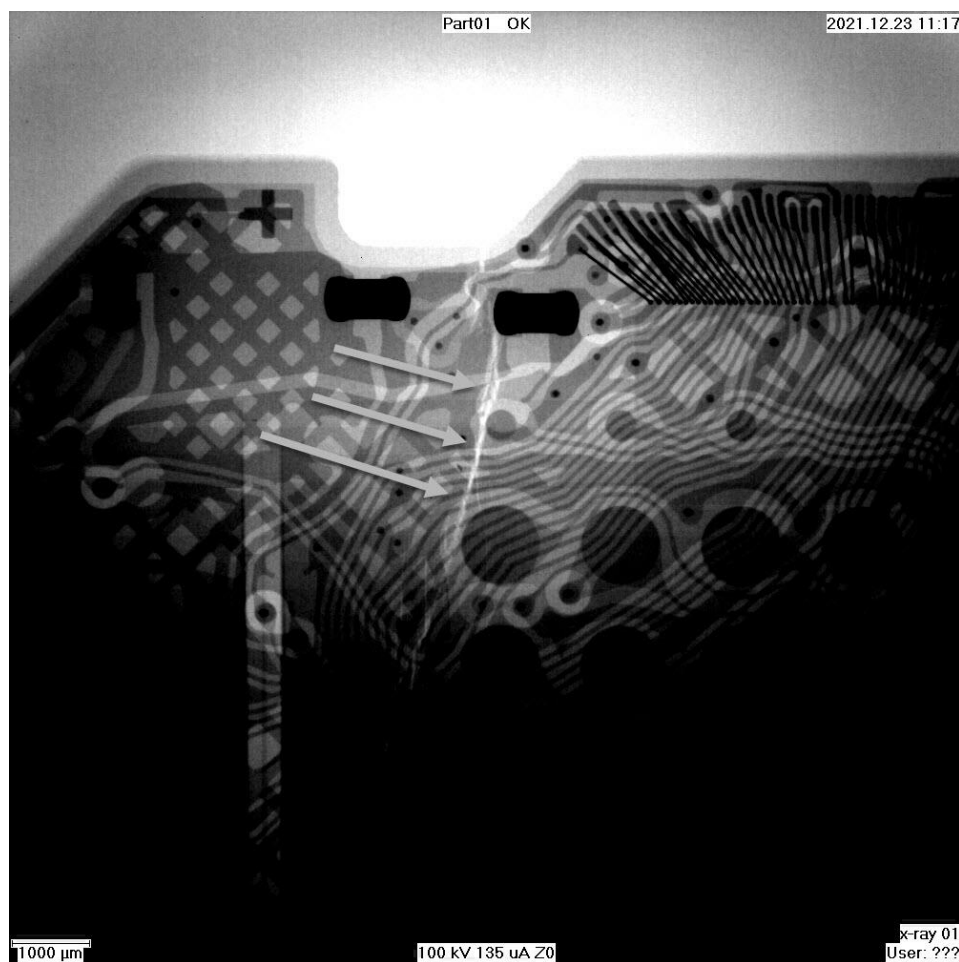
**Figure 5.** X-ray image showing one area of potentially damaged bond wires. The affected area is shown with grey arrows.

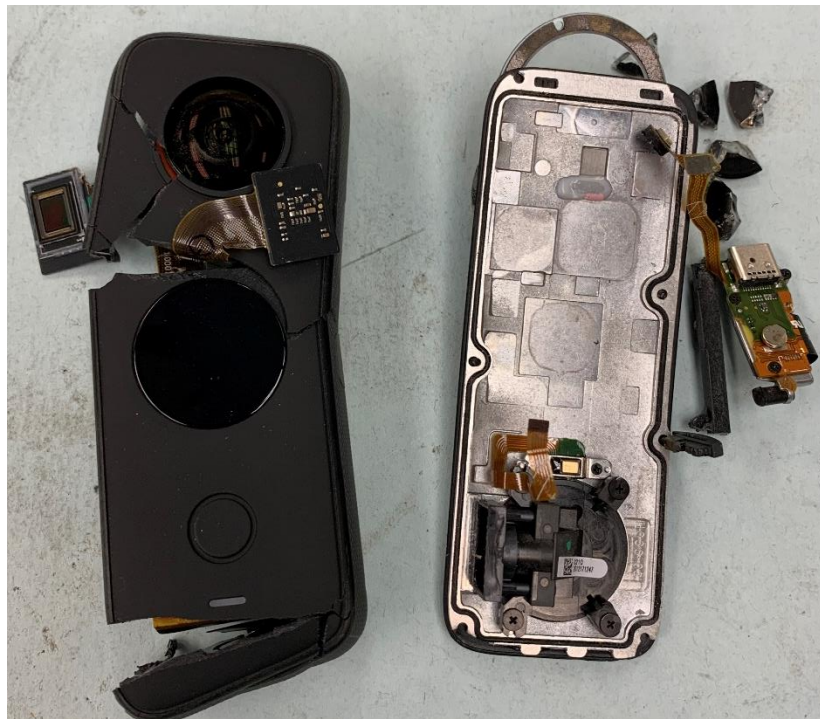
The camera was destroyed in the accident, its arrival condition is shown in Figure 6. The associated microSD card was found seated in the appropriate location in the device. The microSD card was removed and is pictured in Figure 7. A visual inspection did not reveal any damage to the card. The microSD card was read via a PC and a forensic write blocker.

**Figure 6.** Photo of the Insta360 OneX2 as received.
