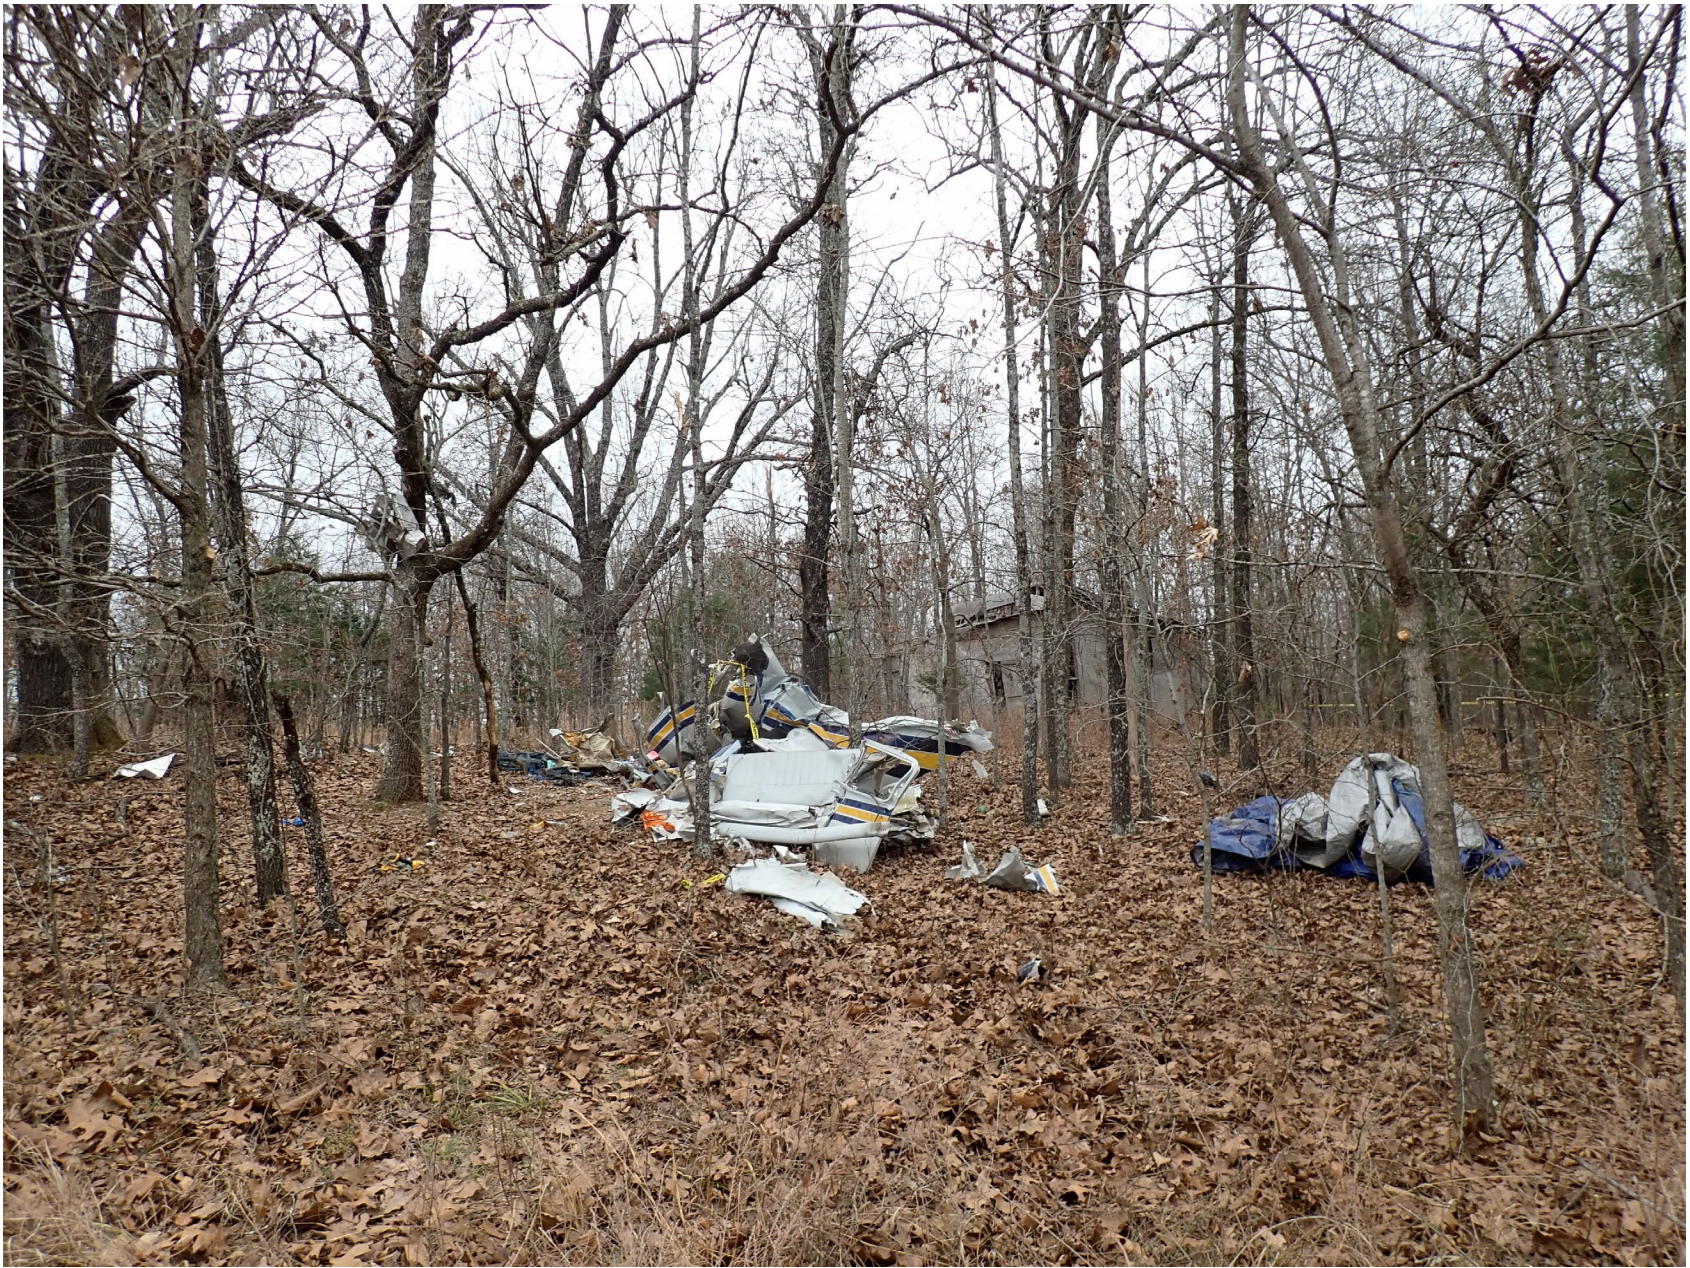
**Photo 1 – View of the wreckage at the accident site (courtesy of Textron Aviation).**

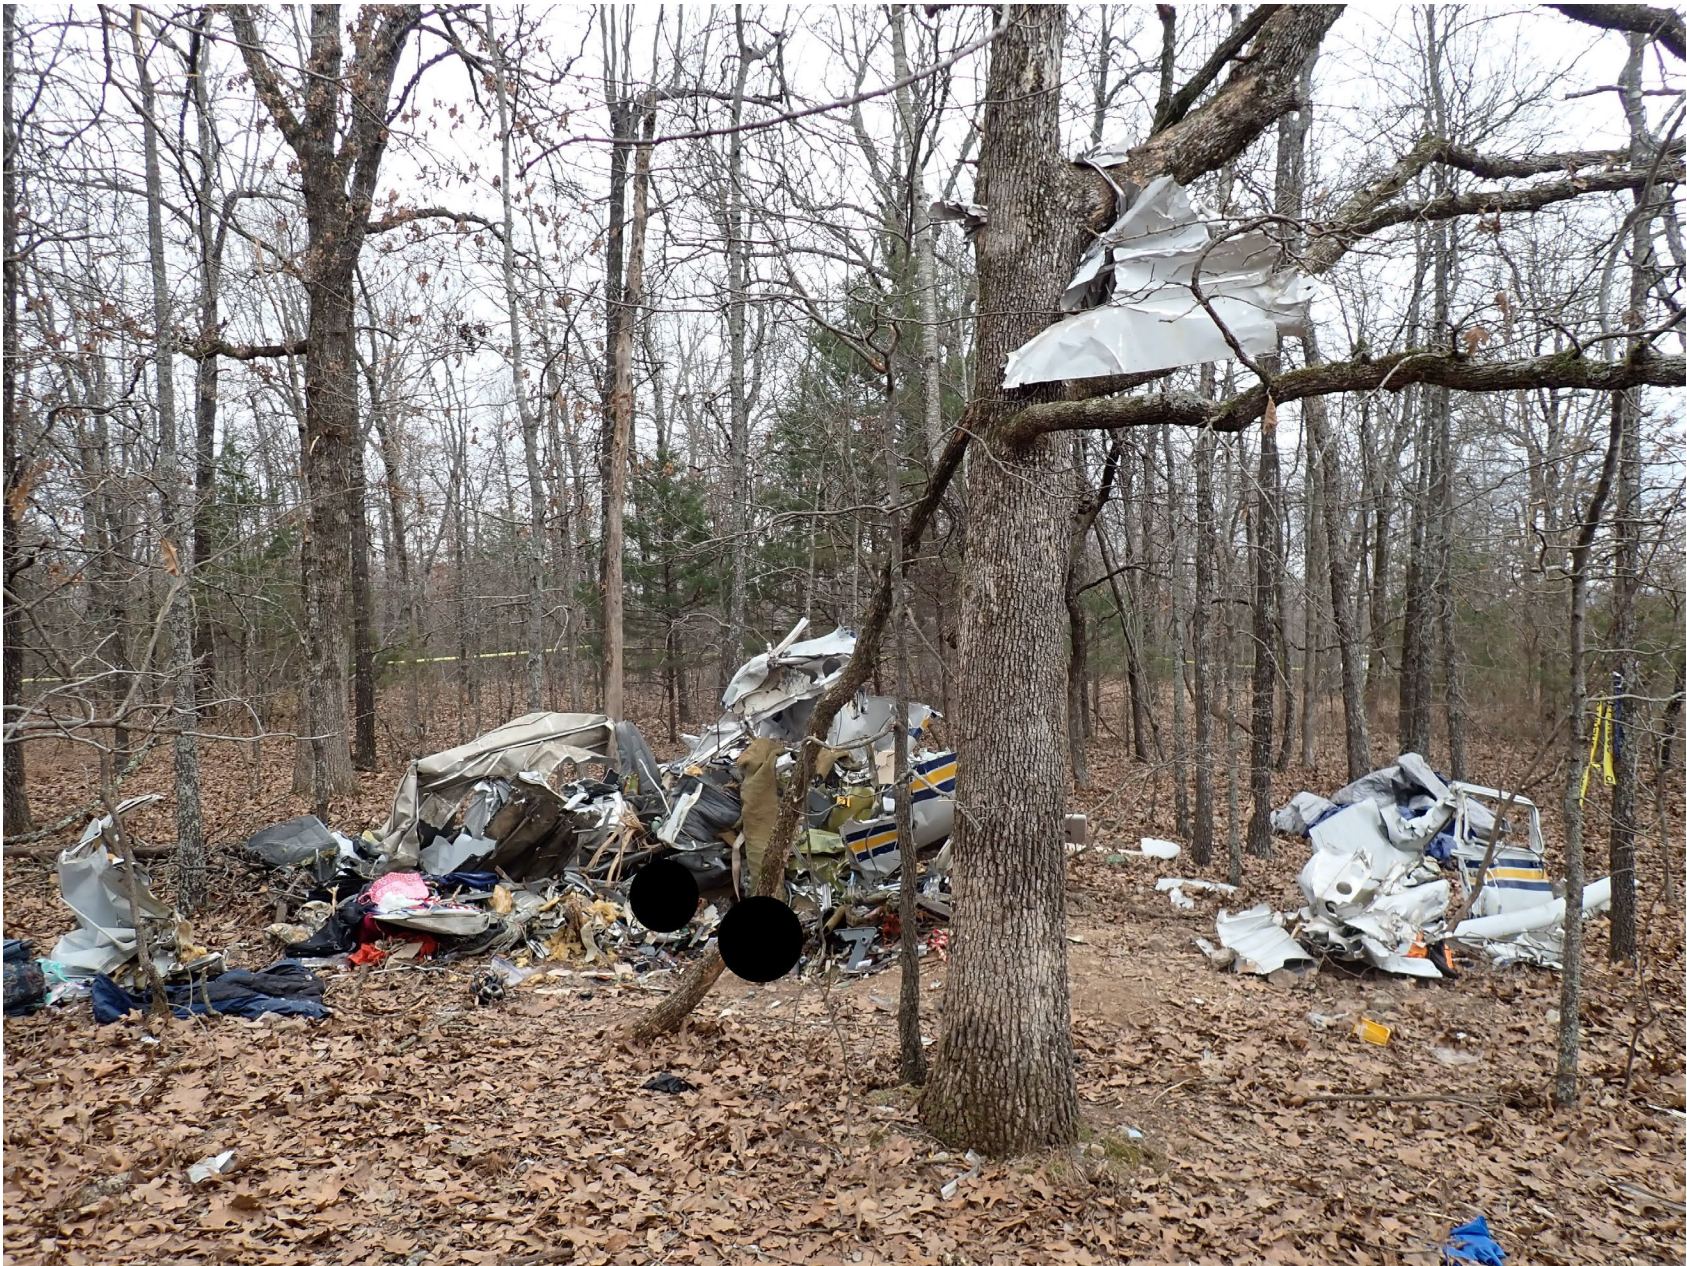
**Photo 2 – View of the wreckage at the accident site (courtesy of Textron Aviation).**

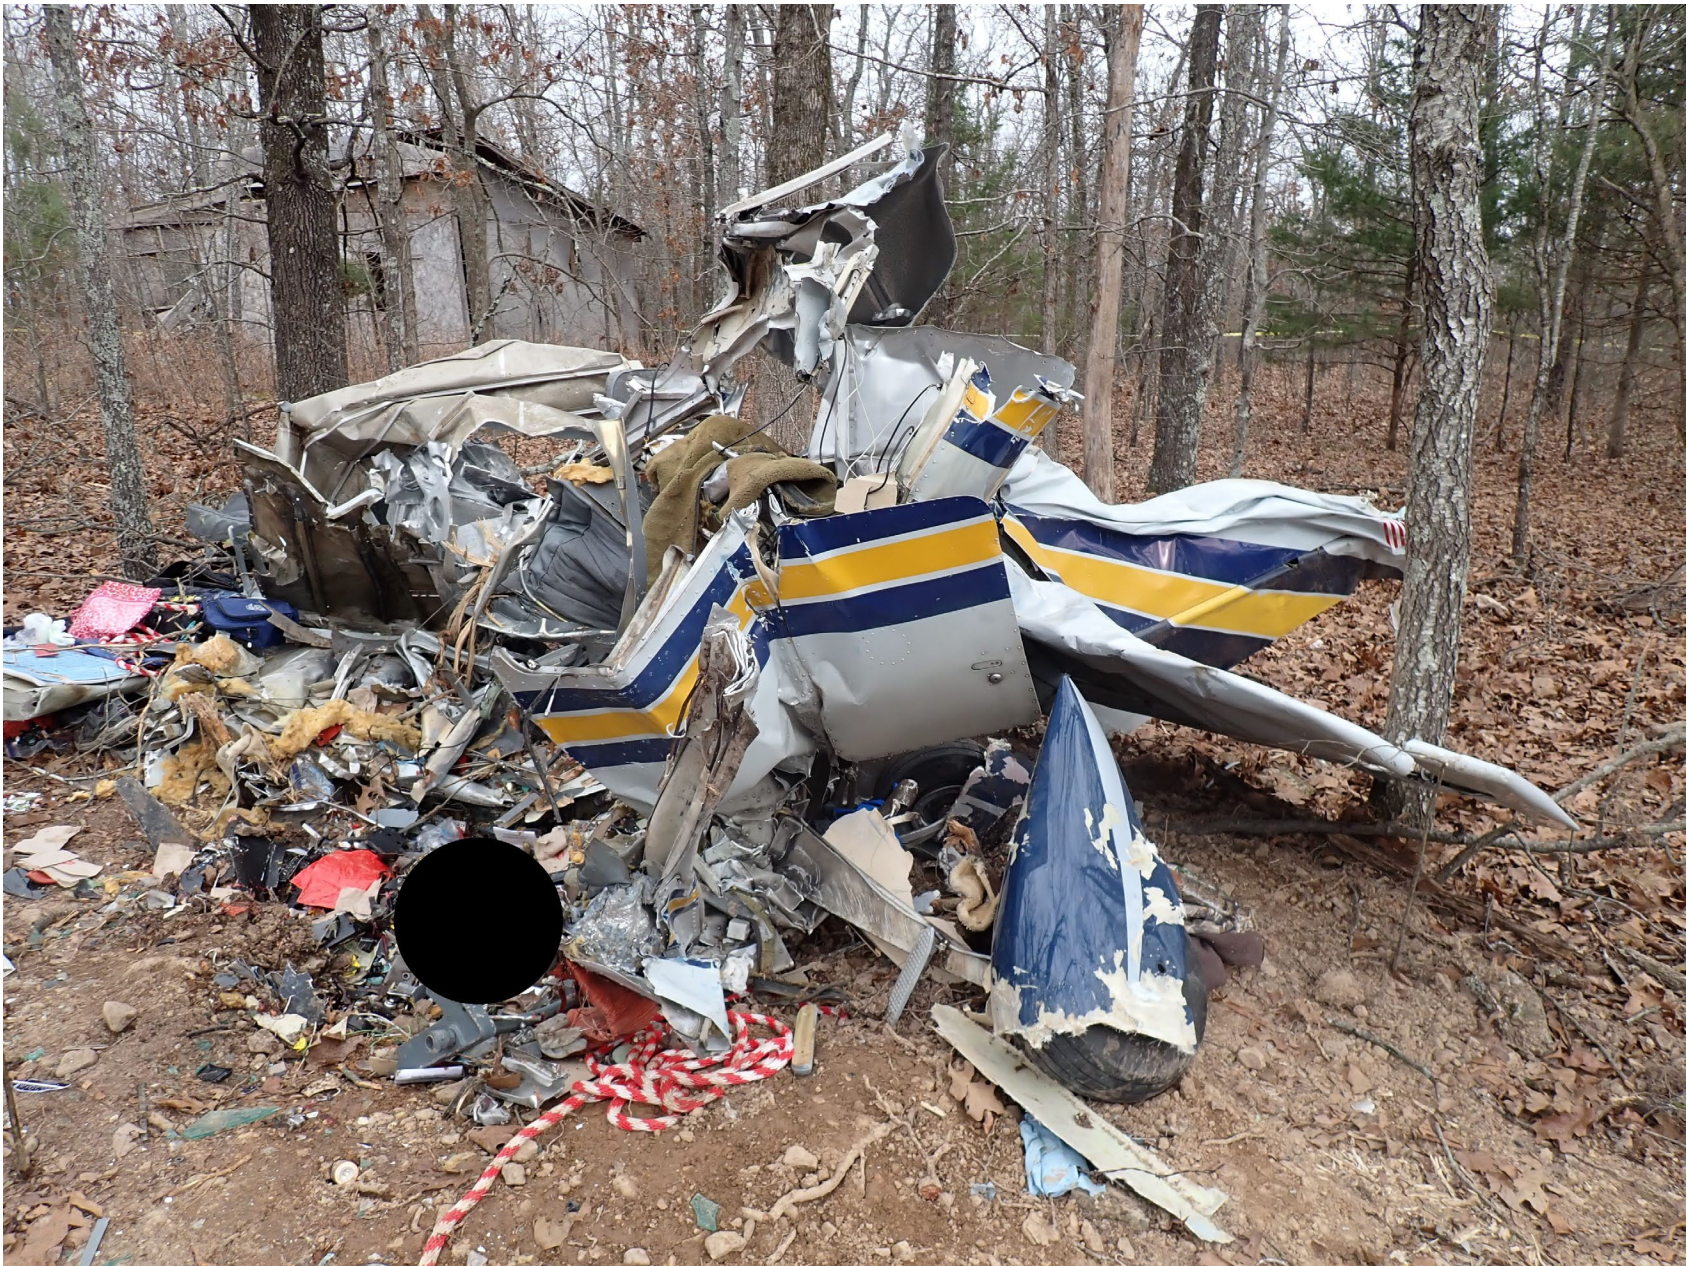
**Photo 3 – View of the wreckage at the accident site (courtesy of Textron Aviation).**

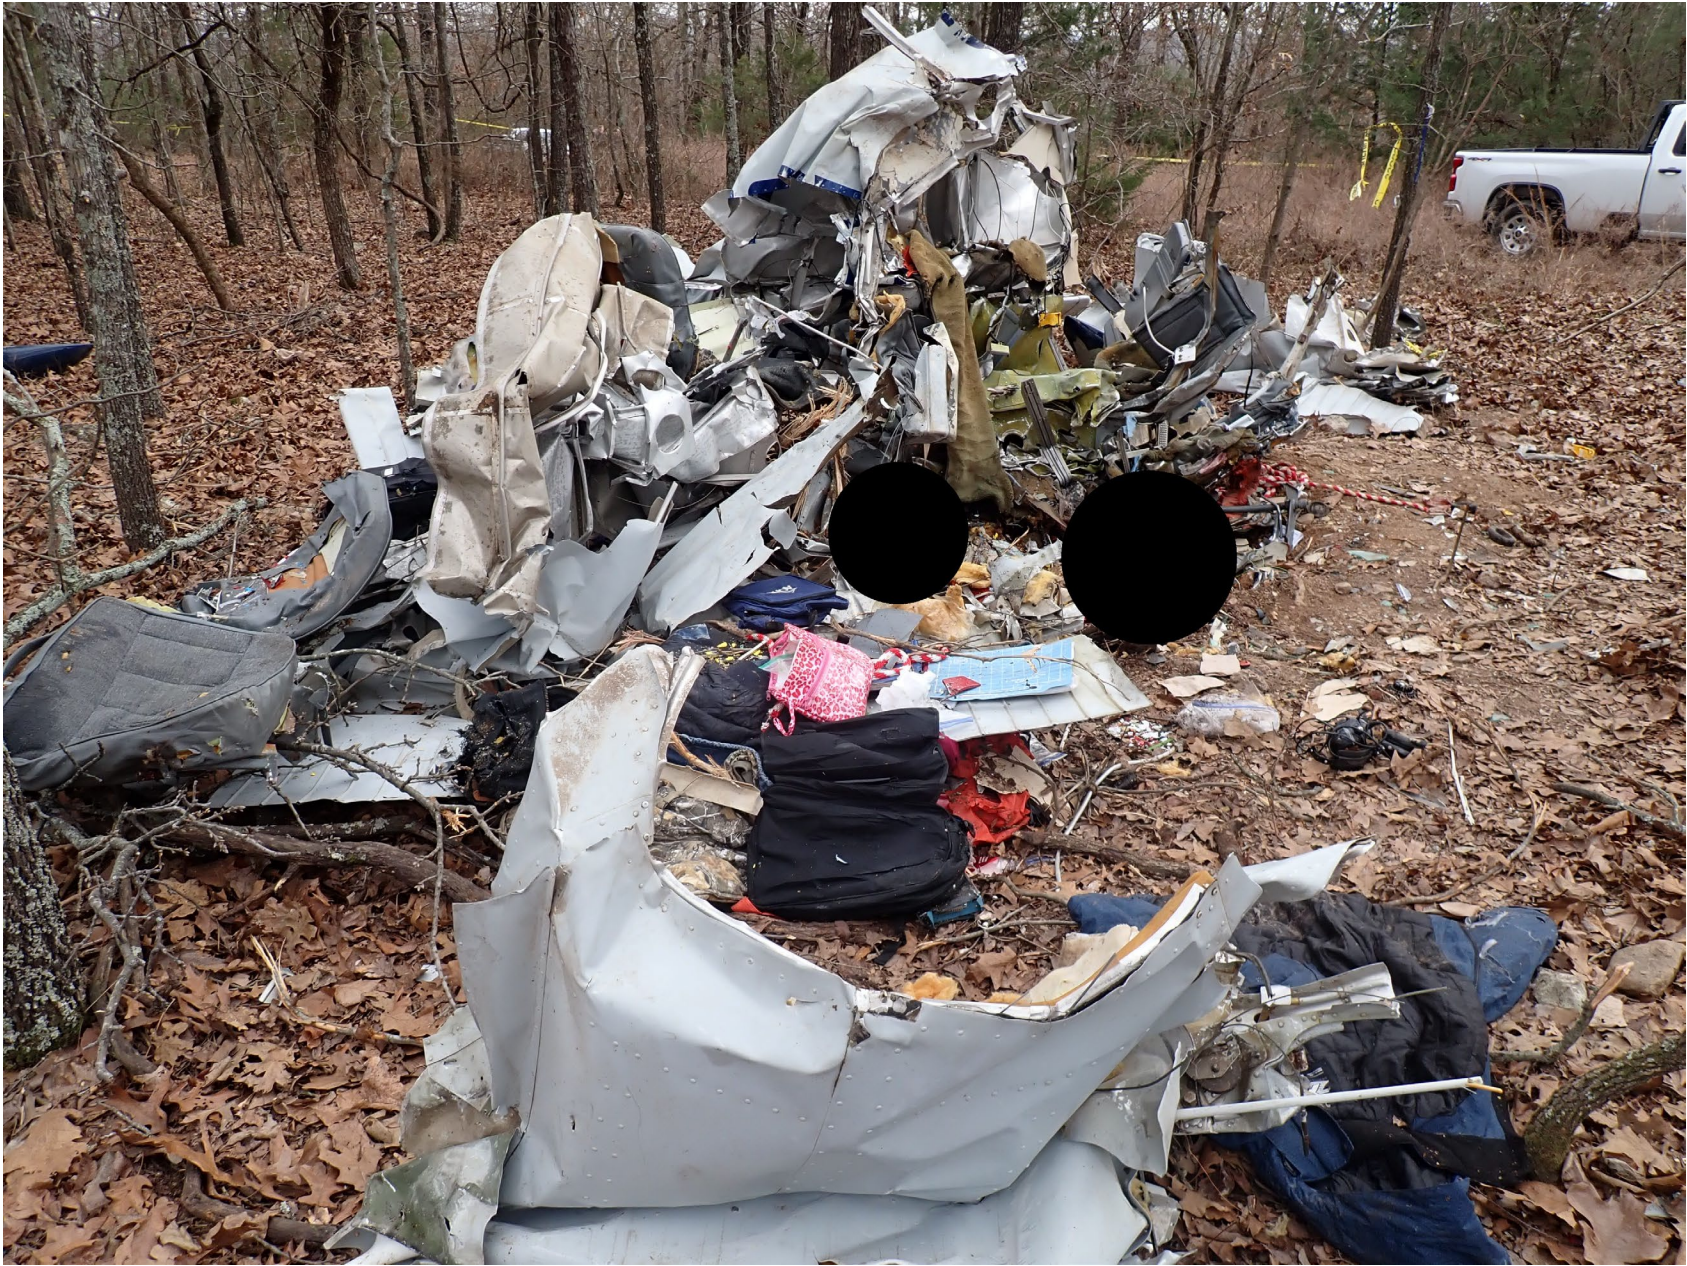
**Photo 4 – View of the wreckage at the accident site (courtesy of Textron Aviation).**

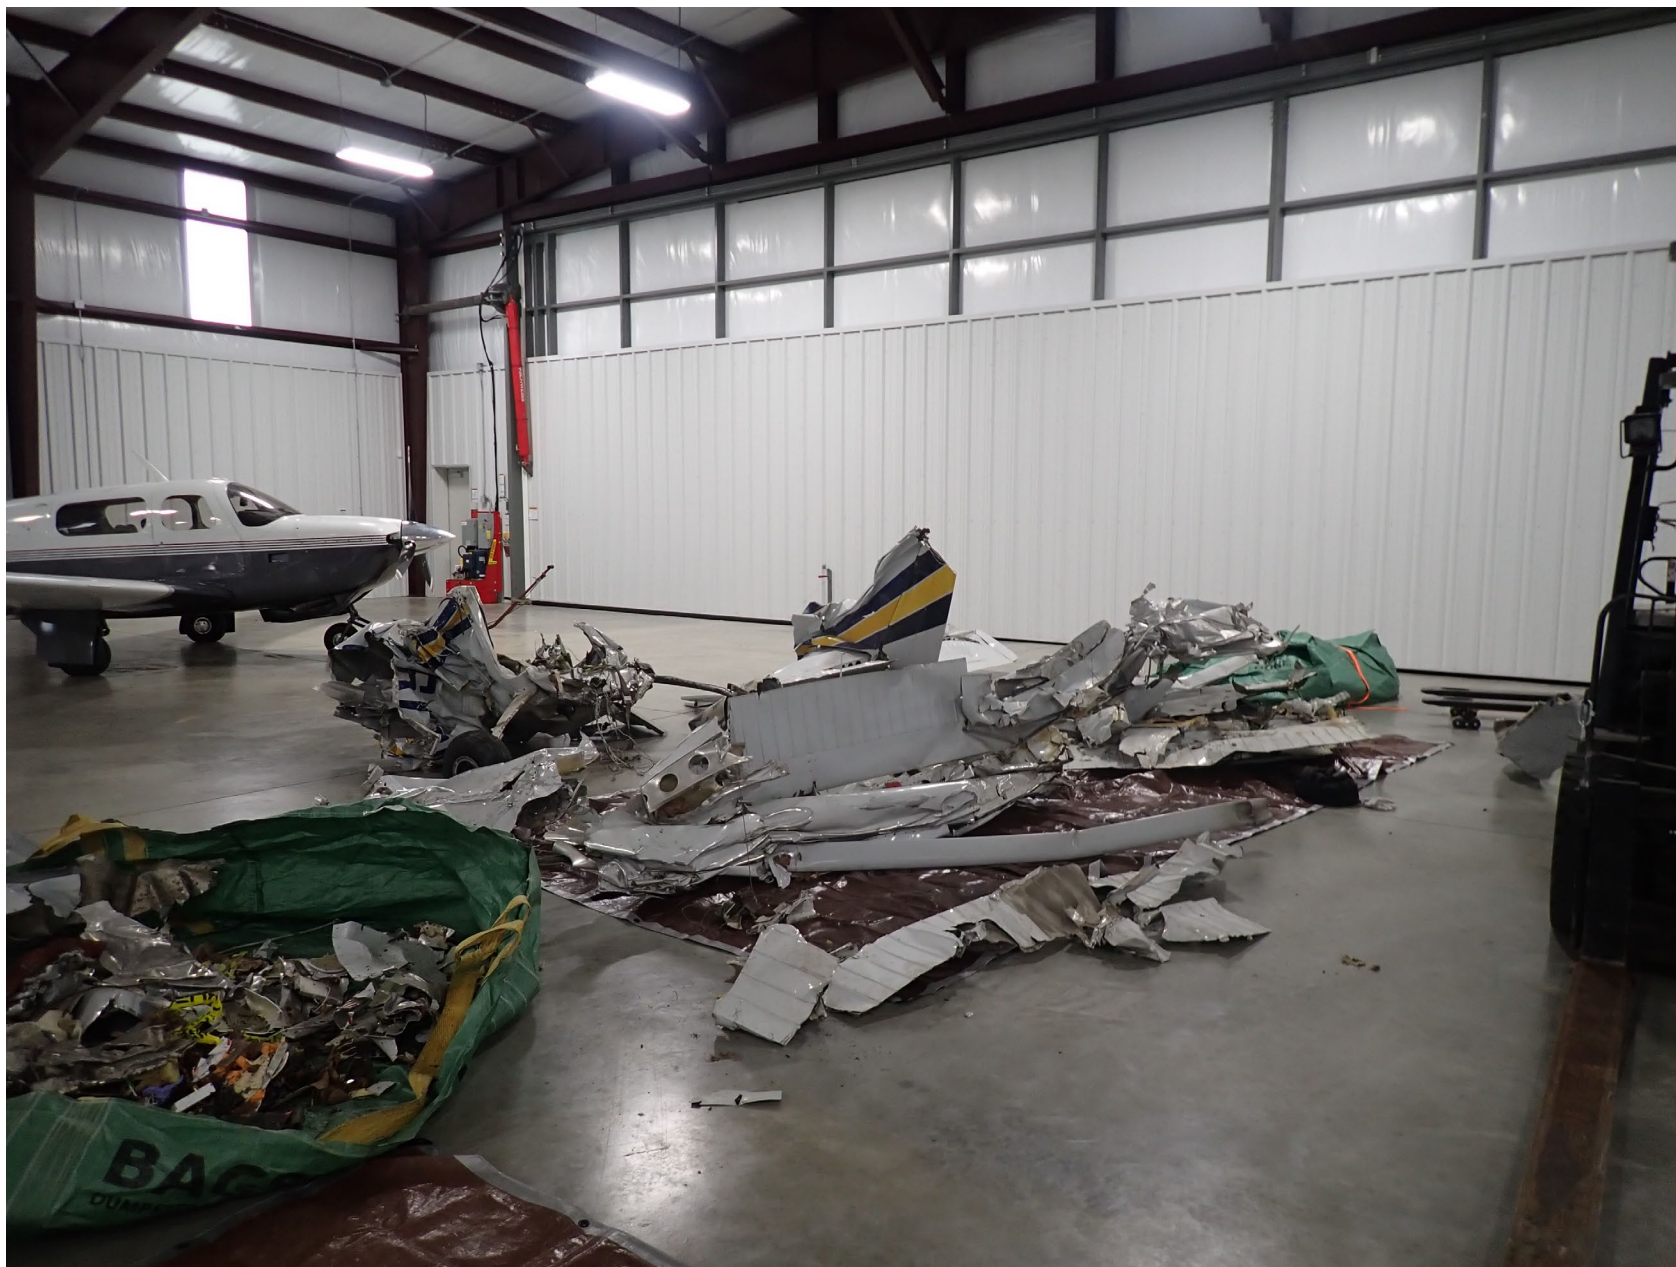
**Photo 5 – View of the wreckage laid out at the salvage facility (courtesy of Textron Aviation).**

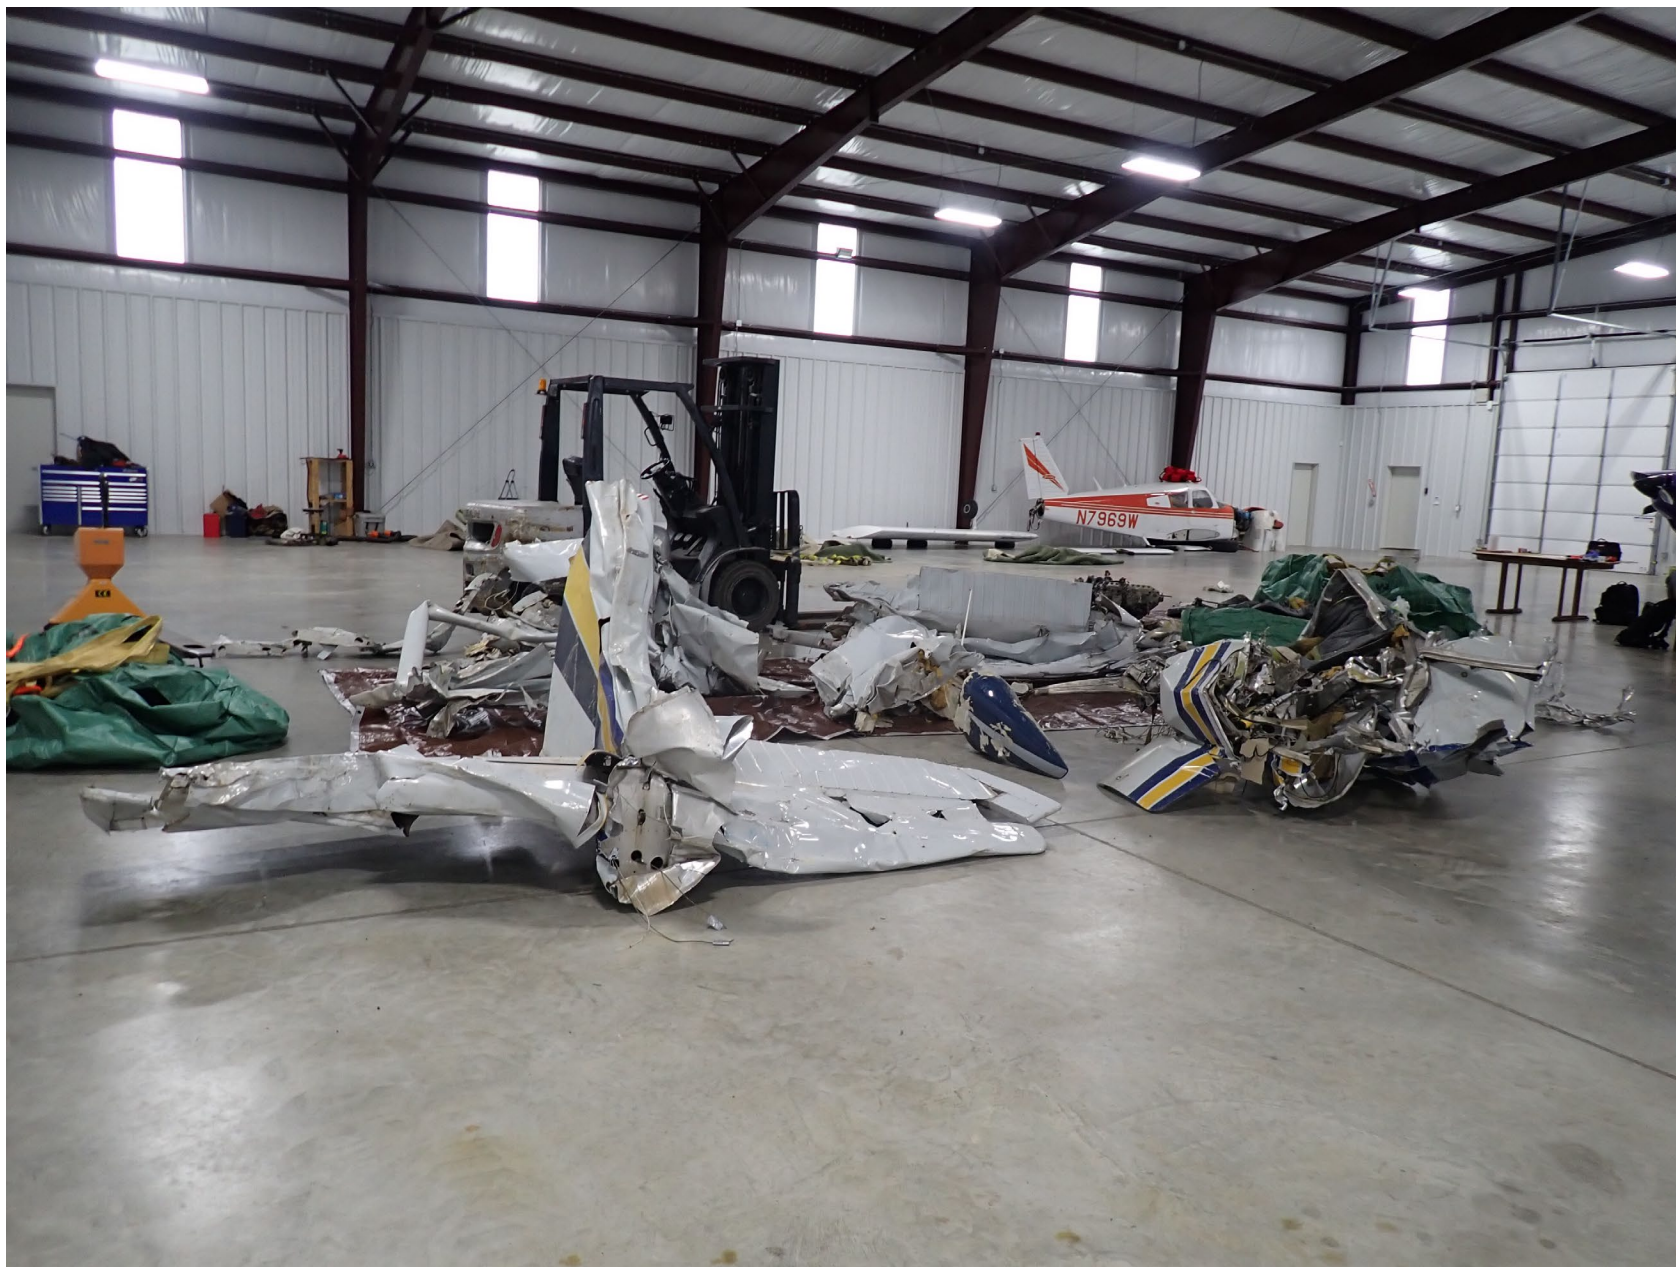
**Photo 6 – View of the wreckage laid out at the salvage facility (courtesy of Textron Aviation).**

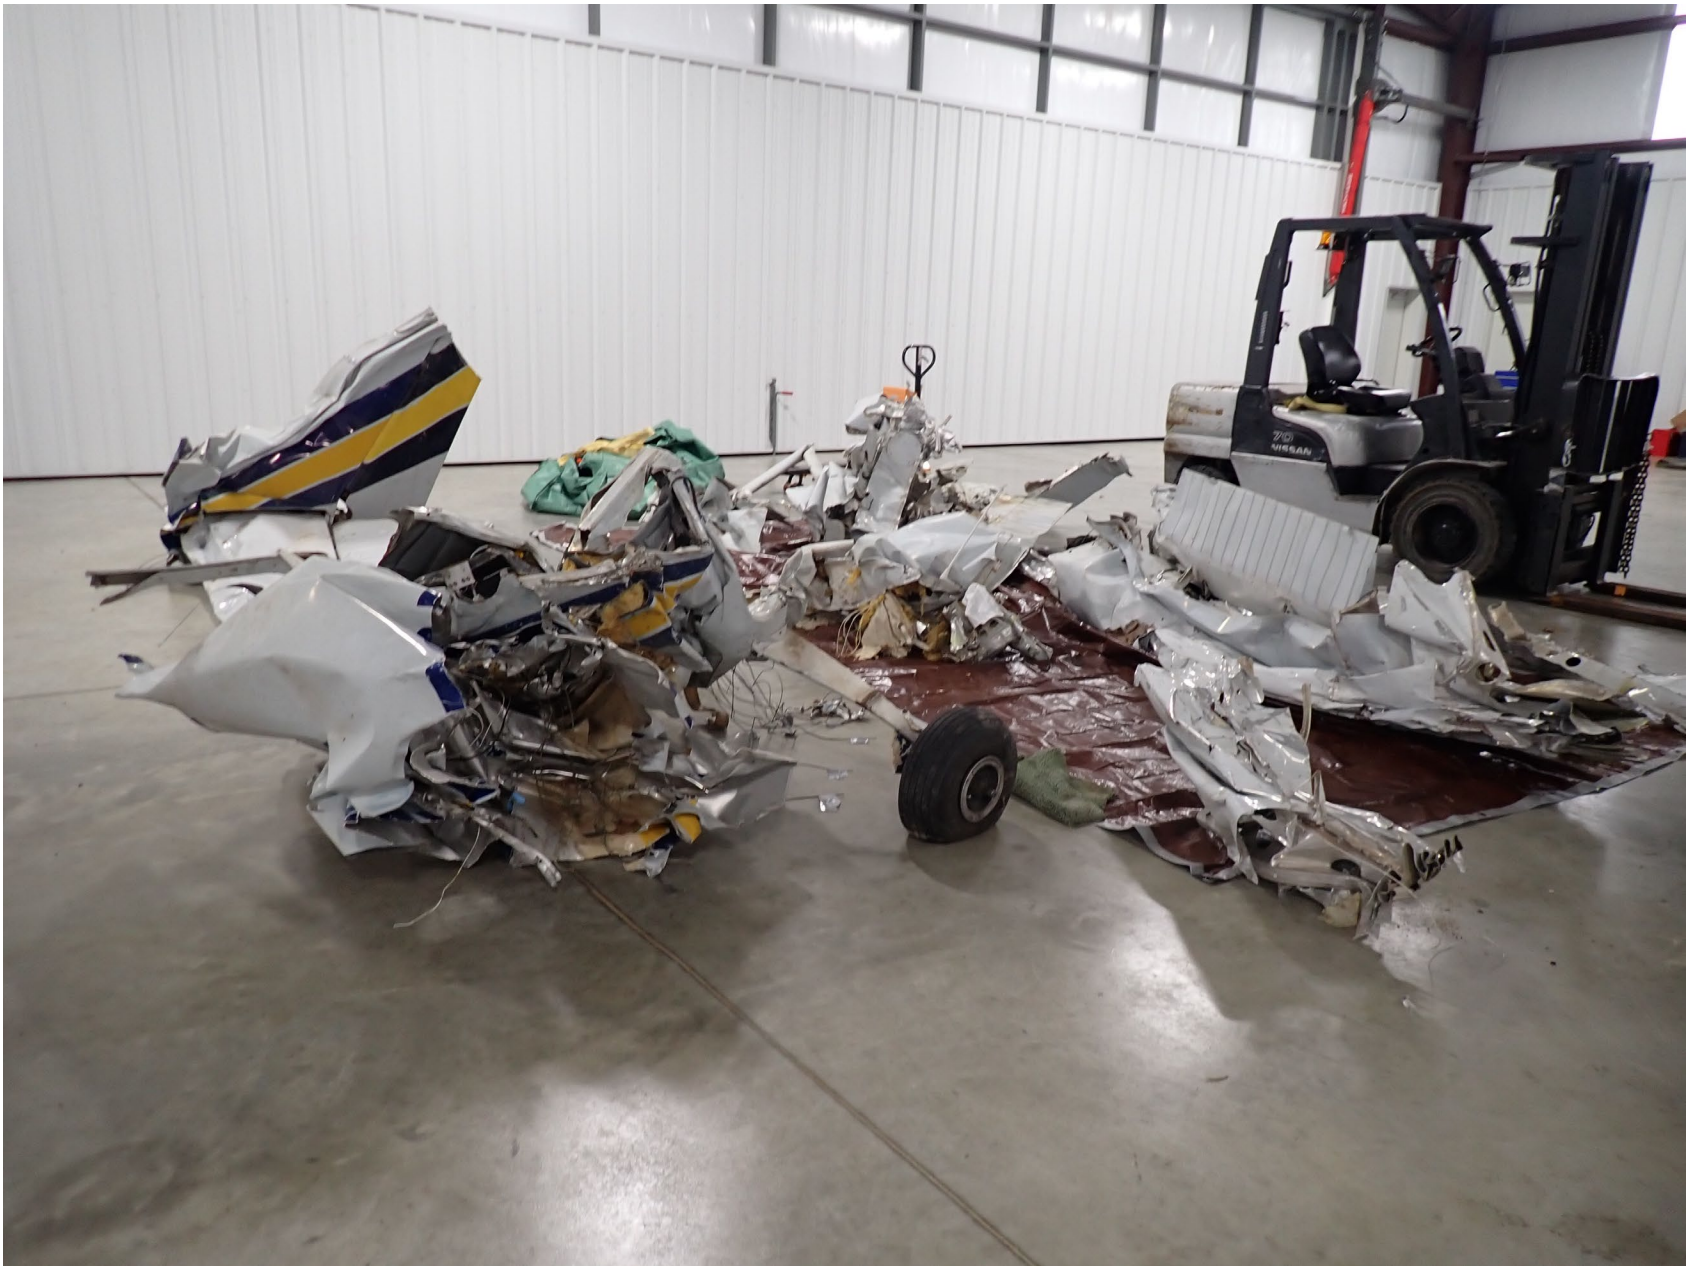
**Photo 7 – View of the wreckage laid out at the salvage facility (courtesy of Textron Aviation).**

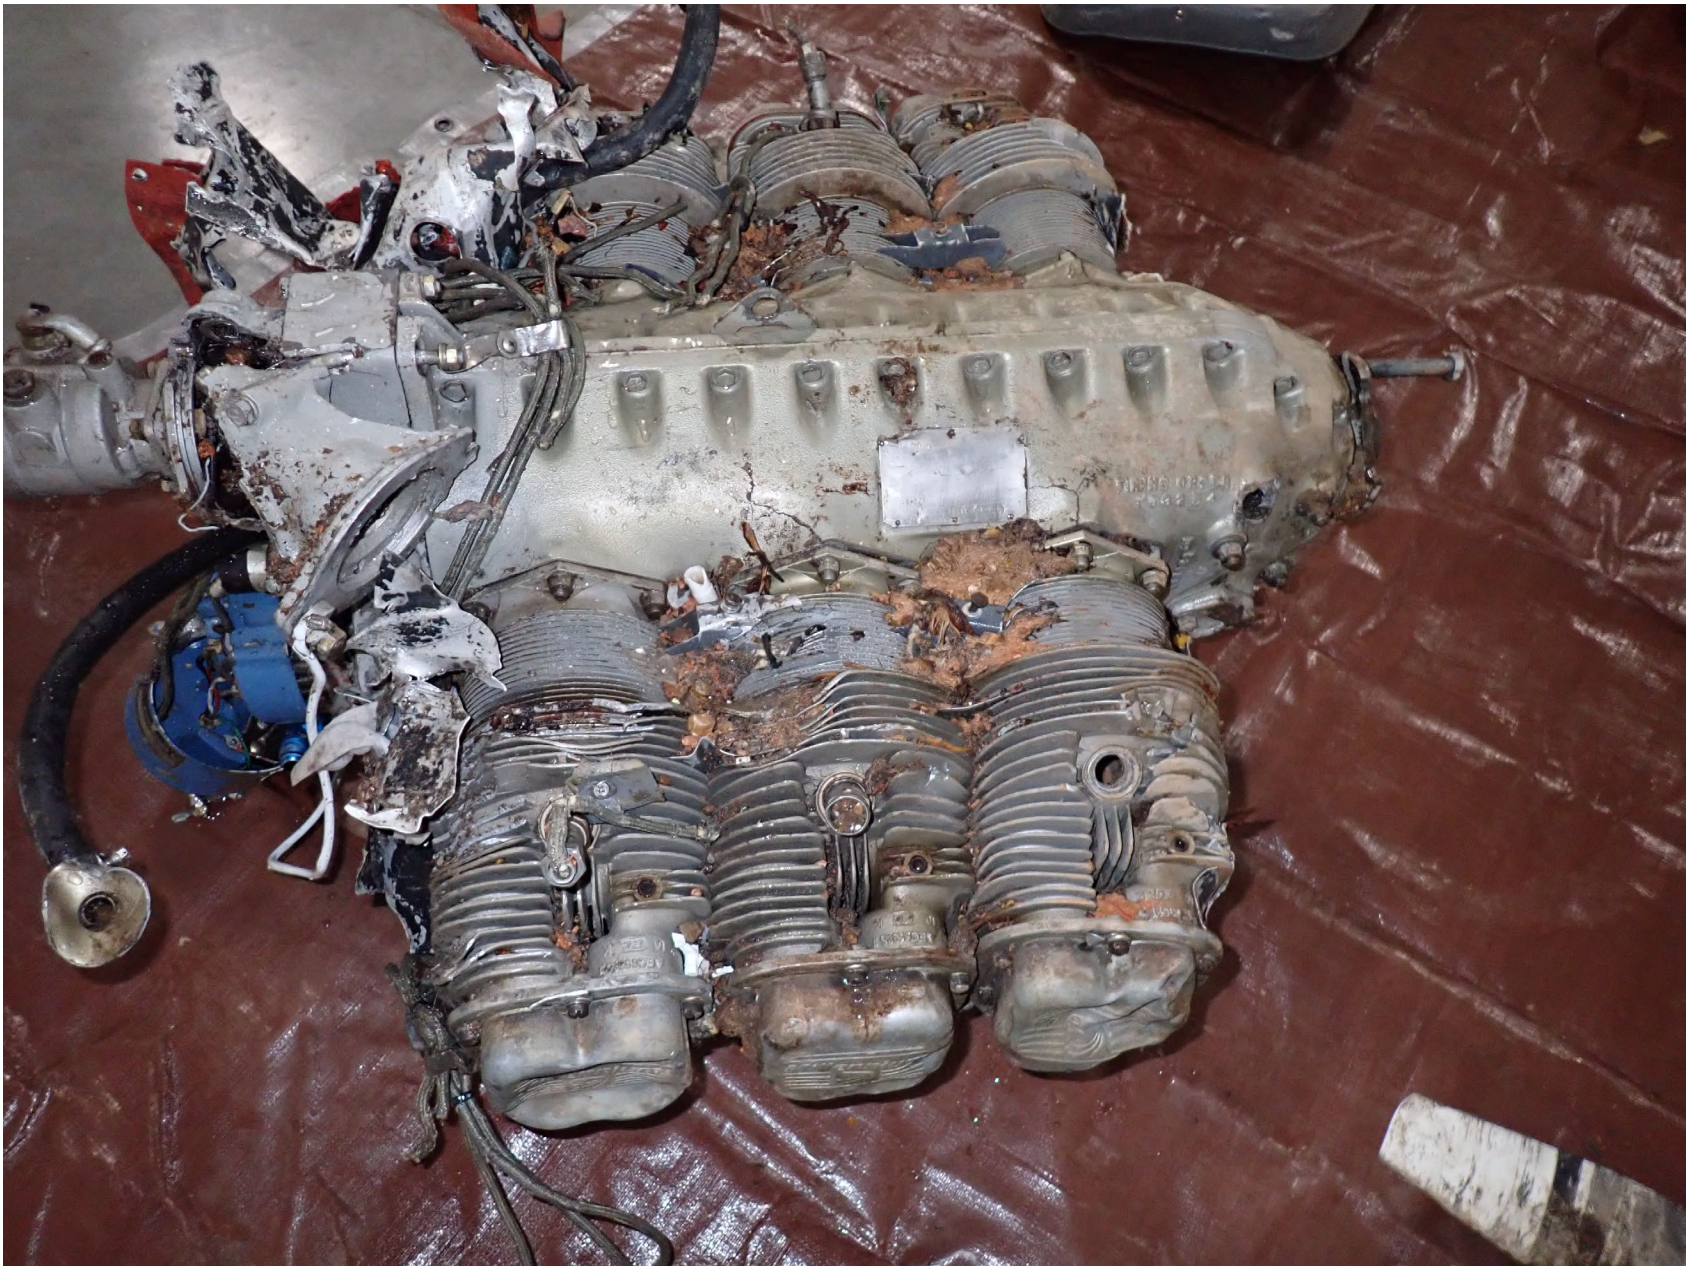
**Photo 8 – View of the engine at the salvage facility (courtesy of Textron Aviation).**

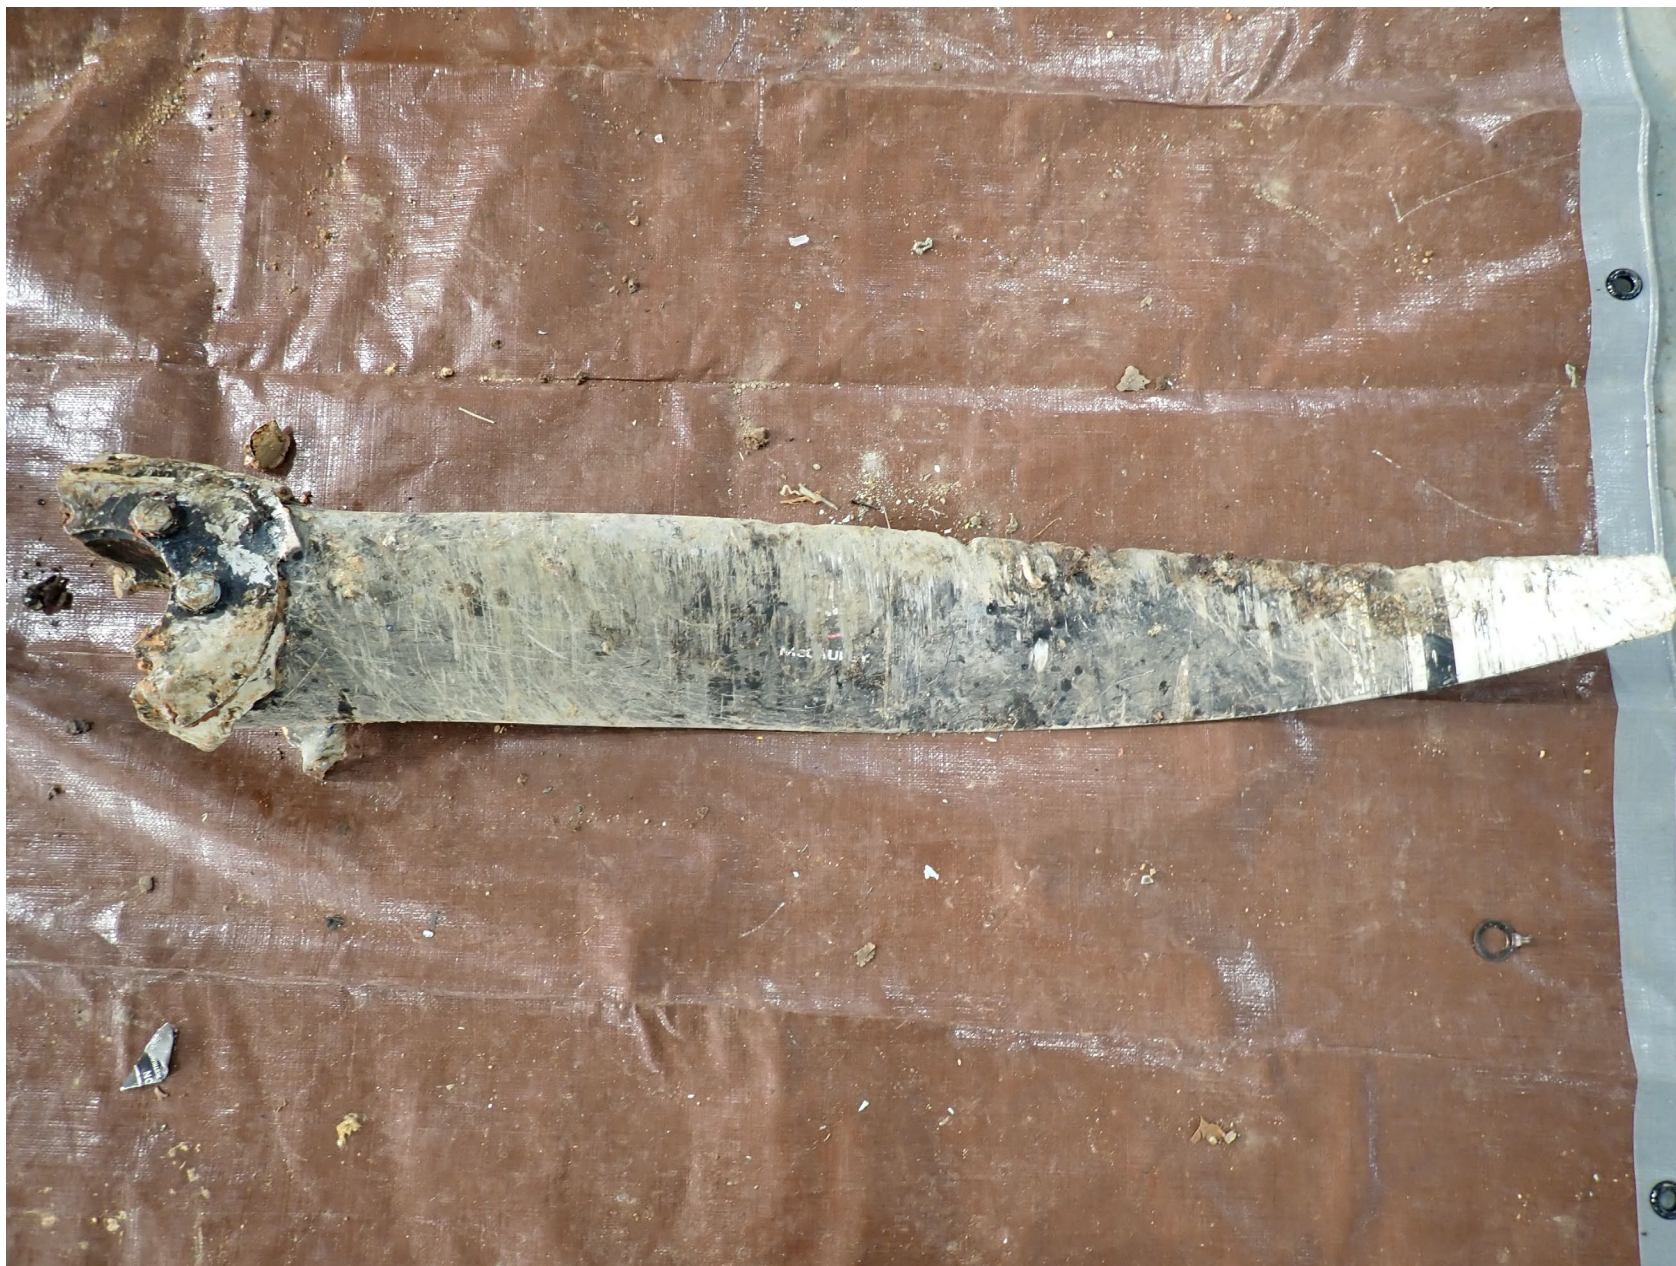
**Photo 9 – View of propeller blade A at the salvage facility (courtesy of Textron Aviation).**

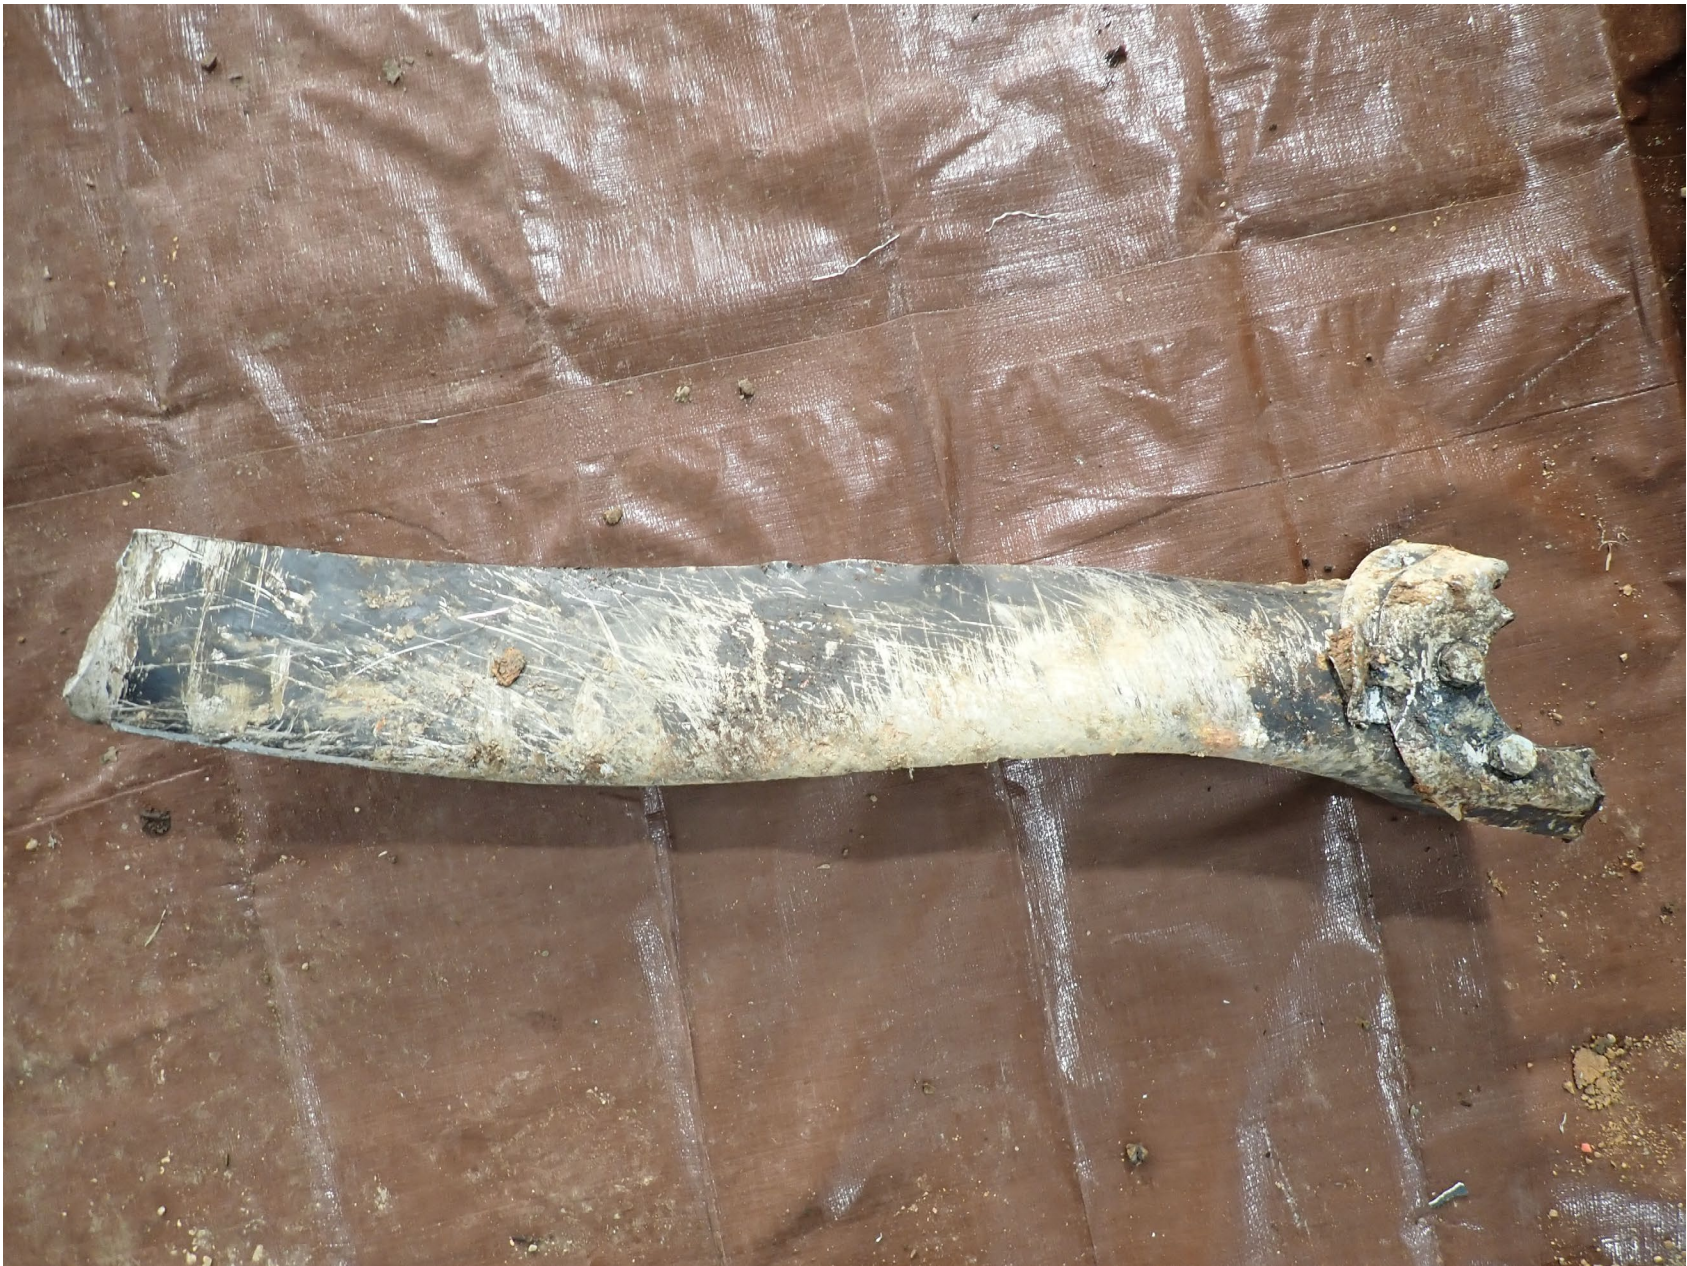
**Photo 10 – View of propeller blade B at the salvage facility (courtesy of Textron Aviation).**
