**NATIONAL TRANSPORTATION SAFETY BOARD**

**On-Scene Examination Notes**

**CEN22FA086**

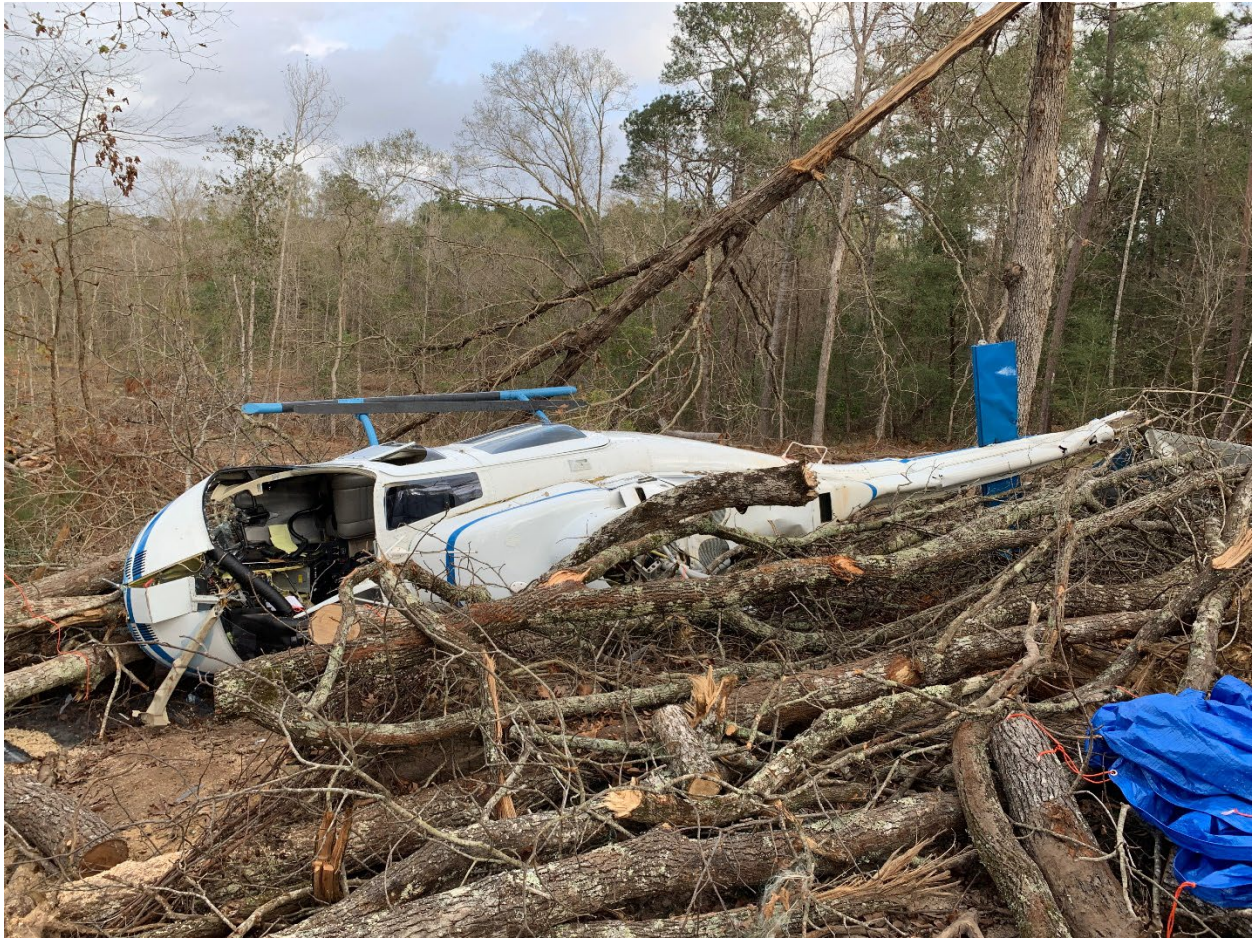
The helicopter was predominately intact with the main rotor separated at the mast. The rotor mast was fractured just below the rotor head. Both main rotor blade inboard sections remained attached to the rotor head. The outboard portions of both main rotor blades had separated from the inboard blade sections. All pieces of the rotor blades with the exception of one leading edge outboard portion were located at the accident site. The left landing skid was fractured and located beneath the helicopter.
