# National Transportation Safety Board

CEN22FA086

Specialist's Factual Report

Location: Livingston, Texas  
Date: December 30, 2021  
Time: 1141 central standard time (CST)  
Helicopter: Bell 206B, 206B LLC, N8AU

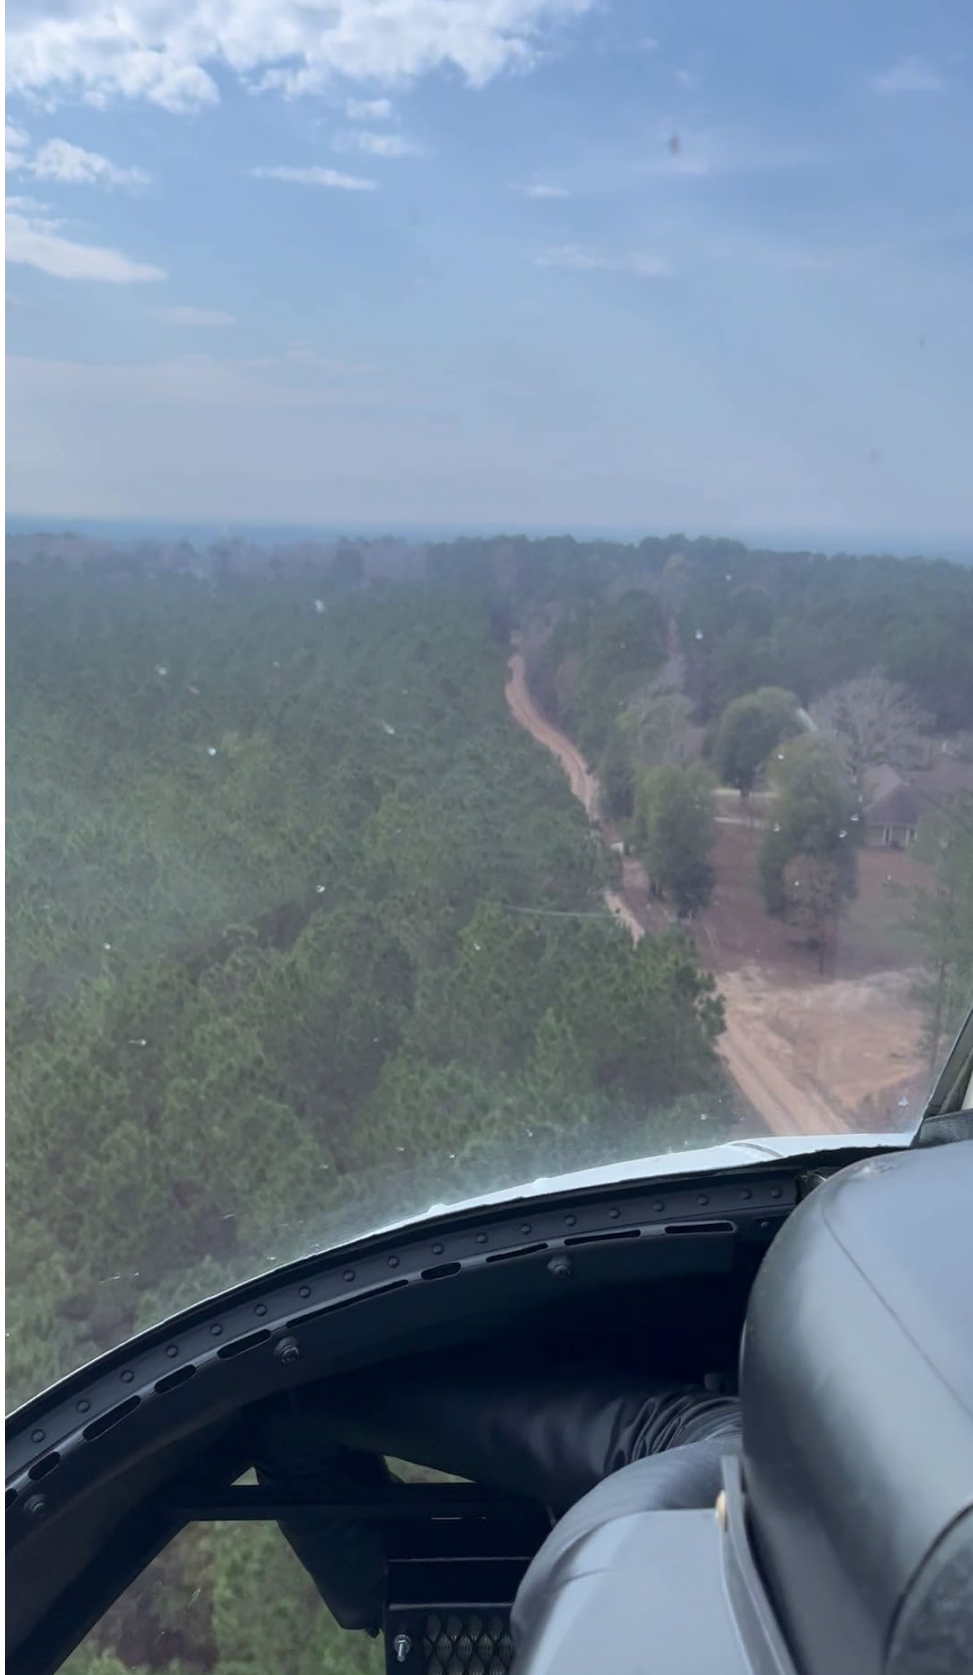
**Figure 1.** View captured at 0:12 Video Elapsed Time.

| <b>Video Elapsed Time (m:ss)</b> | <b>Observation</b> |
|---|---|
| <b>0:12</b> | Some conversation is heard, followed by, "I see him in the backyard." The helicopter was following a road and flying at an altitude just above the tree line (see figure 1). |

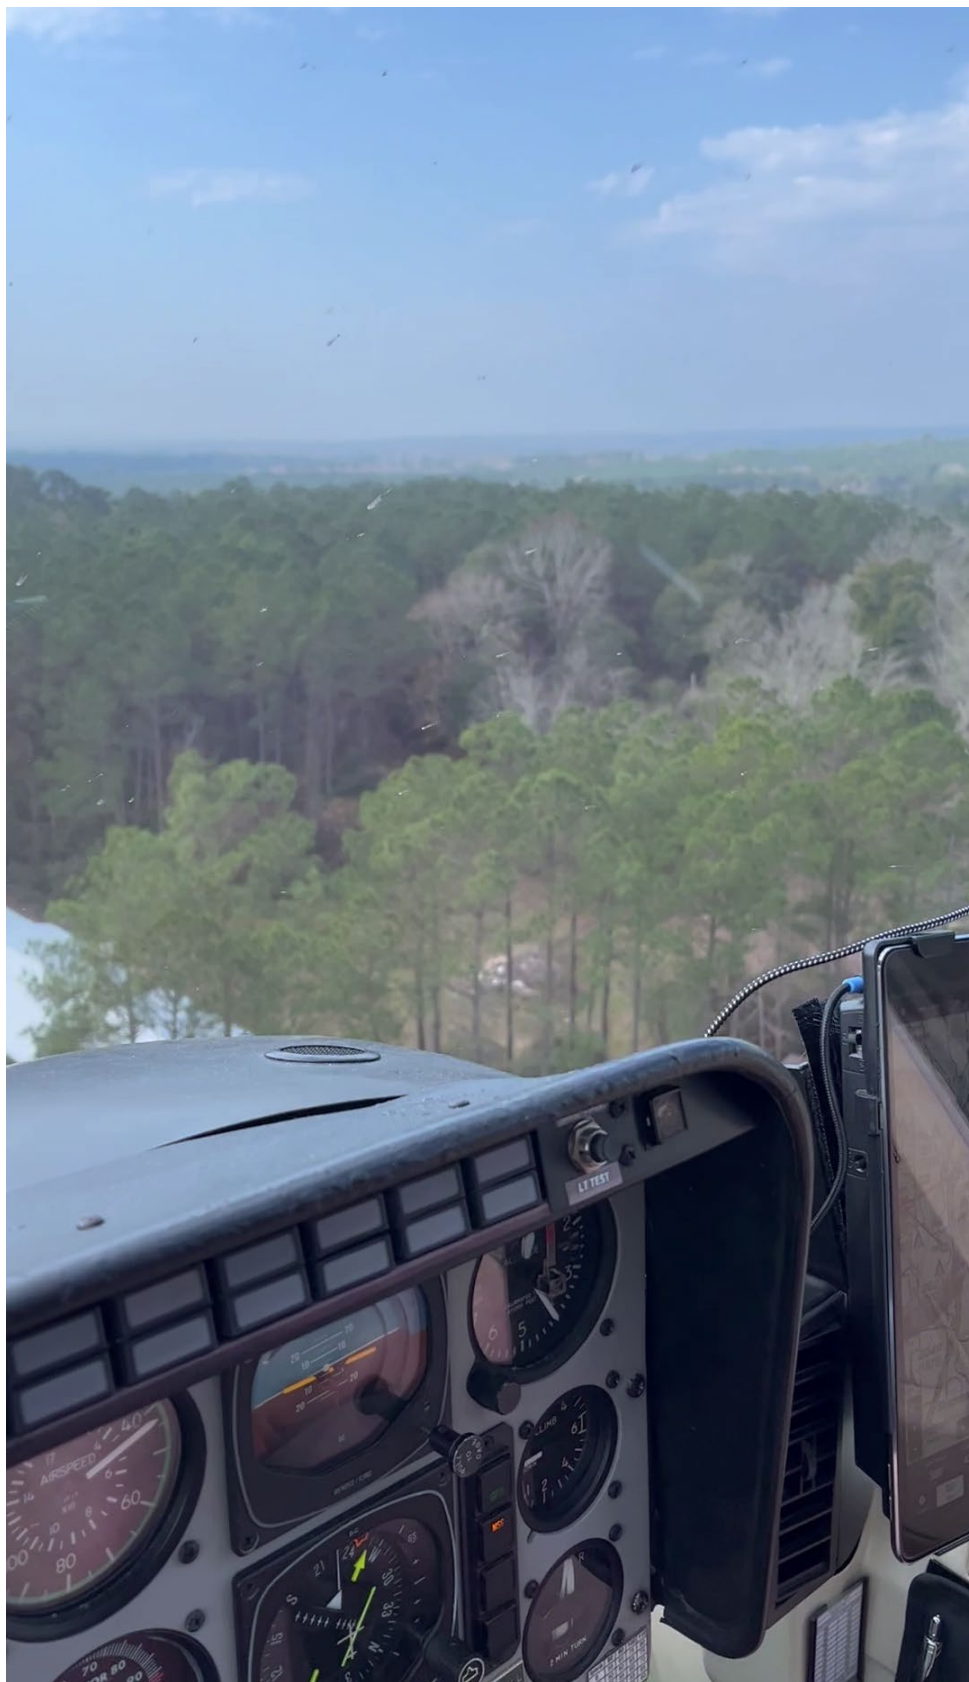
**Figure 2.** Instrument panel view captured at 0:18 Video Elapsed Time.

| <b>Video Elapsed Time (m:ss)</b> | <b>Observation</b> |
|---|---|
| <b>0:18</b> | The camera panned to the starboard side of the aircraft and captured a portion of the instrument panel. The airspeed was between 40 and 45 knots (kts). The attitude indicator showed no pitch but a slight left roll. The altitude was approximately 400 feet (ft). The heading was approximately 230 degrees (deg). A status bar displayed an illuminated "GPS" in green and "MSG" in orange. The annunciator panel was not illuminated with any warnings or cautions (see figure 2). |

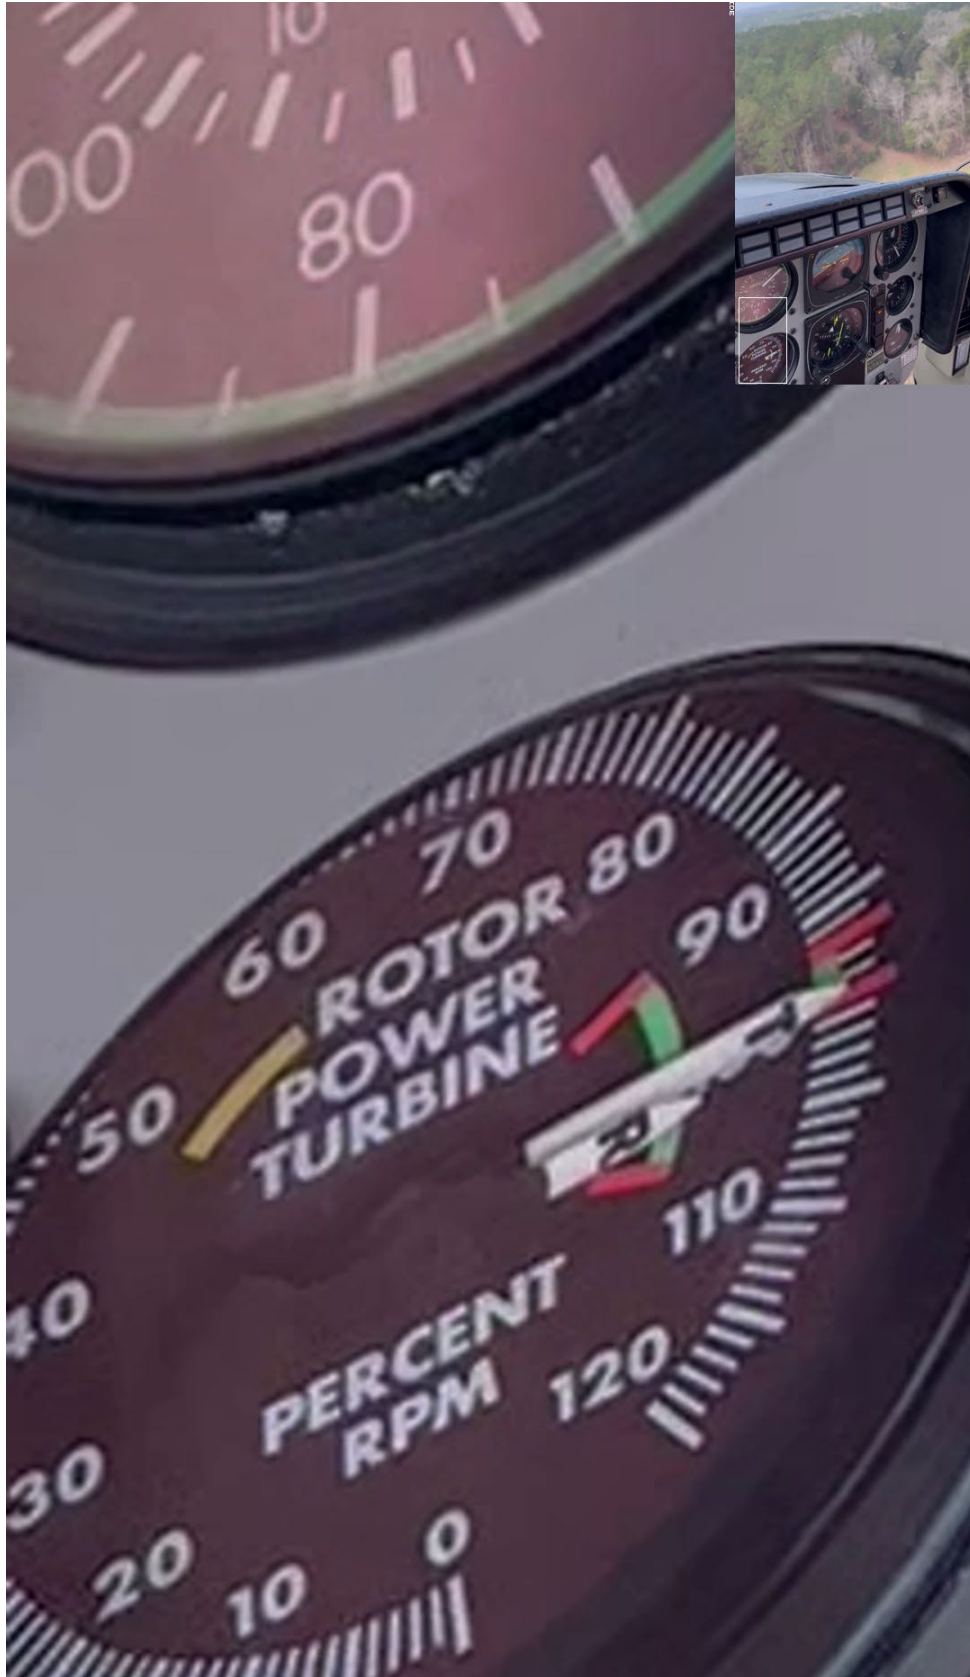
**Figure 3.** Zoomed in portion of the Dual Tachometer, taken at 0:22 Video Elapsed Time.

| <b>Video Elapsed Time (m:ss)</b> | <b>Observation</b> |
|---|---|
| <b>0:22</b> | The helicopter began a right turn. The dual tachometer was visible and captured the power turbine between 97% and 100% and the rotor between 90% and 100%. Airspeed was slightly below 40 kts. The attitude indicator displayed that the aircraft was in a right roll. The altimeter displayed approximately 400 ft (see figure 3). |

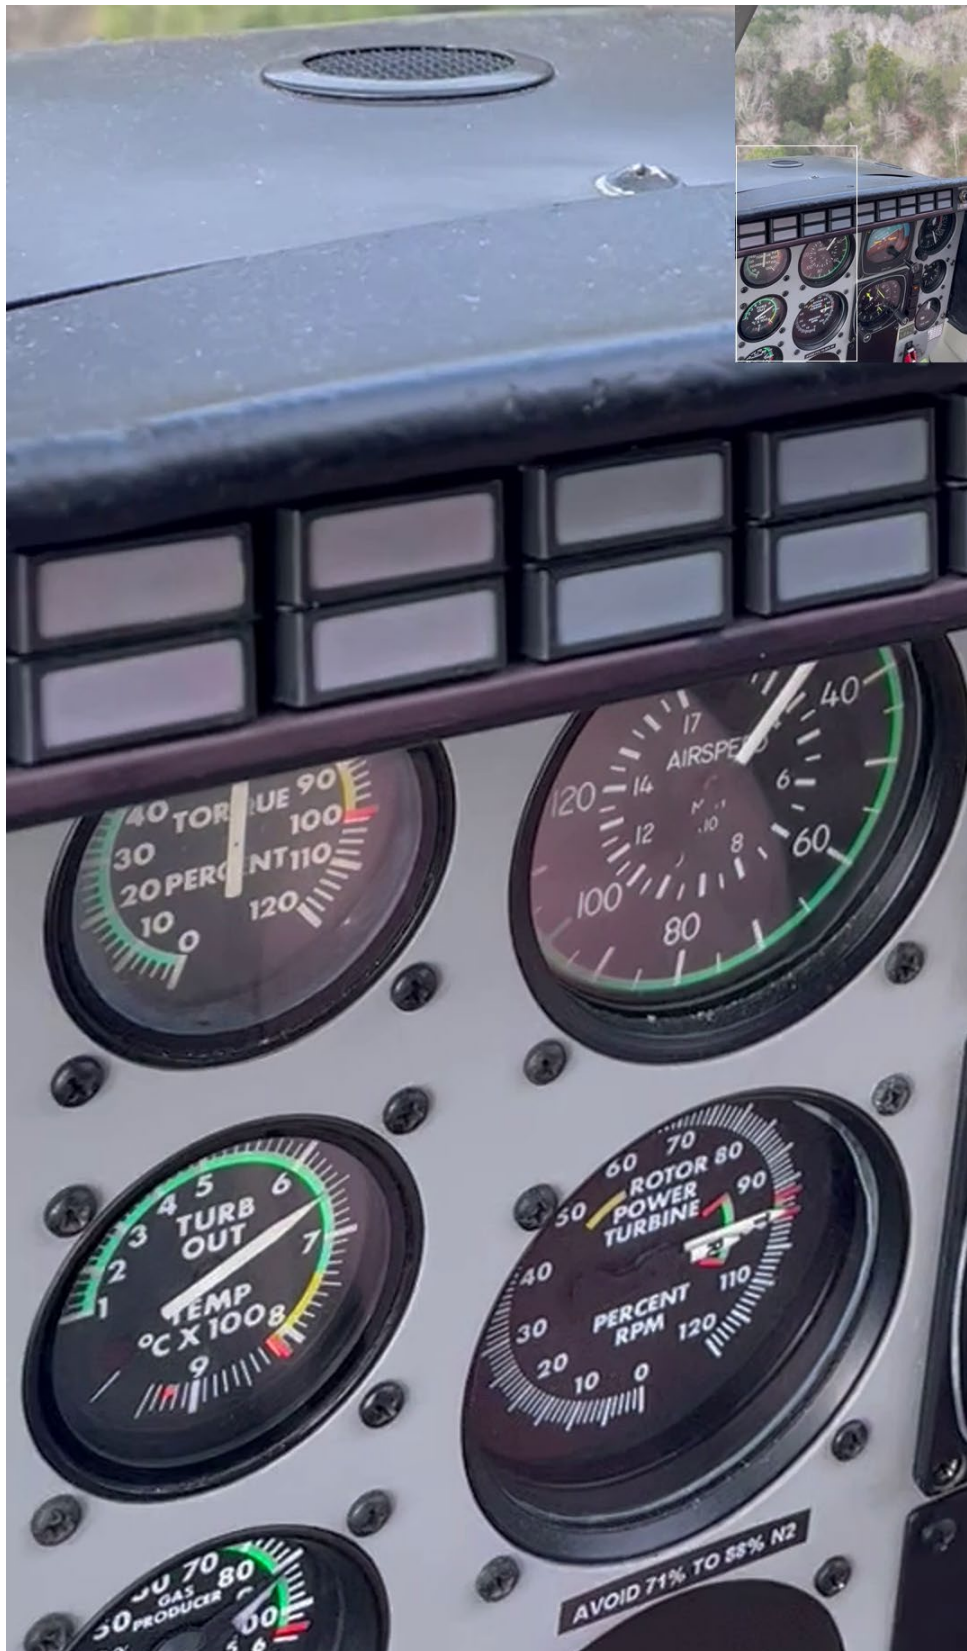
**Figure 4.** Zoomed in portion of the Torque and Turbine Outlet Temperature gauges captured at 0:26 Video Elapsed Time.

| <b>Video Elapsed Time (m:ss)</b> | <b>Observation</b> |
|---|---|
| <b>0:26</b> | The helicopter continued the right turn. Torque was approximately 60%. The turbine outlet temperature (TOT) was approximately 650 degrees Celsius (degC). The airspeed was approximately 35 kts (see figure 4). |

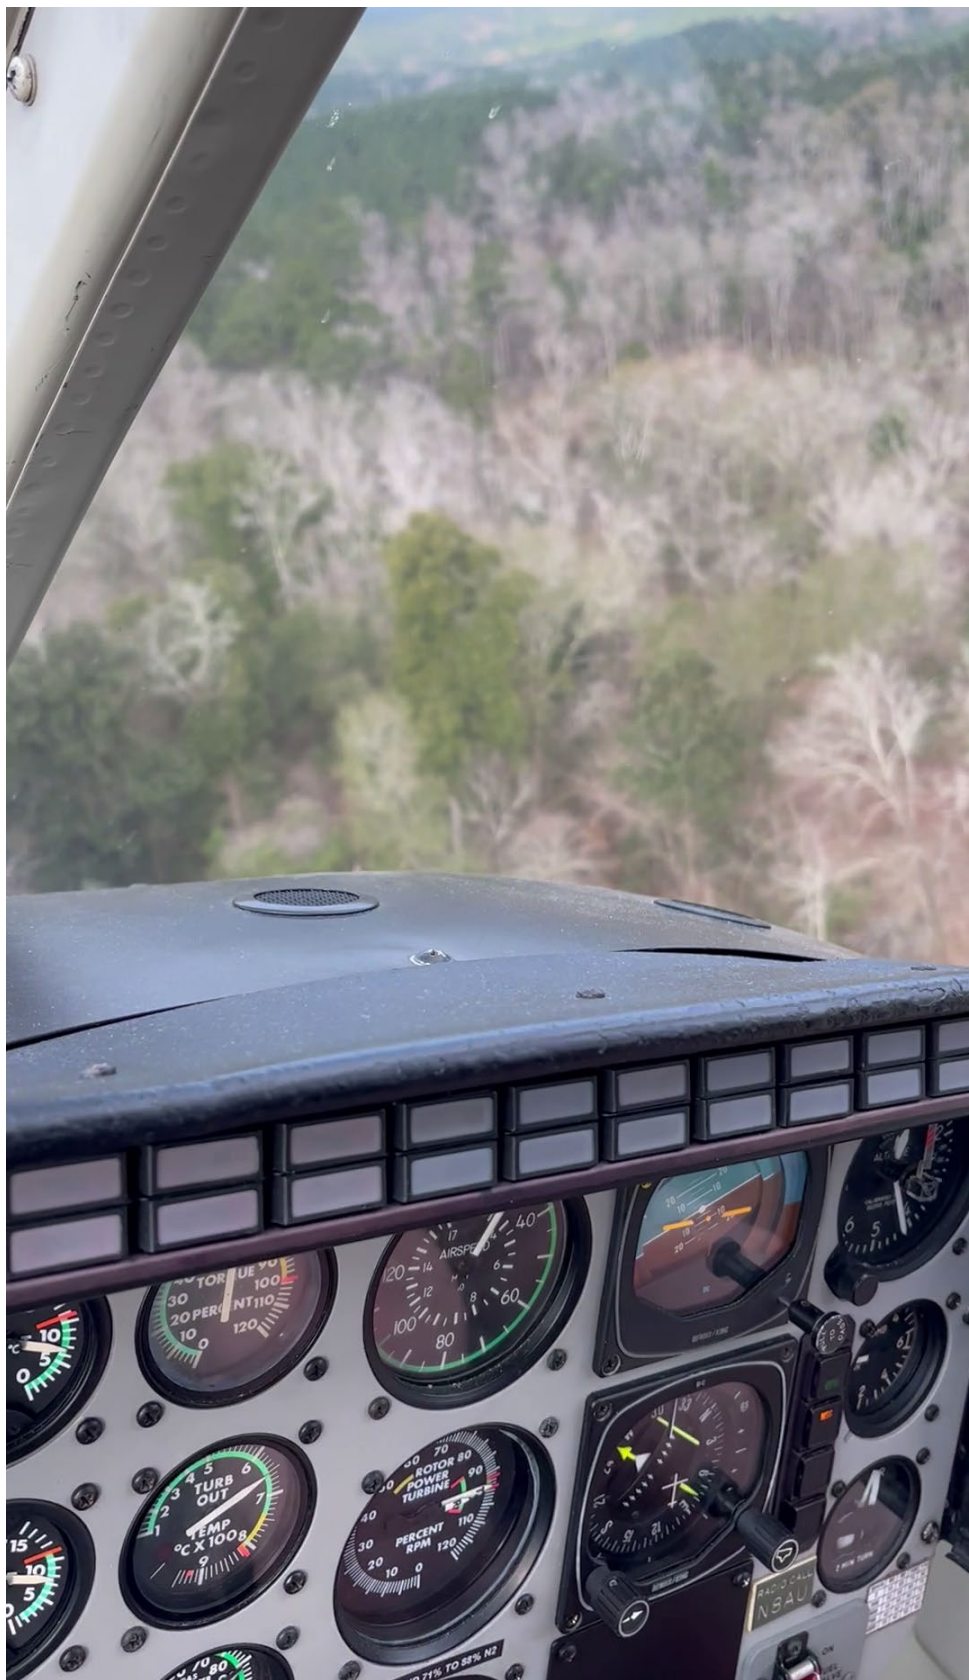
**Figure 5.** Instrument panel view captured at 0:27 Video Elapsed Time.

| <b>Video Elapsed Time (m:ss)</b> | <b>Observation</b> |
|---|---|
| <b>0:27</b> | The oil temperature was between 60 and 70 degC and the transmission oil temperature was between 70 and 80 degC (see figure 5). |

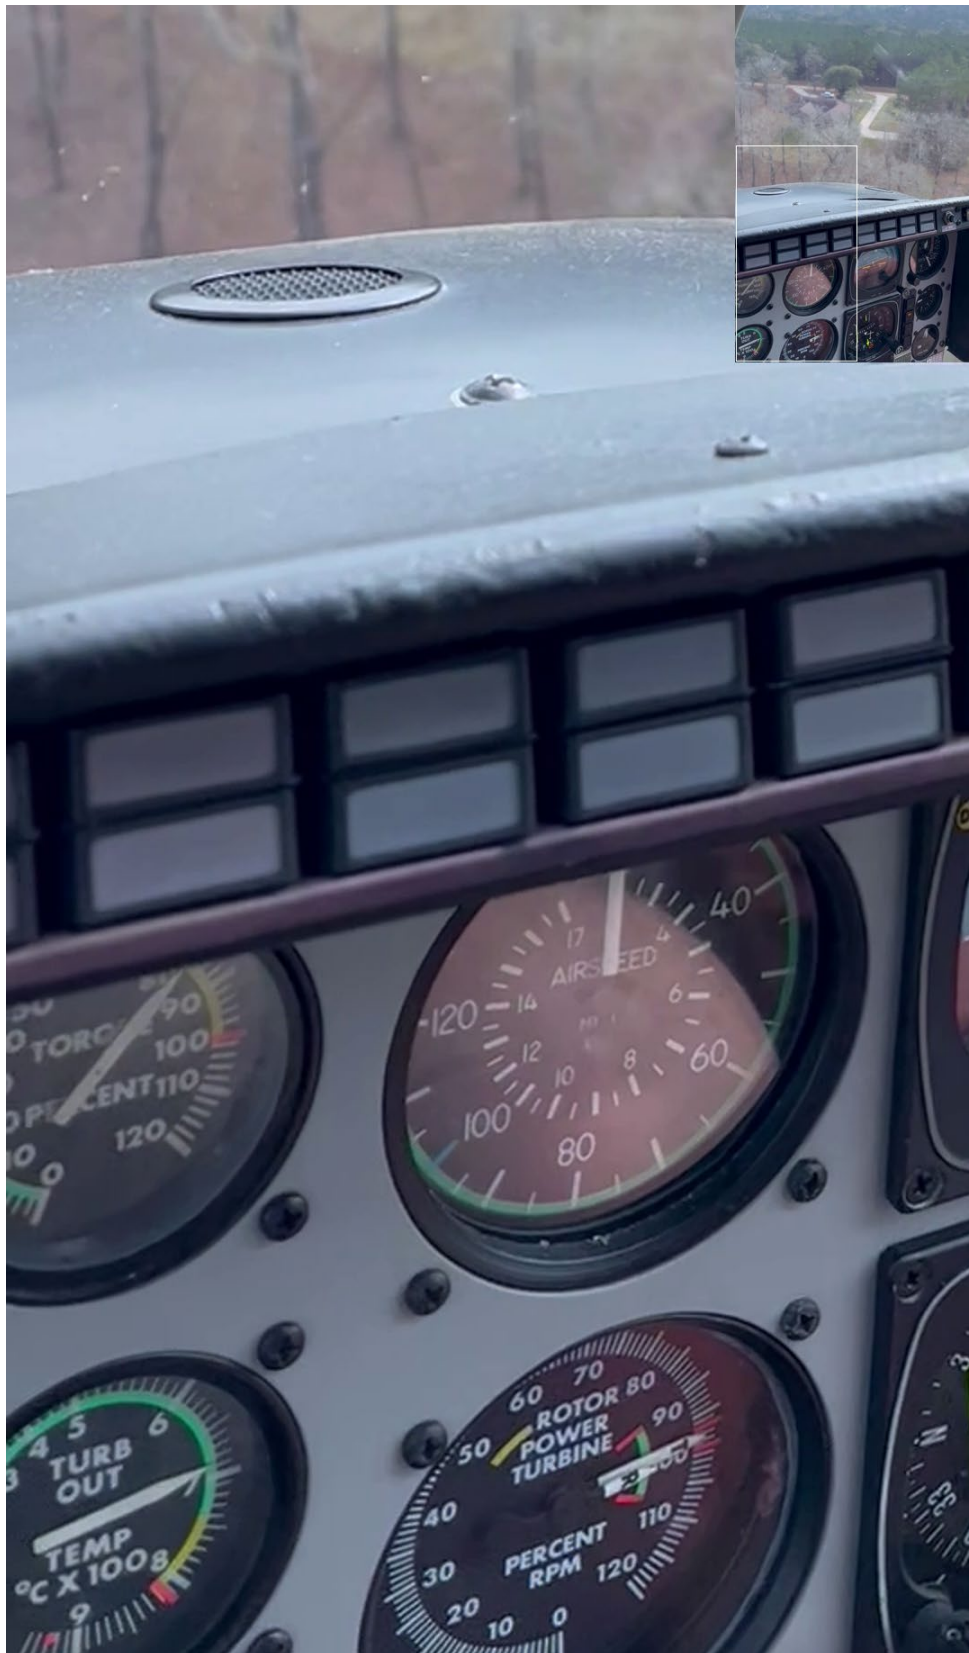
**Figure 6.** Zoomed in portion of the Torque and Turbine Outlet Temperature gauges captured at 0:38 Video Elapsed Time.

| <b>Video Elapsed Time (m:ss)</b> | <b>Observation</b> |
|---|---|
| <b>0:38</b> | As the helicopter was behind the home, the torque indicator displayed approximately 82%. The TOT gauge was approximately 690 degC. The airspeed was approximately 0 kts (see figure 6). |

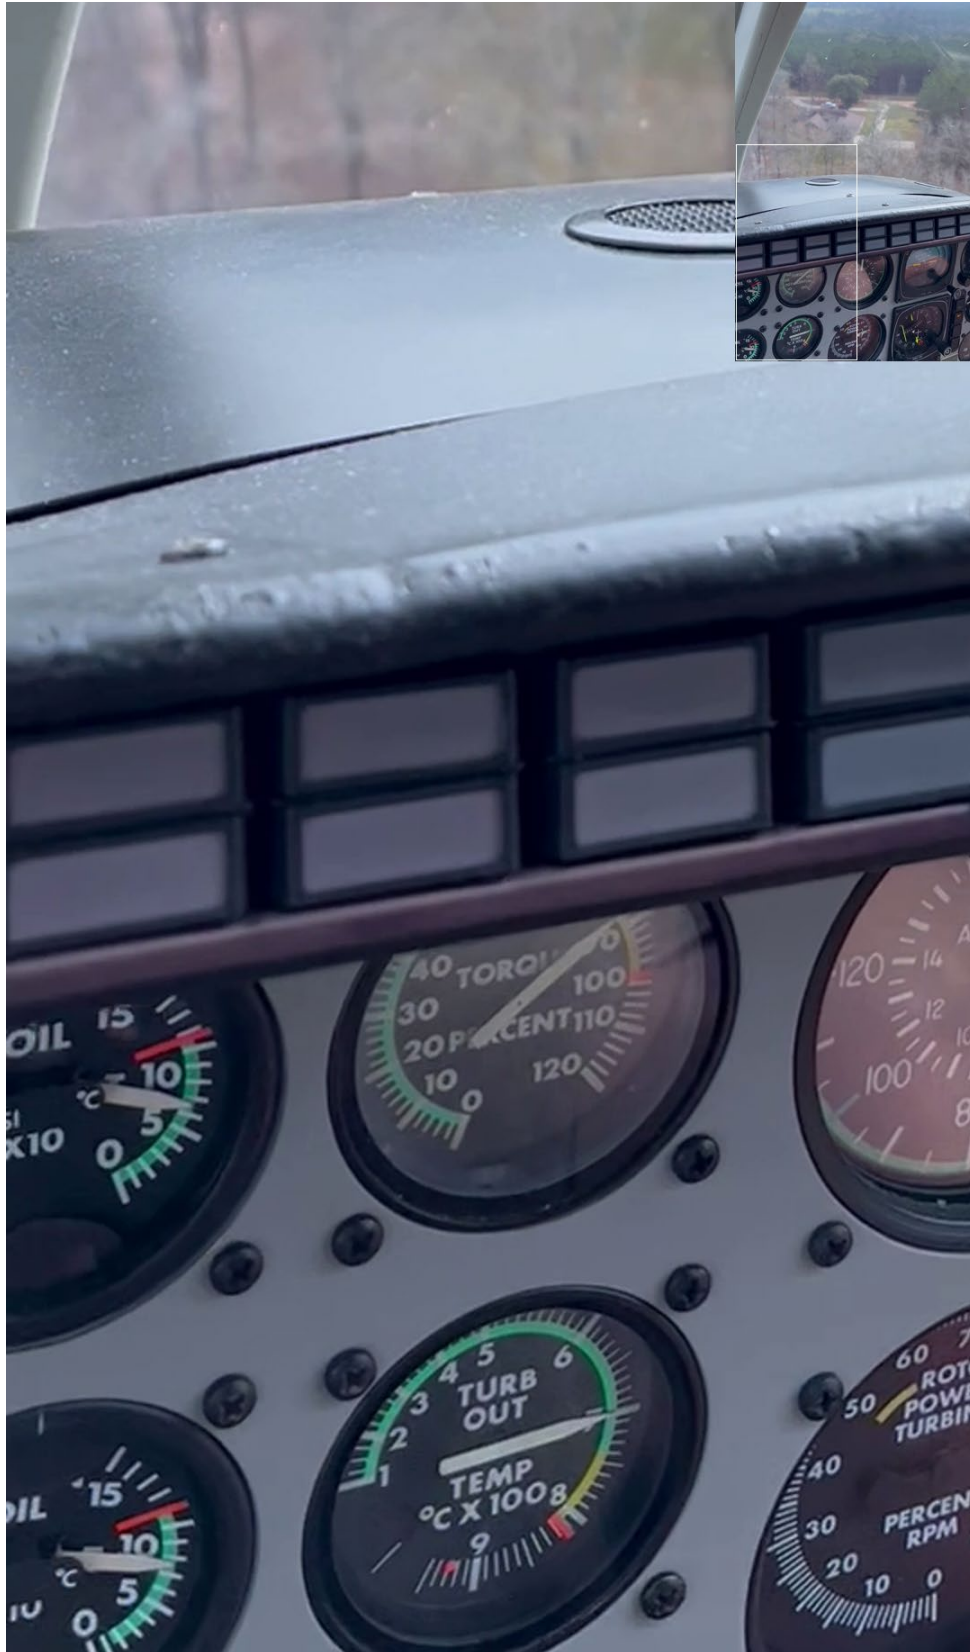
**Figure 7.** Zoomed in portion of the Torque and Turbine Outlet Temperature gauges captured at 0:39 Video Elapsed Time.

| <b>Video Elapsed Time (m:ss)</b> | <b>Observation</b> |
|---|---|
| <b>0:39</b> | The torque indicator displayed approximately 89%. The TOT gauge was approximately 700 degC. The airspeed was approximately 0 kts (see figure 7) |
