### NATIONAL TRANSPORTATION SAFETY BOARD Office of Aviation Safety Washington, DC 20594

#### SUMMARY OF AIRCRAFT EXAMINATIONS

-- CEN22FA096 --

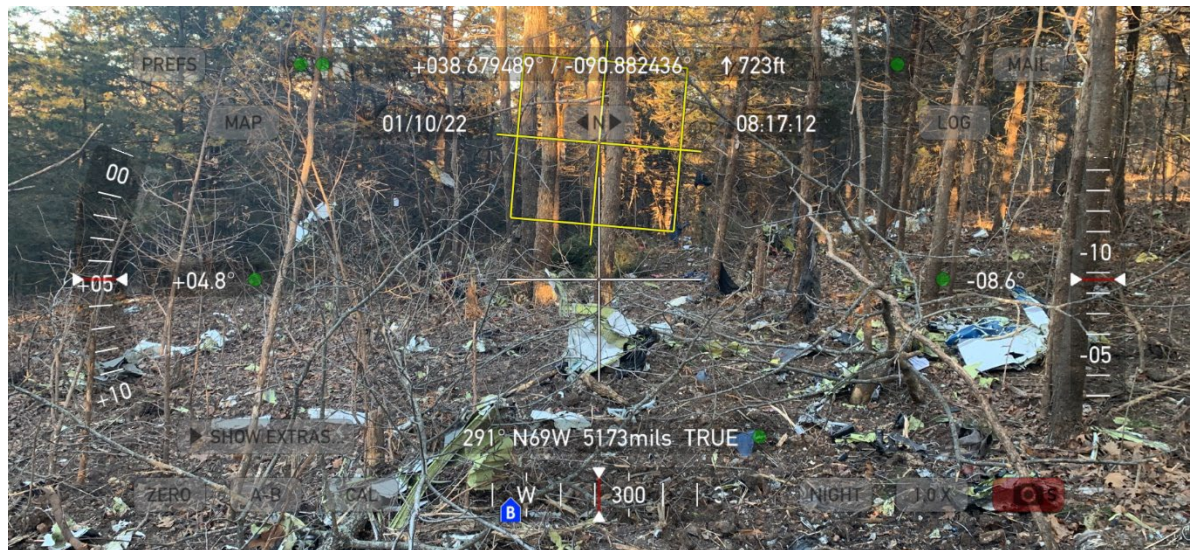
The airplane impacted into forested terrain at a high airspeed about 0.4 miles northwest of the last recorded air traffic control data. The airplane debris path was on a westerly heading and highly fragmentary. Broken tree limbs indicated the airplane was in a steep descent with a left wing low attitude at impact.

Photo 1 – Accident Site as Viewed in the Direction of Debris Path, NTSB Photo

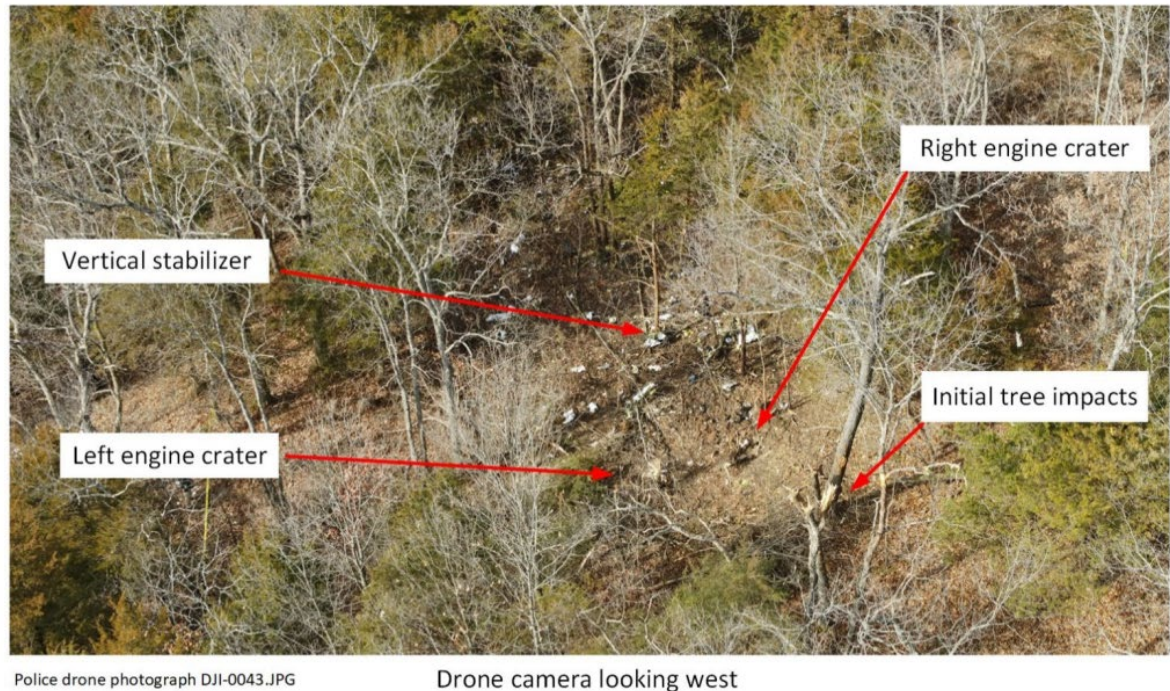
Photo 2 – Overhead View of Accident Site, Photo Courtesy of Police

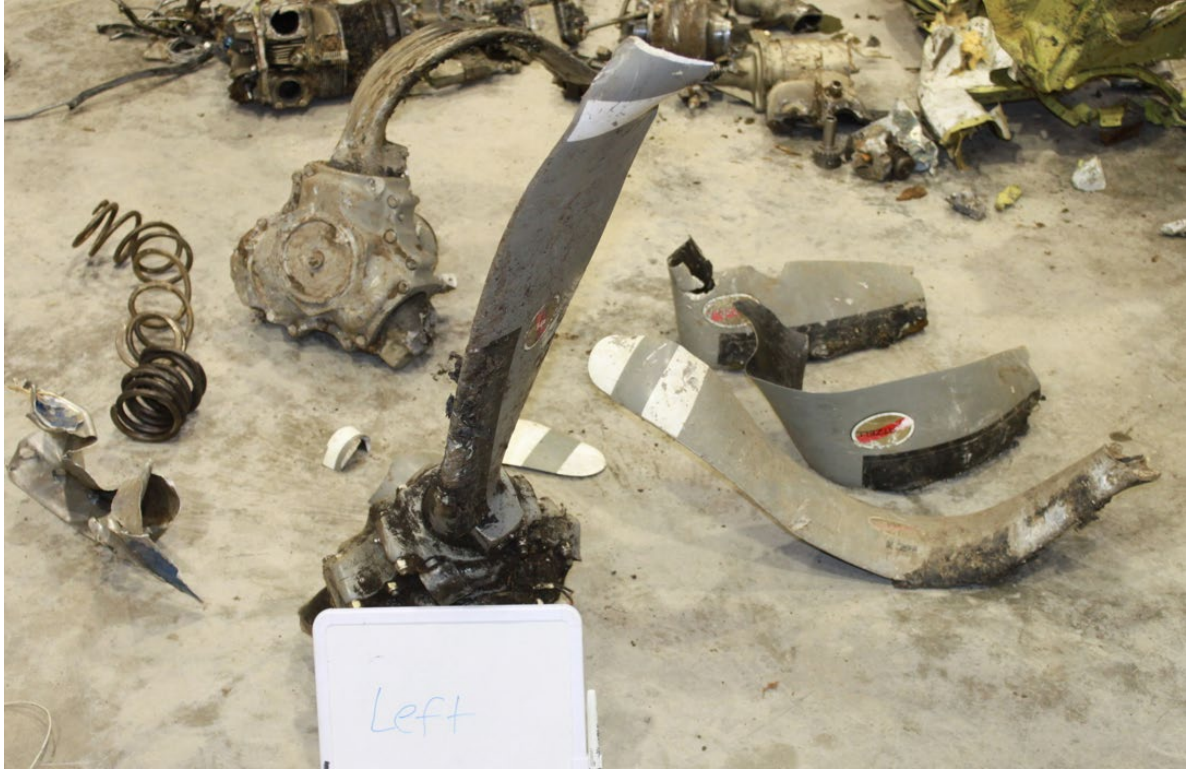
Both three-blade propeller assemblies were recovered at the crash scene and were highly fragmented. Both propeller assemblies fractured from the engine crankshaft flange. All six blade butts remained in their respective propeller hubs. The spinner dome and bulkhead were torn from each propeller assembly.

The hydraulic units (cylinder, piston and feathering spring) fractured from the hub units. Both hub units remained mostly intact. All six counterweights fractured from the blade shanks. Two blades in each propeller assembly fractured outboard of the counterweight boss. The shank and mid-blade section of one blade remained in one hub, and the majority of one blade remained in the other hub. One blade that fractured at the shank was not found.

All five of the blades that were recovered exhibited varying degrees of chordwise/rotational scoring, leading edge gouging, bending, and twisting. Four fractured blade fragments were found at the crash scene.

Photo 3 – Propellers at Recovery Location, NTSB Photo

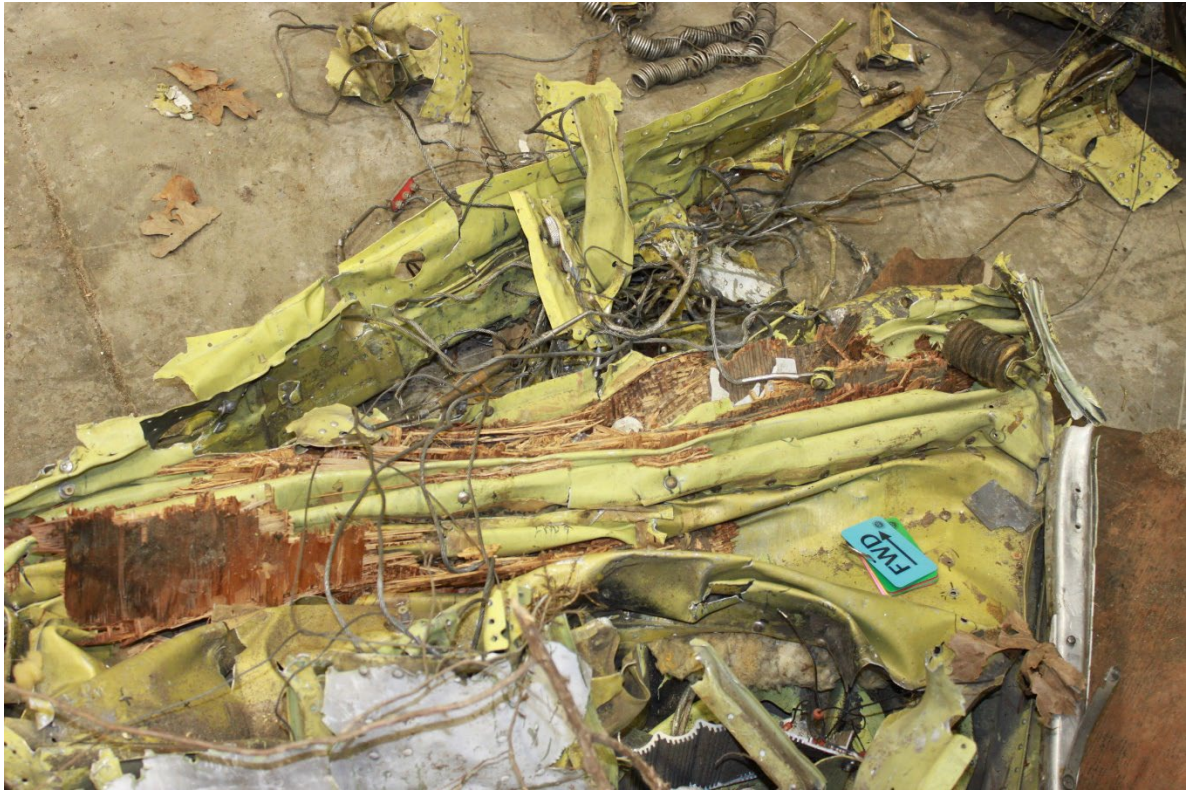
The floor of the aft fuselage was significantly compressed.

Photo 4 – Aft Fuselage Floor at Recovery Location, NTSB Photo
