## **NATIONAL TRANSPORTATION SAFETY BOARD**

### **ON SCENE OBSERVATIONS**

**CEN22FA111**

Location: Hutchinson, MN  
Date: January 31, 2022  
Aircraft: Cirrus SR22, Registration N227BD, Serial #3134  
NTSB IIC: Samantha Link

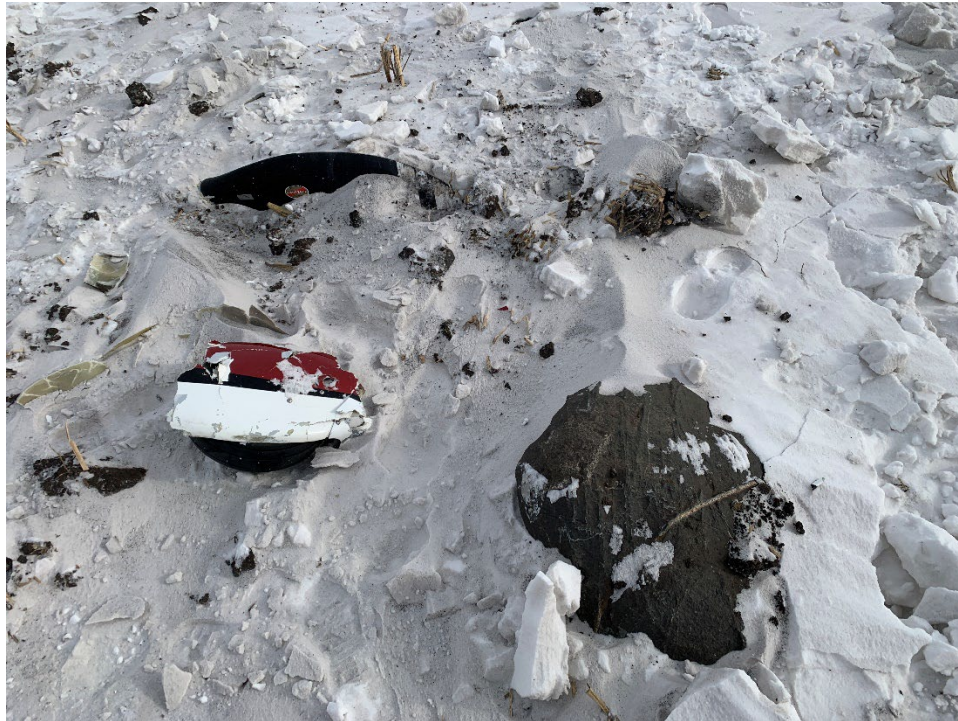
Figure 1: First Identified Point of Impact

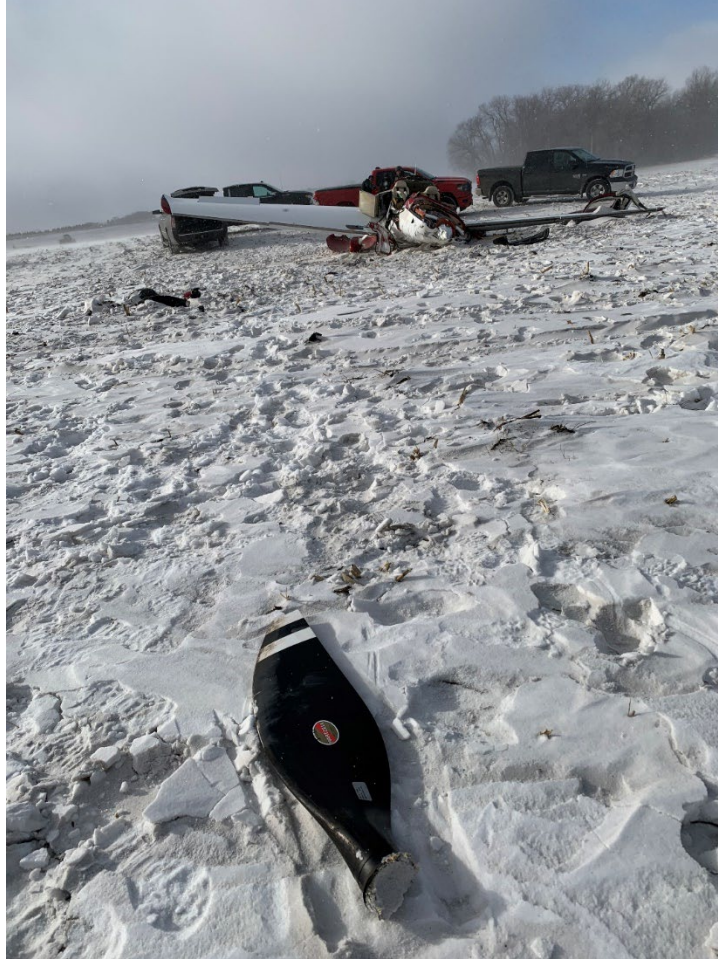
The airplane touched down in an open snowy field about 2 miles southeast of the Hutchinson Municipal Airport – Butler Field (HCD), Hutchinson, Minnesota. The airplane came to rest mostly whole, and the debris field was contained to the immediate area. The first identified point of impact was located about 10 feet southeast of the main wreckage. It consisted of a rock, the nose gear tire, and one propeller blade. A narrow line of oil extended about 5 feet towards the main wreckage. Another propeller blade was about 20 feet east of the main wreckage, and the final propeller blade was located about 400 feet southwest of the main wreckage.

Figure 2: Accident Site Overview

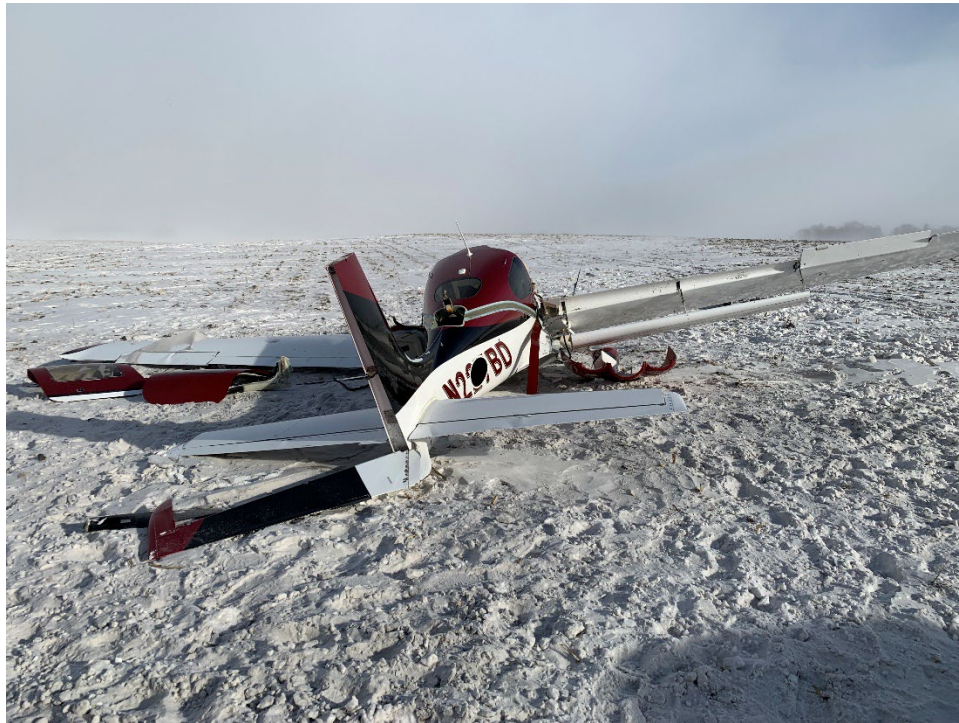
The main wreckage came to rest upright, with the nose of the airplane facing toward the east. The lower portion of the forward fuselage and lower engine compartment were crushed upward. The sides of the fuselage were cracked in between the instrument panel and the front seats, the forward fuselage and engine area came to rest slightly nose down and toward the left. The left wing remained attached to the fuselage, and the aft fuselage remained intact. The vertical stabilizer, horizontal stabilizer, and elevators remained attached and exhibited some damage. The rudder was fracture separated at all but its lowest attachment point.

Figure 3: Aft looking Forward

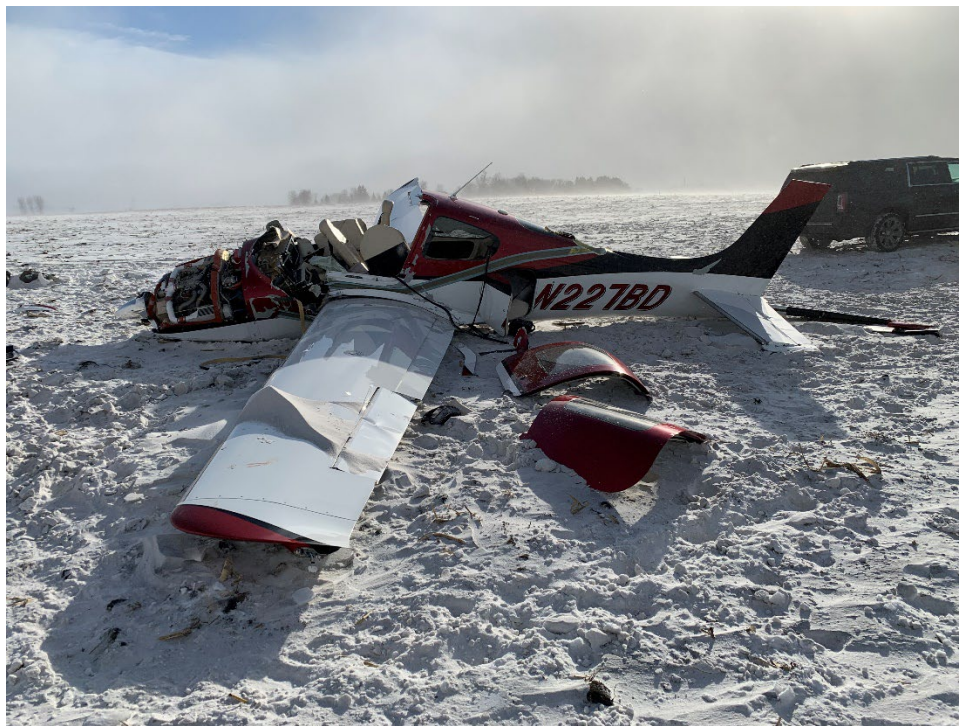
Figure 4: Left Side of Airplane

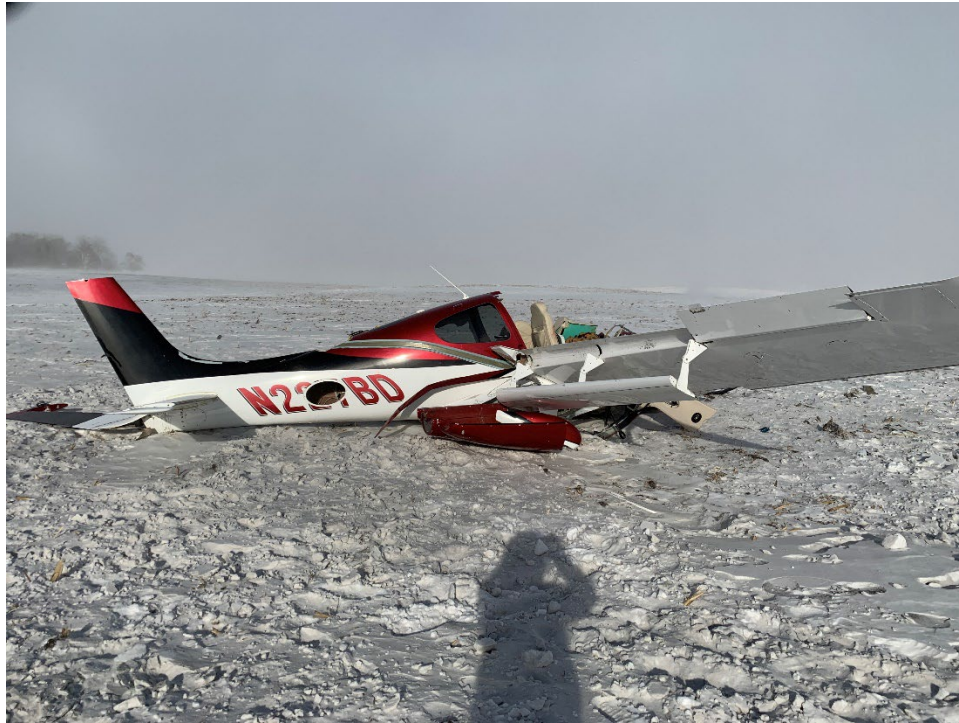
Figure 5: Right side of Airplane

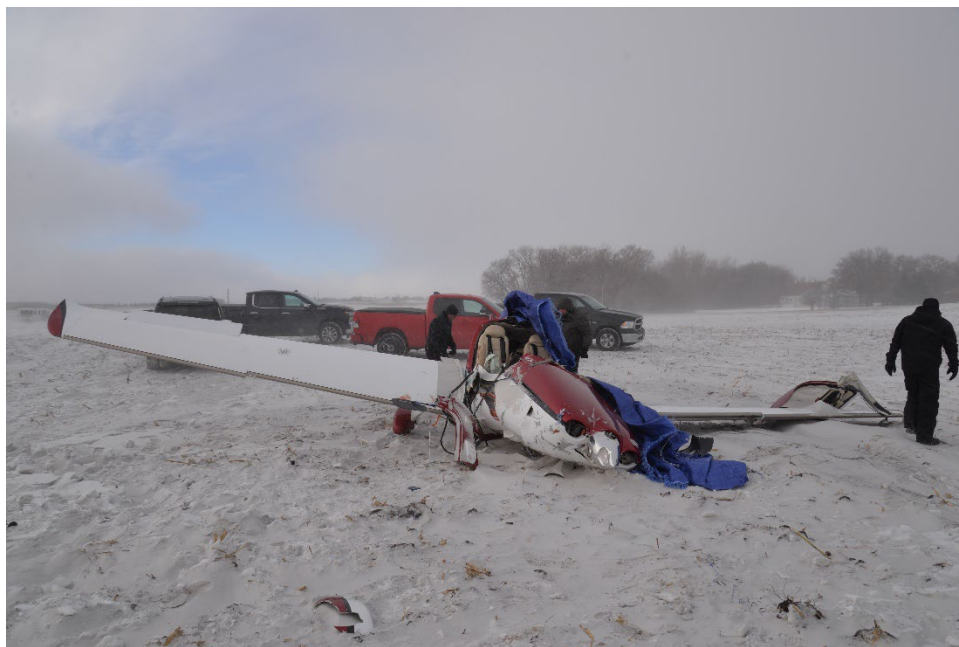
Figure 6: Forward Right side of Airplane

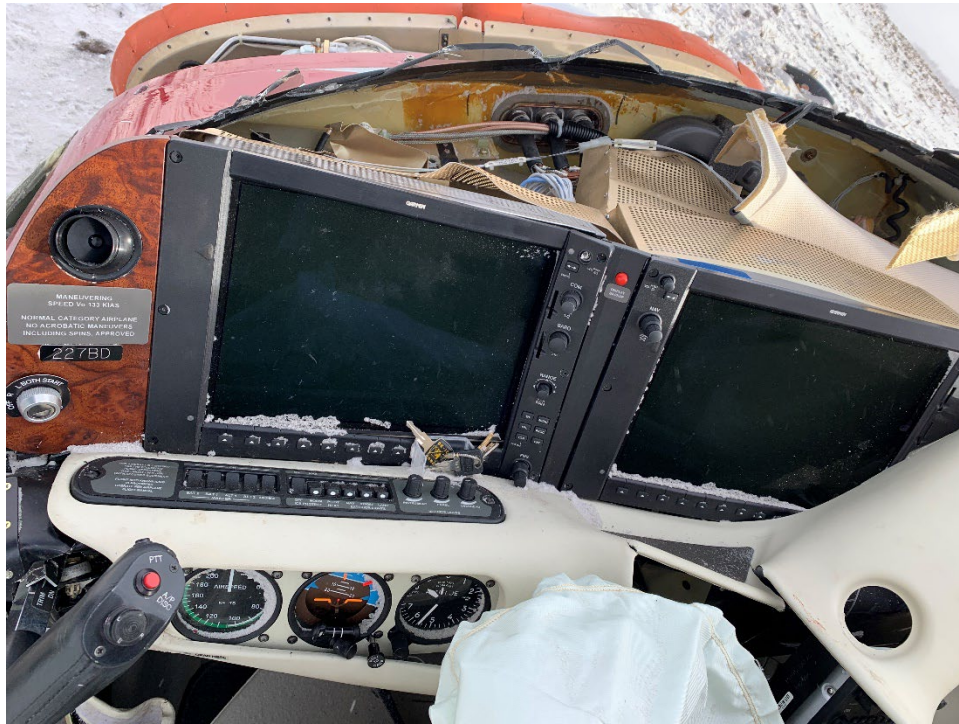
- All fracture signatures were consistent with overload.
- The cabin area:
  - The primary flight display and multifunctional display (MFD) remained intact, and a memory card was found within the MFD.

- The card was removed for data download.
  - The ignition switch and fuel selector were found in the off position.
    - First responders noted that they turned both of these items off.

- The fuel selector was on the right-wing fuel tank before they turned it to the off position.
  - The flap control was found in the “up” position.

- The throttle control was found mostly forward, and the mixture control was found mostly aft.
  - The Hobbs meter read: 1015.7
  - The flight meter was: 775.2

Figure 7: Instrument Panel

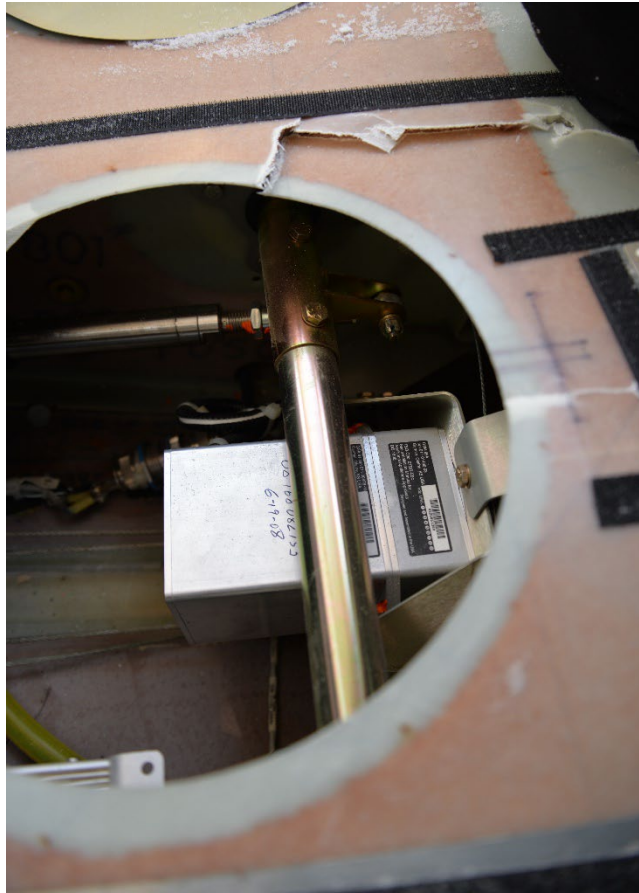
- The aft seats remained in place.
    - They were removed to expose the flap actuator and flight control cables.
- The flap actuator screw was observed in the fully extended position, which is consistent with the flaps in the up position.

Figure 8: Flap Actuator Screw

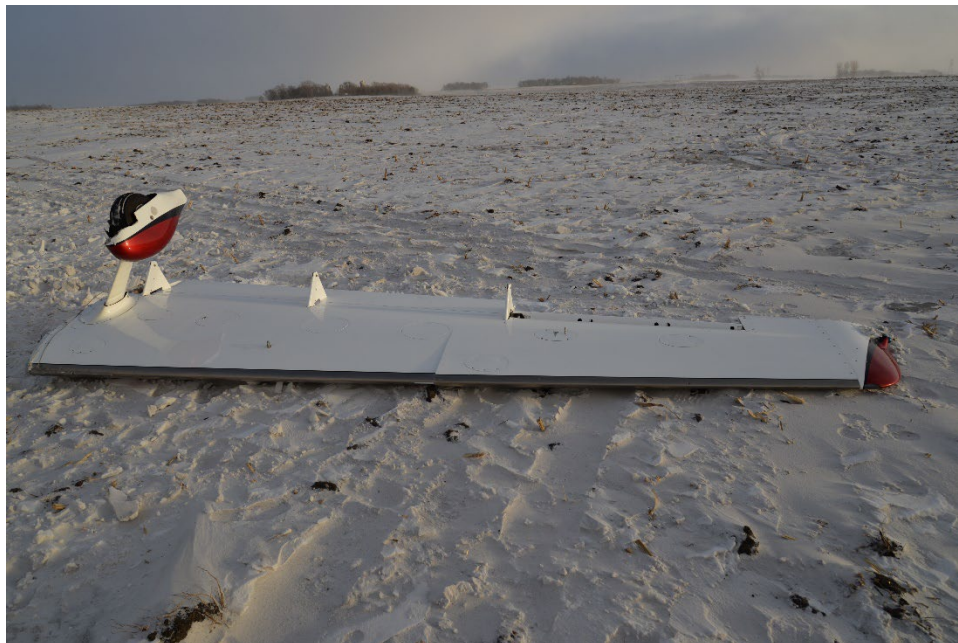
- The rocket and parachute bag were not present.
  - The parachute retention strap remained secured and was unremarkable.
- The right wing remained mostly whole, but was fracture separated at the trailing edge. The wing was overall bent forward.

- The flap torque tube was observed fracture separated.
  - The fuel tank cap remained secured in place
    - The cap was removed, and no fuel was noted in the wing tank.

Figure 9: Underside of Right Wing

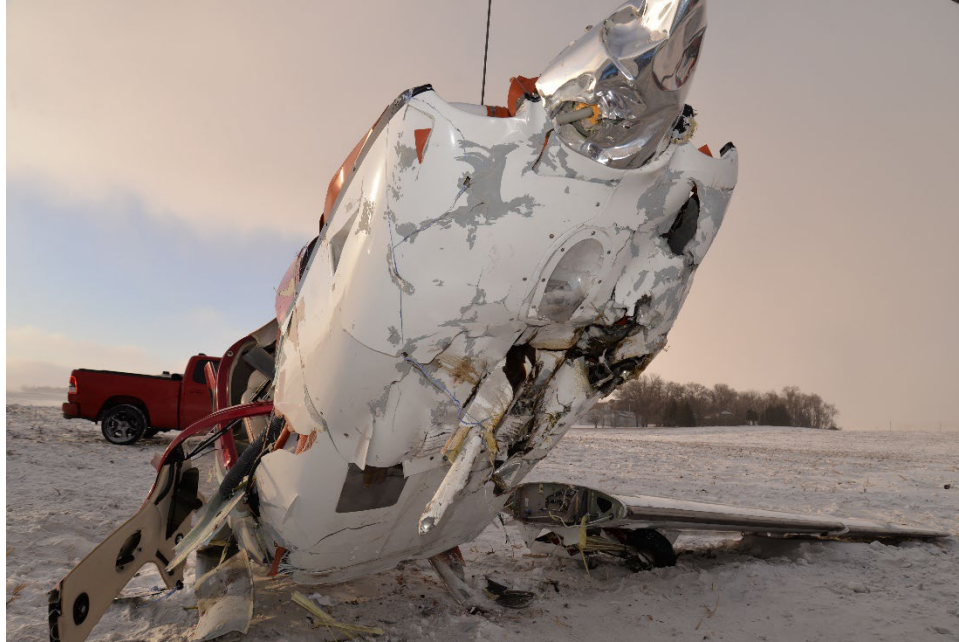
- The airplane came to rest on its belly, the lower forward fuselage was flattened. The forward cabin area was compressed with the engine compartment.
- The nose landing gear strut was bent toward the right and came to rest against the lower engine cowling.

Figure 10: Underside of forward fuselage/engine compartment

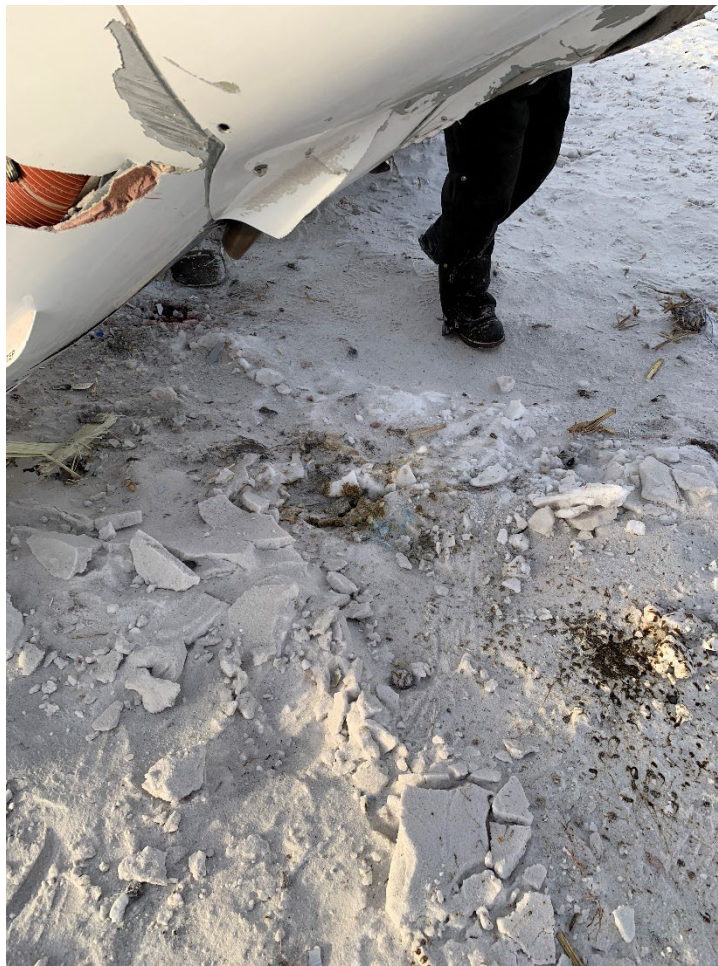
Figure 11: Blue stain observed in the snow as the engine was moved

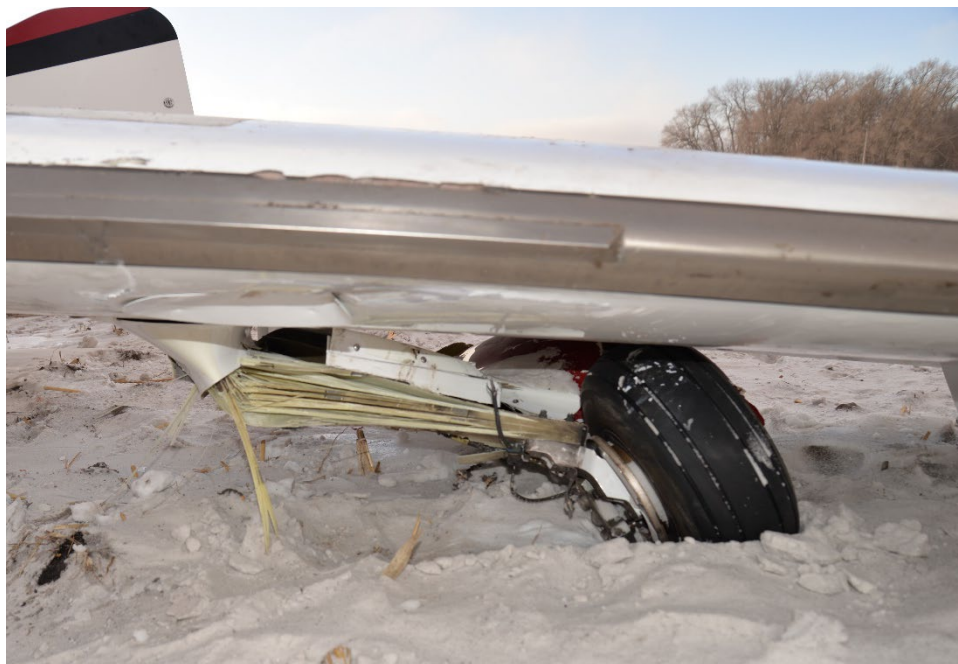
- No corresponding blue staining was noted in the snow below the wing.
  - The left main landing gear was bent outward and came to rest touching the lower wing skin.

- The left main landing gear strut was heavily splintered.
    - The wheel pant was fracture separated and came to rest under the wing.
- The aft fuselage remained attached to the cabin area and was mostly intact.

**Figure 12: Splintered left Landing gear Strut**

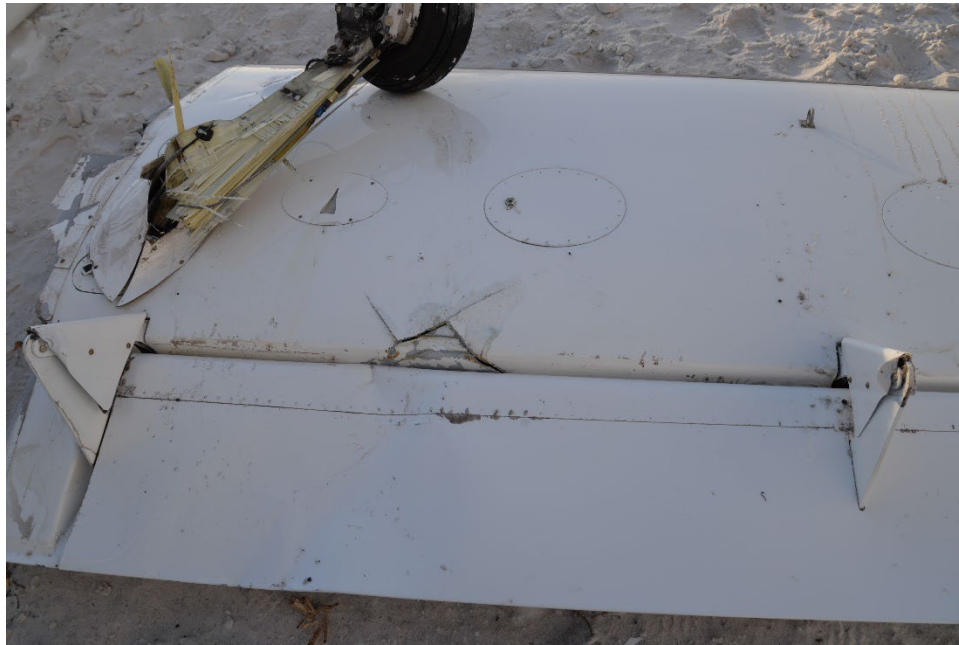
- Several cuts were made in the top of the wing and no fuel was noted in the fuel tank.
    - The underside of the left wing exhibited cracking. In the vicinity of these cracks was a small area of blue staining consistent with 100LL aviation fuel.

Figure 14: Underside inboard left wing. Note: blue staining.

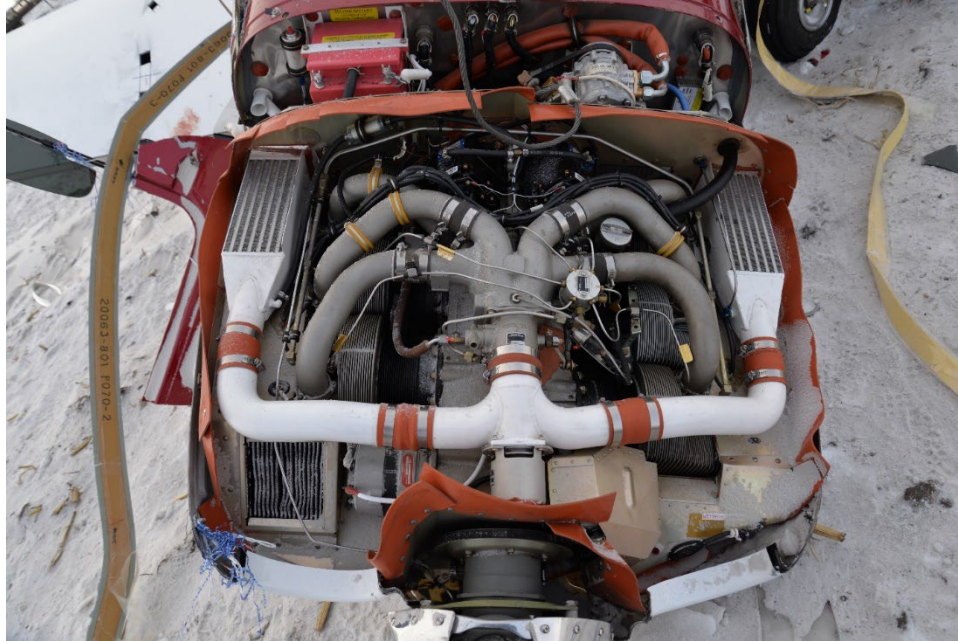
- The upper engine cowling was removed.
  - Continental Motors, Model: IO-550-N, Serial #691789
- There were no obvious indications of catastrophic failure.
- The engine appeared clean, and all major components remained attached.
- The oil stick was removed, and the engine contained 4 quarts of oil.
  - Some oil was noted near the initial impact point.
  - When the airplane was moved for recovery purposes, the oil sump was observed breached, and oil exited the engine.
- The lower engine cowling was crushed upwards.
  - The nose landing gear strut was crushed upwards and to the right; into the engine compartment, and it breached the oil sump.
- When the airplane was moved for recovery, a small amount of fuel exited the engine compartment area and left about 6-inch fuel stain in the snow.
  - The lower cowling was crushed up into the engine compartment.

Figure 15: The Engine Compartment

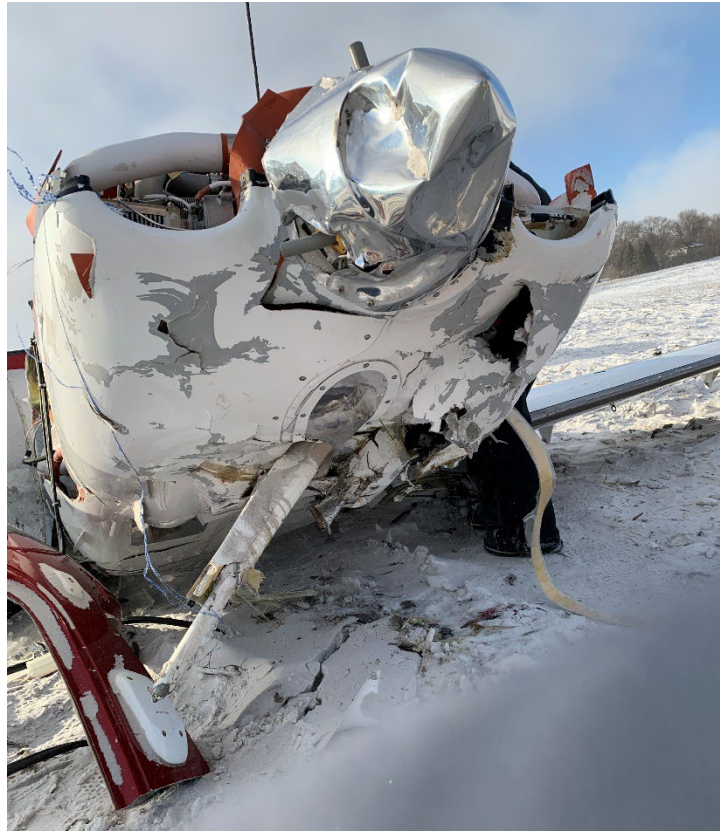
- Cracking was noted on the outboard tip, on the face side of the blade.
- The propeller spinner exhibited dents throughout. None of these dents indicated rotational scoring.

Figure 16: Dents to Spinner

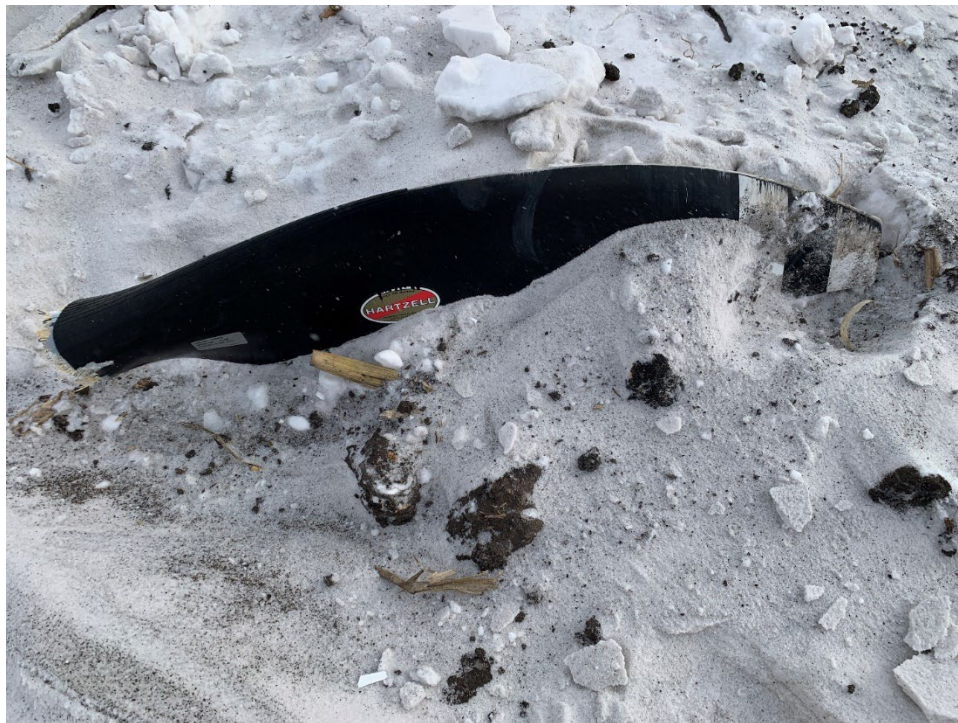
- All three propeller blades were fracture separated from the propeller hub.
  - One blade came to rest near the first identified point of impact.
    - Chordwise scratching was noted on the chamber side of the blade near the blade tip.

- The leading edge was polished about midspan extending to the blade tip.
  - A second blade was observed about 20 feet east of the initial point of impact.

Figure 17: Propeller Blade at the First Identified Point of Impact

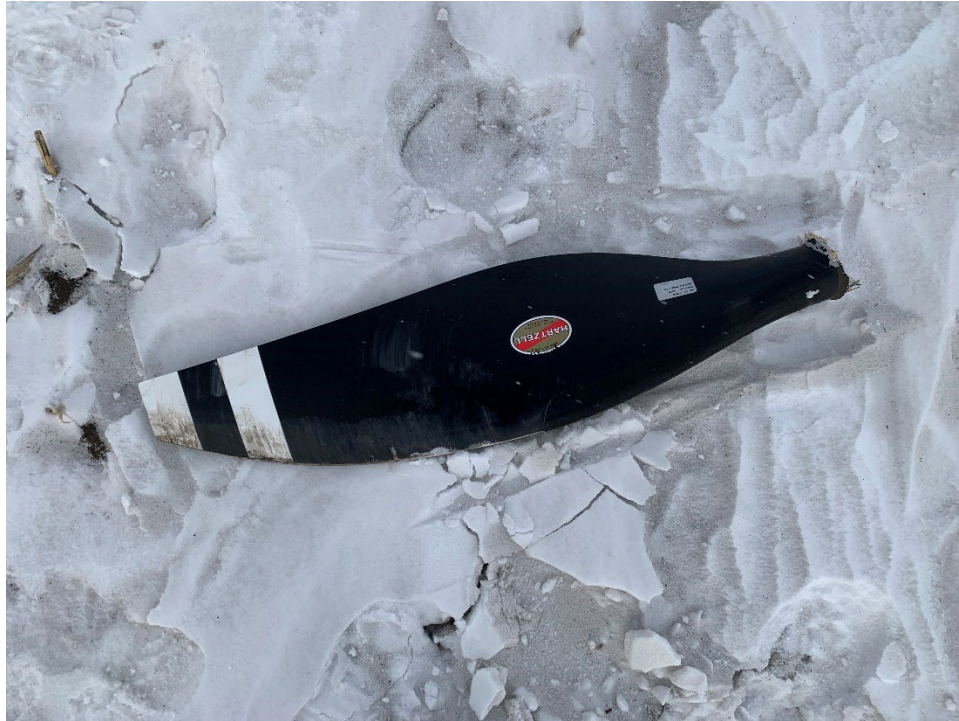
- Chordwise scratching was noted on the chamber side of the blade from about midspan all the way out to the tip of the blade.
      - The leading edge of the blade was polished in this area.

Figure 18: Propeller Blade found about 20 feet east

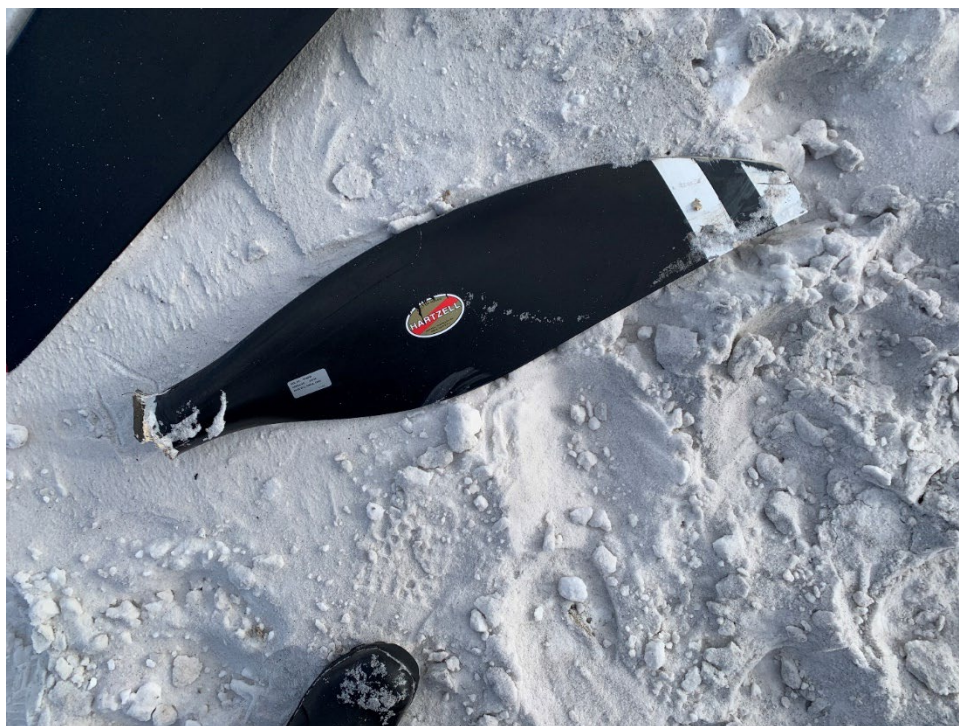
- The third blade was observed about 400 feet southwest of the initial point of impact.
    - Longwise scuff marks were noted on the chamber side of the blade near the blade tip and about midspan.

Figure 19: Propeller Blade Found about 400 feet southwest
