## **NATIONAL TRANSPORTATION SAFETY BOARD**

# **AIRFRAME AND ENGINE EXAMINATION**

**CEN22FA111**

Location: Hutchinson, MN  
Date: January 31, 2022  
Aircraft: Cirrus SR22, Registration N227BD, Serial #3134  
NTSB IIC: Samantha Link

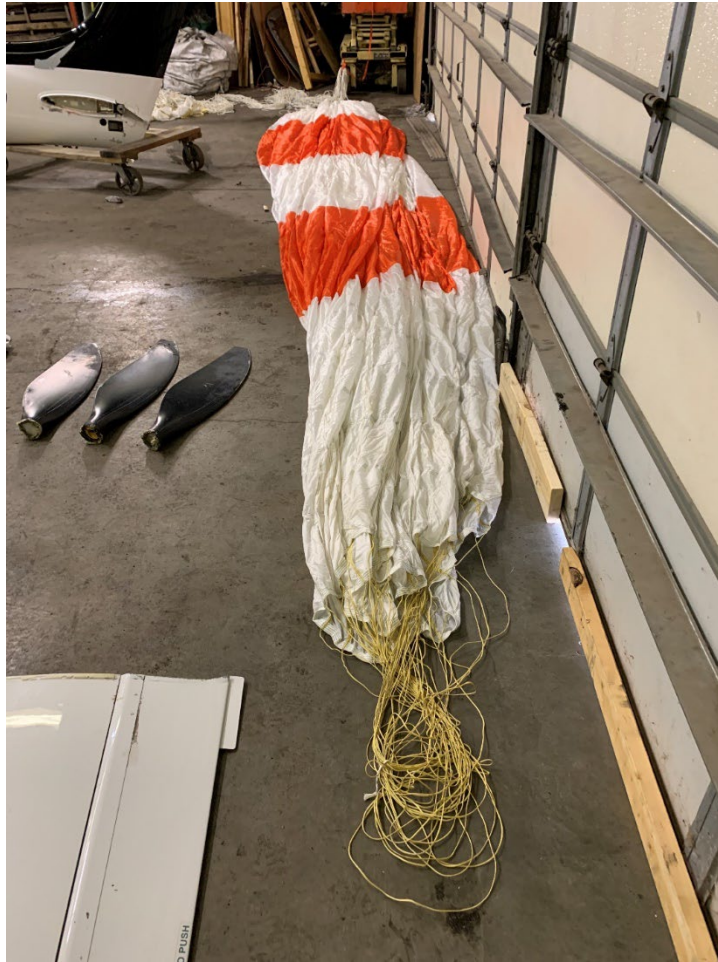
Figure 2: Parachute

- Parachute D-bag and rocket were recovered.
  - The deployment bag appeared normal.
  - The incremental bridal stitches were completely unzipped.
  - The rocket remained intact and remained secured to the deployment bag.
- The parachute itself was laid out. All retention lines remained attached and secured.
- The slider was found at the bottom of the straps.
- The connection between the parachute retention straps and the airplane straps remained intact and secured.
- The airplane straps were fully extended and cut by first responders.
  - The line cutter cut the tail straps and the snub was fully extended.

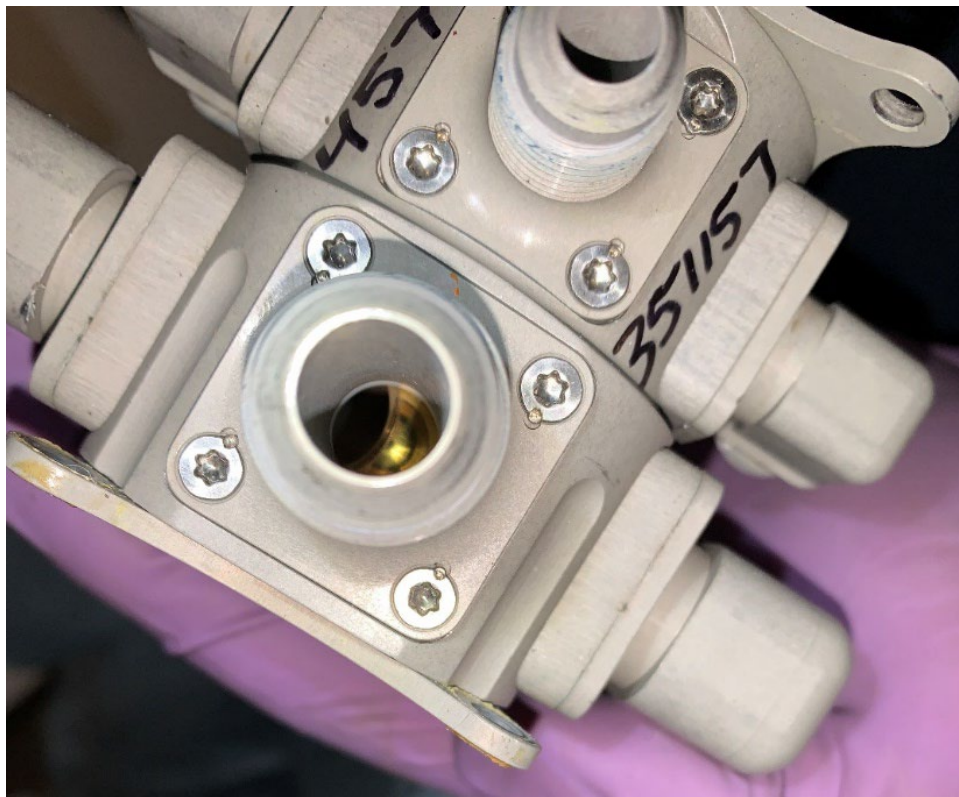
Figure 4: Fuel Selector Valve

- The fuel selector handle was able to be manipulated by hand.
  - The faceplate was removed and the pin between the shaft between the valve handle and to the valve shaft housing was fractured at the shaft. The pin remained in the bottom of the handle.

- The shaft housing was removed, and the shaft remained intact.
  - The fuel valve itself was removed from the airframe.
    - The valve was found in between the right fuel tank and off.

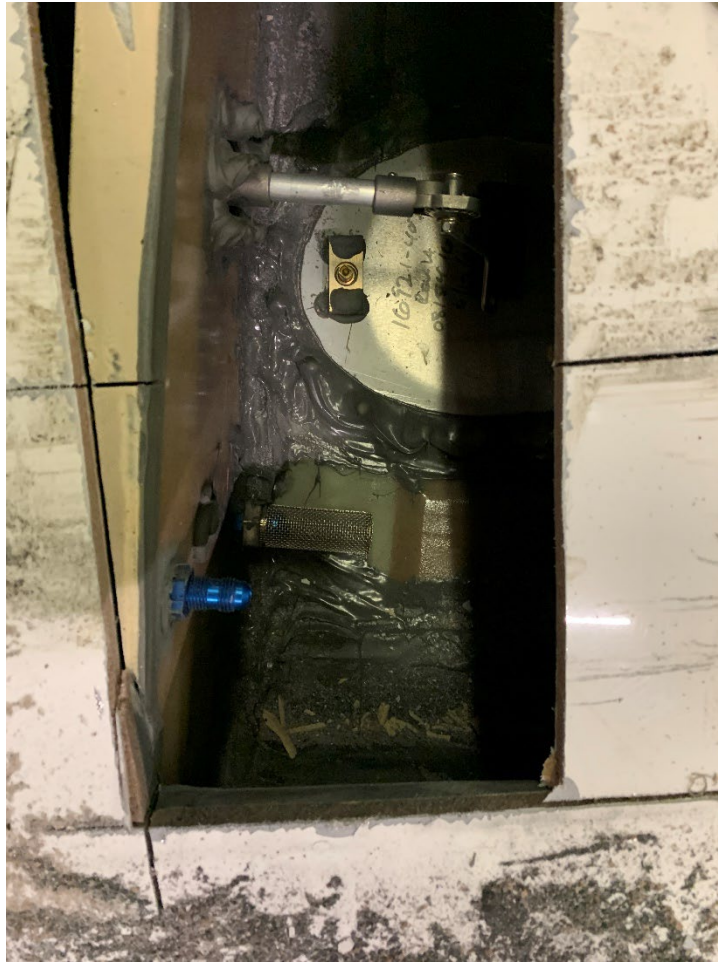
Figure 5: Left Wing

- The fuel inlet screen from each wing was clear of debris.
- The left wing header tank had a small amount of fuel.
- The right wing header tank had a small amount of fuel.

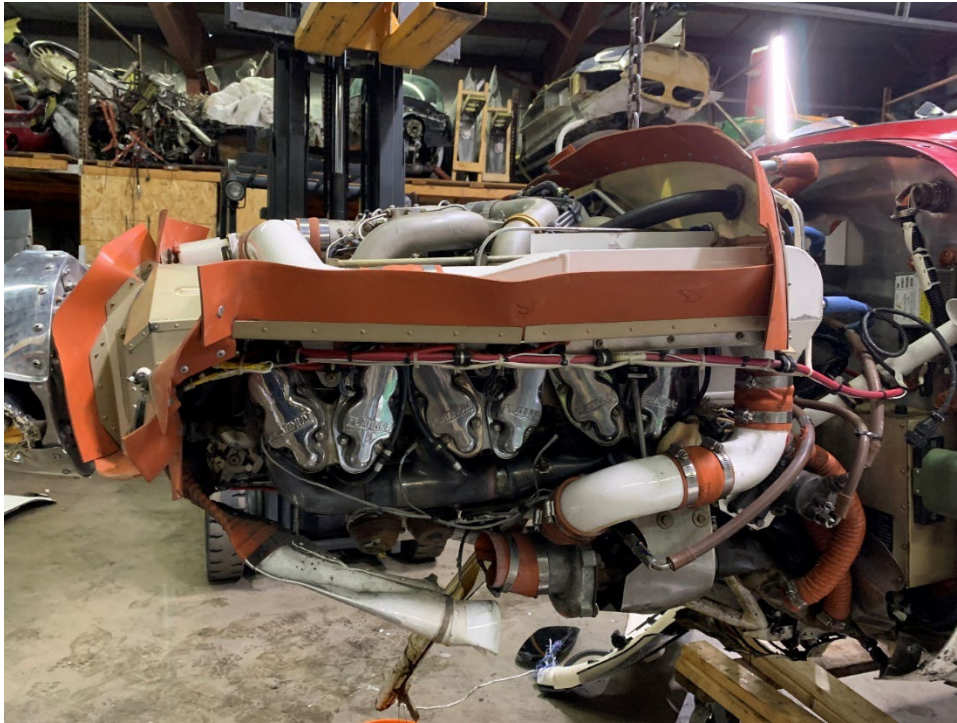
Figure 6: Left Side of Engine

- The propeller governor control was manipulated in the cockpit and corresponding motion was observed at the propeller governor.
- The Left side intercooler was removed to access the cylinders.

- The upper spark plugs for cylinders 2, 4, and 6 were removed and were consistent with normal operations
- Cylinders 2, 4, and 6 were borescoped
  - The piston heads, valves, lower spark plugs, and cylinder walls were all consistent with normal operations.

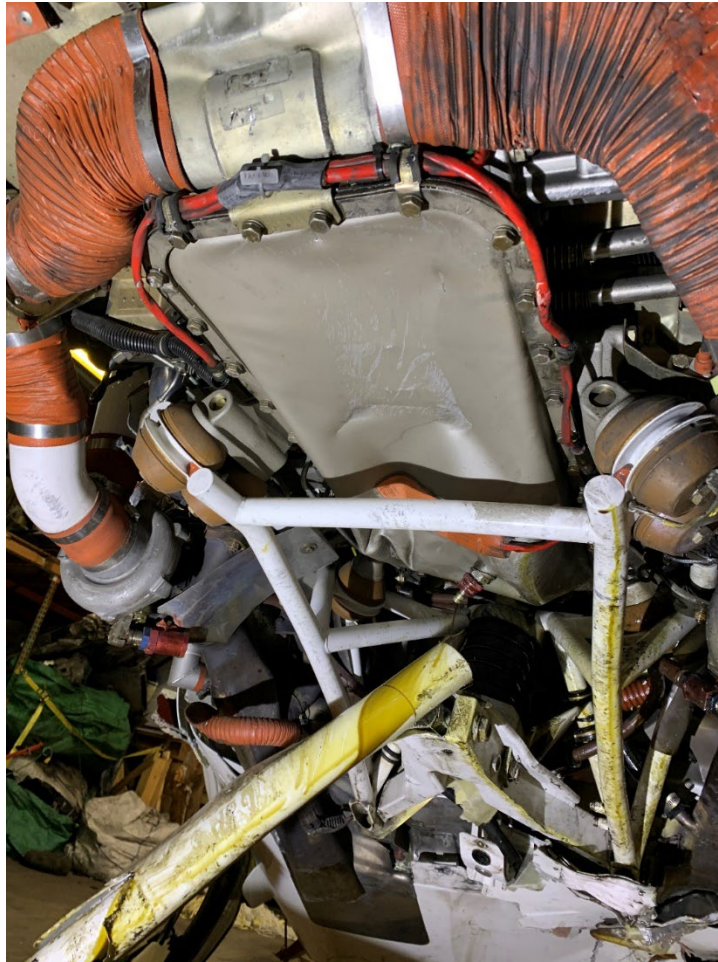
Figure 8: Bottom of Engine

- The fuel inlet line to the boost pump was removed and no fuel was noted.
- The fuel strainer was damaged and unable to be reached.
