**National Transportation Safety Board**

CEN22FA111

**EXAMINATION SUMMARY**

Location: Hutchison, Minnesota  
Date: January 31, 2022  
Time: 1256 central standard time  
Aircraft: Cirrus SR22, N227BD

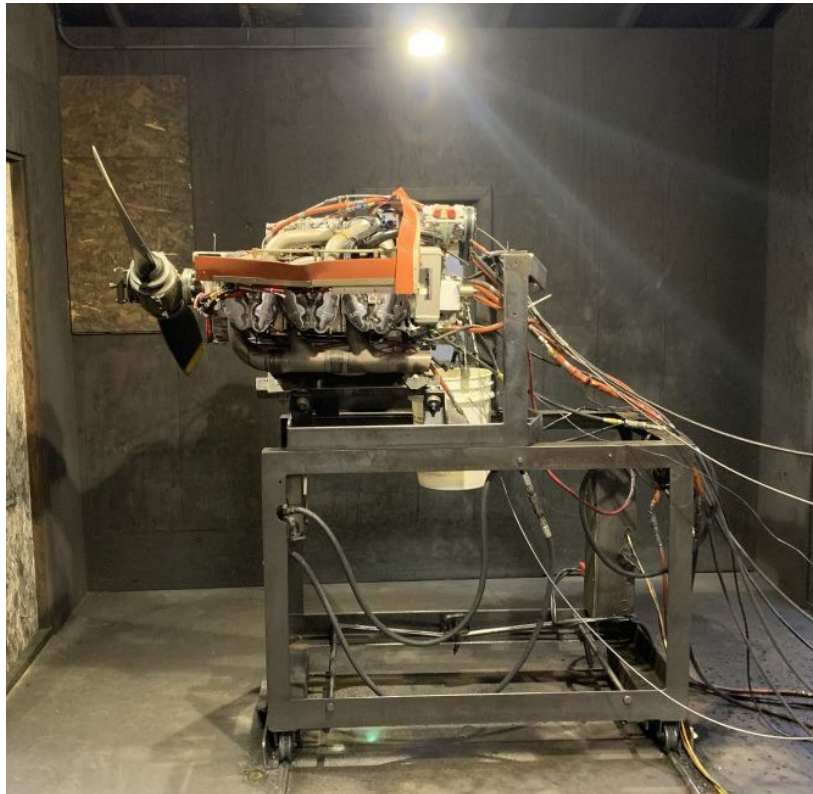
Two test runs were conducted in the presence of the NTSB investigator. The runs were about 30 seconds and 60 seconds in duration, respectively. The engine started normally and ran to approximately 2,900 rpm. Throttle response was smooth and immediate, and the throttle idle check was normal. A magneto check produced a drop of approximately 80 rpm on each magneto, and engine operation was

continuous and smooth during that time. Oil pressure stabilized about 65 psi during the runs.

*Figure 1 - Engine installed in test cell*

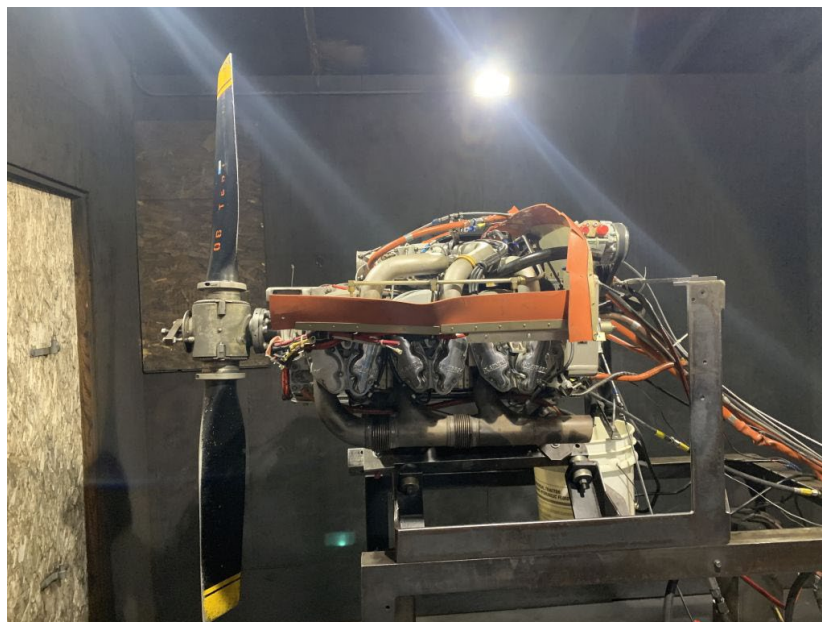
*Figure 2 - Left side of engine*

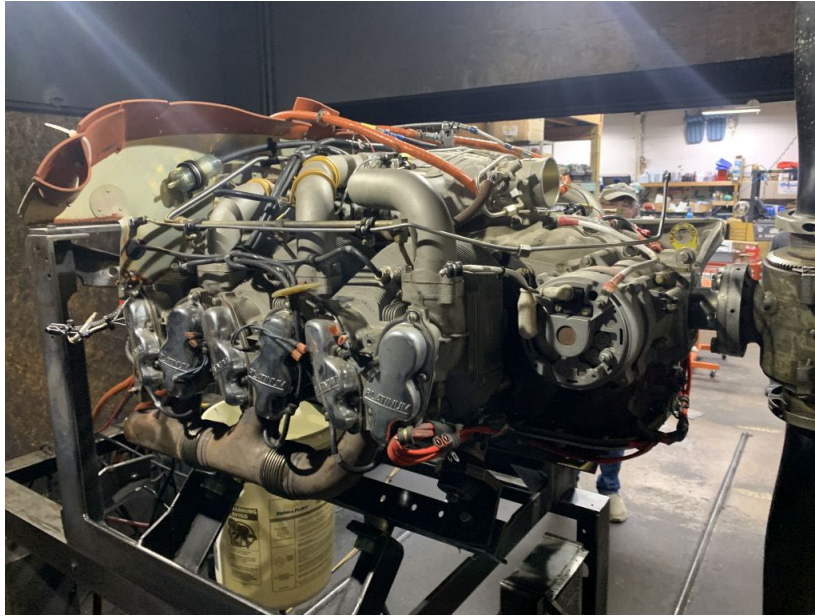
*Figure 3 - Right side of engine*

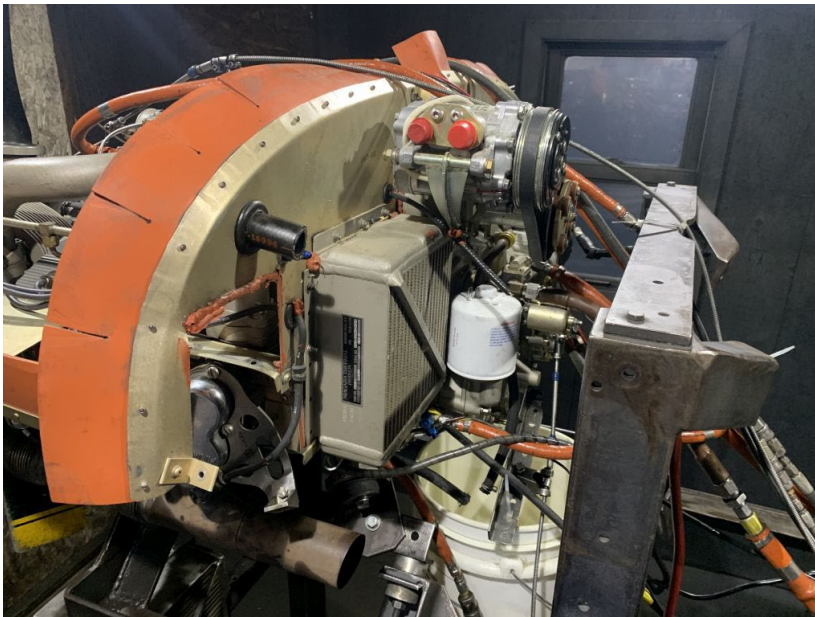
*Figure 4 - Accessory section of engine*

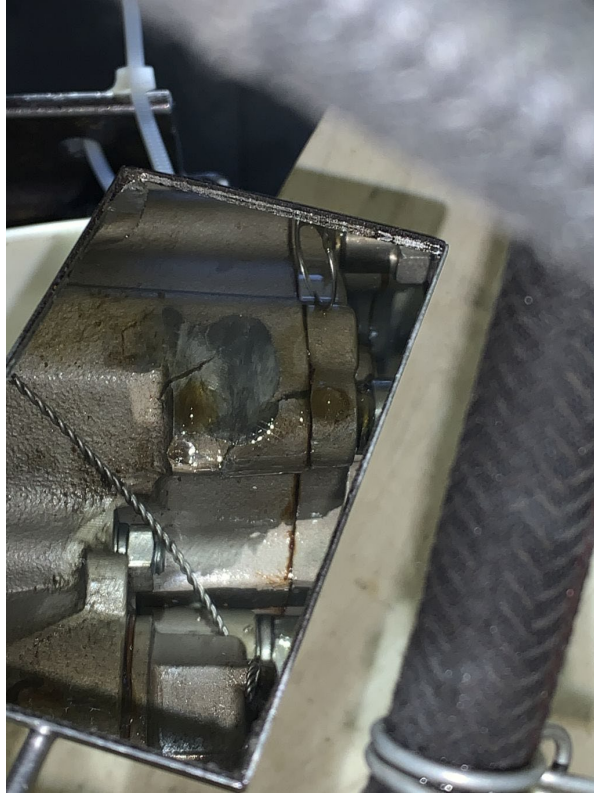
The engine was prepared for a test run prior to arrival of the NTSB investigator. The oil sump and #6 cylinder exhaust valve cover were replaced due to impact damage. The remainder of the engine components and accessories were as received. The oil pump housing exhibited damage consistent with impact which caused an oil leak during the run. In addition, a small oil leak was observed at the replaced valve cover. The run time was limited for this reason.

Figure 5 - Impact damage to oil filter housing

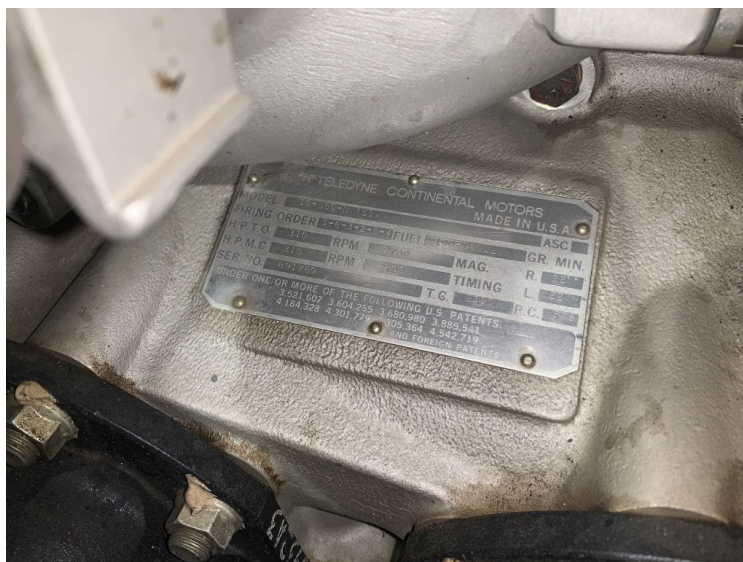
Figure 6 - Engine data plate
