## Ohio State Highway Patrol – Crash Reconstruction and Analysis Unit

### Crash Reconstruction

**Case Number:** 22 171007 0645

### **Reconstruction Assistance**

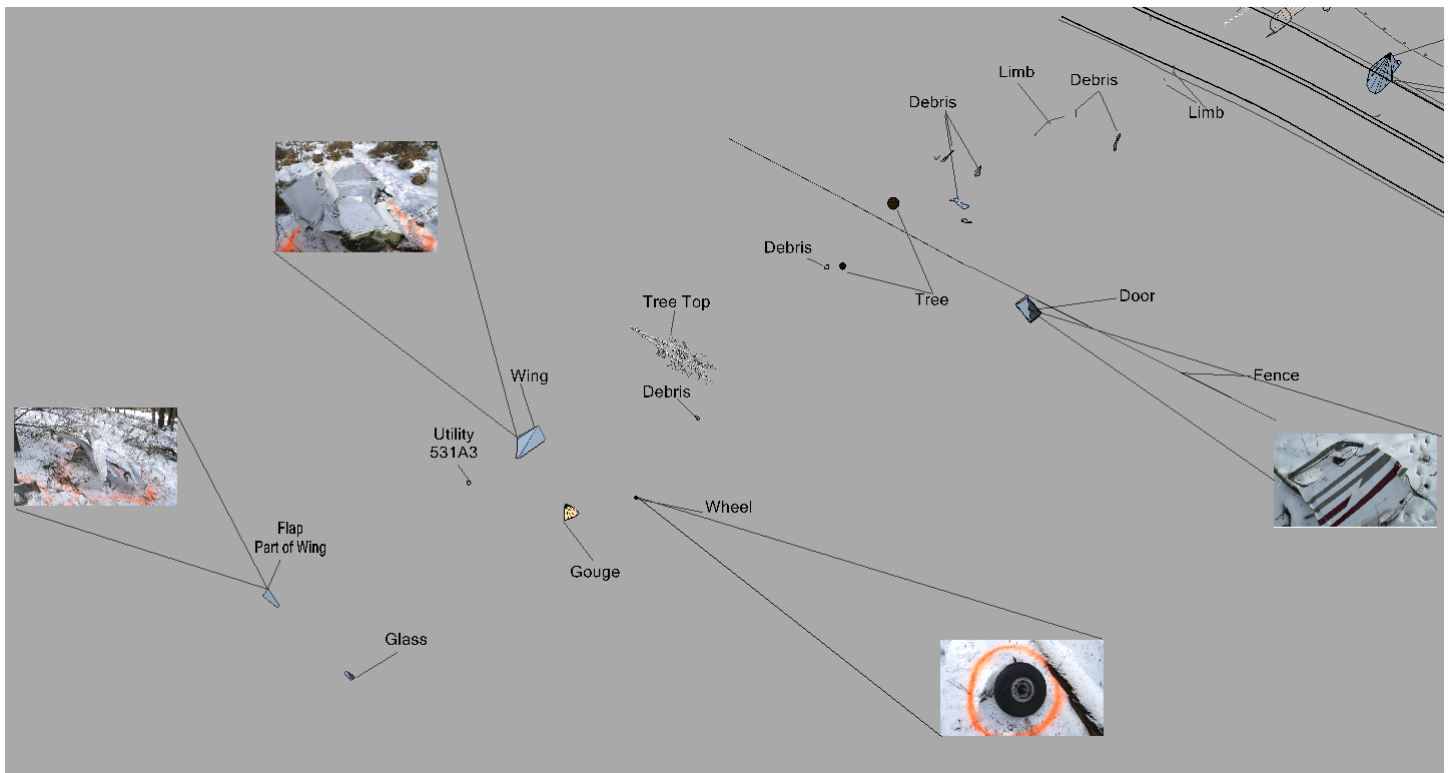
South side of Linnville Road

As I arrived at the scene, I could see a trail of debris on the south side of Linnville Road, in a wooded area. On Linnville Road, there was a wing, several scrapes, and a heavily damaged guard rail, where it appeared the plane had hit and travelled under it. A large portion of the plane's tail was still attached to the guard rail. The plane continued off the north side of Linnville Road down over an embankment and through a state fence. It came to rest in a field just beyond the fence.

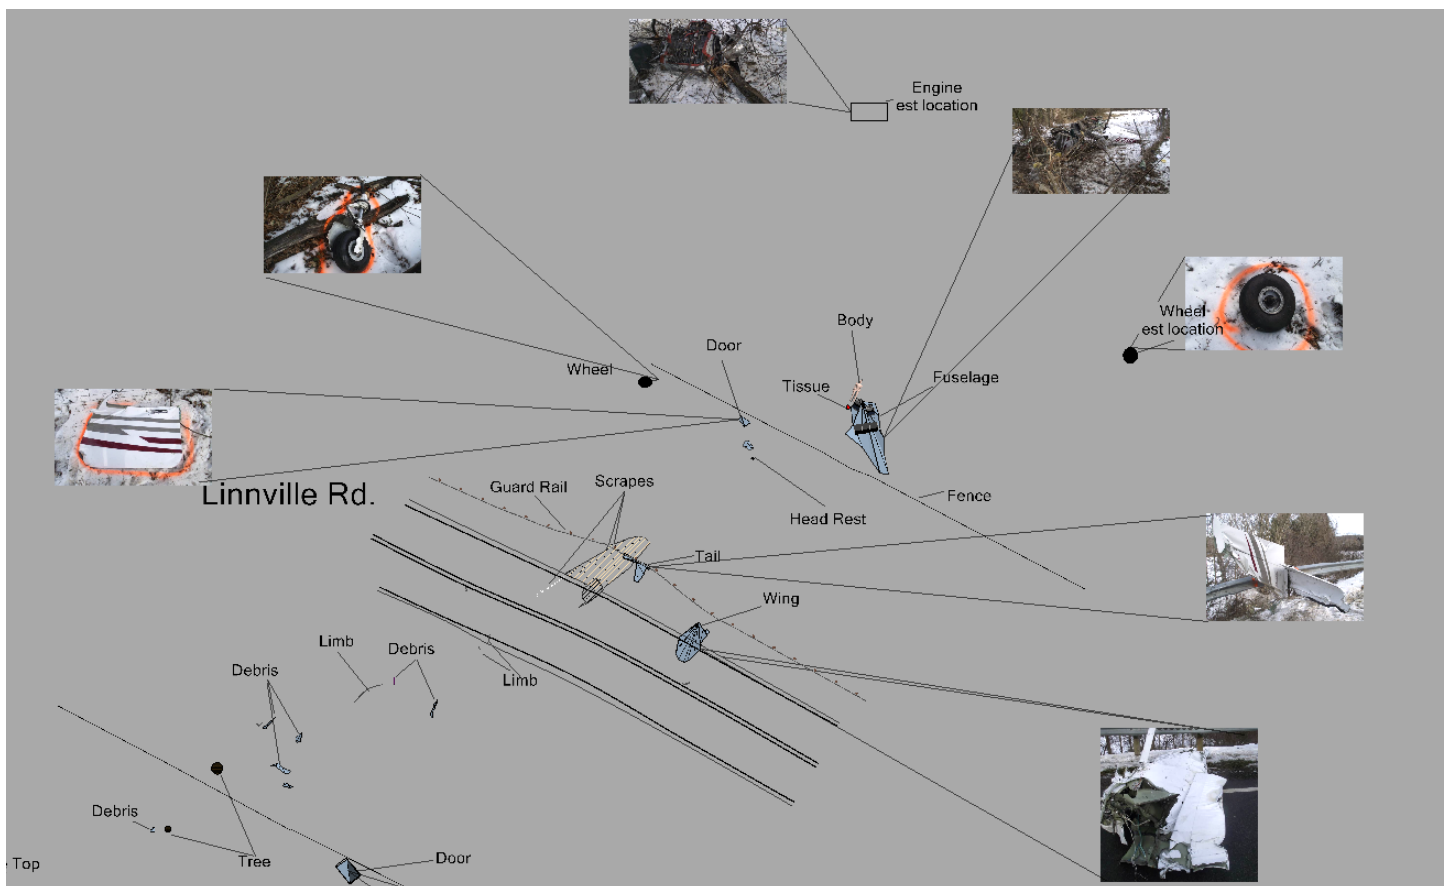
North side of Linnville Road

The fuselage was heavily damaged. The engine was detached, the passenger compartment was torn open and the front seats were detached. The pilot had come to rest in front of the fuselage.

Note: Two points failed to store: the engine and the furthest tire north of the fuselage. These points were placed in as estimated locations and should not be used as true measured points.
