# National Transportation Safety Board

CEN22FA119

Factual Report 23-030

Location: Olathe, Kansas  
Date: February 13, 2022  
Vehicle: Piper PA-46-500TP, N2445F  
Investigator: John Brannen, ASI-CEN

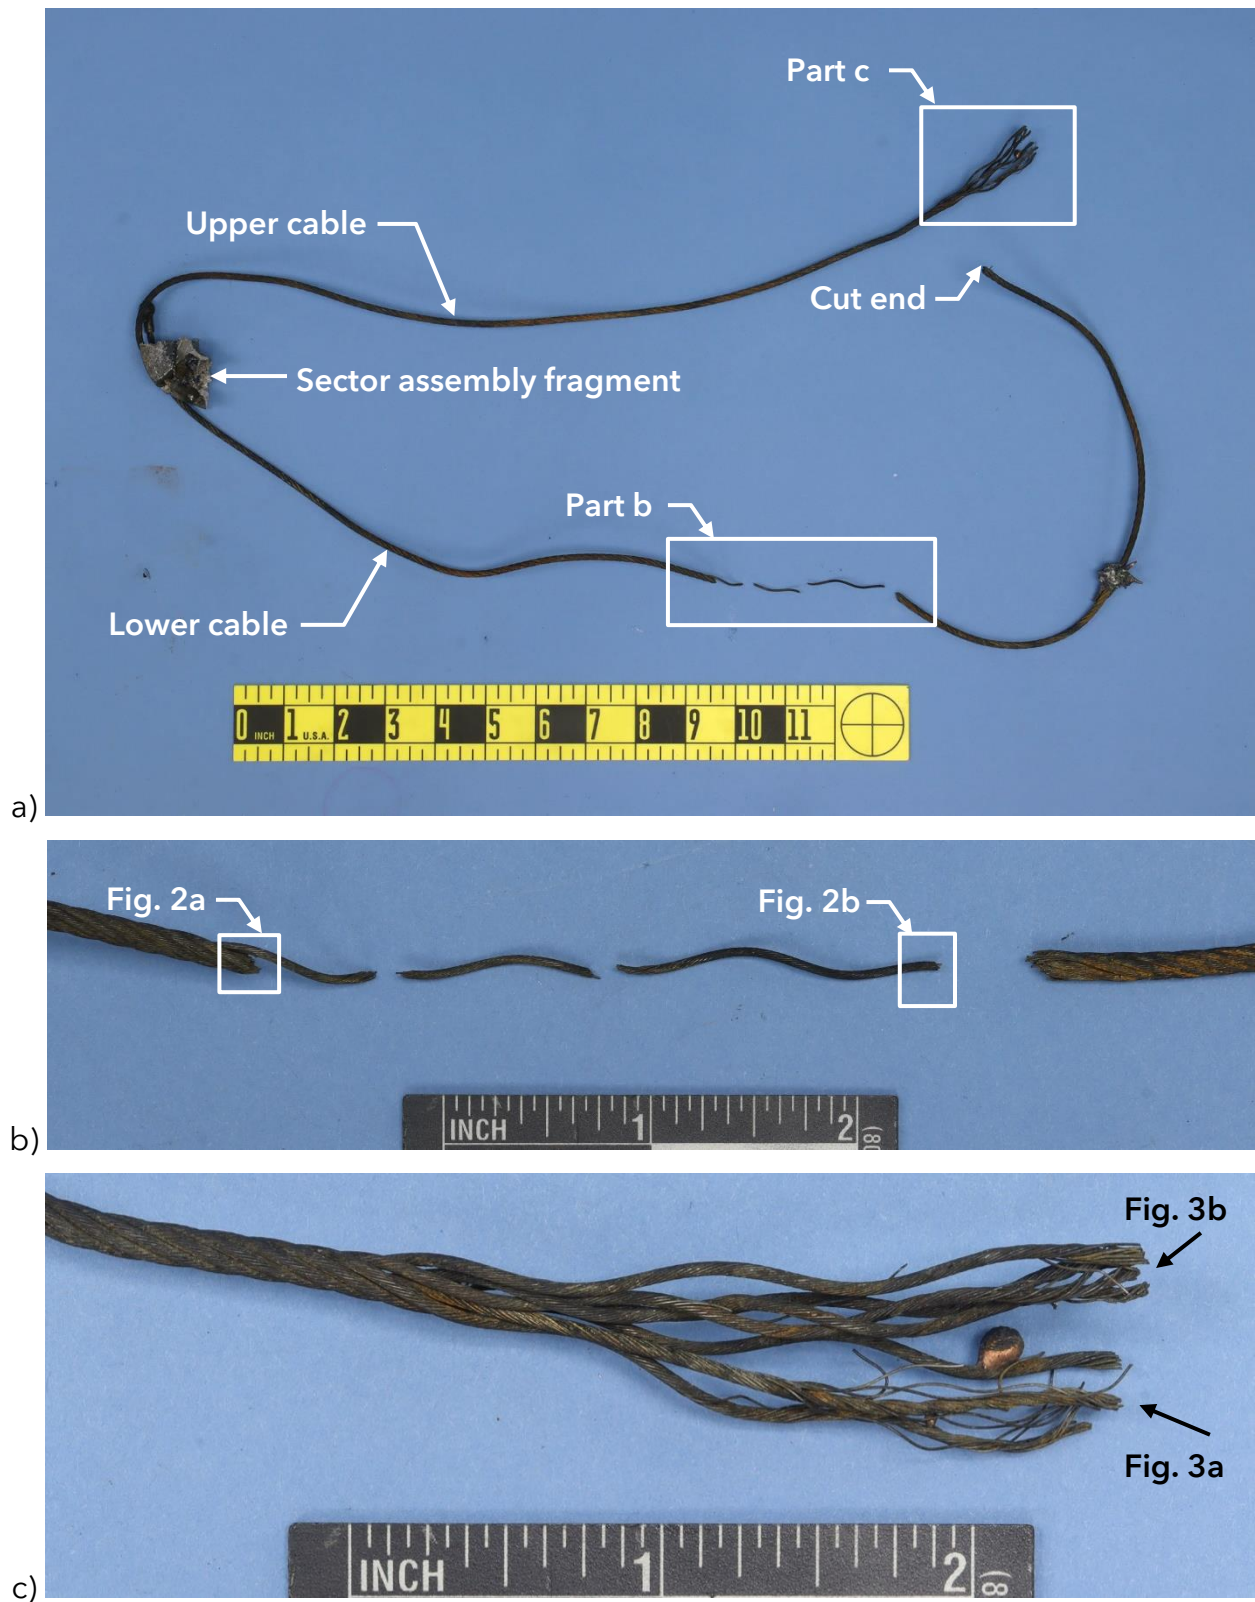
Three pieces of left aileron balance cables were submitted to the NTSB Materials Laboratory for examination, as shown in figure 1a. The cables consisted of seven strands with nineteen wires per strand. Two of the cable pieces were attached to the left aileron sector assembly, one being the outboard fragment of the lower cable and the other being the outboard fragment of the upper cable. The third piece appeared to be a continuation of the lower cable. Both lower and upper cables were fractured. The lower and upper cable fractured ends are shown in greater detail in figures 1b and 1c, respectively. The fractured ends were examined with the aid of a stereomicroscope.

**Figure 1.** Images of the as-received aileron control cables: a) overview images; b) lower cable fracture; and c) upper cable fracture.

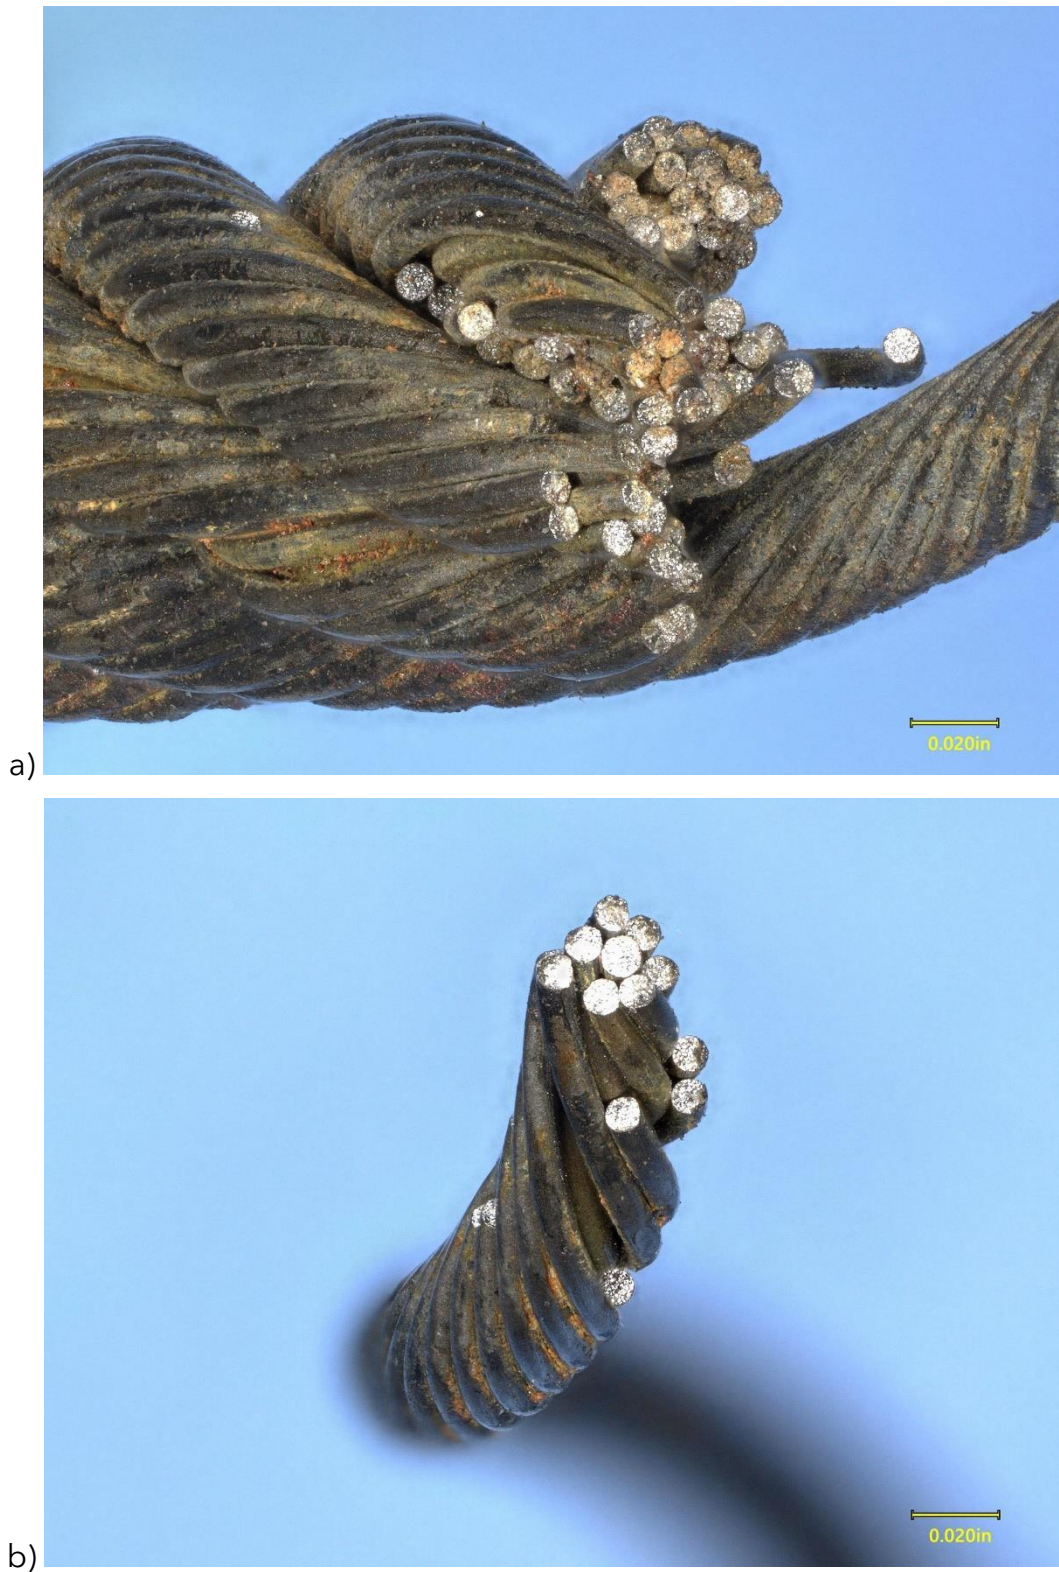
The lower cable fracture exhibited features consistent with brittle fracture. Six of the strands had fractured approximately 14 inch from the cable's outboard end and the seventh strand had fractured approximately 3 inch further inboard. While fixturing the cable for imaging with a digital optical microscope, the single long strand cracked at two locations (see figure 1b). Digital optical microscope images of the fractured strands are shown in figures 2a and 2b. The wire fracture surfaces had a shiny granular appearance and there was no apparent necking of the wires. The observations were consistent with post-crash brittle fracture from embrittlement of the cable.

**Figure 2.** Images of the fractured lower cable: a) six fractured strands, as indicated in figure 1b and b) the seventh fractured strand, also indicated in figure 1b.

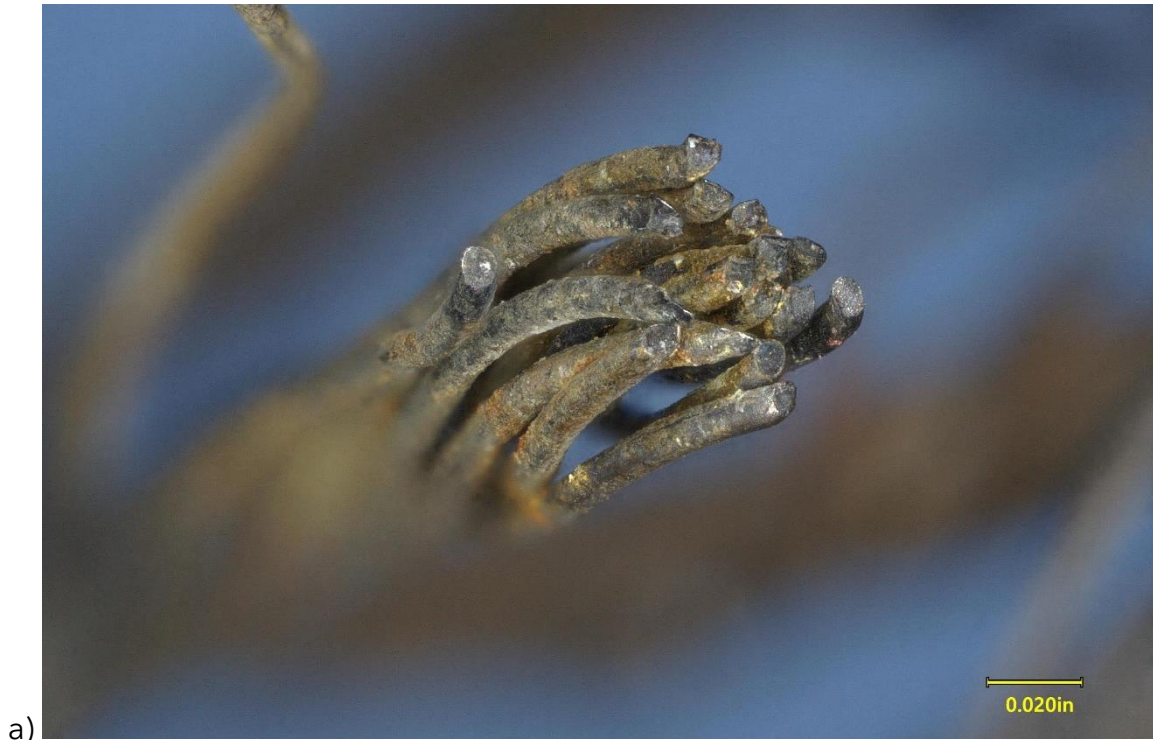
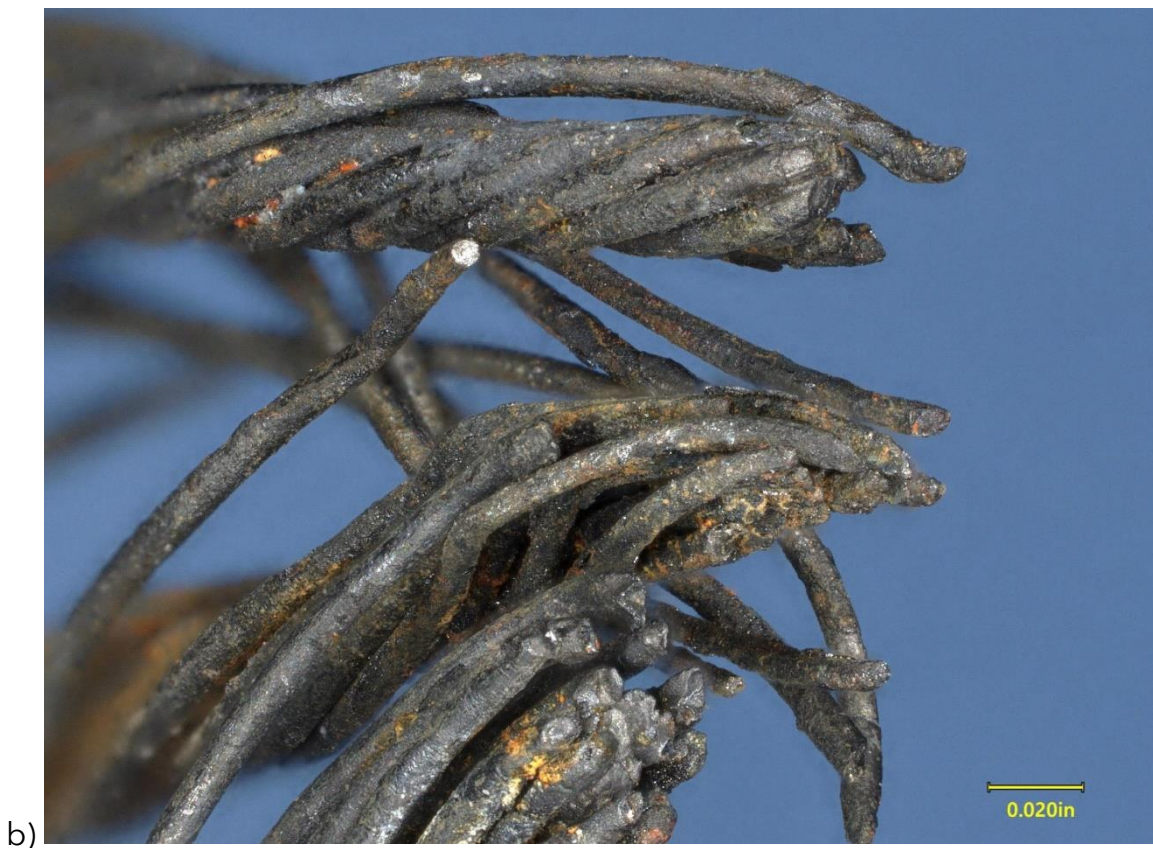
The upper cable fracture exhibited features with overstress separation. The cable strands were splayed apart, as seen in figure 1c. Several strand fractures are shown in figures 3a and 3b. Most of the wires exhibited slanted fractures and/or transverse deformation at the fracture. Some wires exhibited necking at the fracture. The fractured wire ends were dark and oxidized, consistent with exposure to fire. The observations were consistent with a shear separation of the cable.

**Figure 3.** Images of the fractured upper cable: a) and b) fractured strands, as indicated in figure 1c.
