# National Transportation Safety Board

CEN22FA119

## **POWERPLANTS**

Group Chair's Factual Report

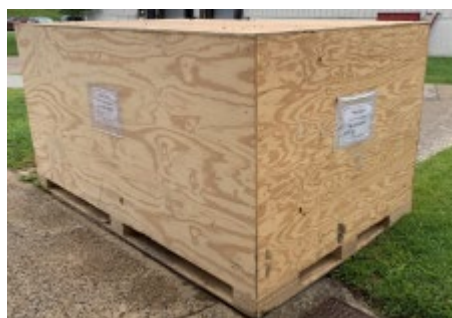
PHOTO 2: BOX AS SHIPPED

The engine arrived still secured in the shipping container and the container was opened in the presence of the examination team (Photo 2). The engine was in the container with the 9:00 to 11:00 o'clock position towards the bottom of the crate (left side down) (Photo 3).

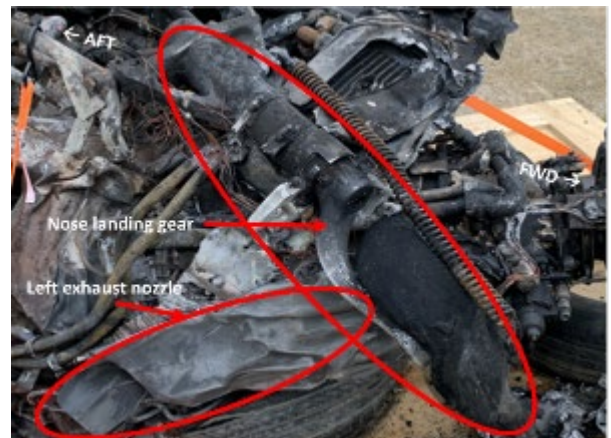
PHOTO 4: BOTTOM OF ENGINE

There was no evidence of uncontainment. Portions of the airframe engine cowlings were still attached to the engine and engine mounting trusses and had to be cut away. The entire engine was coated with black soot.

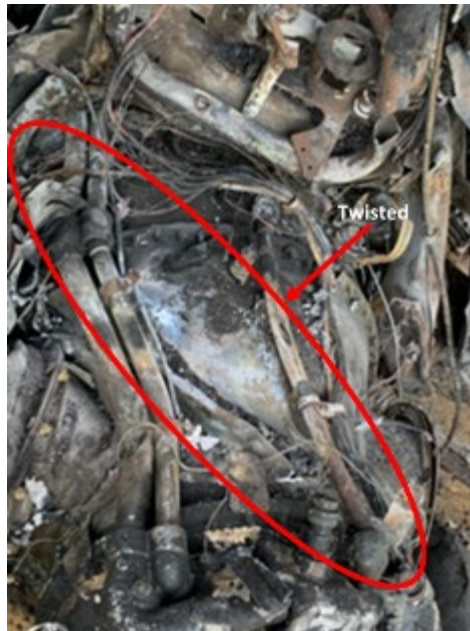
PHOTO 5: EXHAUST DUCT HOUSING TWIST

The firewall was bent aft and around the engine. The exhaust duct had visible angular deformation, consistent with torsional loading (Photo 5).

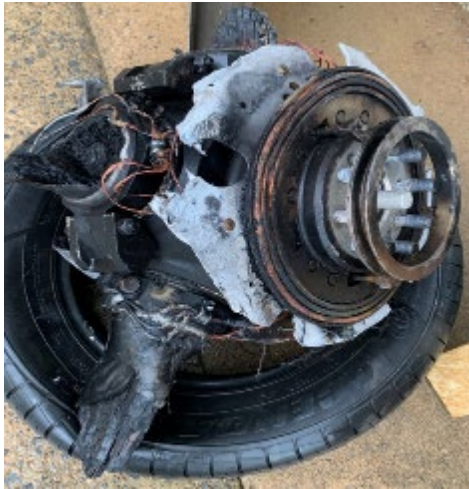
PHOTO 6: PROPELLER

All five propeller blades were broken at the hub (Photo 6). During removal of the propeller hub, the hub could be rotated by hand.

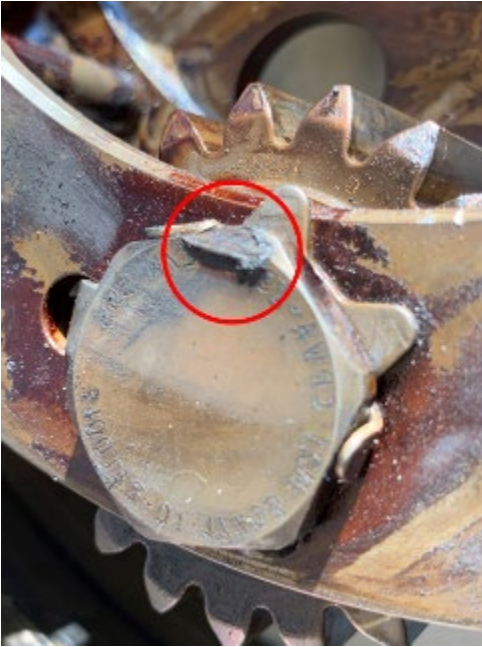
PHOTO 11: CONTACT ON BOLT HEADS

All five of the RGB 2<sup>nd</sup> stage planet gears turned freely. There were witness marks on the outer ring gear retaining bolts of the upstream face of the 2<sup>nd</sup> stage (Photo 11). A corresponding rub mark was on the downstream face of the RGB 1<sup>st</sup> stage carrier (Photo 12) consistent with impact.

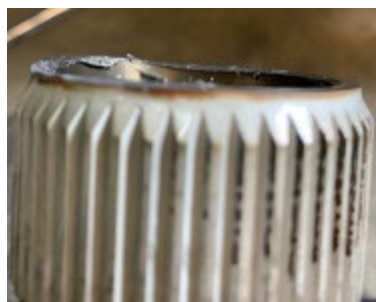
PHOTO 13: PROPELLER SHAFT

The propeller shaft was fractured adjacent to the engine RGB 2<sup>nd</sup> stage carrier, forward of the carrier splines, but was clean and oil-wetted. (Photo 13). The fracture surface appeared consistent with overload.

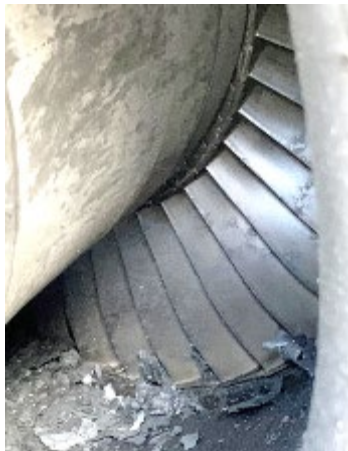
The 2<sup>nd</sup> stage PT blades and outer shrouds appeared intact (Photo 14). The downstream (aft) face of the disk, blade roots, and balancing rim exhibited

PHOTO 14: 2<sup>ND</sup> STAGE PT BLADES, WITH CHARRED AIRFRAME DEBRIS (BOTTOM)

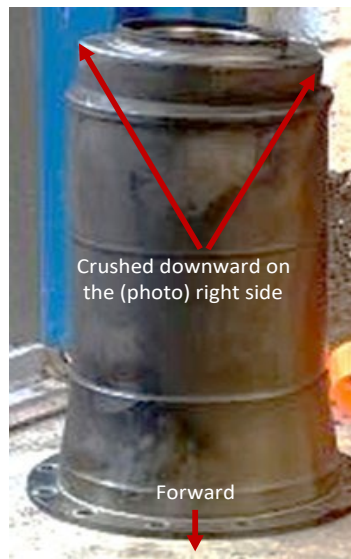
PHOTO 15: PT SHAFT HOUSING

The aft end of the PT shaft housing was asymmetrically crushed (Photo 15). The No. 3 and No. 4 bearings were clean, lightly oil-wetted, and rotated freely (Photo 16). The No. 4 bearing retention bolts were fractured.

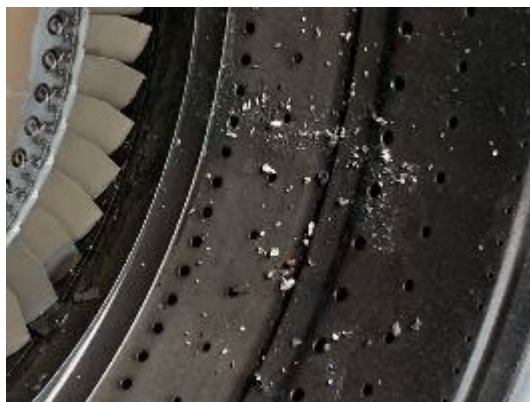
PHOTO 17: DEBRIS IN THE GAS PATH

Shiny, metallic debris was noted throughout the axial and centrifugal compressor, as well as the compressor turbine and combustion chamber (Photo 17).

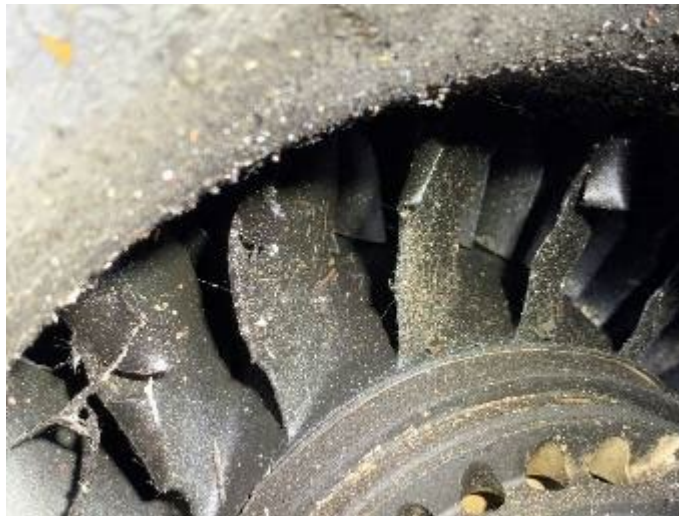
PHOTO 18: 1<sup>ST</sup> STAGE COMPRESSOR DAMAGE

With the AGB removed, the 1<sup>st</sup> stage axial compressor rotor blades and stator vanes could be seen. The 1<sup>st</sup> stage compressor blade airfoils were dented, torn, and bent opposite the direction of rotation (Photo 18). The 1<sup>st</sup> stage stators were all full-length and intact. There was evidence of tip rub and some impact damage present on all blades. There was no visible damage to the centrifugal impeller when viewed through a compressor bleed valve port on the gas generator case. The compressor was not disassembled further.

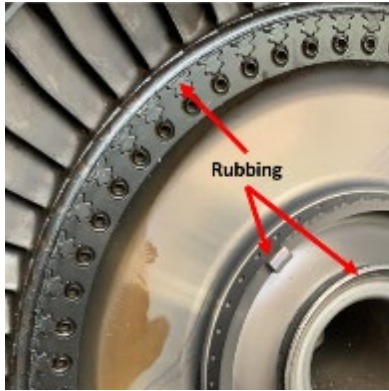
PHOTO 19: DOWNSTREAM (AFT) FACE, COMPRESSOR TURBINE

The compressor turbine was difficult to rotate by manually turning the blades. After removal of the AGB, tip rub was observed on all blades, with rubbing on the fir trees, disk bore, and balance weights. Rubbing was also noted on the downstream (AFT) (Photo 19) and upstream (Front) (Photo 20) blade platforms.

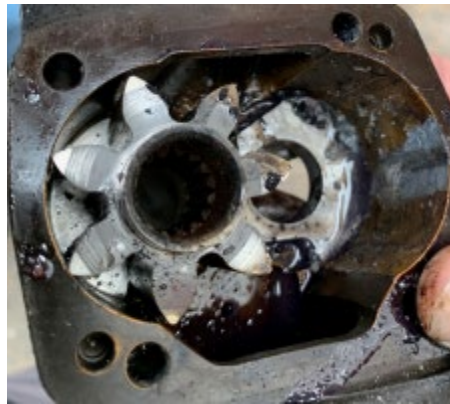
PHOTO 21: OIL PUMP

The pressure oil pump had debris inside consistent with the housing material. The displacement gears, whole and intact, had cut into the pump housing wall (Photo 21).

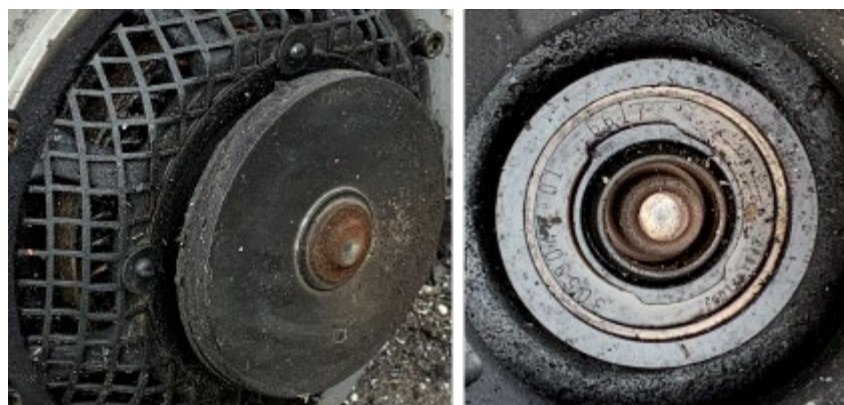
PHOTO 22: STARTER-GENERATOR

The oil tank was not intact; fragments of the tank were found in the shipping container. The starter-generator (Figure 5, Item 1) shaft was fractured (Photo 22).

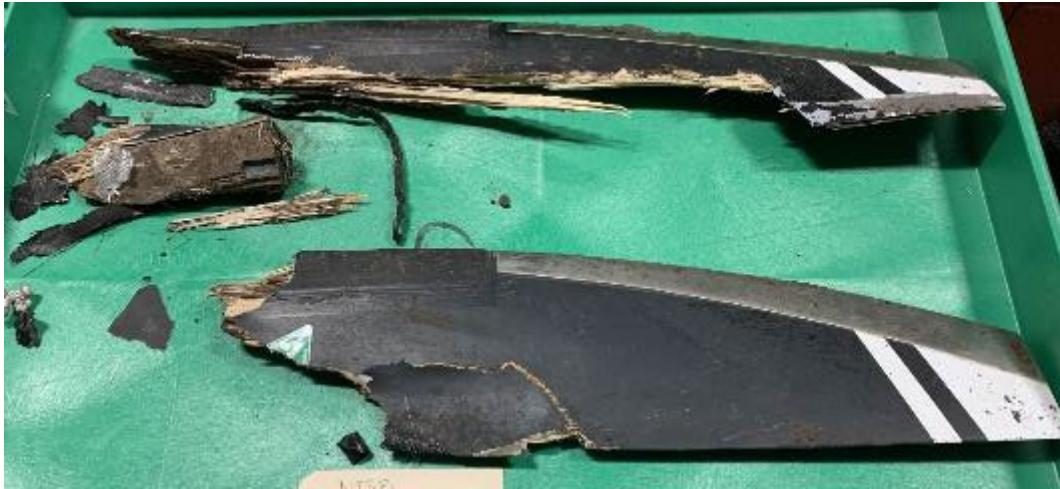
PHOTO 26: TWO RECOVERED PROPELLER BLADES

All the propeller blades were broken at the roots; only two airfoils were partially recovered on-scene. Both recovered blades were fractured, exposing the inner wood core (Photo 26).

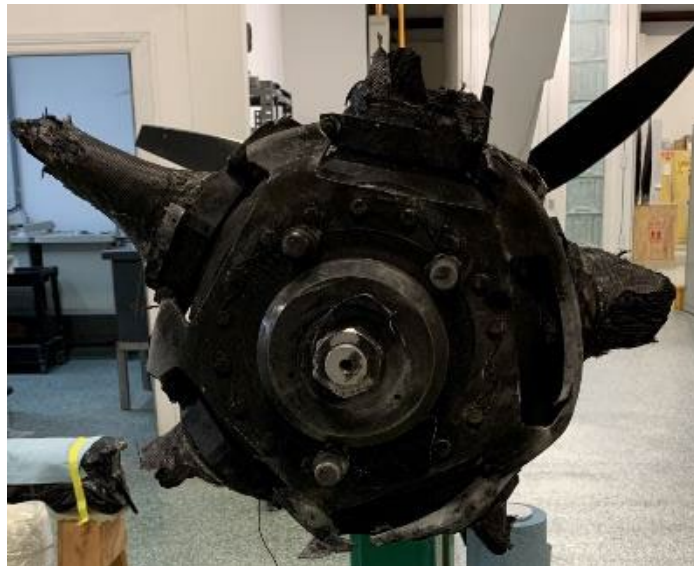
PHOTO 27: BURNED PROP HUB

The propeller was entirely sooted from the post-impact fire (Photo 27). The roots of all five propeller blades were present in the propeller hub and burnt/thermally distressed/fire damaged.

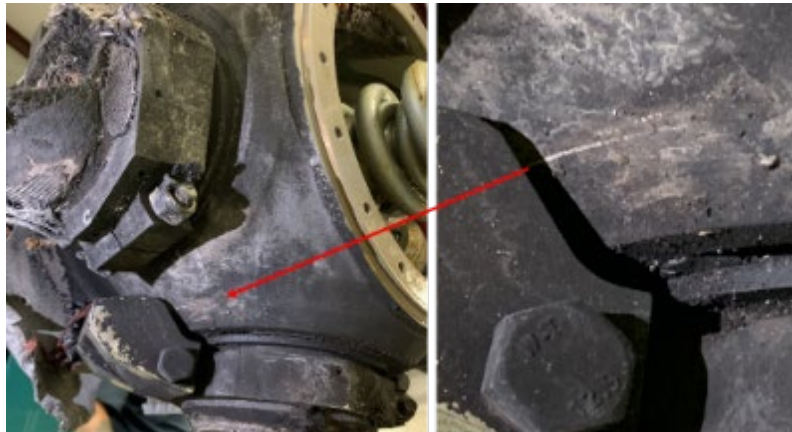
The exterior was heavily sooted. The aluminum components were all melted, consistent with being exposed to the post-impact fire. Snap rings were all present, keeping the blade roots locked in and level. Shiny, clean scuff marks were noted on the hub behind three of the five counterweights, as the counterweights may have shifted at some point after the post-crash fire (Photo 30).

PHOTO 30: SHINY SCUFF MARKS BEHIND THE COUNTERWEIGHTS

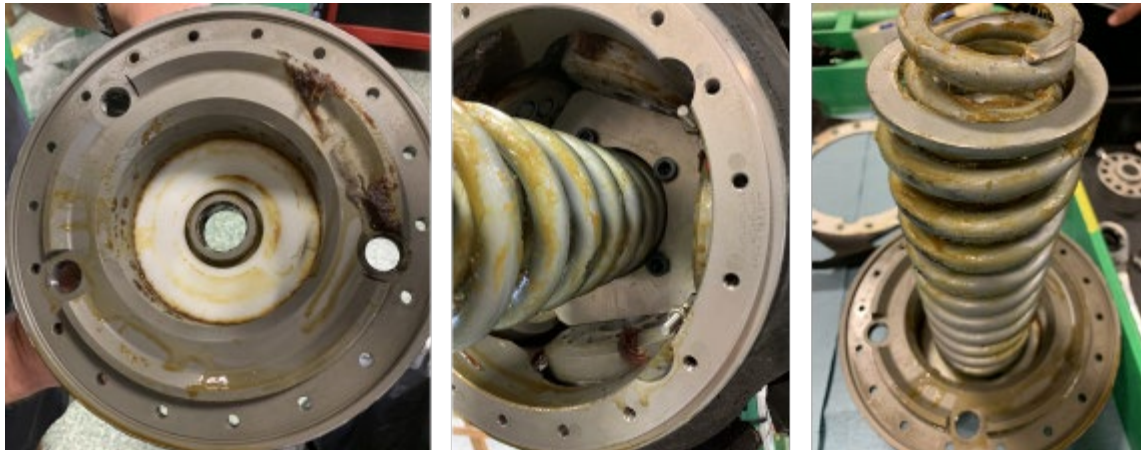
PHOTO 31: FEATHERING SPRING, RETURN SPRING, AND RETAINING RINGS

The feathering and retaining springs were whole, intact, and still under compression (Photo 31). The servo piston was whole, intact, and otherwise undamaged. The retaining rings at the forward and aft end of both springs were intact and otherwise unremarkable.

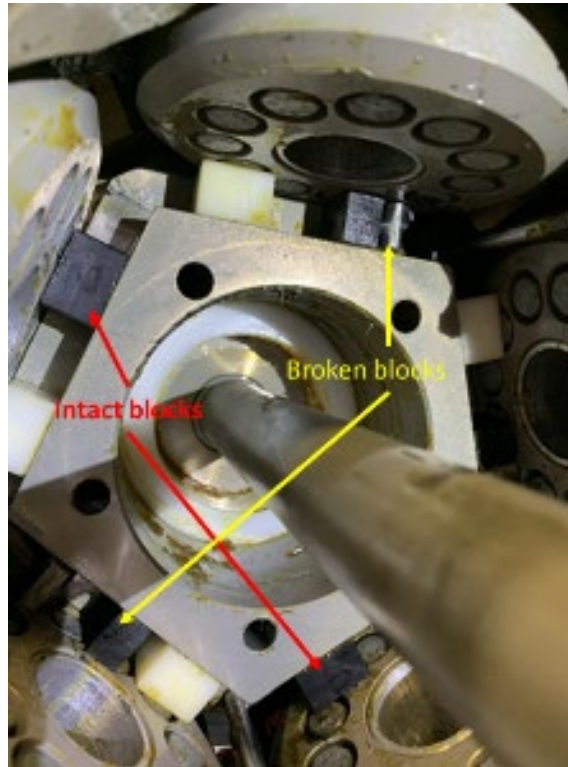
the axial movement of the servo piston turns the blades through the pitch change blocks. The movement of the servo piston moves two retaining plates which hold the front and back of the black and white blocks for each blade. The phenolic pitch change blocks (black) for propeller blades Nos. 2 and 5 were intact; however, the pitch change blocks for propeller blades Nos. 1, 3, and 4 were fractured (Photo 32).

PHOTO 32: AFT PITCH CHANGE PLATE WITH BROKEN PHENOLIC BLOCKS.

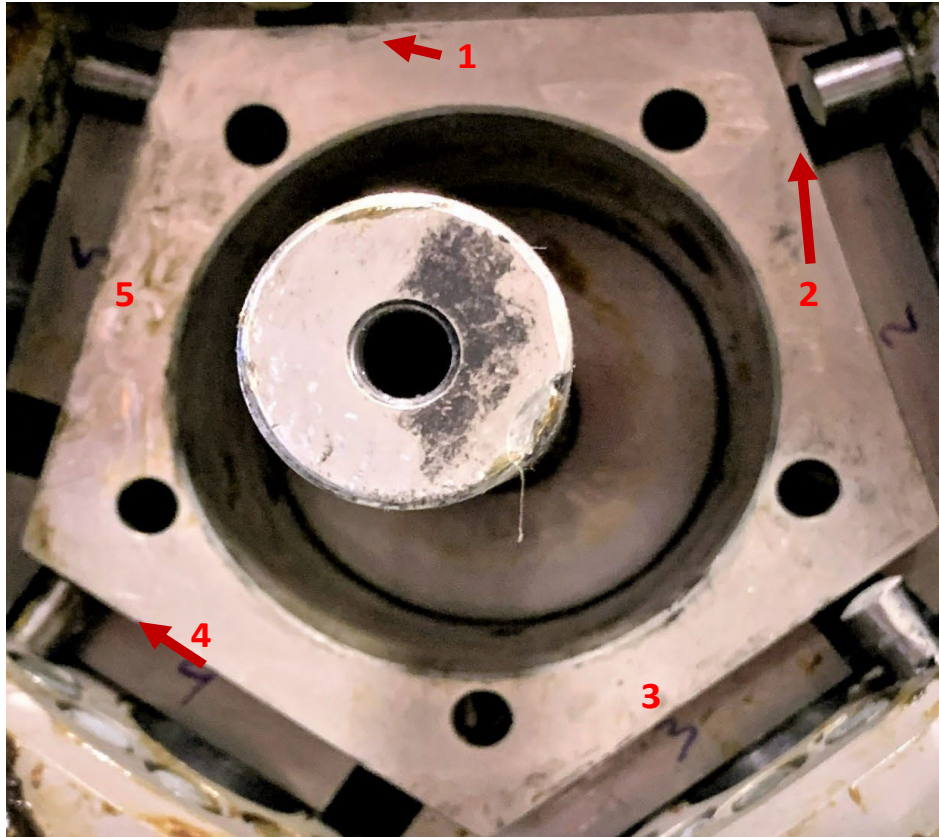
PHOTO 34: FORWARD FACE OF THE AFT PITCH CHANGE PLATE

Small indentations and scuff marks were noted on the forward face of the aft pitch change plate (Photo 33). The marks all measured 5.8 -7 centimeters (cm) (2.28 - 2.75 inches) from the installation alignment hole for the blade pins (Photo 34).

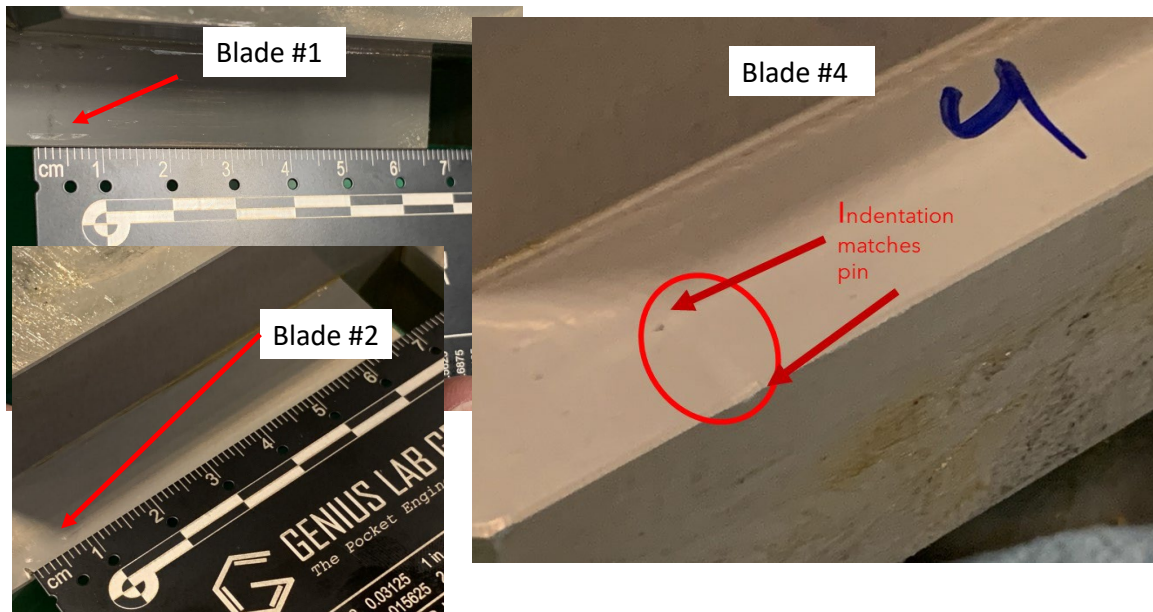
PHOTO 33: INDENTATION AND SCUFF MARKS ON THE PITCH CHANGE PLATE

The indentations and scuff marks to the pitch-change plate were compared to path of travel of the pin within the phenolic blocks (Figure 7). Two of the measurements, those greater than 6cm, were outside the normal length of travel for the pins. The mark at 5.8 cm (2.28 inches) on propeller blade No. 4, corresponds to 3.79 cm (1.49 inches) from the center of rotation. This would equate to a pitch angle of approximately 26-34 degrees; according to MT Propeller, this falls in the cruise

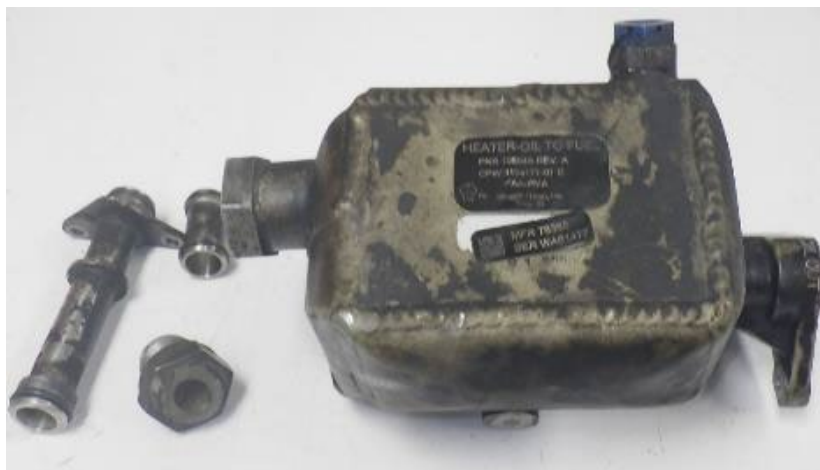
PHOTO 35: FUEL/OIL HEAT EXCHANGER (PHOTO COURTESY OF P&WC)

This heat exchanger was an airframe supplied component (Photo 35). The unit was covered with a black and oily deposit. The fuel outlet tube was present; the fuel inlet fitting was severed. The oil outlet and inlet ports were present and clean. One mounting support was fractured and missing. The lockwires were present and in the right locations. There were light fretting marks on the transfer valve outside diameter.

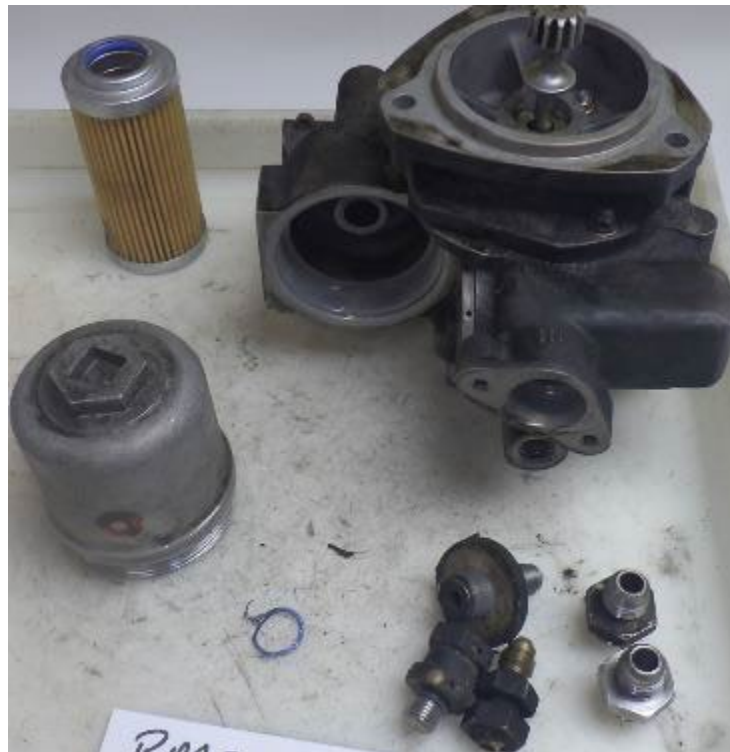
PHOTO 36: FUEL PUMP; COURTESY OF P&WC

The fuel pump S/N 011287 matched the original pump shipped with the engine (Photo 36). The housing was covered with black deposits. The outlet fuel fitting was partially pulled out of the housing. The input shaft was rotated by hand in step movements. The fuel inlet port appeared clean. Lockwires were in the appropriate locations except for the fuel filter bowl, which was missing the lockwire. Prior to testing the fuel pump, the outlet fuel filter bowl was removed revealing a clean outlet fuel filter with no visible debris between the pleats. The fuel inlet screen was removed and was found clean as well.

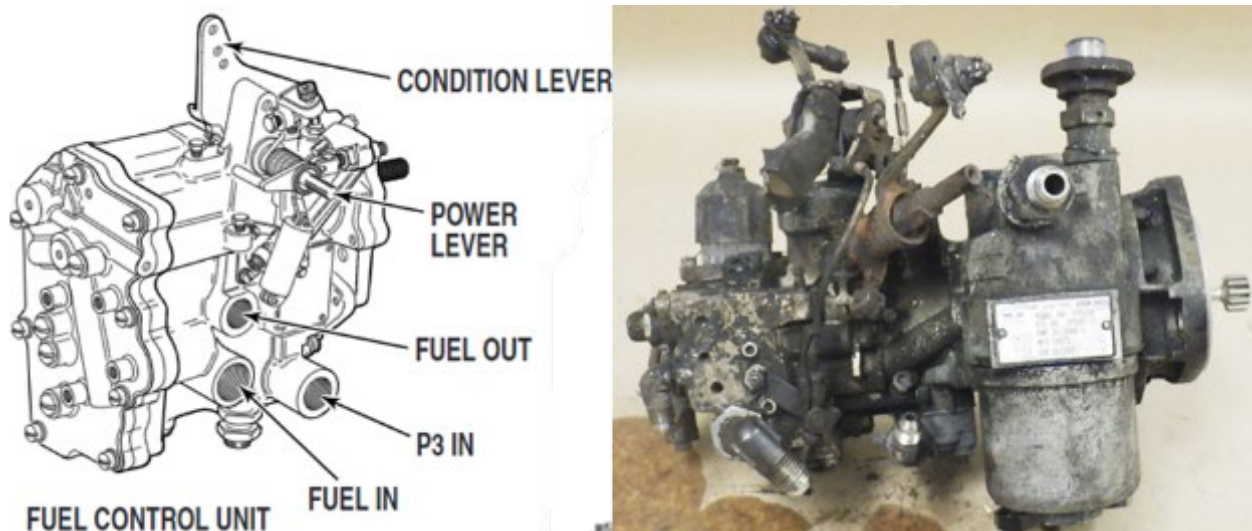
PHOTO 37: FCU DIAGRAM (PT6 OPERATOR'S MANUAL COURTESY OF P&WC) (LEFT) AND SUBJECT FCU(RIGHT)

The FCU housing was sooted (Photo 37, right). The metal components showed surface corrosion. The inlet fitting and throttle shaft were bent aft. The condition lever bracket was fractured. The minimum pressurizing valve housing was missing, along with the identification data plate. The manual override lever was bent aft and would not rotate full-travel by hand. The cut-off lever was bent inward. The acceleration adjustment cup was dented and perforated. The power trim was in the stowed position. The nylon coupling, where the fuel pump was removed, was in place and in good condition. The FCU drive shaft was rotated by hand with normal resistance. The acceleration adjustment lockwire, high-pressure relief valve lockwire, and high-pressure relief valve seal were damaged. Due to the impact damage, it was not possible to test the unit.

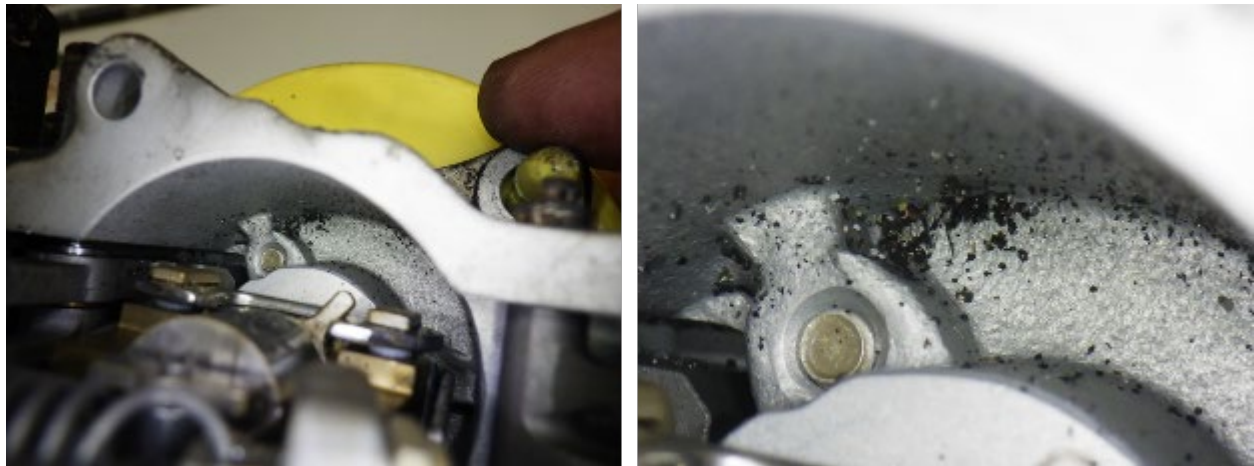
PHOTO 38: P3 & PY AIR INLETS (COURTESY OF P&WC)

Small particles were present in the Px (P3 after going through a restrictor, involved in controlling the compressor bleed valve) and Py air passages to the bellows cavity (Photo 38). Contaminants were observed on the cap bearing assembly, the governor weights, in the drive and flow bodies housing cavities. There was no spool gap, failing the CMM requirement. A thin film of a greyish residue was present on the Py pad and the Py bleed mating faces. There were no visible signs of wear. The Px pad showed a dimple at the contact point with the fluted pin head. The air inlet adaptor P3 and Py ports showed presence of small particles. The Pa (ambient pressure) bleed, Py orifice and Py bleed were clean. There was a thin, darkish deposit on the fluted pin valve hat (adaptor side). The removed bellows showed contaminant on the governor side, consistent with excess rust inhibitor protection applied on the flow body housing bellows bore during assembly.

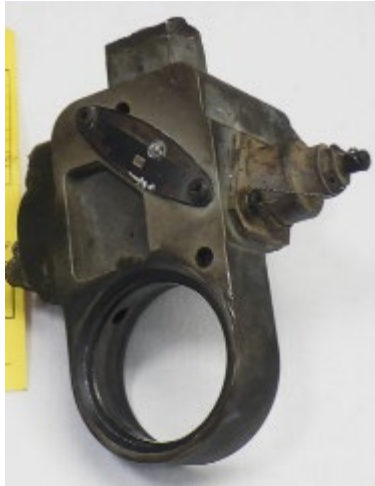
PHOTO 39: TORQUE LIMITER (COURTESY OF P&WC)

The P&WC records showed the original unit installed was P/N 3055738-01 (Honeywell P/N 4138012-2) S/N C79505. The identification data plate was illegible (Photo 39). The housing was partially sooted. There was oil coking or burnt packing on the mounting ring and in the inlet port. Surface corrosion was present on the metal parts. The Py fitting appeared clean. The lockwires were in place at the proper location. The seals were present and in the proper locations.

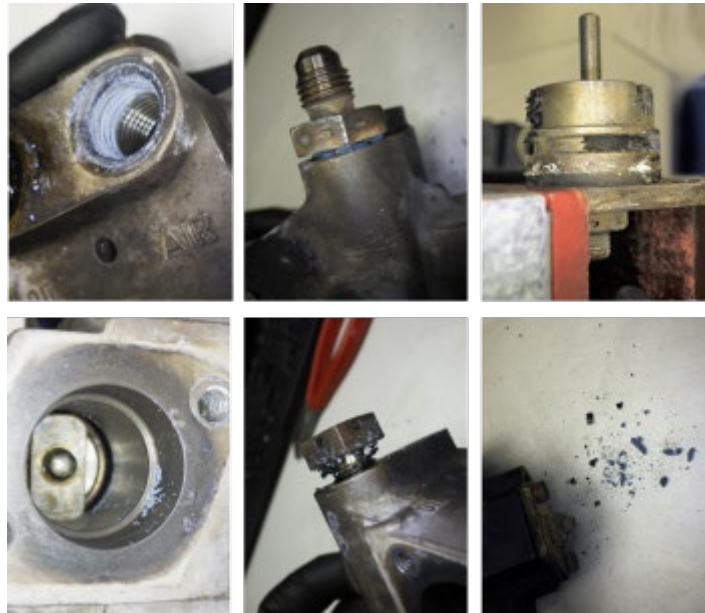
Disassembly of the unit showed all preformed packings were either very brittle and cracked or reduced to powder, which could explain the external leakage and the deviation to the specifications observed during testing (Photo 40). The remaining components were in good condition.

PHOTO 40: BRITTLE PACKINGS (COURTESY OF P&WC)

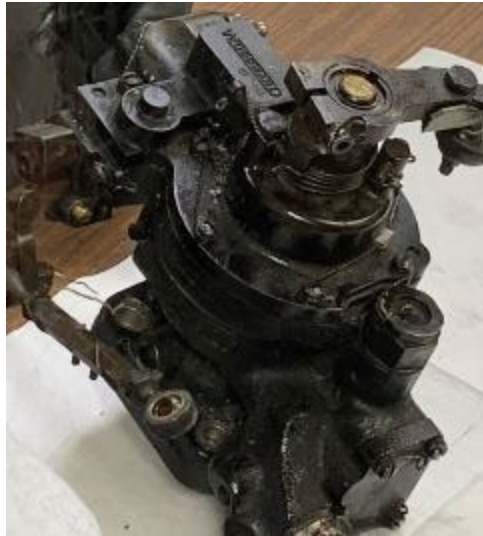
PHOTO 43: PROPELLER GOVERNOR, UNPACKED AT WOODWARD  
(COURTESY OF WOODWARD)

There were several customized fittings and hardware attachments, as well as several foreign wires and seals all indicative that the CSU had been serviced at some time by someone other than Woodward. The visual condition was deemed "pretty bad but testable" according to the Woodward mechanics (Photo 43). The repair date on the assembly was confirmed to be July 8, 2021.

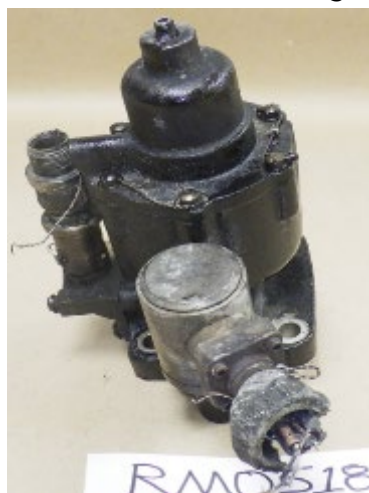
PHOTO 46: OVERSPEED GOVERNOR (COURTESY OF P&WC)

The overspeed governor is an airframe-supplied part; therefore, it is unknown if it was an original installation. Upon initial examination at P&WC, it was heavily sooted (Photo 46). The airframe harness connector was melted on the feathering solenoid connector. The reset solenoid airframe harness connector was present but was unable to be removed by hand. The solenoid body was rotating by hand, but the movement was limited to few degrees. There was an impact damage next to the speed adjustment screw. The input shaft was rotating by hand. The reset and feather solenoids lockwire going to the connectors were broken. A lockwire from the cover retaining bolts was broken and a section was missing.

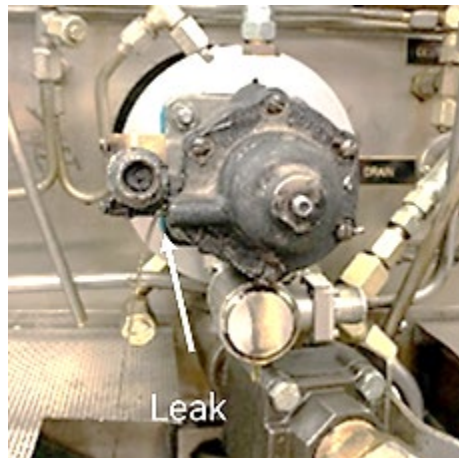
During testing of the overspeed governor, a leak was observed at the reset solenoid (Photo 53). The governor reacted to an overspeed condition at a significantly lower RPM than normal. On a second test run, with the solenoid energized (open), a significant leak was noted at the reset solenoid. The reset solenoid was removed, and the test re-run with a shop supplied serviceable solenoid. With a shop supplied solenoid installed, the governor and reset function performed closer to test specification, possibly suggesting the accident reset solenoid was partially open.

PHOTO 53: RESET SOLENOID LEAKING DURING INITIAL TESTING  
(COURTESY OF WOODWARD).

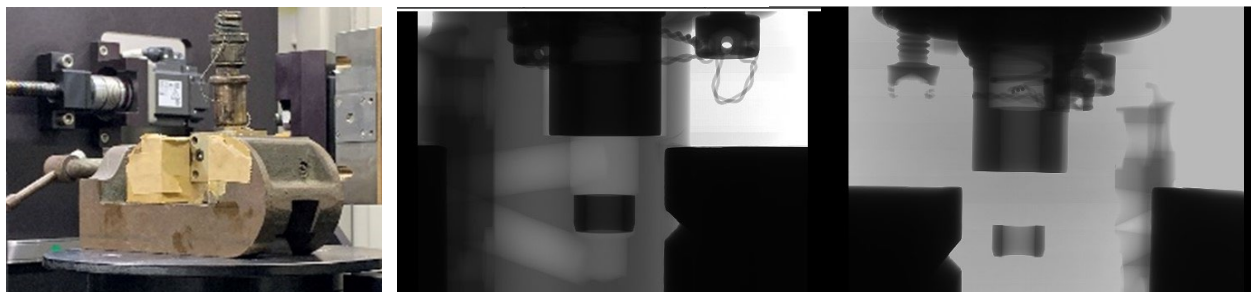
PHOTO 54: X-RAY SET-UP (LEFT); IMAGES OF FEATHERING SOLENOID (CENTER, LEFT; COURTESY OF WOODWARD)

Both the feathering and reset solenoids were x-rayed and leak tested at the Woodward facilities (Photo 54). The reset solenoid (Woodward P/N 1310-105) poppet and spring were offset at an angle within the housing (Photo 55). The reset solenoid leaked at lowest possible pressure setting (Photo 56), with valve de-energized (closed). A small differential pressure was noted, suggesting the poppet was only partially displaced.

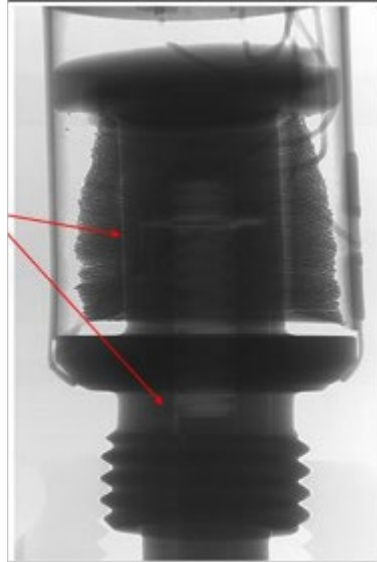
PHOTO 55: RESET SOLENOID X-RAY (COURTESY OF WOODWARD; MODIFIED BY NTSB)

Solenoid  
damage:  
top is bent,  
not aligned  
with  
poppet  
(bottom)

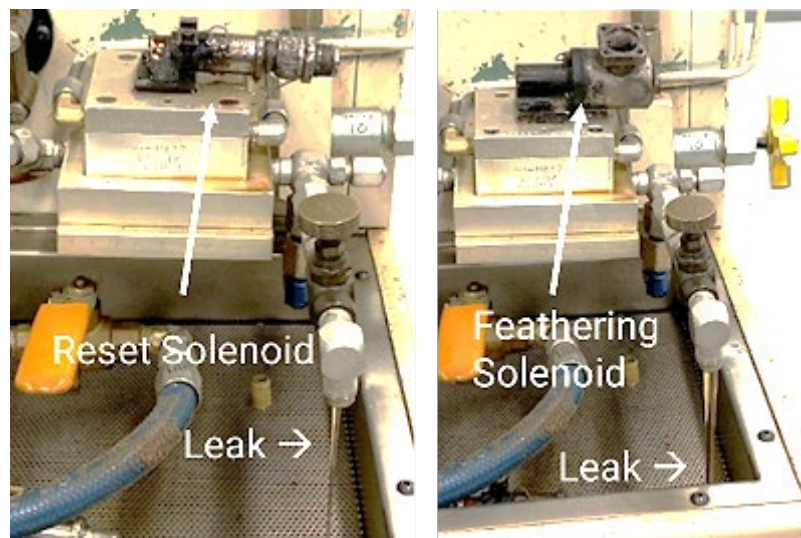
PHOTO 56: LEAK TEST OF THE OVERSPEED GOVERNOR RESET AND FEATHERING SOLENOIDS (COURTESY OF WOODWARD)

The feathering solenoid (Woodward P/N 1310-118) also leaked at lowest possible pressure setting, registering no differential pressure (Photo 56). The poppet, or plunger, was not visible in the x-rayed image as it is made of a Kel-F plastic. According to Woodward, the observed leak was most likely due to the plastic poppet having melted during the post-impact fire.

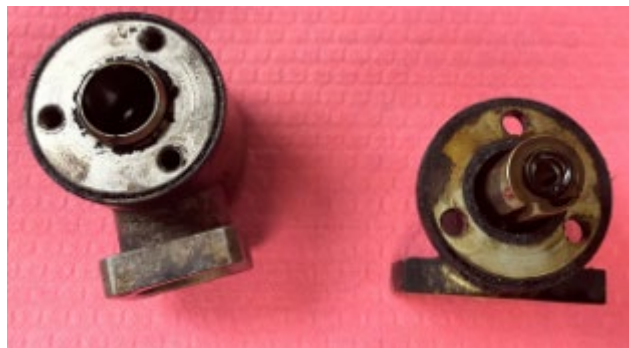
PHOTO 58: FEATHERING SOLENOID HOUSING (COURTESY OF WOODWARD)

To disassemble the feathering solenoid, the lockwire was removed and the solenoid was separated from the housing (Photo 58). A small amount of oil was present on the top of the solenoid. The plunger and spring separated with the body. The O-ring was charred and burned. Heat distortion to the packing was clearly evident, and, in removing the spring and plunger, the poppet, which is made of KEL-F plastic, was not present.

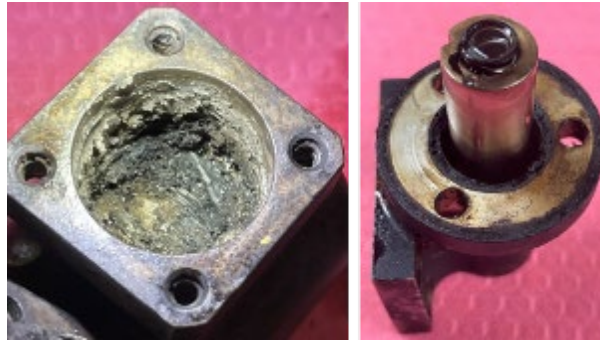
It was noted that the nameplate, which is an adhesive sticker, was missing from the housing. The alignment pins, pressed in radially to align and hold the solenoid to the body, were confirmed to be installed correctly 180-degrees out from each other and were sheared internally. All potting was missing inside the connector, and the housing held dried and crumbly deposits. According to Woodward, the debris was most likely the stycast - a thermally conductive epoxy used to encapsulate components for heat dissipation and thermal shock - and RTV (Photo 59).

PHOTO 59: DEPOSITS IN THE HOUSING (LEFT) AND EXPOSED SPRING IN THE SLEEVE(COURTESY OF WOODWARD)
