**NATIONAL TRANSPORTATION SAFETY BOARD  
Office of Aviation Safety  
Washington, DC 20594**

**SUMMARY OF AIRCRAFT EXAMINATION**

**CEN22FA145**

Location: Pond Creek, Oklahoma  
Date: March 17, 2022  
Time: 4:38 pm Central Daylight Time  
Aircraft: Piper PA-30 (S/N 30-1504) N8357Y

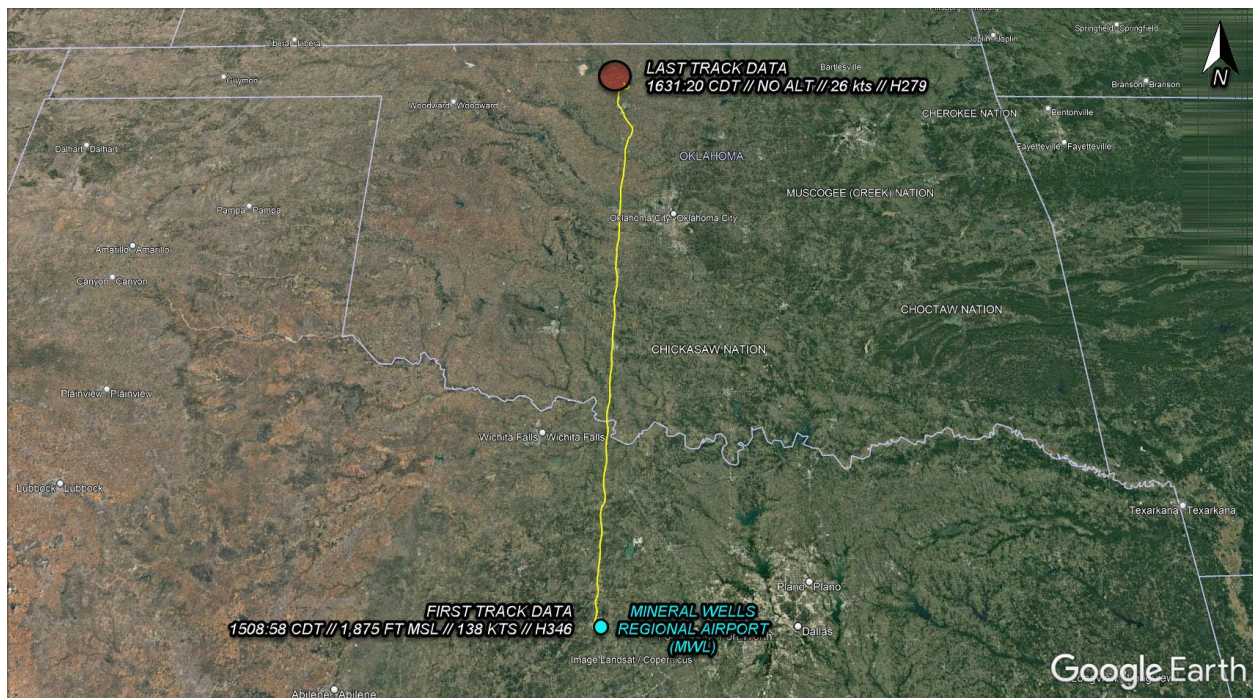
Figure 1. ADS-B Flight Track.

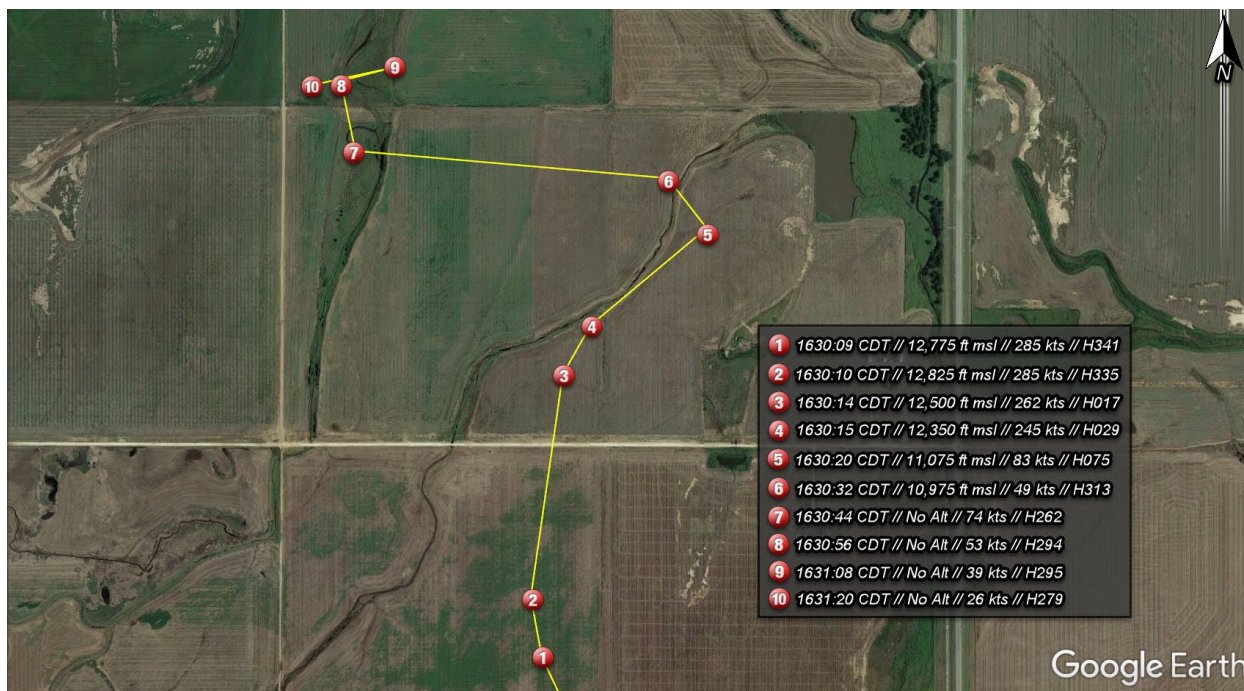
Figure 2. Radar Depiction of the End of the Flight Track.
